Failure Investigation Report – Liquefied Natural Gas (LNG) Peak Shaving Plant, Plymouth,
Washington

DOT US Department of Transportation
PHMSA Pipeline and Hazardous Materials Safety Administration
OPS Office of Pipeline Safety, Western Region
WUTC Washington Utilities and Transportation Commission (PHMSA Interstate Agent)

Principal Investigator Scott Rukke, WUTC
Senior Accident Investigator Peter Katchmar, PHMSA
Region Director Chris Hoidal, PHMSA
Date of Report 4/28/2016
Subject Failure Investigation Report – Liquefied Natural Gas (LNG)
Peak Shaving Plant, Plymouth, Washington
Operated by Williams Partners Operating, LLC

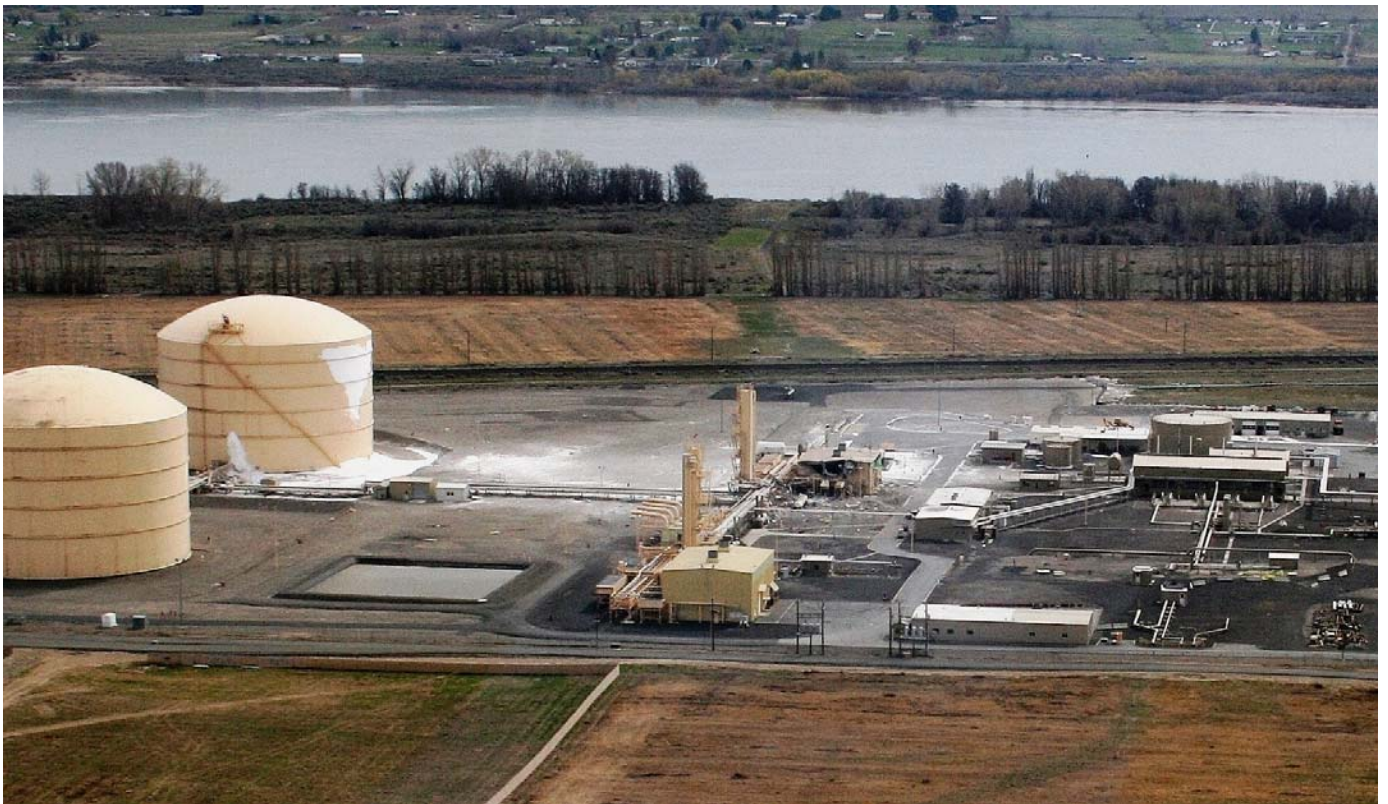
Aerial view taken shortly after the failure. Looking South toward Columbia River.

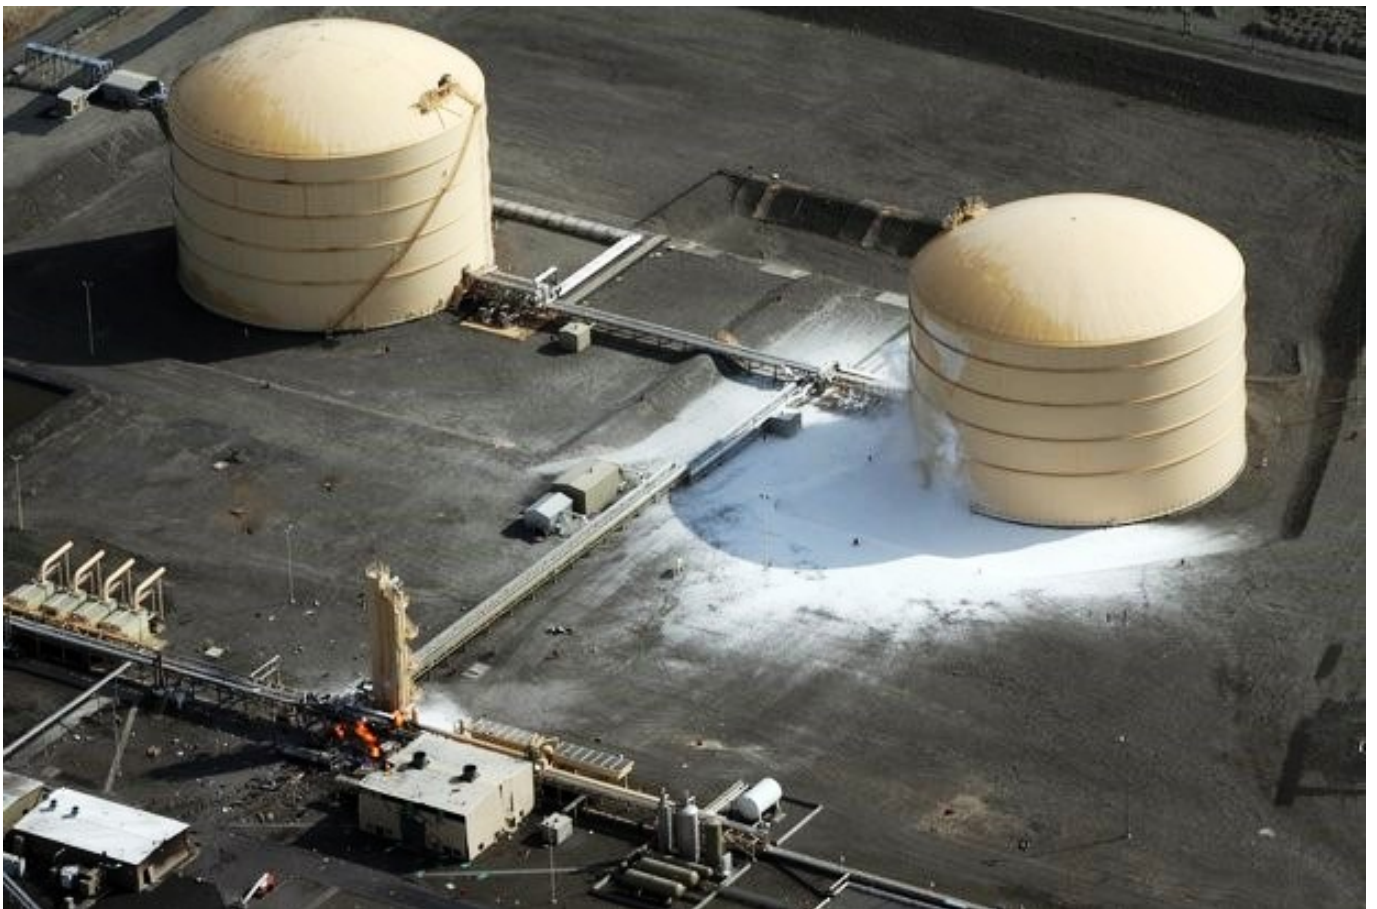
The penetration of the outer shell of the LNG-1 storage tank caused the Perlite insulation between the annulus of the inner and outer tanks of the storage tank to be compromised, thereby allowing LNG "boil-off" gas to escape. Boil-off gas is the product of the constantly vaporizing LNG present in the inner tank which is open at the top. It was unknown whether boil off gas was originating directly from a debris-caused penetration of the inner tank shell of LNG-1 or was migrating through the top of the inner tank, through the annulus between the two tanks, and out the penetration of the outer tank. Regardless, a decision was made to evacuate the town of Plymouth and the surrounding communities within a two-mile radius. It was later confirmed that the inner tank of LNG-1 was not penetrated. The inner tank did sustain a minor dent, which was repaired.

Aerial view taken shortly after the failure. Fires still burning. Perlite insulation leakage from the penetrated outer LNG-1 storage tank. Control room lower left.

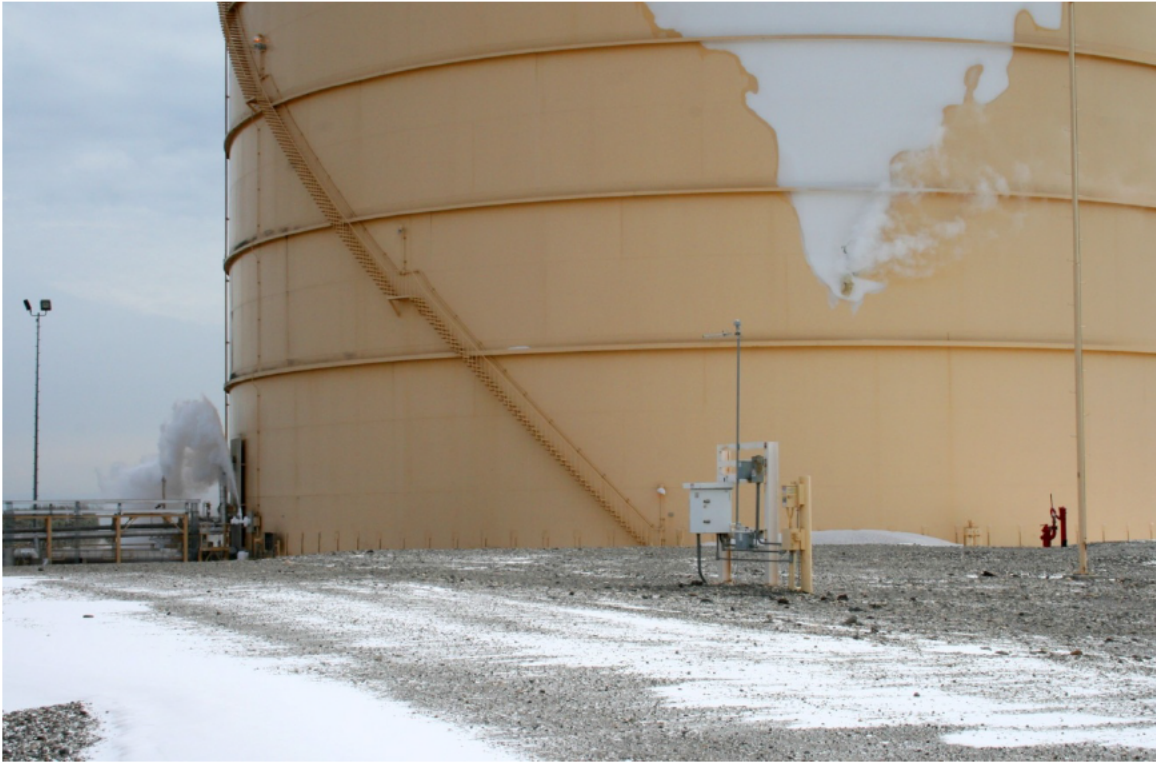
Additionally, a protruding one half-inch diameter instrumentation pipe located near the bottom of the LNG-1 tank was damaged. This allowed LNG to release in a spray and vaporize. There was no pooling of the LNG and there was no resulting vapor (methane) cloud that left the plant. As soon as the plant was made safe, Williams' personnel donned cryogenic suits, entered the facility and closed the valve between the damaged pipe and LNG-1 tank wall, shutting off the LNG release at the tank. The release continued for approximately 25 hours and an estimated 9.3 barrels per hour or a total of 234 barrels was released.

View of the outer shell penetration of the LNG-1 storage tank, looking east. Leaking 1/2-inch LNG instrument line lower left side of tank. V-shaped ice formation above outer shell penetration. Perlite insulation on ground lower left.

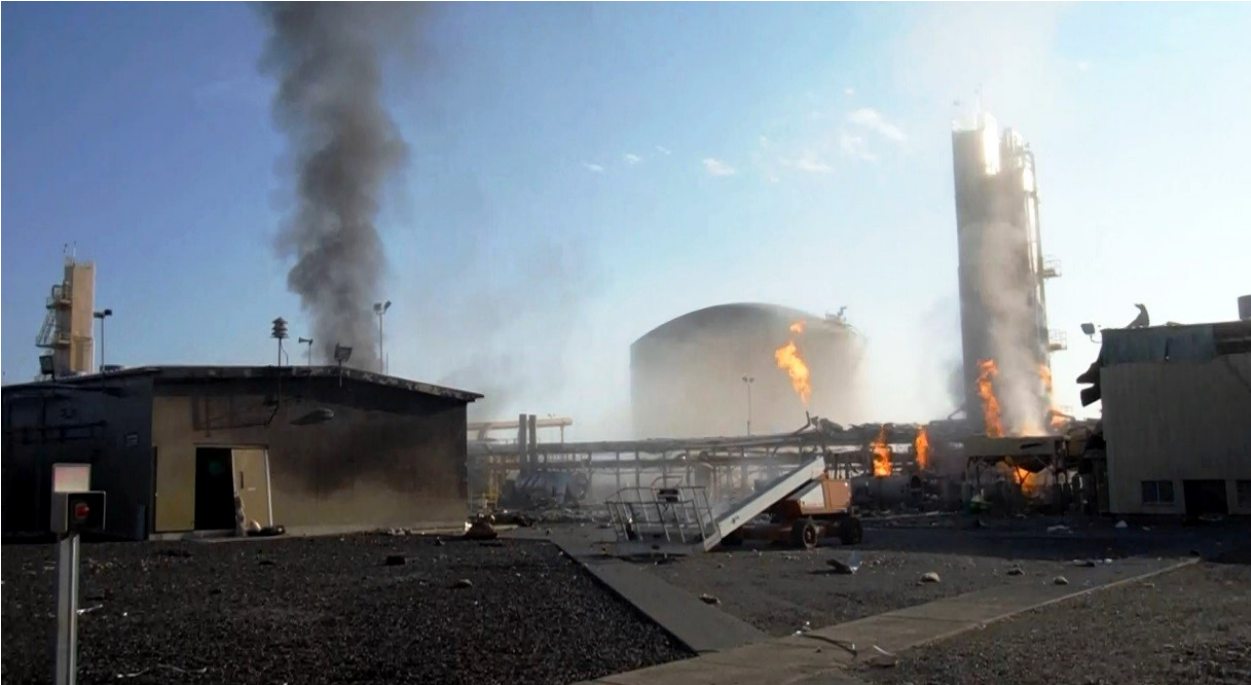
Control room – center left. LNG-1 compressor building center right, refrigerant tower to the left of the compressor building. Natural gas fires from severed purification loop piping near the failed adsorber.

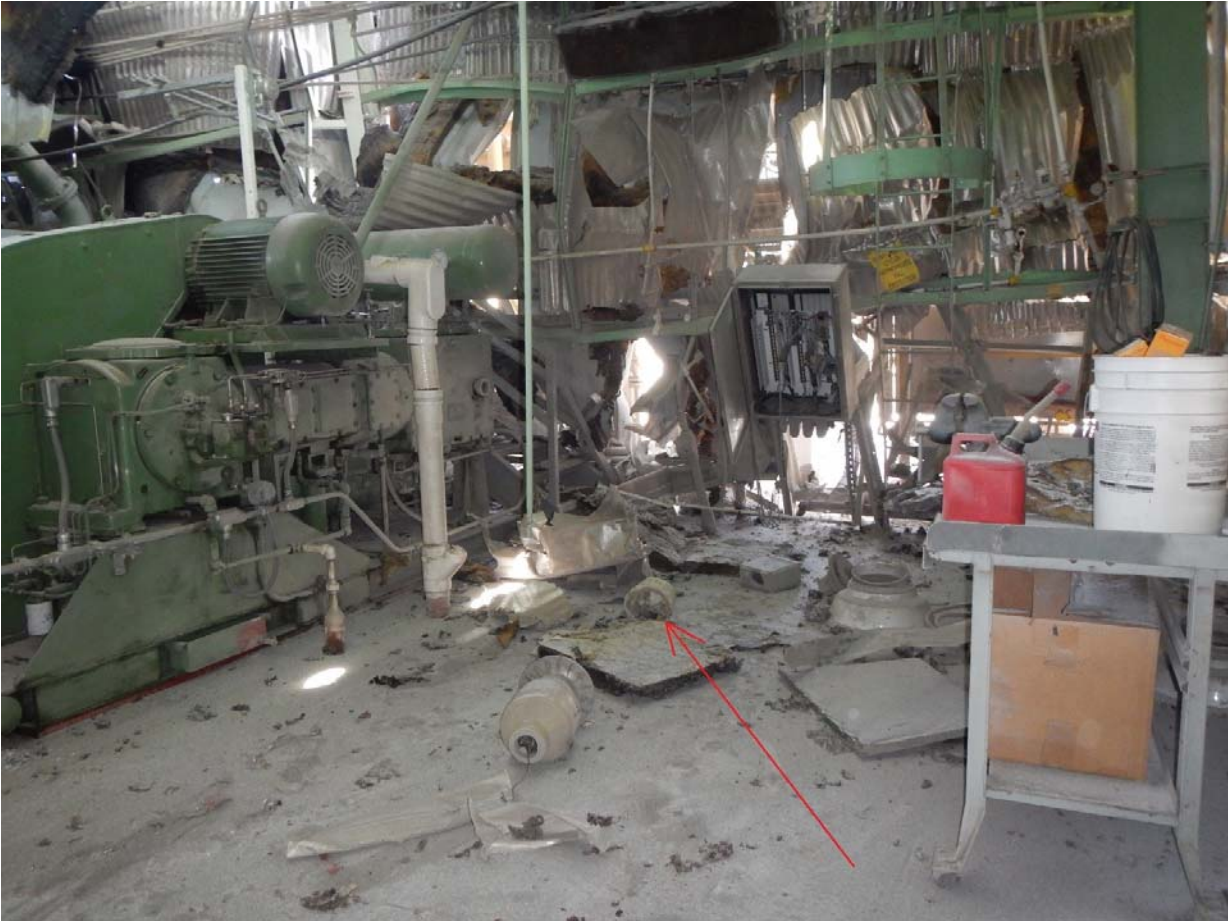
View from inside the Compressor Building where 2 employees were listening for the compressor start-up. The failed adsorber was on the outside of the back wall in this picture. The employee that was hospitalized with burns was in this area. Red arrow points to a hard hat.

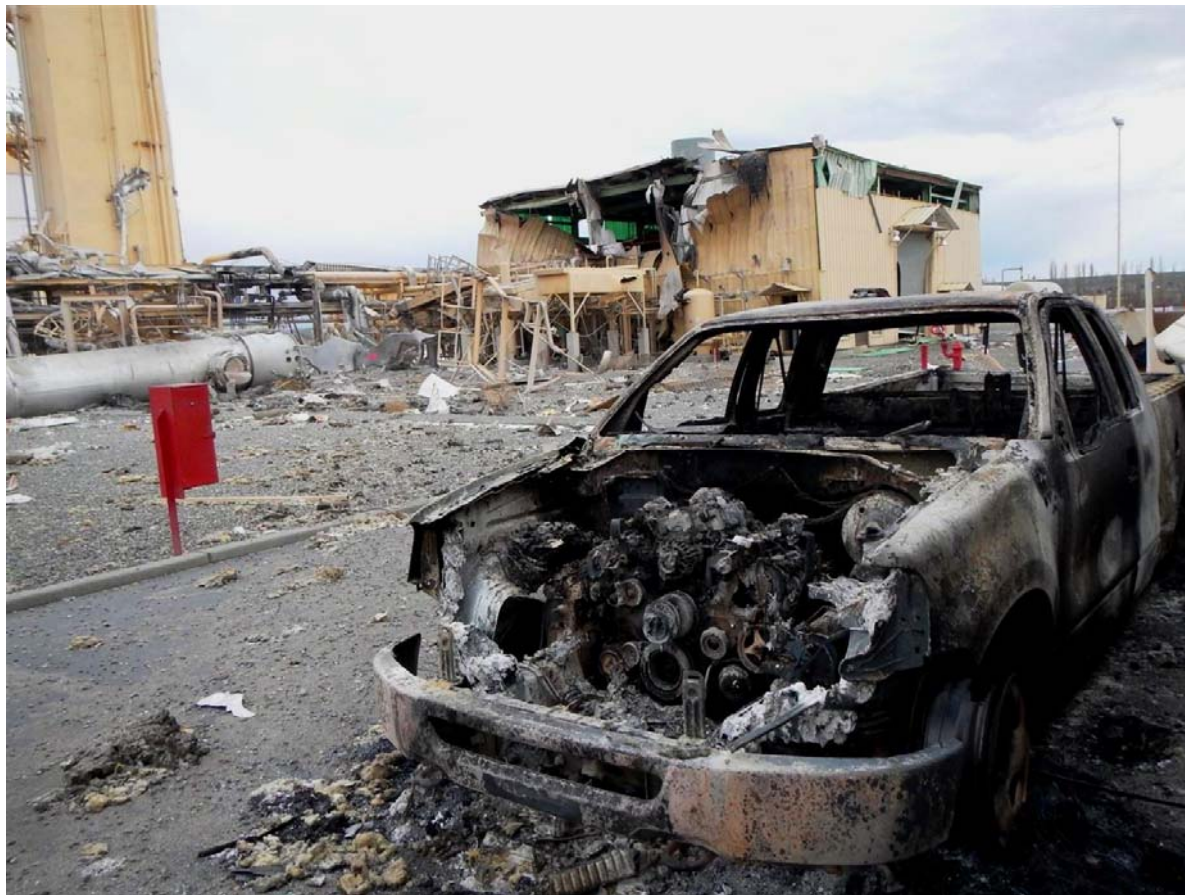
Looking SE towards the failure site from in front of the Control Room. One of the twin adsorbers lying on its side. Compressor building in center-back. Refrigerant tower top-left. Use burned truck as reference.

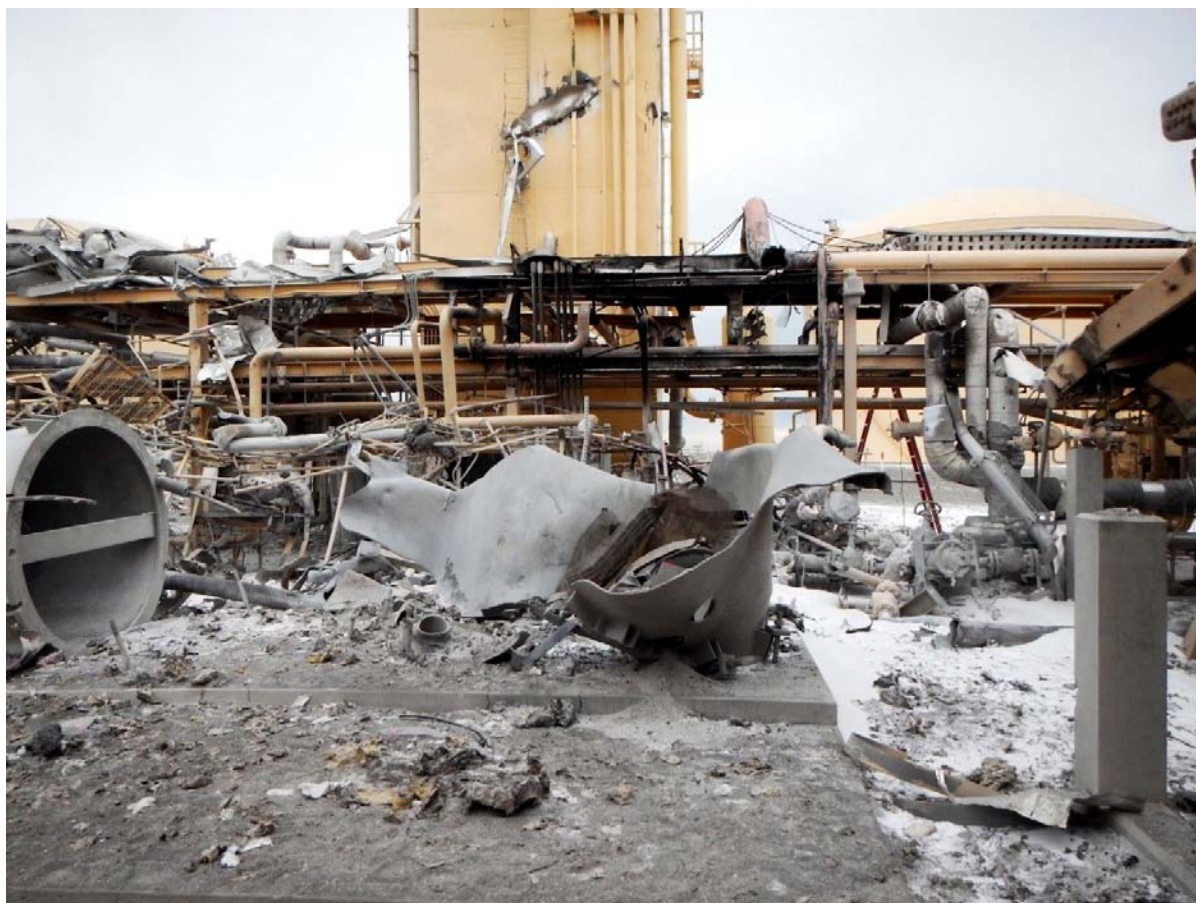
Remnants of the failed adsorber base center. Refrigerant tower top center. Large piece of debris from the failed adsorber embedded in the center of tower.

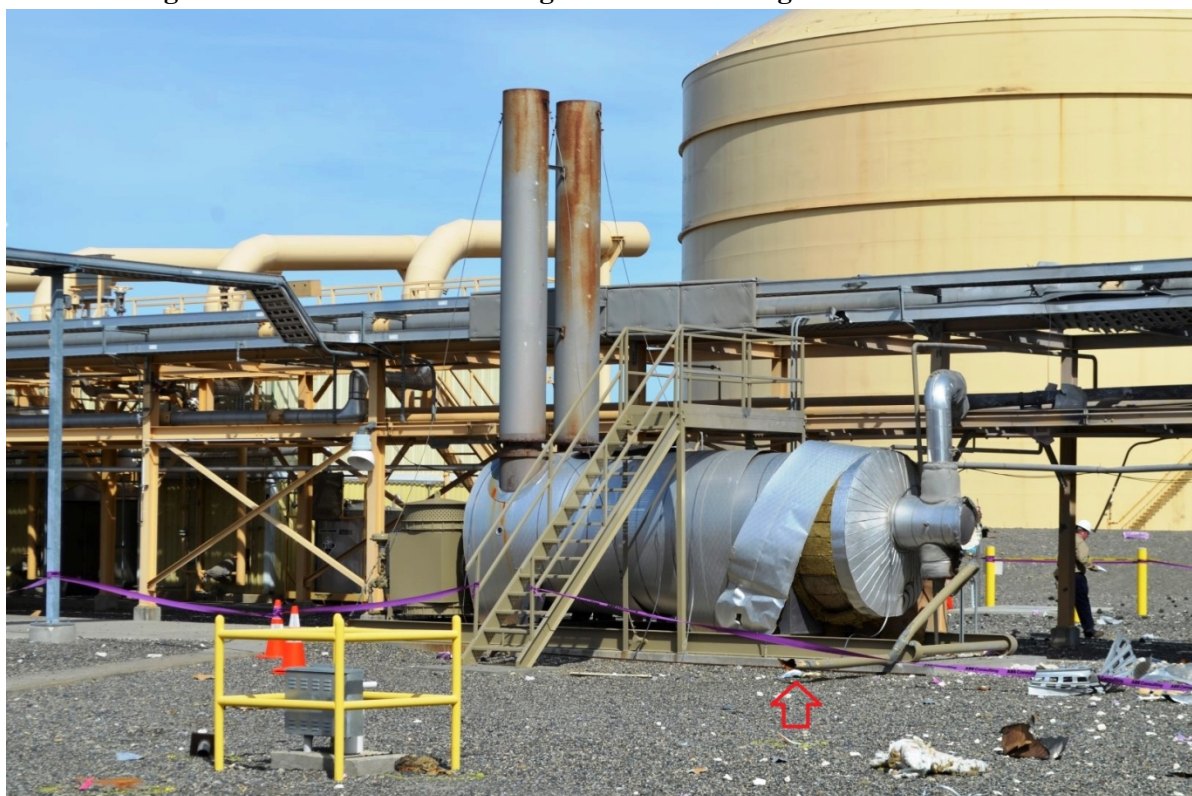
The primary cause of this failure was a substandard purge performed after leaving the LNG-1 purification loop open to the atmosphere from November 1, 2013, to March 18, 2014. A flammable gas-air mixture remained in the system which then entered the salt bath heater and auto-ignited during start-up.

LNG-1 Salt Bath Heater where auto-ignition initiated. Red arrow indicates a failure point in the 4-inch heater gas inlet. The piping is blown outward and down. It would normally be behind the heater and up on the pipe rack. Looking Northeast. The LNG-2 storage tank in the background.

3. Removal of the salt bath heater involved in the incident and replacement with a new “tight wound helical coil” heater that does not use a salt bath. This allows for more consistent heat distribution to the gas.

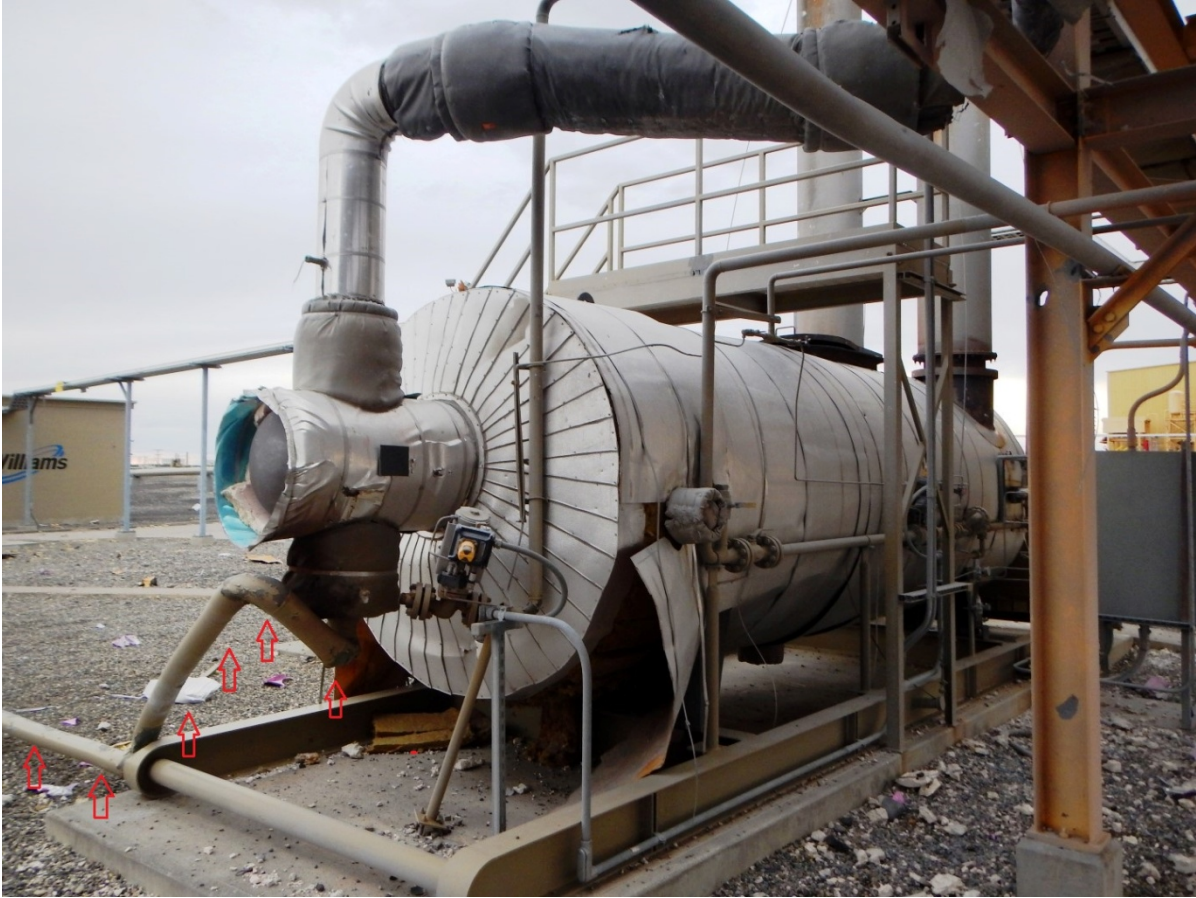
Another view of the Salt Bath Heater. The 4-inch gas inlet piping denoted with red arrows. The piping is blown to the left of the heater. Looking northwest.

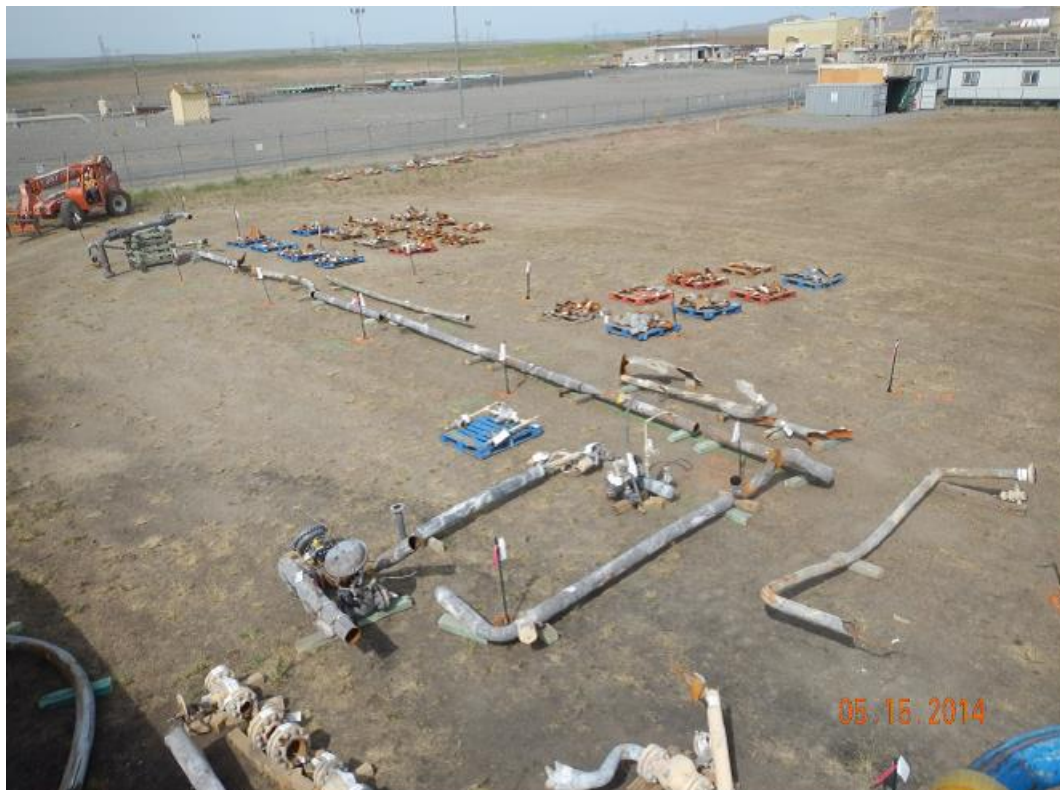
Failed piping reassembled in secured evidence yard placed in as close to original piping configuration as possible. Stakes are placed at pipe rack cross members. Close observation reveals numerous internal failures of the piping caused by “rolling detonation”. The 4” Salt Bath Heater inlet piping is placed next to the 6” outlet Salt Bath Heater piping. The pallets hold all of the small fragmented pieces of the 4” pipe.
