**Test Report No. 607531-02-1-11**

**STANDARD DELINEATOR TESTING SPECIFIC TO  
MANAGED LANE USE FOR OPTIMIZATION OF  
SERVICE LIFE – PHASE 2**

**State of Florida Department of Transportation**

**TEXAS A&M TRANSPORTATION INSTITUTE PROVING GROUND**

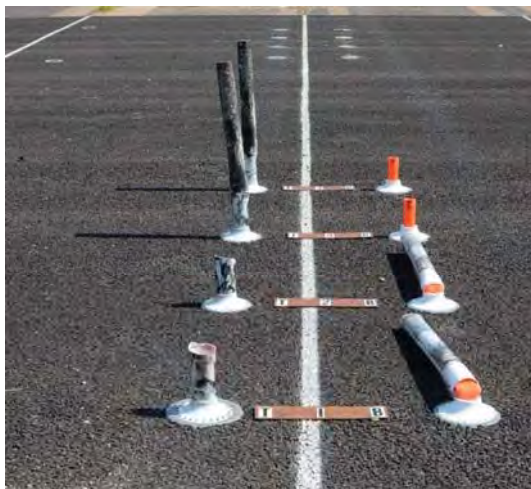
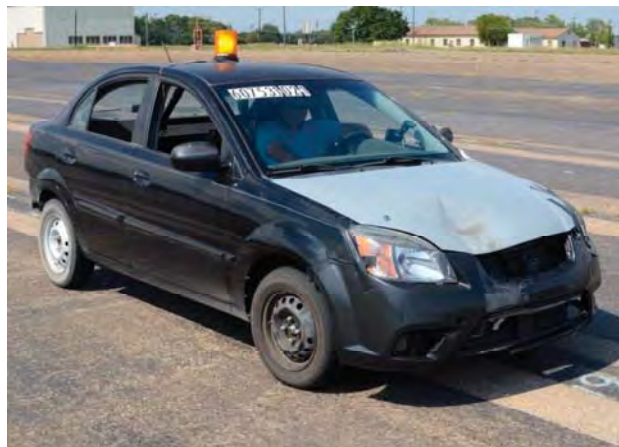
Figure 3.5. 607531-02-1 Delineators and Test Vehicle after Testing.

Test No. 607531-02-1 yielded the results shown in Table 3.2. For the Pexco City Post 8GD36ORG101 Glue Down Sample, seven samples failed to resist 200 impacts. A failure to restore to within 15 degrees of vertical was observed for delineator #4B on run 3, delineator #3B on run 10, delineator #1B on run 54, delineator #2B on run 60, delineator #2T on run 168, and delineator #3T on run 189. Delineator #1T had a tear of more than 50% of the cross on run 189. Delineator #4T completed all 200 runs. Ambient temperature was greater than or equal to 82°F throughout the conducted test.

The primary mode of failure was fracturing of the samples near the base and exceeding the maximum allowable degree of list/lean.

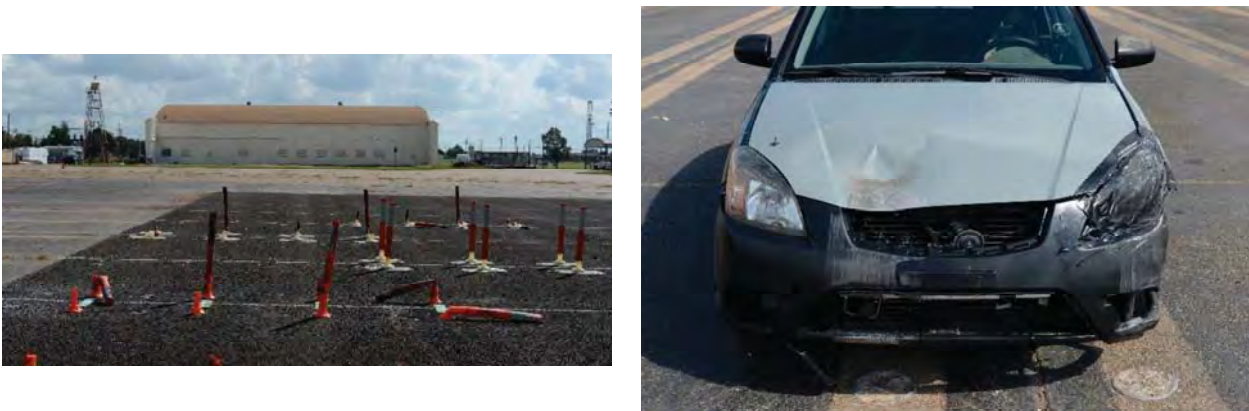
**Figure 3.9. 607531-2 Delineators and Test Vehicle after Testing.**

Table 3.3 documents the list/lean and failure modes witnessed under Test No. 607531-02-2. All eight of the samples failed to resist 200 impacts. A failure to restore to within 15 degrees of vertical was observed for delineator #2B on run 74, delineator #4B on run 87, delineator #3B on run 108, delineator #3T on run 110, delineator #4T on run 124, delineator #2T on run 140, and delineator #1T on run 190. Delineator #1B completely tore from the base on run 95. Ambient temperature was greater than or equal to 82°F throughout the conducted test.

The primary mode of failure was fracturing of the samples near the base and exceeding the maximum allowable degree of list/lean.

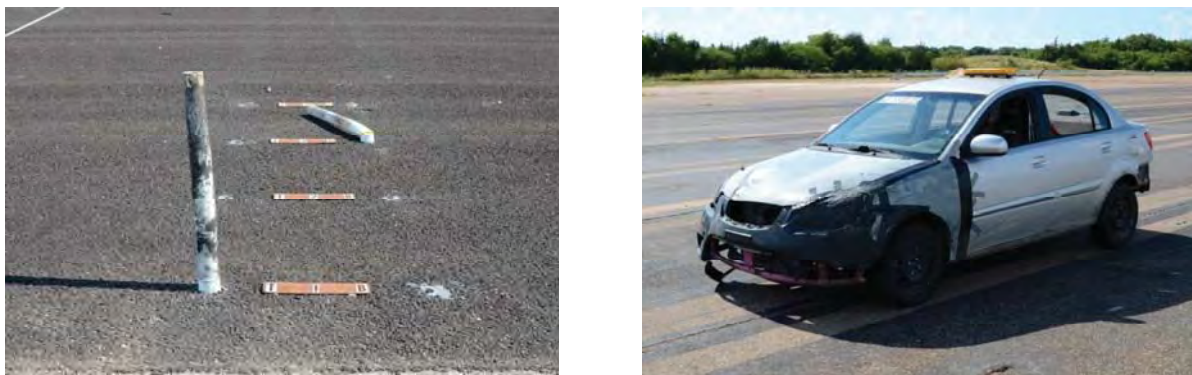
Figure 3.13. 607531-02-3 Delineators and Test Vehicle after Testing.

Table 3.4 documents the list/lean and failure modes witnessed under Test No. 607531-02-3. Seven of the samples failed to resist 200 impacts. A failure to restore to within 15 degrees of vertical was observed for delineator #1B on run 1, delineator #3T on run 3, delineator #2B on run 14, delineator #3B on run 19, delineator #4B on run 20, and delineator #4T on run 91. Delineator #2T completely tore from the base on run 3, and delineator #1T completed all 200 runs. Ambient temperature was greater than or equal to 82°F throughout the conducted test.

The primary mode of failure was exceeding the maximum allowable degree of list/lean and post fracture near the base.

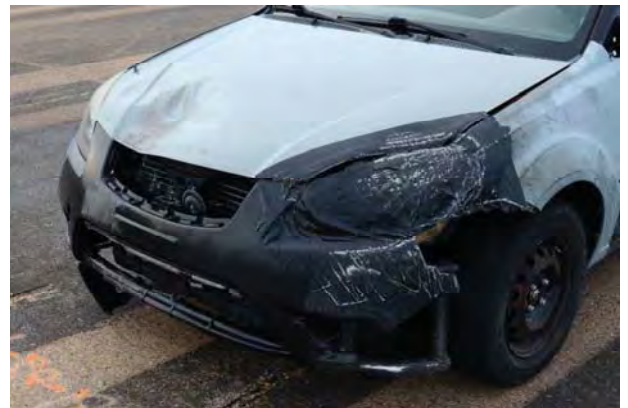
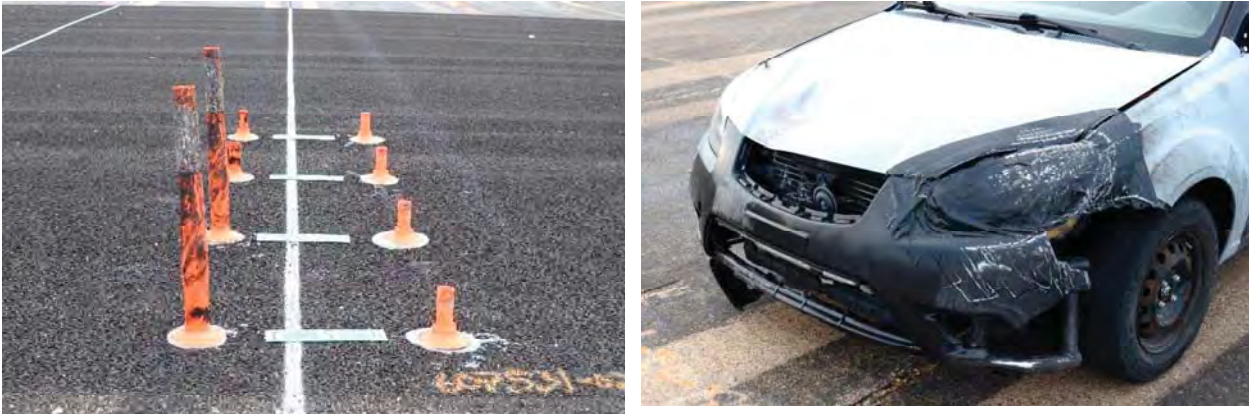
The primary mode of failure was tearing of the post approximately one foot above the base and fracture of the post at the base.

**Figure 3.18. 607531-02-4 Delineators and Test Vehicle after Testing (Concrete Surface).**

Figure 3.20. 607531-02-4 Delineators and Test Vehicle after Testing (Asphalt Surface).

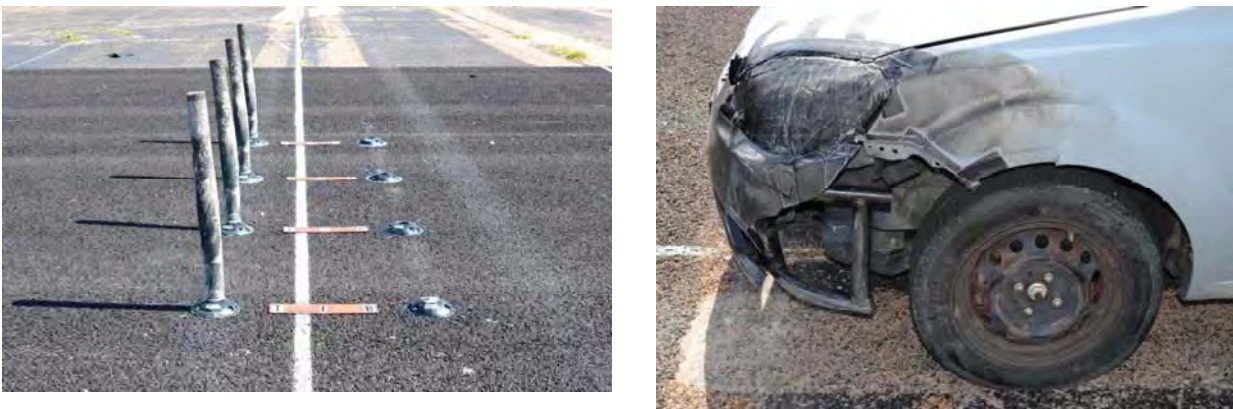
Figure 3.24. 607531-02-5 Delineators and Test Vehicle after Testing.

Table 3.6 documents the list/lean and failure modes witnessed under Test No. 607531-02-5. Four samples failed to resist 200 impacts. Delineators #2B, #3B, and #4B separated from the bases on run 22. A failure to restore to within 15 degrees of vertical was observed for delineator #1B on run 25. Delineators #1T, #2T, #3T, and #4T completed all 200 runs. Ambient temperature was greater than or equal to 82°F throughout the conducted test.

The primary mode of failure was post separation at the base. This was mainly caused by the pin tearing through the bottom of the post.

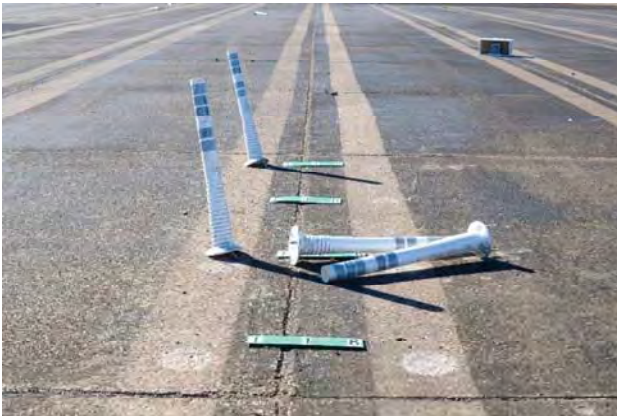
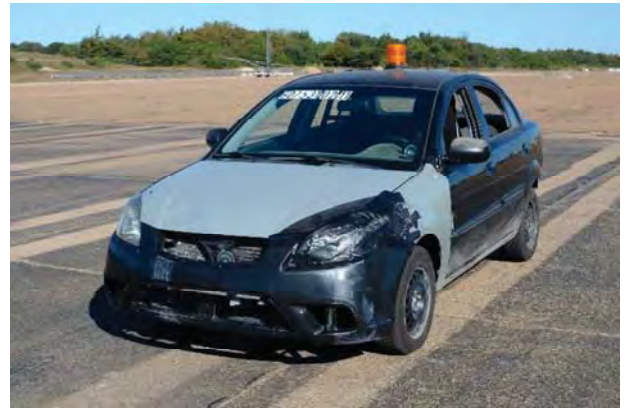
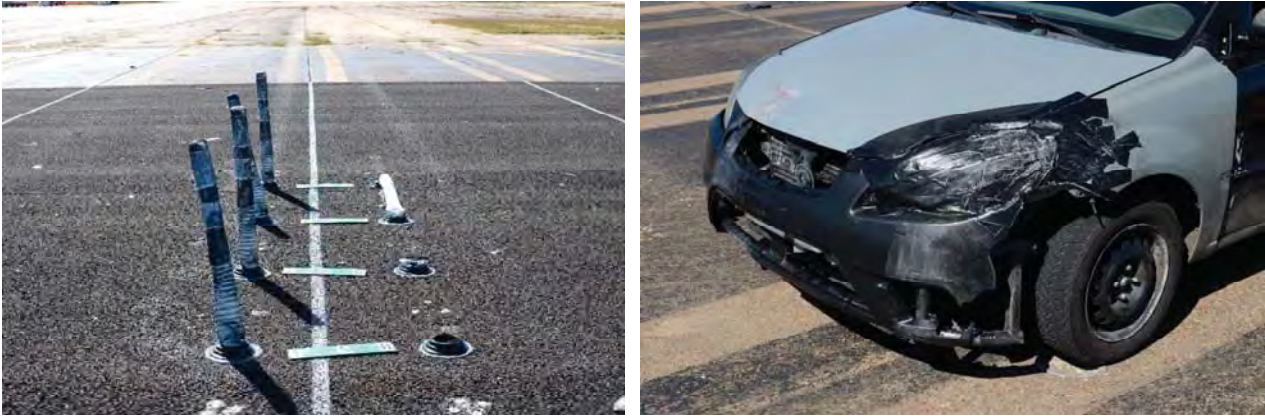
Table 3.10 documents the list/lean and failure modes witnessed under Test No. 607531-02-11. Fourteen of the samples failed to resist 50 impacts. The attachment failed on all the delineators on the concrete surface, # 1T, #1B, #2T, #2B, #3T, #3B, #4T, and #4B, on run 1. A failure to restore to within 15 degrees of vertical was observed for delineator #5B on run 1, delineator #6B on run 2, delineator #7B on run 28, and delineator #5T on run 47. A complete post tear was observed for delineator #8B on run 6, and a tear of more than 50% of the cross section was observed for delineator #7T on run 25. Delineators #6T and #8T completed 50 runs without failure. Testing was discontinued after run 50, per Sponsor's request. Ambient temperature was greater than or equal to 60°F throughout the conducted test. This is below the required temperature.

The primary mode of failure was pull out of the mechanical anchors for the delineators on the concrete surface and exceeding the maximum allowable degree of list/lean for the delineators on the asphalt surface.

**Figure 3.47. 607531-02-11 Delineators and Test Vehicle after Testing (Concrete Surface).**

Figure 3.49. 607531-02-11 Delineators and Test Vehicle after Testing (Asphalt Surface).
