Ref. No. Docket PG-070175

Subject: 2007 Standard Inspection of Kittitas County Distribution System

WASHINGTON UTILITIES AND TRANSPORTATION COMMISSION
2007 Natural Gas Pipeline Standard Inspection Report
Puget Sound Energy – Kittitas County District
Docket No. PG-070175

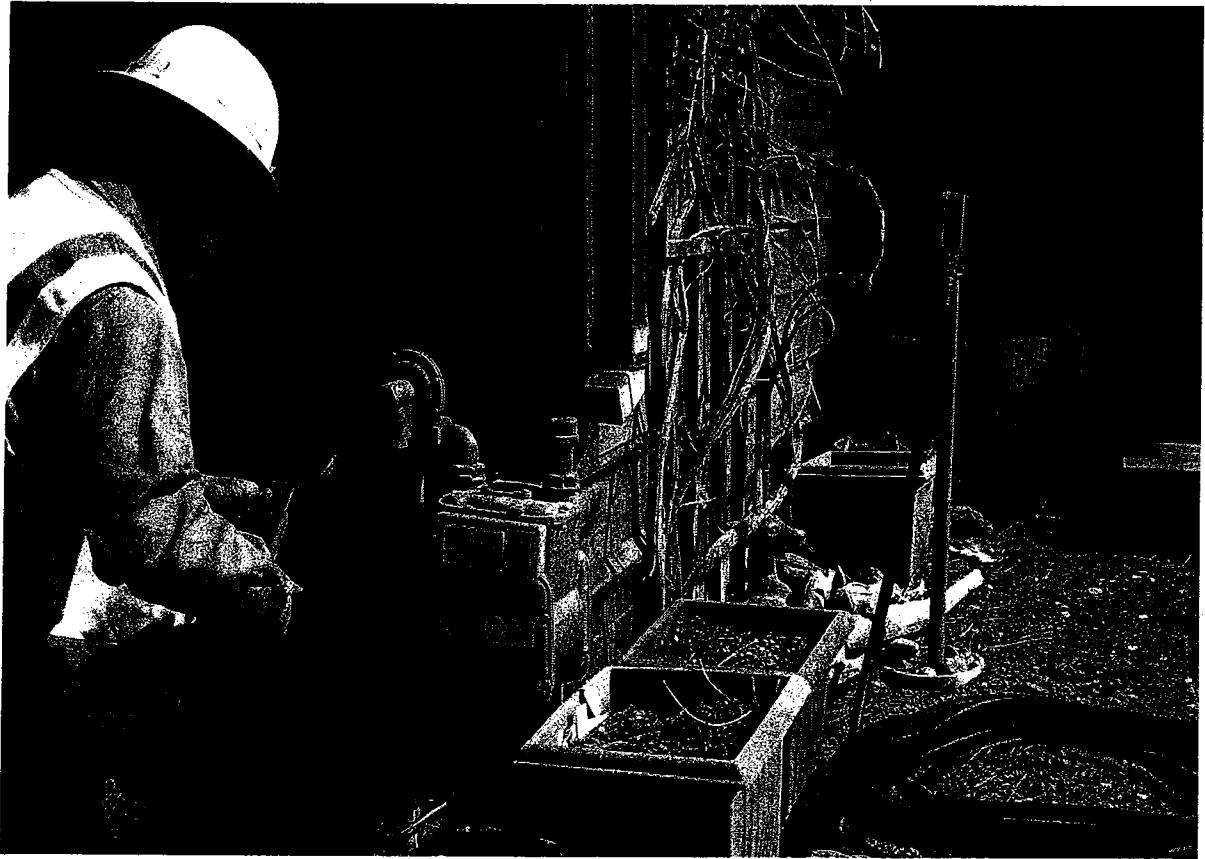
During the 2001 inspection (Docket No. 010854) meter sets were found at residences in Kittitas County that were not gas customers. PSE removed those meter sets after the inspection. During this inspection, six year later, additional meters were found that are not used or useful without the customer's fuel lines. Again, the meter sets are not adequately supported (Refer to photo on next page).

Please provide a complete list of locations where the service lines are in-place and not providing service. How many of these service lines have meter sets which are not connected to a fuel line?
