February 16, 2012

RE: Puget Sound Energy- Ingham Fire
SEAL Job No. 21151.

12040 8th Avenue NE (gas line crossing oil vent line):

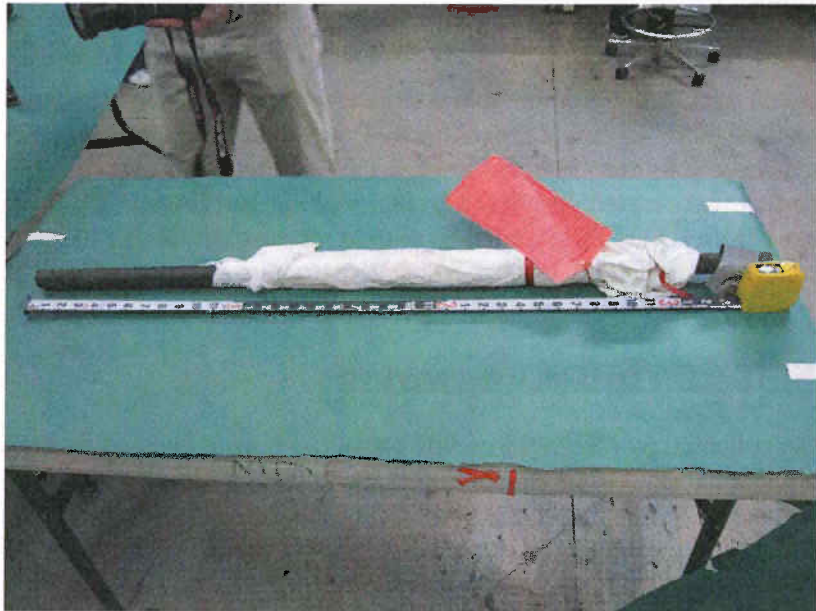
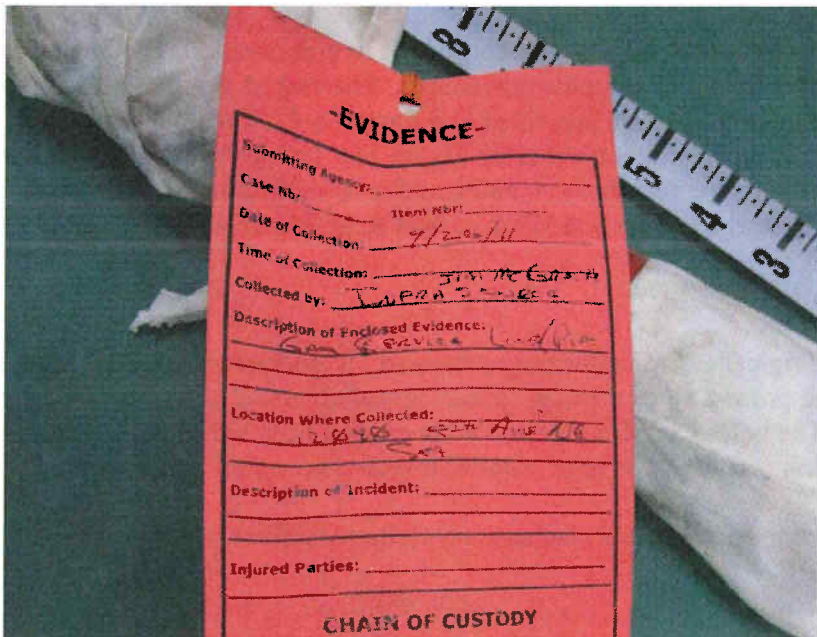
This pipe section was collected by Infrasource on 9-26-11, as evidenced by the tag attached to the rapped pipe section; Figure 1. The gas service line pipe was made from steel, was 42 inches long with 1.2 inch outer diameter and wall thickness of 0.11 inch. The pipe contained a slightly oval hole with major and minor diameters as 0.3 inch and 0.22 inch; Figures 2 and 3. The surface coating on the pipe had melted. A section of the pipe was cut containing ¼ of the hole wall, as shown in Figure 4. The removed section contained the ¼ hole in a corner and is shown from the inner diameter (ID) and outer diameter (OD) side in Figure 5. The hole was clearly created from OD toward the ID, as seen by the missing material at the hole wall. The hole surface appeared smooth with no fracture features; Figure 6.

Figure 1. Color photographs showing the gas line from 12040 8th Avenue NE and the attached tag.

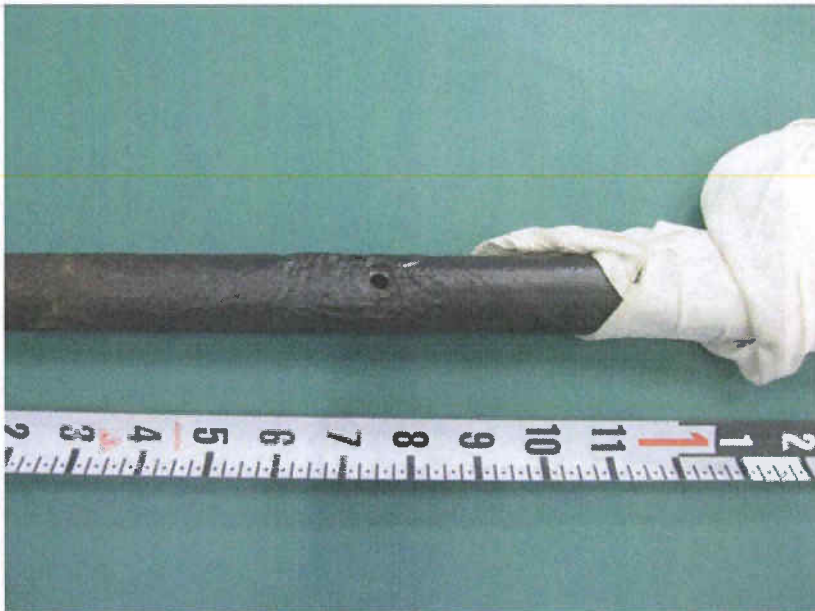
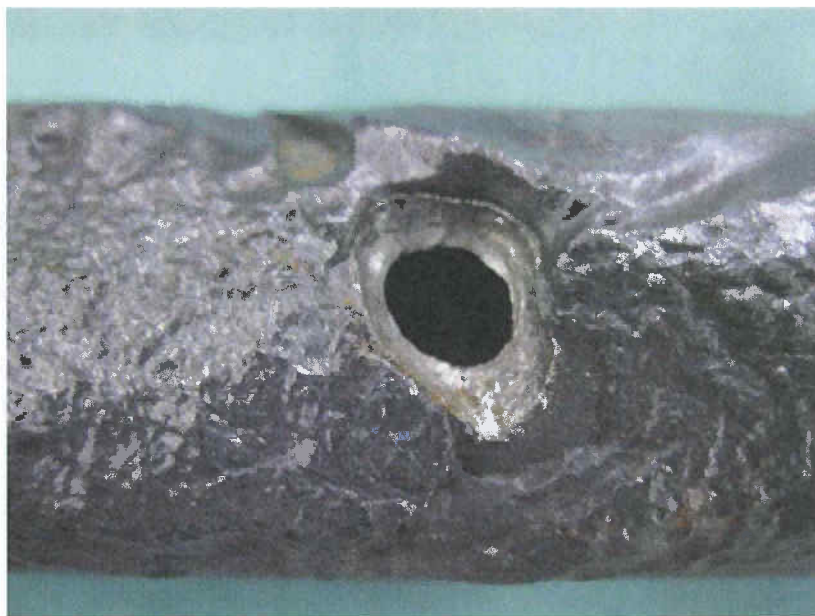
Figure 2. Detailed color photographs showing a hole in the gas line from 12040 8th Avenue NE.

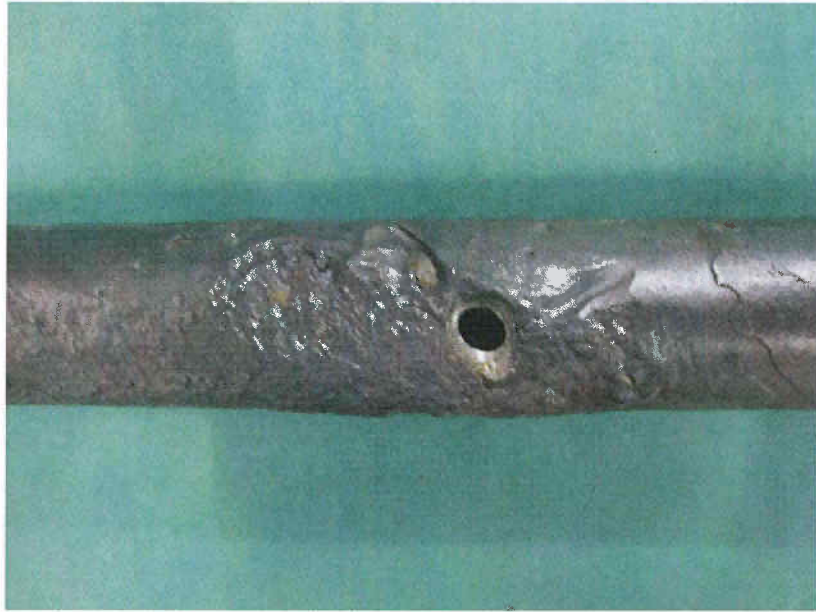
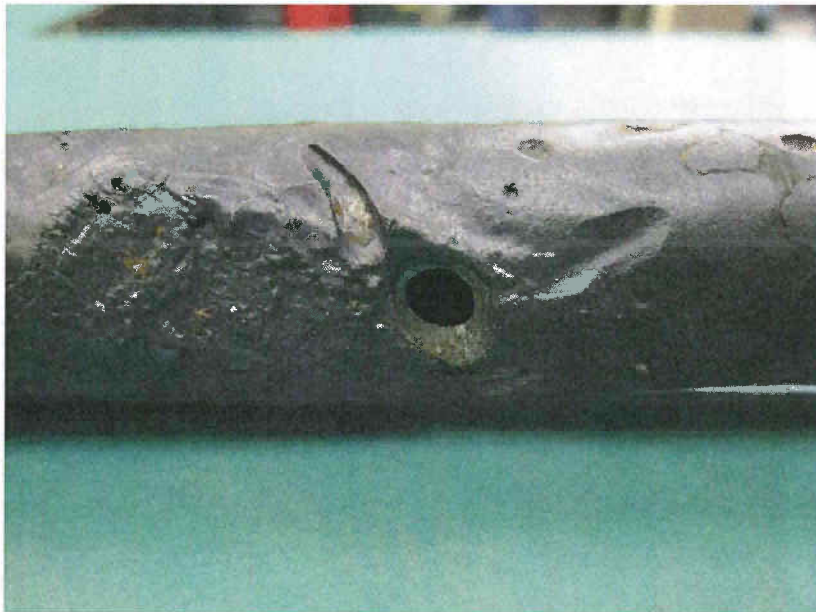
Figure 3. Detailed color photographs showing the hole in the gas line from 12040 8th Avenue NE. The surface coating is melted around the hole.

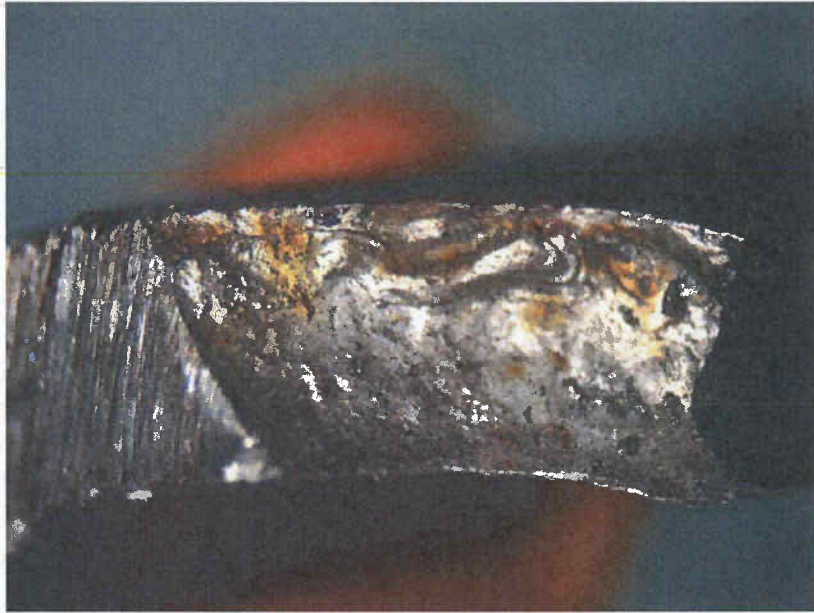
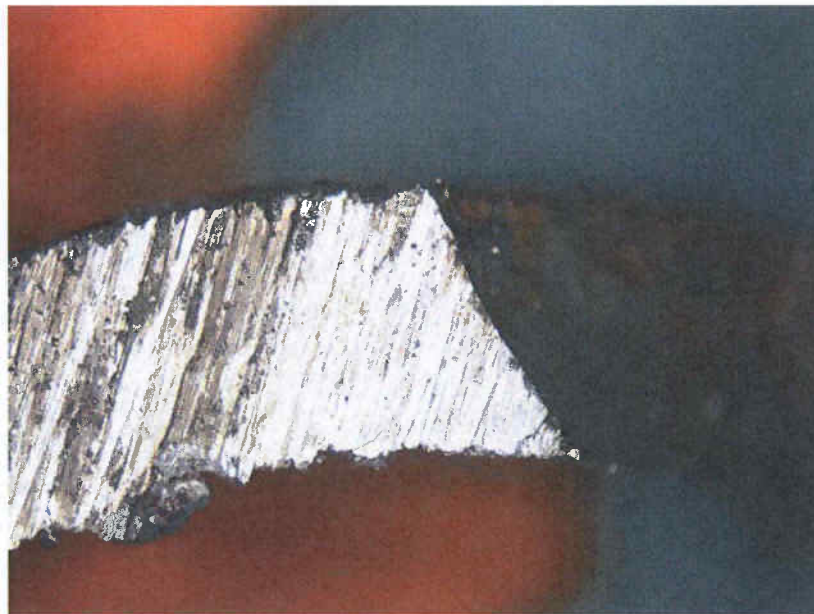
Figure 6. Detailed color photographs showing the hole surface and the hole profile of the section removed from the gas line from 12040 8th Avenue NE. (a) Hole surface, 20X; (b) Hole Profile with OD on top of photo, 20X.

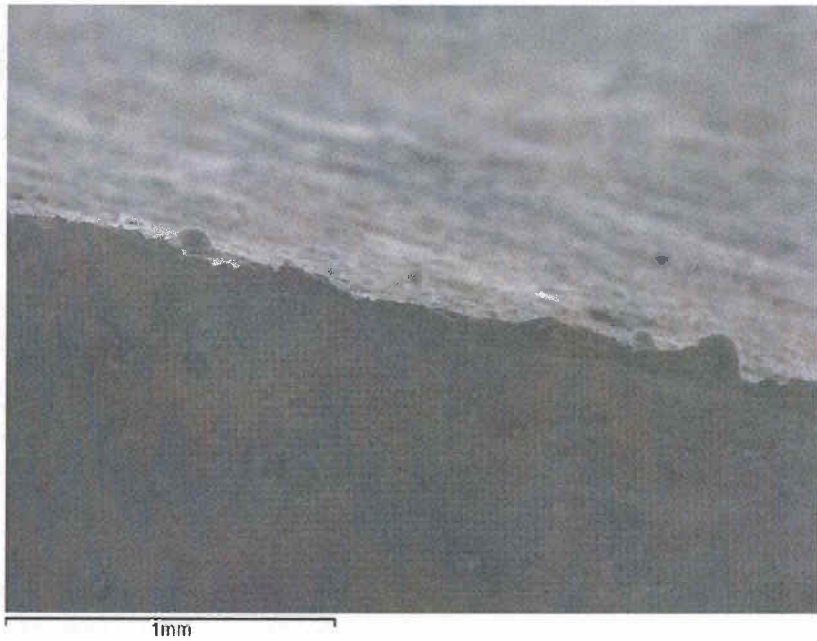
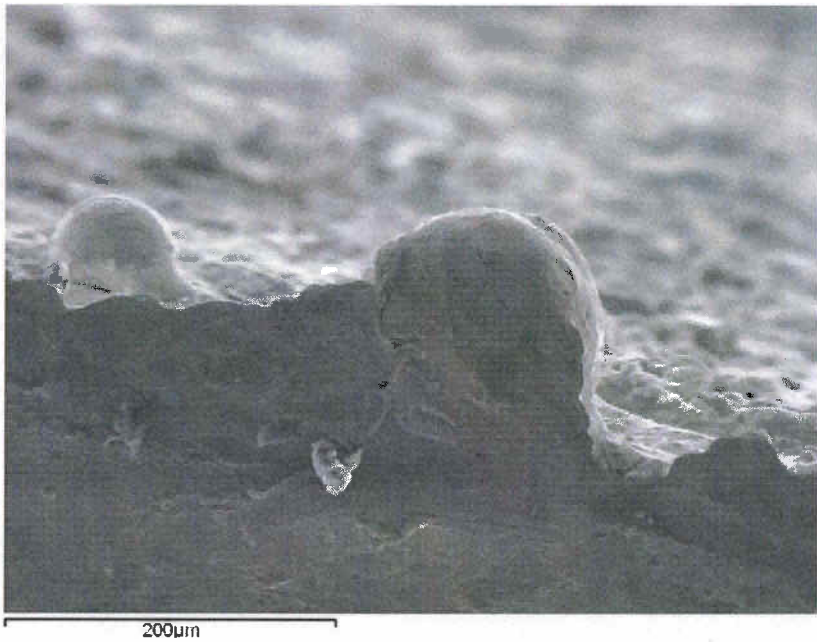
Scanning Electron Microscope (SEM) examination of the hole surface at ID transition revealed melted globules of steel, indicating melting by electrical arcing forming the hole; Figure 7. Energy dispersive X-ray (EDX) analysis of the pipe material indicated a plain carbon steel.

Figure 7. Detailed SEM micrographs showing the hole surface at ID transition from the section removed from the gas line from 12040 8th Avenue NE. (a) ID surface, 50X; (b) ID surface, 250X.

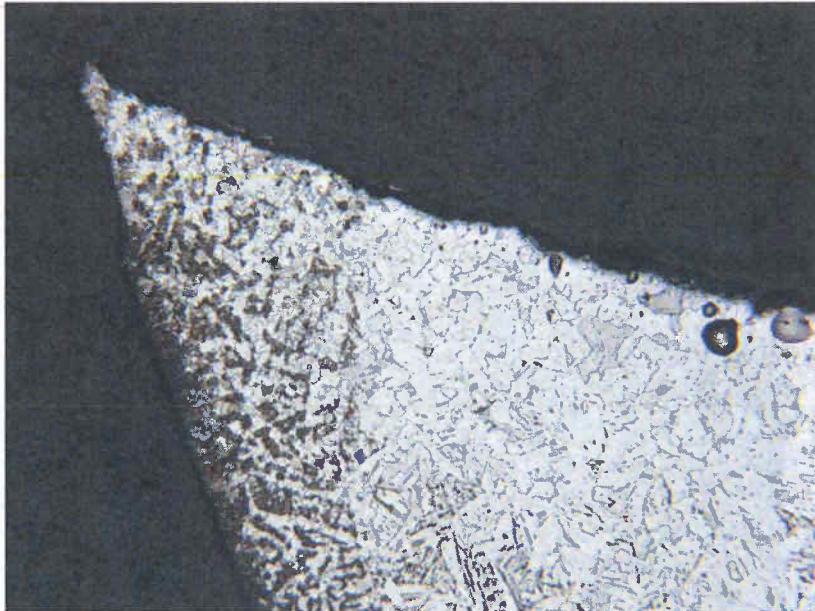
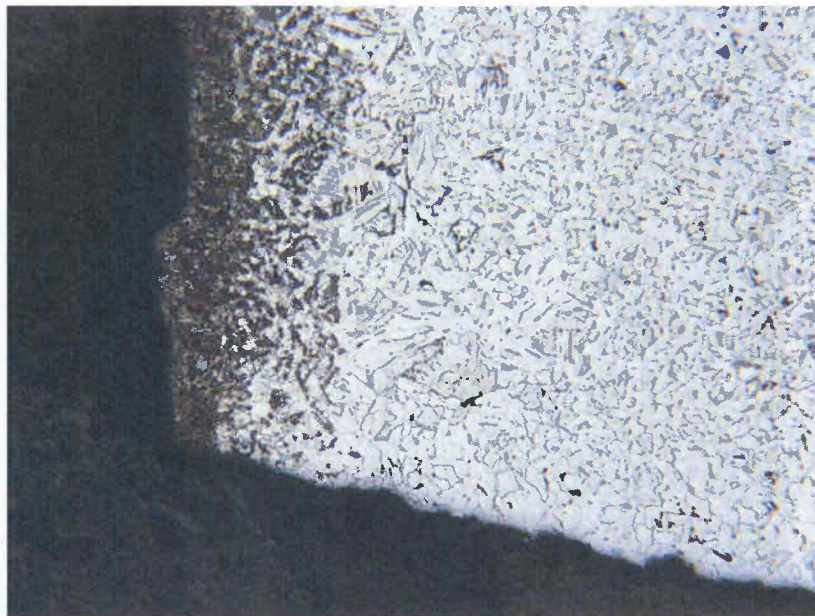
A metallographic mount was made with the hole wall in cross section. The mount was ground, polished and etched using standard metallographic procedures. The etched mount was examined using an optical microscope and the micrographs are presented in Figures 8-11. The surface of the hole from ID to OD revealed an altered microstructure due to melting and re-solidification of the surface; Figures 8-10. The hole surface also revealed a small void; Figure 10(a). The general microstructure of the steel indicates a low to medium carbon steel; Figure 11.

Figure 8. Detailed optical micrographs showing the hole surface in cross section of the sample removed from the gas line from 12040 8th Avenue NE. (a) ID surface, etched, 50X; (b) OD surface, etched, 50X.

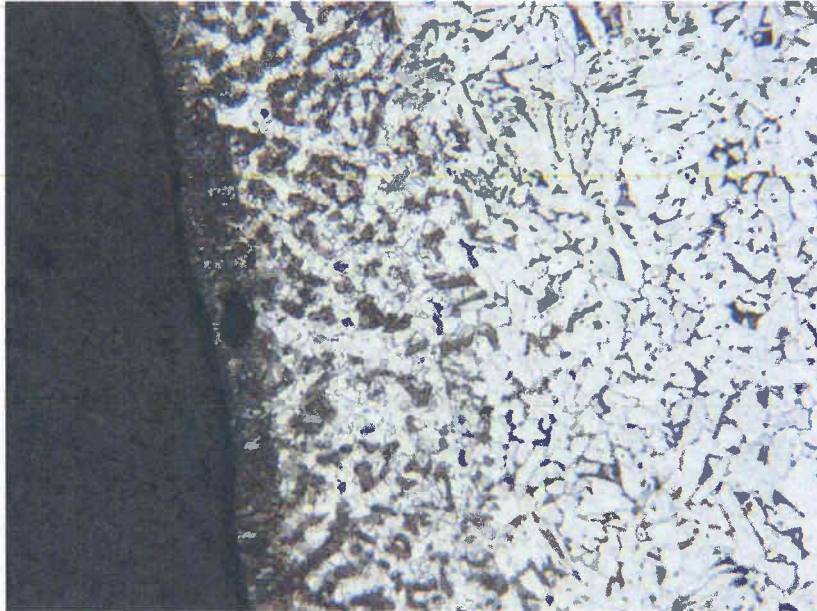
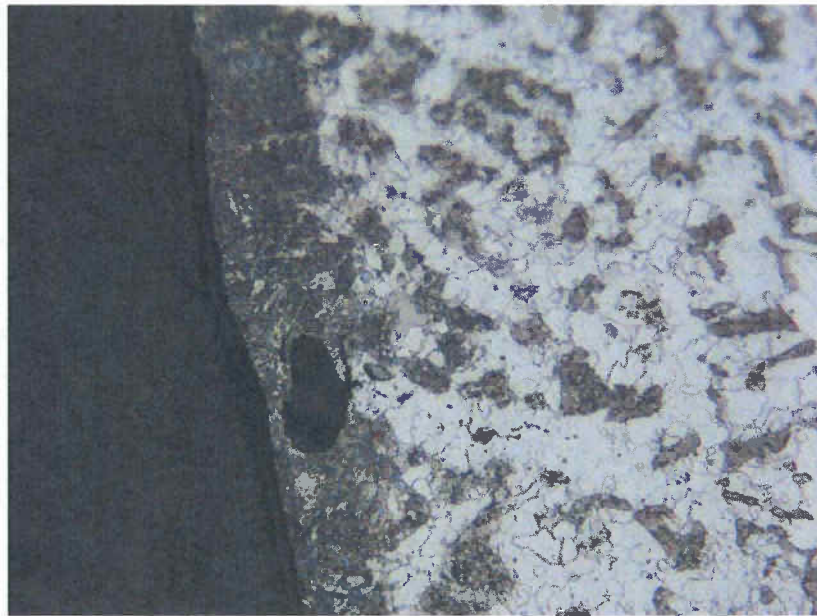
Figure 10. Detailed optical micrographs showing the hole surface in cross section of the sample removed from the gas line from 12040 8th Avenue NE. (a) Midway between OD and ID, etched, 100X; (b) Midway between OD and ID surface at void, etched, 200X.

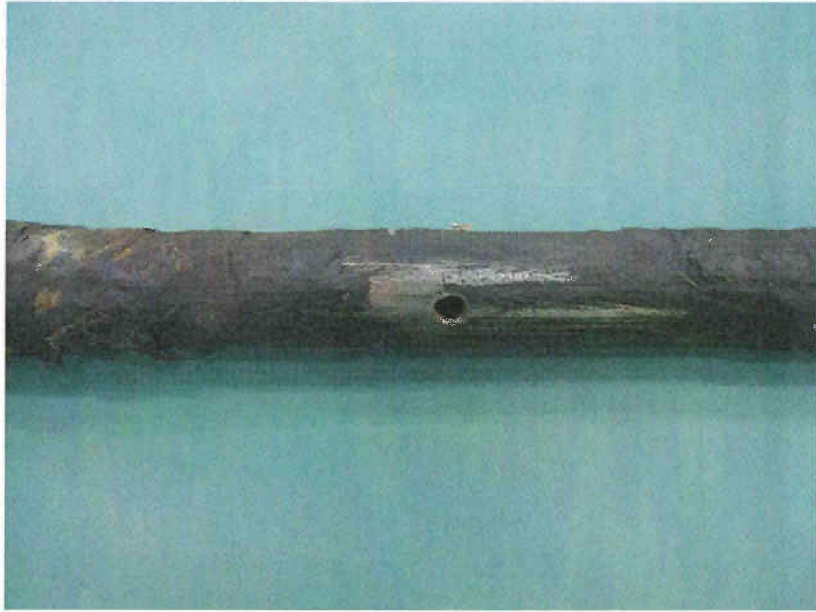
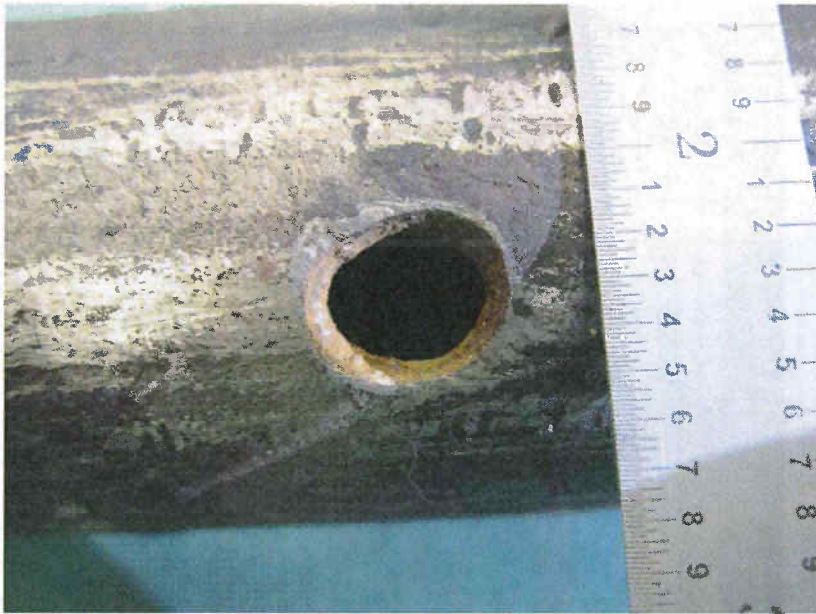
This pipe section was collected by Infrasource on 9-27-11, as evidenced by the tag attached to the pipe section; Figure 12. The gas service line pipe was made from steel, was 53 inches long with 1.69 inch outer diameter and wall thickness of 0.135 inch. The pipe contained a slightly oval hole with major and minor diameters as 0.48 inch and 0.40 inch; Figure 13. A section of the pipe was cut containing $\frac{1}{4}$ of the hole wall, as shown in Figure 14. The removed section contained the $\frac{1}{4}$ hole in a corner and is shown from the ID and OD side in Figure 15. The hole was clearly created from OD toward the ID, as seen by the missing material at the hole wall. The hole surface appeared smooth with no fracture features and re-solidified surface; Figure 16.

Figure 13. Detailed color photographs showing a hole in the gas line from 913 NE 122nd Street.

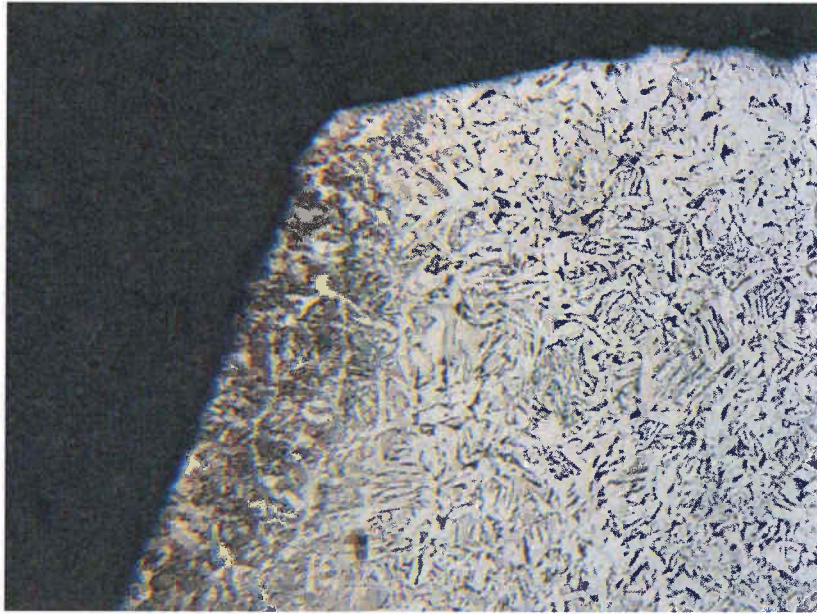
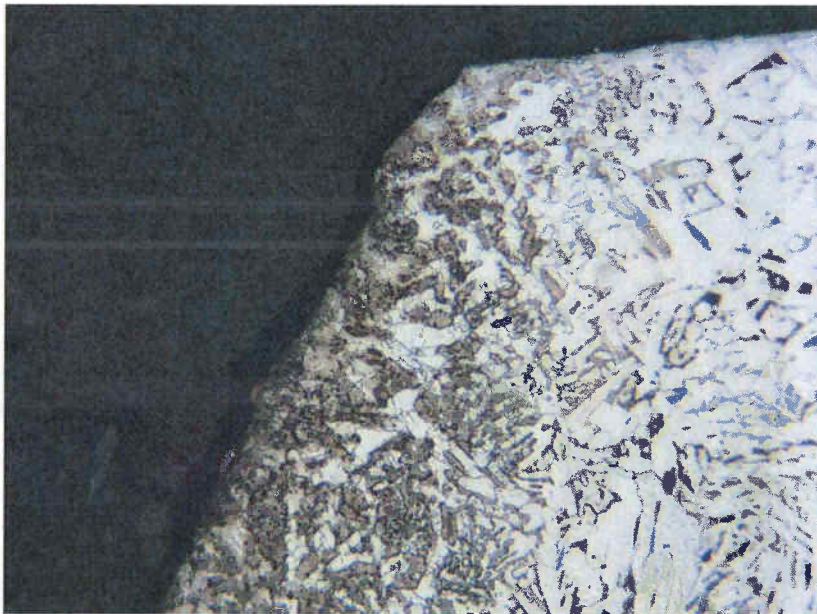
A metallographic mount was made with the hole wall in cross section. The mount was ground, polished and etched using standard metallographic procedures. The etched mount was examined using an optical microscope and the micrographs are presented in Figures 17-20. The surface of the hole from ID to OD revealed an altered microstructure due to melting and re-solidification of the surface; Figures 17-19. The general microstructure of the steel indicates a medium carbon steel; Figure 20.

Figure 17. Detailed optical micrographs showing the hole surface in cross section of the sample removed from the gas line from 913 NE 122nd Street. (a) OD surface, etched, 50X; (b) OD surface, etched, 100X.

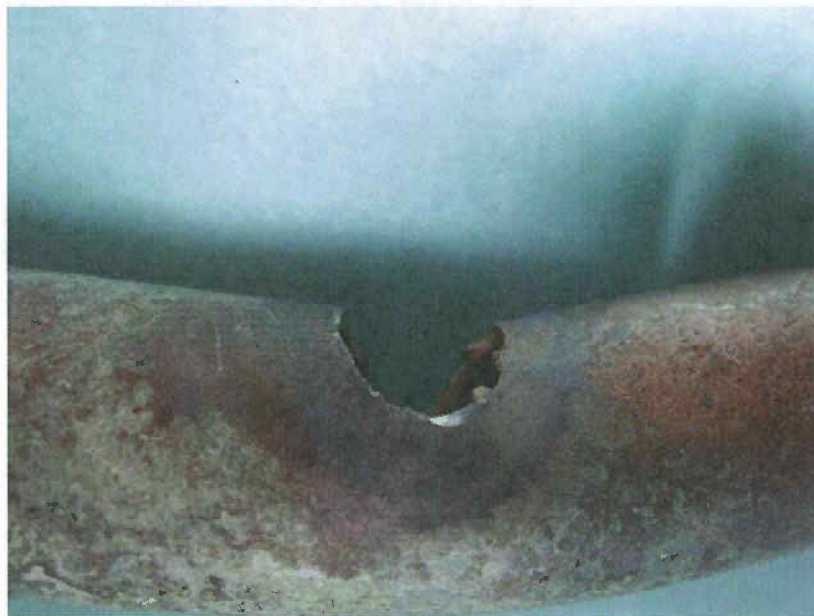
The copper water line that was allegedly in contact with the gas line is shown in Figure 21(a). The attached tag to the water line is shown in Figure 21(b). The periphery of the hole in the copper line shows melted copper balls, indicating it is caused by arcing; Figures 22 and 23. The line was clamped and pinched at a location adjacent to the hole; Figure 24.

Figure 22. Color photographs showing the hole in the copper water line from 913 NE 122nd Street.

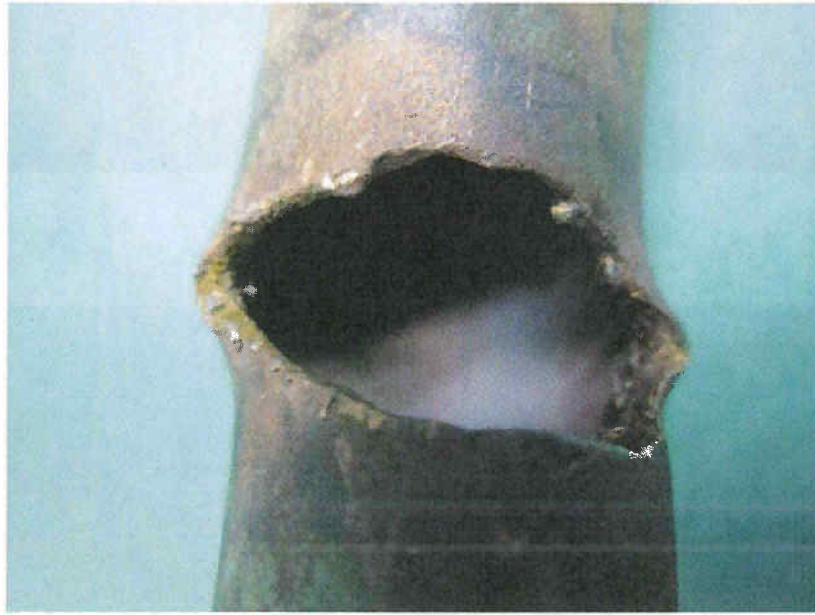
Figure 23. A detailed color photograph showing the hole in the copper water line from 913 NE 122nd Street.

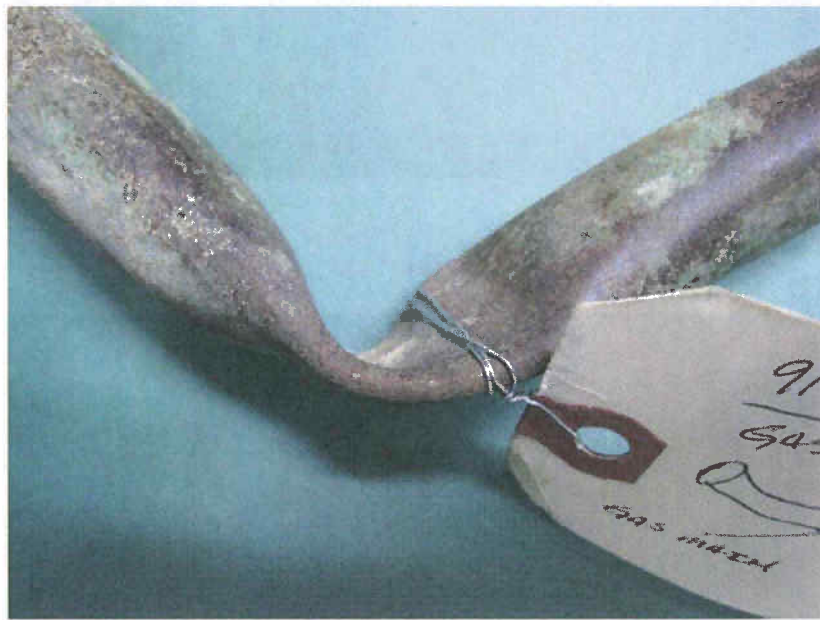
Figure 24. A detailed color photograph showing the pinched area in the copper water line from 913 NE 122nd Street.

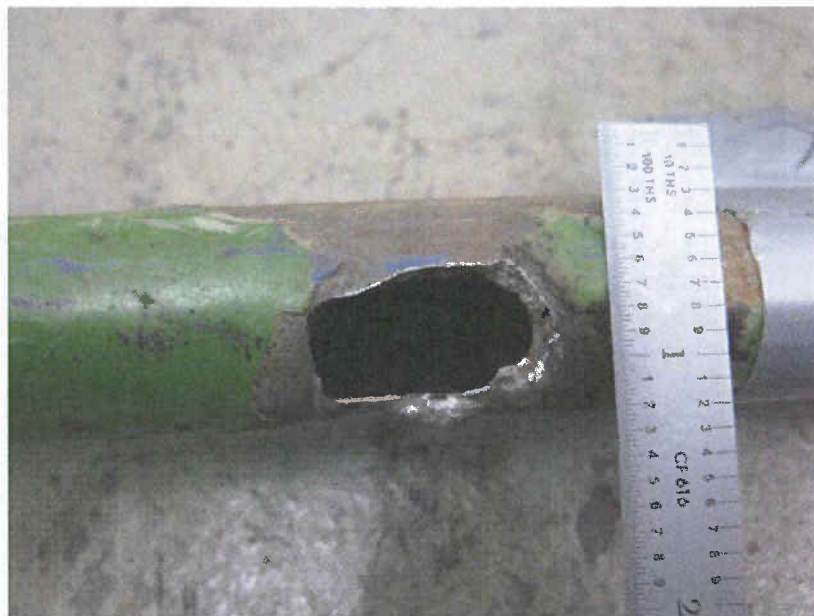
This pipe section was collected by Infrasource on 9-26-11, as evidenced by the tag attached to the pipe section; Figure 25. The gas service line pipe was made from steel, coated with green epoxy Scotchkote 101, was 158 inches long with 1.15 inch outer diameter and wall thickness of 0.11 inch. The pipe contained an irregular shaped oval hole with major diameter as 1.0 inch and minor diameter as 0.6 inch; Figure 26. The green coating had melted and evaporated or flaked off around the hole. A section of the pipe was cut containing $\frac{1}{4}$ of the hole wall, as shown in Figure 27. The removed section contained the $\frac{1}{4}$ hole in a corner and is shown from the ID and OD side in Figures 28-30. The hole was clearly created from OD toward the ID, as seen by the missing material at the hole wall. The hole surface appeared smooth with no fracture features and re-solidified surface; Figure 30.

Figure 26. Detailed color photographs showing a hole in the gas line from 1016 NE 127th Street.

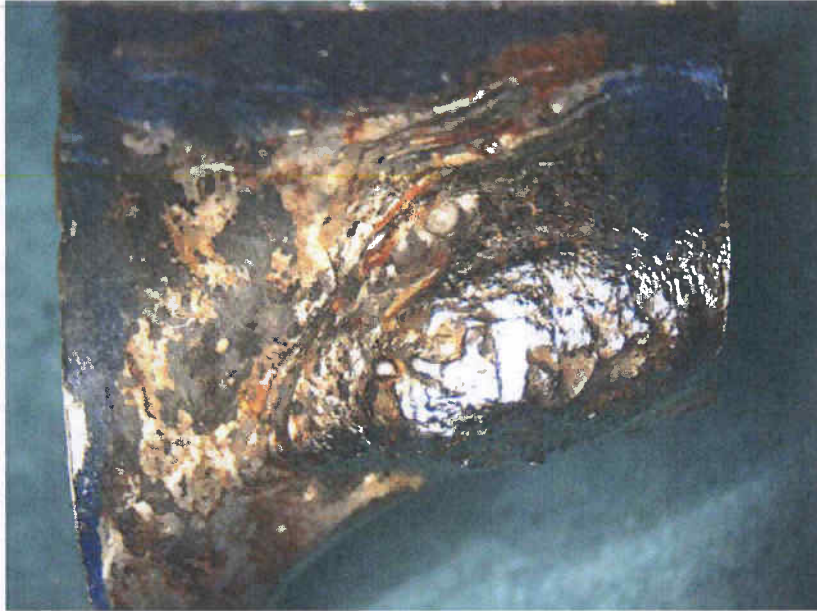
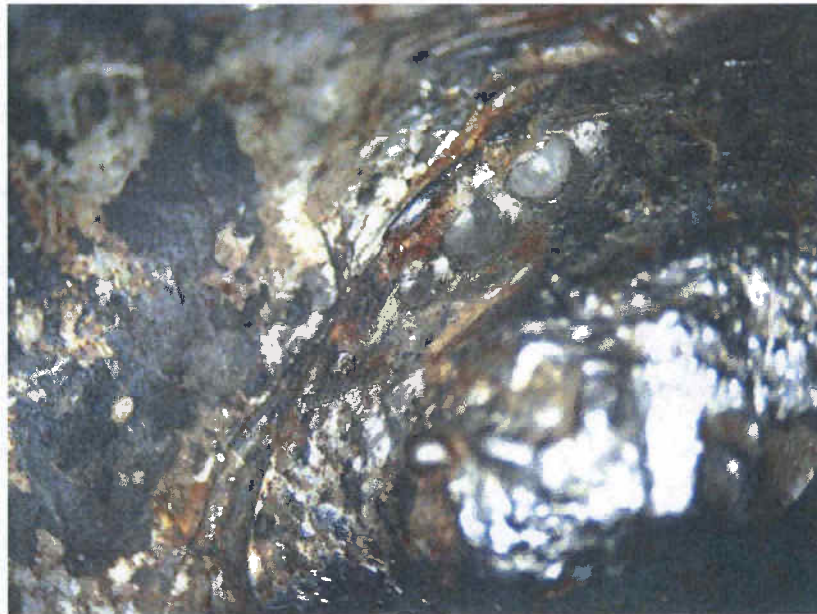
Figure 30. Detailed color photographs showing the OD surface near the hole of the section removed from the gas line from 1016 NE 127th Street. (a) OD surface, 10X; (b) OD Surface, 20X.

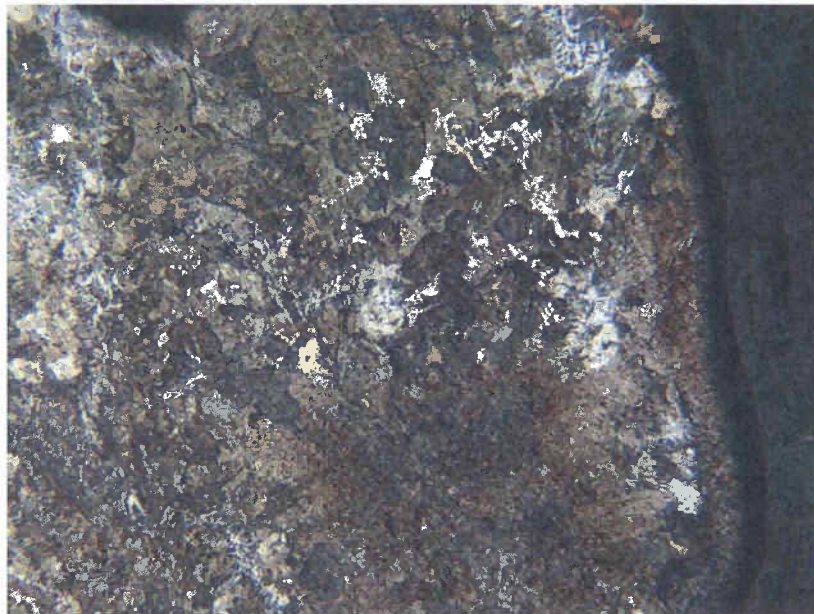
A metallographic mount was made with the hole wall in cross section. The mount was ground, polished and etched using standard metallographic procedures. The etched mount was examined using an optical microscope and the micrographs are presented in Figures 31-33. A large void (gas bubble) was present near the hole surface that was created during the arcing, melting and re-solidification process; Figure 31. The surface of the hole from ID to OD revealed an altered microstructure due to melting and re-solidification of the surface; Figure 32. The general microstructure of the steel indicates a medium carbon steel; Figure 33.

Figure 32. Detailed optical micrographs showing the hole surface in cross section of the sample removed from the gas line from 1016 NE 127th Street. (a) ID surface, etched, 50X; (b) ID surface, etched, 100X.

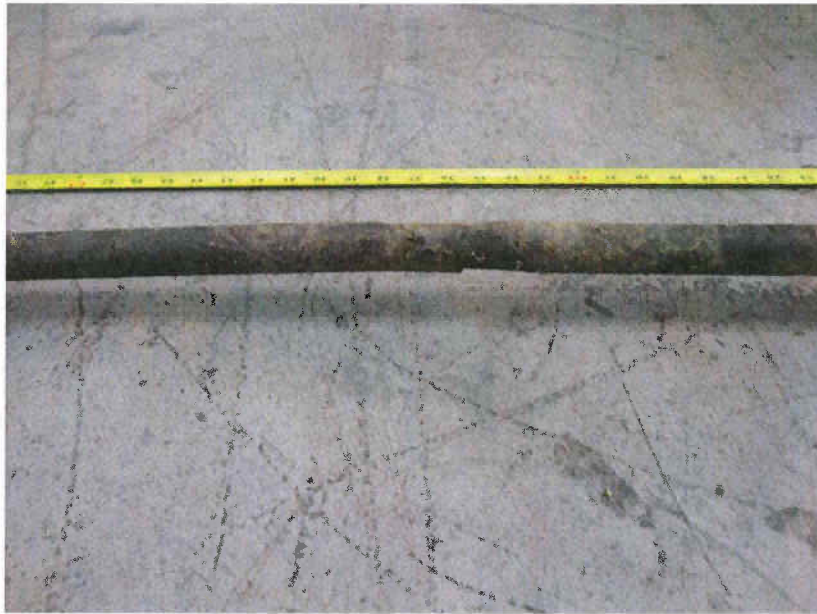
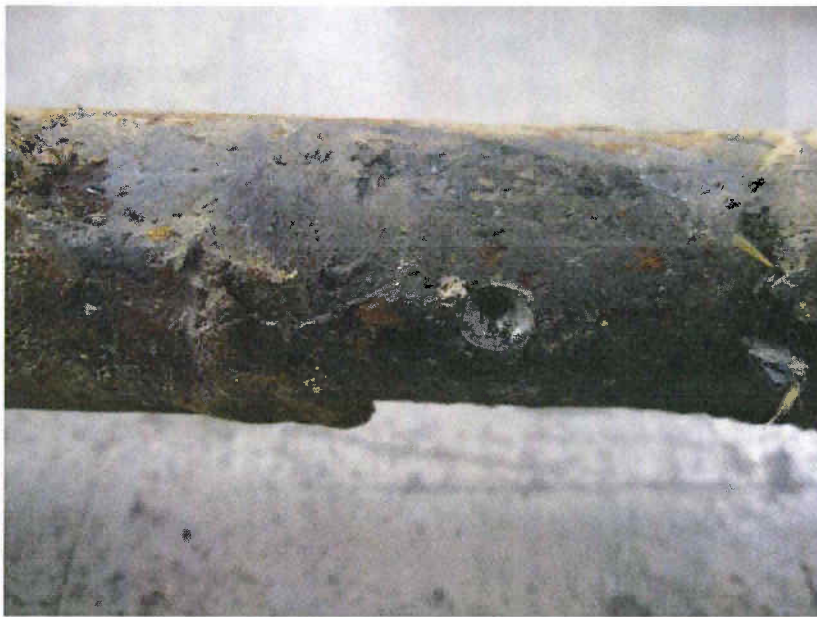
This pipe section was collected by Michael Radcliff on 9-26-11, as evidenced by the tag attached to the pipe section; Figure 34. The gas service line pipe was made from steel, surface coated, was 225 inches long with gas meter attached to one end of the pipe. The pipe has 1.08 inch outer diameter and wall thickness of 0.11 inch. The pipe contained a round hole on the bottom of the pipe with an average diameter of 0.25 inch on the OD surface. A small section of the pipe containing the hole was sectioned; Figure 35. Another section of the pipe containing the hole was marked and cut as shown in Figure 36. The removed section was further cut to expose the hole on the ID surface as shown from the ID and OD side in Figures 37. The hole surface on the OD appeared smooth with no fracture features and re-solidified surface.

Figure 35. Detailed color photographs showing a hole in the gas line from 12312 5th Avenue NE.

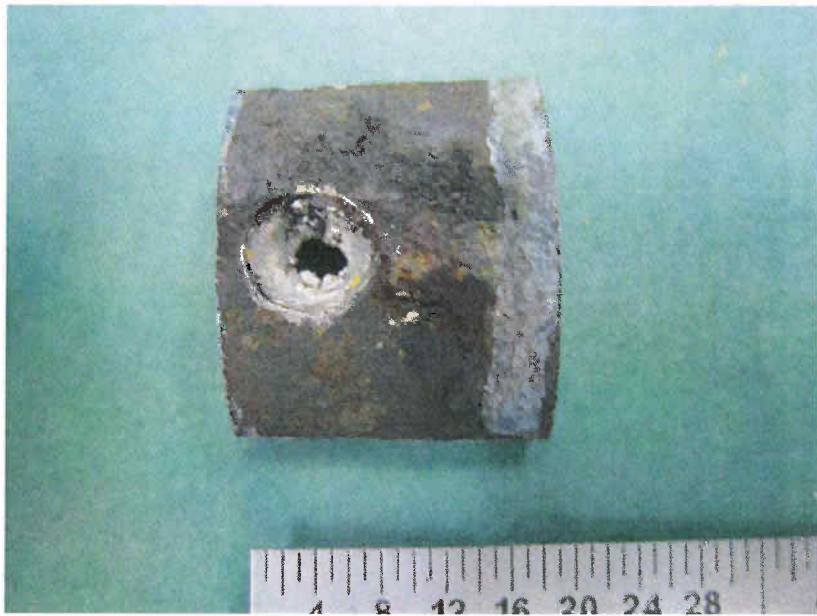
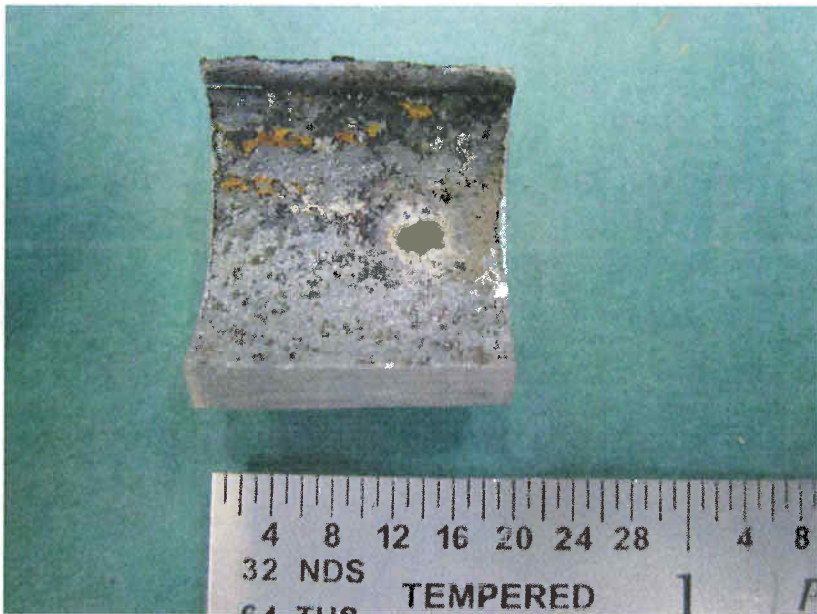
Figure 37. Detailed color photographs showing the hole removed from the gas line from 12312 5th Avenue NE. (a) ID surface; (b) OD surface.

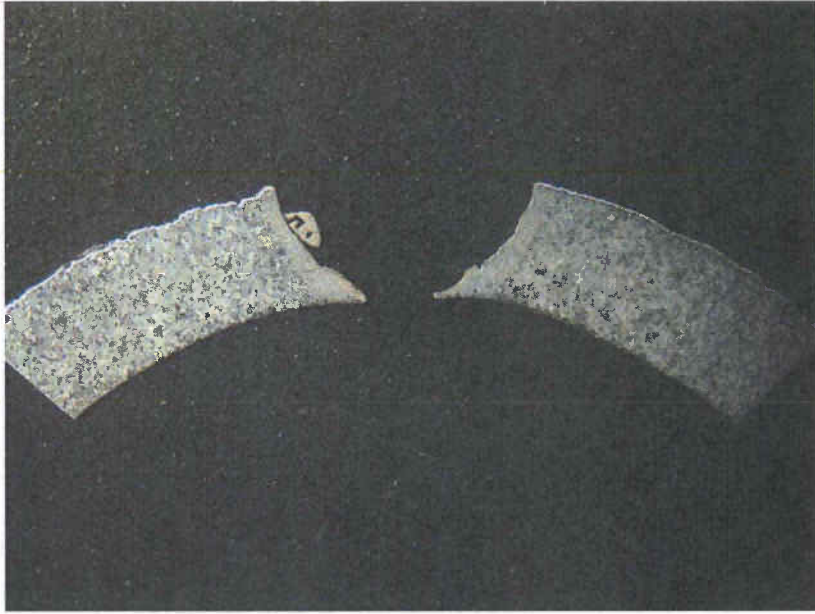
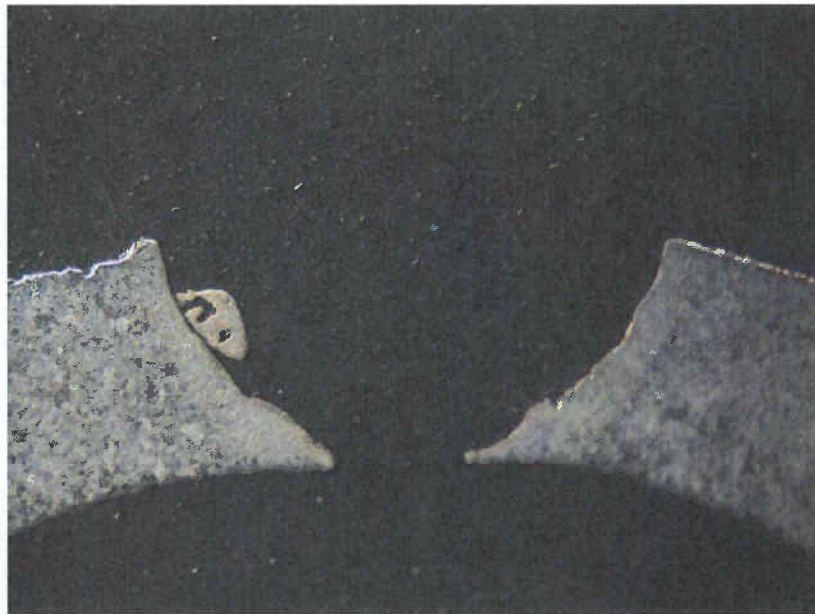
A metallographic mount was made with the entire hole in cross section. The mount was ground, polished and etched using standard metallographic procedures. The etched mount was examined using an optical microscope and the micrographs are presented in Figures 38-41. The hole was clearly created from OD toward the ID, as seen by the missing material; Figure 38. The surface of the hole from ID to OD revealed an altered microstructure due to melting and re-solidification of the surface. The general microstructure of the steel indicates a medium carbon steel; Figure 41.

Figure 38. Optical micrographs showing the hole in cross section of the sample removed from the gas line from 12312 5th Avenue NE. (a) Overall, etched, 10X; (b) Overall, etched, 20X.

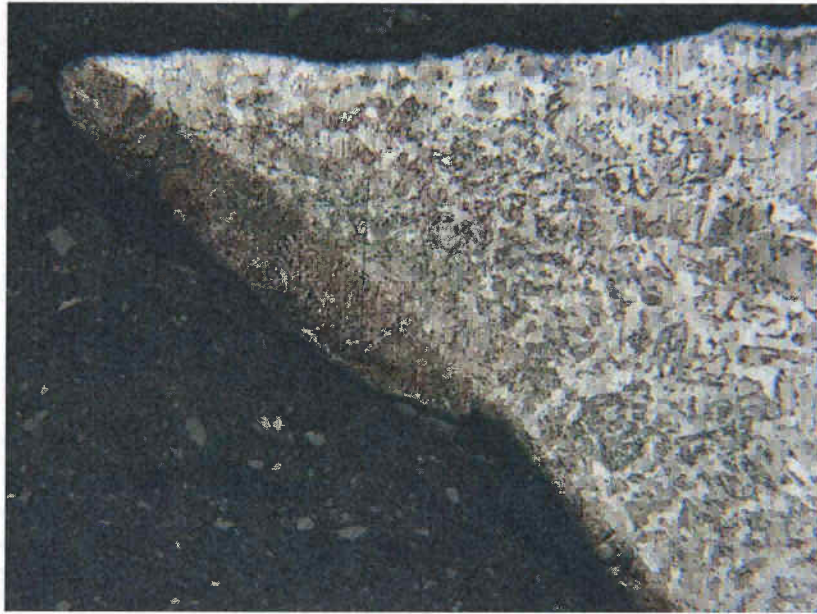
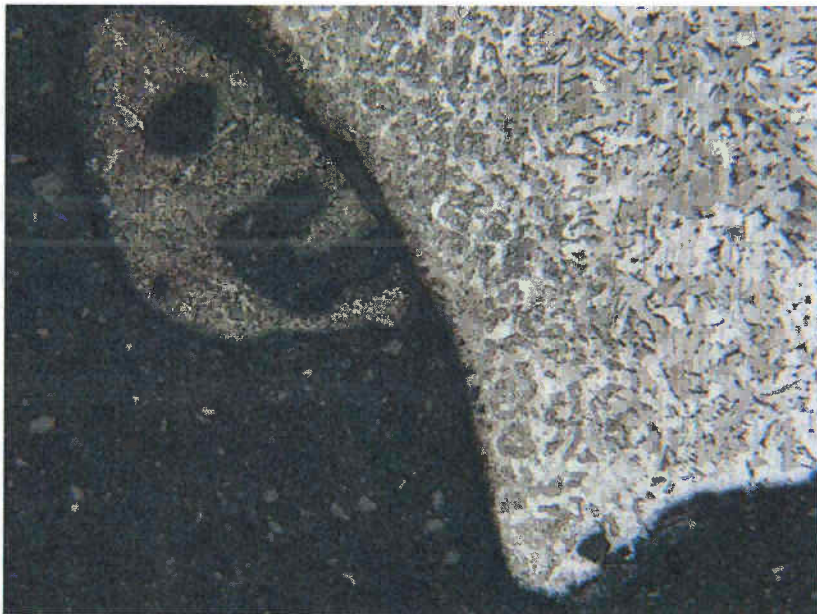
Figure 39. Detailed optical micrographs showing the hole surface in cross section of the sample removed from the gas line from 12312 5th Avenue NE. (a) ID surface, etched, 50X; (b) OD surface, etched, 50X.
