SYNOPSIS

On October 27, 2017, at approximately 9:25 a.m. PDT, northbound Amtrak Train No. 500 (A500-1-27) collided with an occupied automobile at a private crossing at Horseshoe Bend Estates, USDOT Crossing No. 077853A, BNSF Milepost 90.2. BNSF is the host railroad for Amtrak in the State of Washington where Amtrak trains operate on the BNSF Northwest Division. The accident location is approximately three miles south of Castle Rock, WA, and the collision occurred on BNSF main track 2 on the Seattle Subdivision. The two occupants in the automobile were killed. The automobile was destroyed; the leading locomotive of Amtrak Train 500 sustained \$2884.54 in damages. There were no injuries to passengers or crew on board Amtrak Train No. 500. No rail cars derailed because of this accident. This accident occurred on an Amtrak route and it was not PTC preventable.

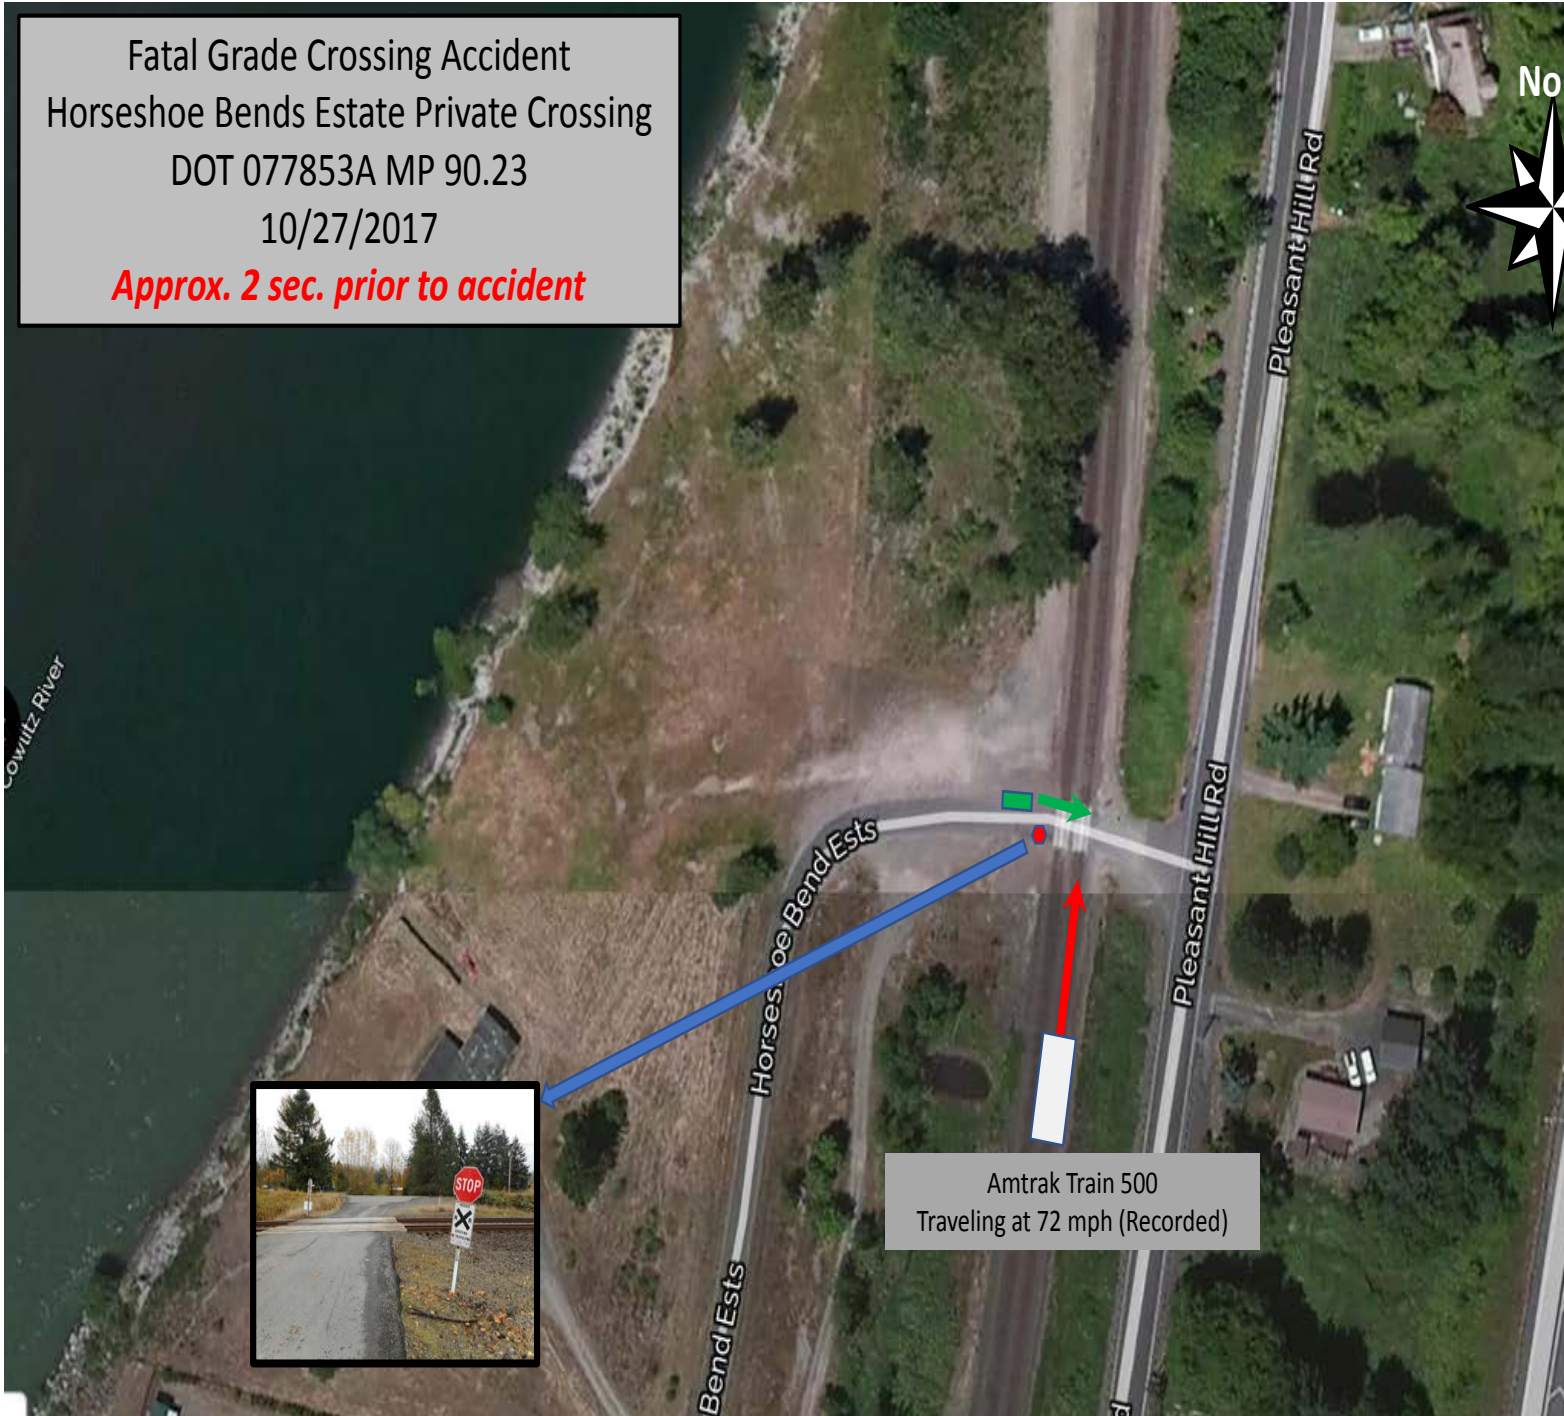
Sketch - Sketch

Horseshoe Bend Estates is a paved, private road which crosses BNSF main track 1 and 2 at a 90° angle from east to west before turning south about 169 feet west of the crossing. From there, the road continues south for several hundred feet, running parallel to the railroad track. Due to vegetation, trains are not generally visible along this section of road.

Analysis – Sight distance at USDOT Crossing No. 077853A: A sight distance analysis was conducted on the west approach at this private crossing equipped with passive warning devices. The analysis revealed sight distance of approximately 615 feet. The recommended sight distance for an automobile departing from a stopped position is approximately 1729 feet, according to the Revised 2nd Ed. of the Railroad-Highway Grade Crossing Handbook, Table 32. The driver of the vehicle in this incident did not stop, even though the crossing was equipped with a stop sign on the day of the accident. Instead, the driver proceeded, without stopping, across the private highway/rail grade crossing at Horseshoe Bend Estates at an estimated average speed of about 14 mph. The necessary sight distance for a vehicle traversing a crossing at 14 mph would be 927 feet, according to the Revised 2nd Ed. of the Railroad-Highway Grade Crossing Handbook, Table 32. In both scenarios described above, the train speed used in Table 32 was the recorded speed of Amtrak Train 500 – 72 mph.

The sight distance south of the private highway/rail grade crossing at Horseshoe Bend Estates, USDOT Crossing No. 077853A is limited by curvature of the track and seasonal vegetation located off railroad property. Removal of some of this vegetation could improve sight distance looking to the south at this location.

Conclusion – This crossing is equipped with stop signs. Motorists complying and stopping on the west approach have a sight distance 1000 feet less than what is recommended. Motorists who ignore the stop sign also have less sight distance than they require based on the speed of trains at this location. Track curvature and seasonal vegetation contribute to reduced sight distance at this crossing.

Conclusion: As a private crossing, Horseshoe Bend Estates, USDOT Crossing No. 077853A, is properly equipped with warning signs. Personnel from the Washington Utilities and Transportation Commission held a meeting at this location with the railroad to determine the possibility of installing additional safeguards at this crossing. Subsequent on-site discussions resulted in several potential safety improvements, including installation of lighted stop signs acquired with Section 130 funding, removal of vegetation and installation of whistle boards at this crossing. The BNSF representative in attendance indicated BNSF would have to investigate the feasibility of the installation of lighted stop signs and whistle boards at Horseshoe Bend Estates. BNSF also plans to reestablish the private crossing agreement with residents who use the crossing.
