Amtrak Passenger Train 501 Derailment  
DuPont, Washington  
December 18, 2017

NTSB/RAR-19/01  
PB2019-100807

# Railroad Accident Report

Amtrak Passenger Train 501 Derailment

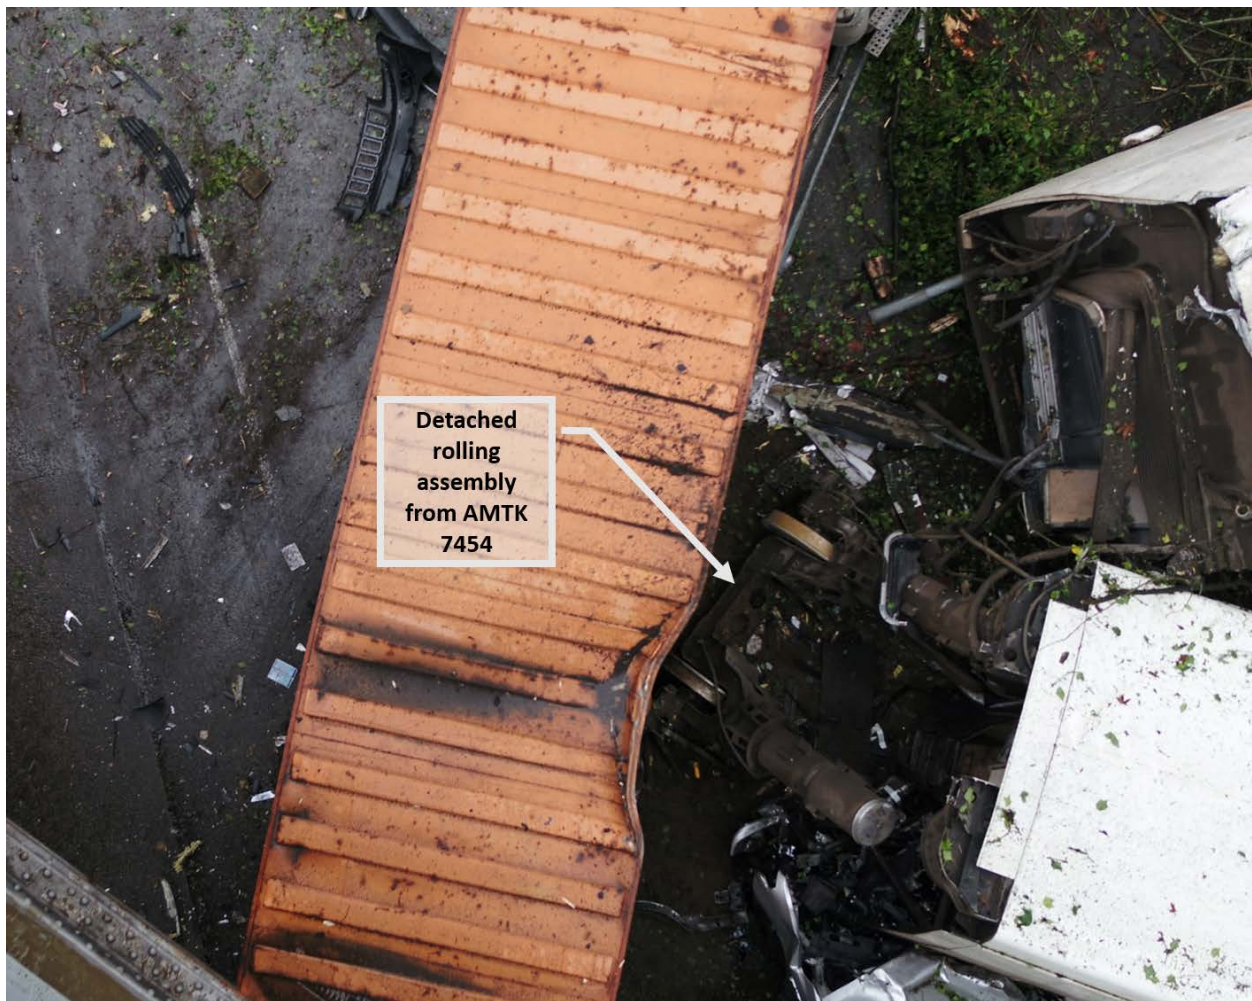
AMTK 7454 (3) followed a similar trajectory as AMTK 7903 (2). The clockwise rotation of AMTK 7903 (2) pushed AMTK 7454 (3) in a counterclockwise rotation about 37° from its original direction of travel. It came to rest on the interstate about 314 feet from the POD. The articulated connection of AMTK 7454 (3) and AMTK 7554 (4) remained intact. Impact indications were observed between the end wall structure of AMTK 7554 (4) and AMTK 7454 (3). Further details of the articulated coupler connections can be found in section 2.6 of this report. The rolling assembly from AMTK 7454 (3) separated from its attachments, however, the assembly remained near the supported end of this railcar. (See figure 11.)

**Figure 11.** Detached rolling assembly from AMTK 7454 (3). (Photo provided by WSP.)

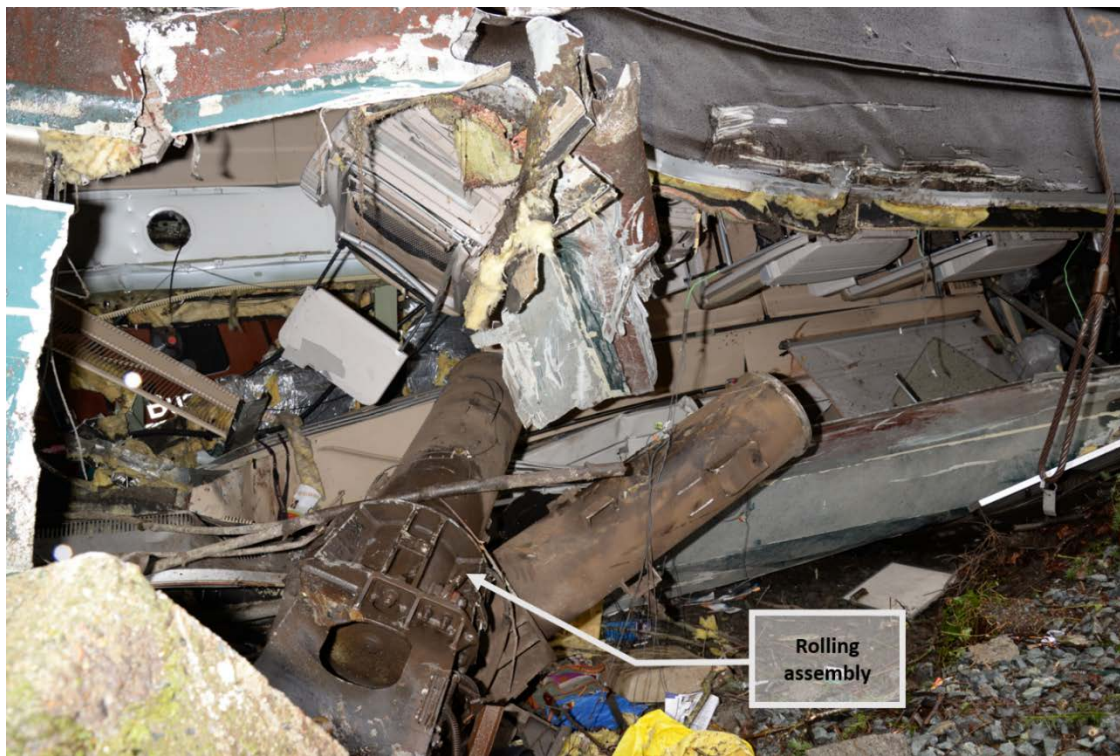
Five rolling assemblies from the Talgo passenger railcars fully detached during the derailment and one partially detached. One of the fully detached rolling assemblies collided with passenger railcar, AMTK 7504 (7), in which three passengers were killed. (See figure 12.)

**Figure 12.** Detached rolling assembly tower partially inside AMTK 7504(7).

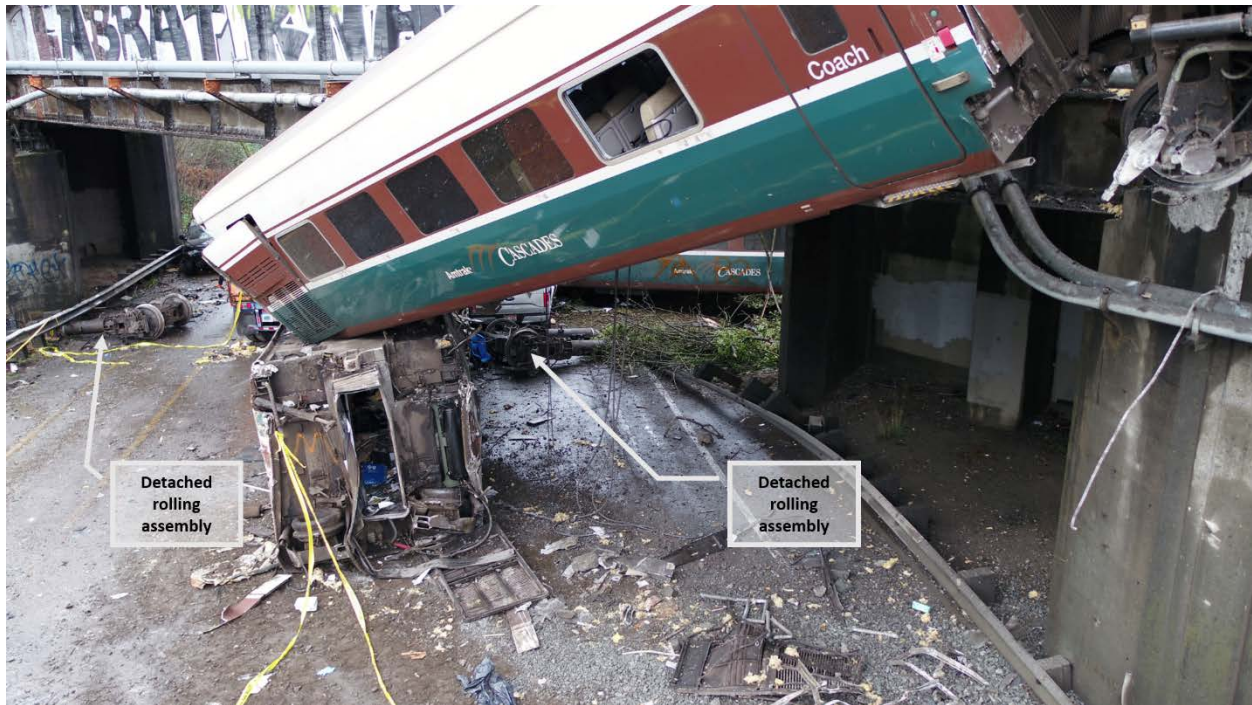
Rolling assemblies are located at the leading end (oriented relative to the direction of travel) of the 12 semipermanently coupled railcars. The rolling assembly from AMTK 7424 (8) was located underneath the bridge next to the left guardrail on the south lanes of I-5. The rolling assembly from AMTK 7421 (11) was located behind a Ford pickup truck on the south lanes of I-5. (See figure 13.)

**Figure 13.** AMTK 7421 (11) resting on AMTK 7424 (8). (Photo provided by WSP.)

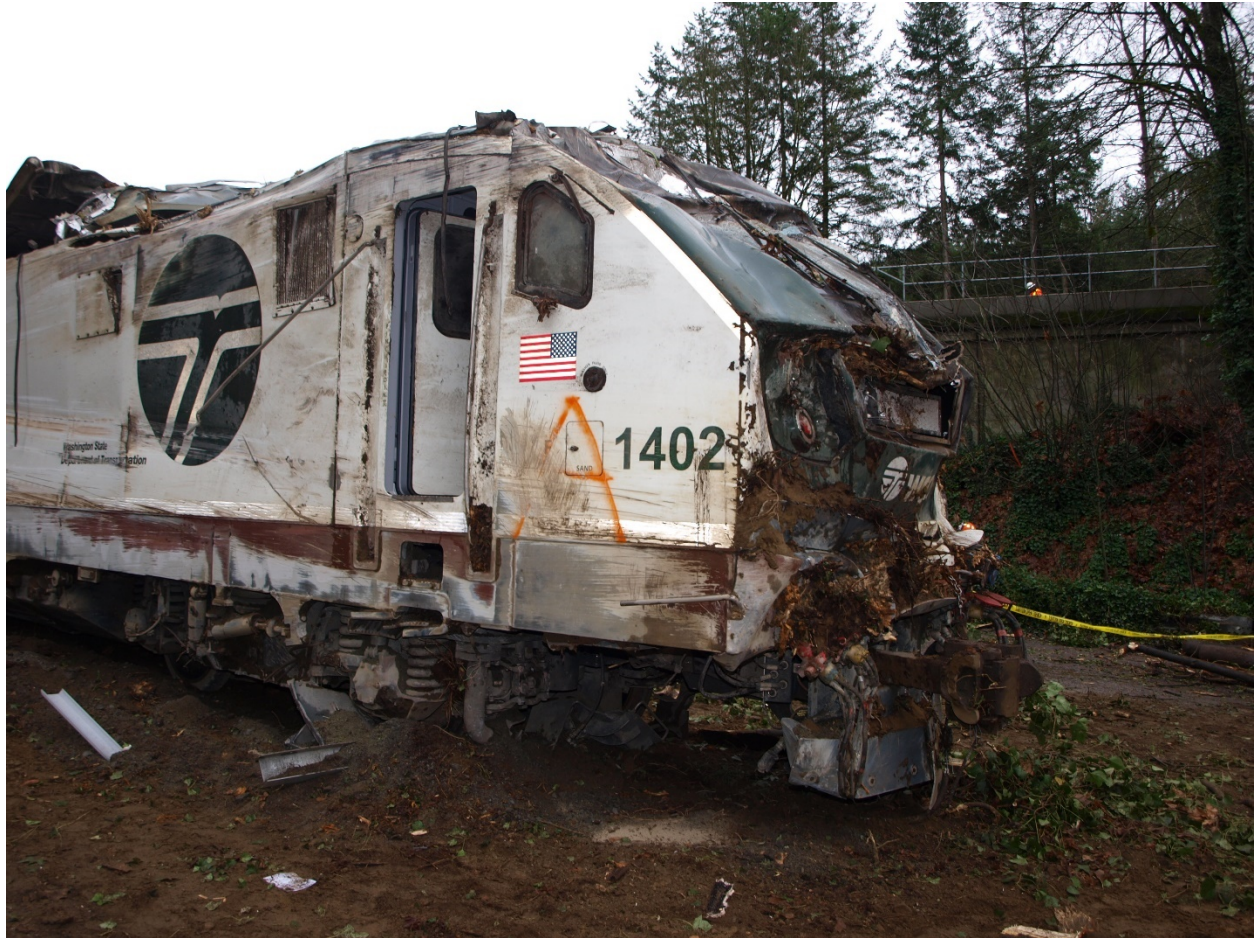
The lead locomotive, WDTX 1402 (1), received impacts to the front top section of the cab. The cab roof deformed into the operator's compartment about 13 inches. The roof panels sheared off, exposing the machine room compartments. The right side of the locomotive exhibited horizontal scrape marks along its full length and mud, dirt, wood, and rocks were lodged into the side panels, consistent with the locomotive proceeding through the woods on its side. The locomotive came to rest about 457 feet from the POD, on the interstate, upright and forward facing, indicating it righted itself as it moved through the wooded area, impacting the adjacent trees and passing through the highway guardrail, which was located beneath the locomotive. (See figure 15.)

**Figure 15.** WDTX 1402 (1) postderailment position.

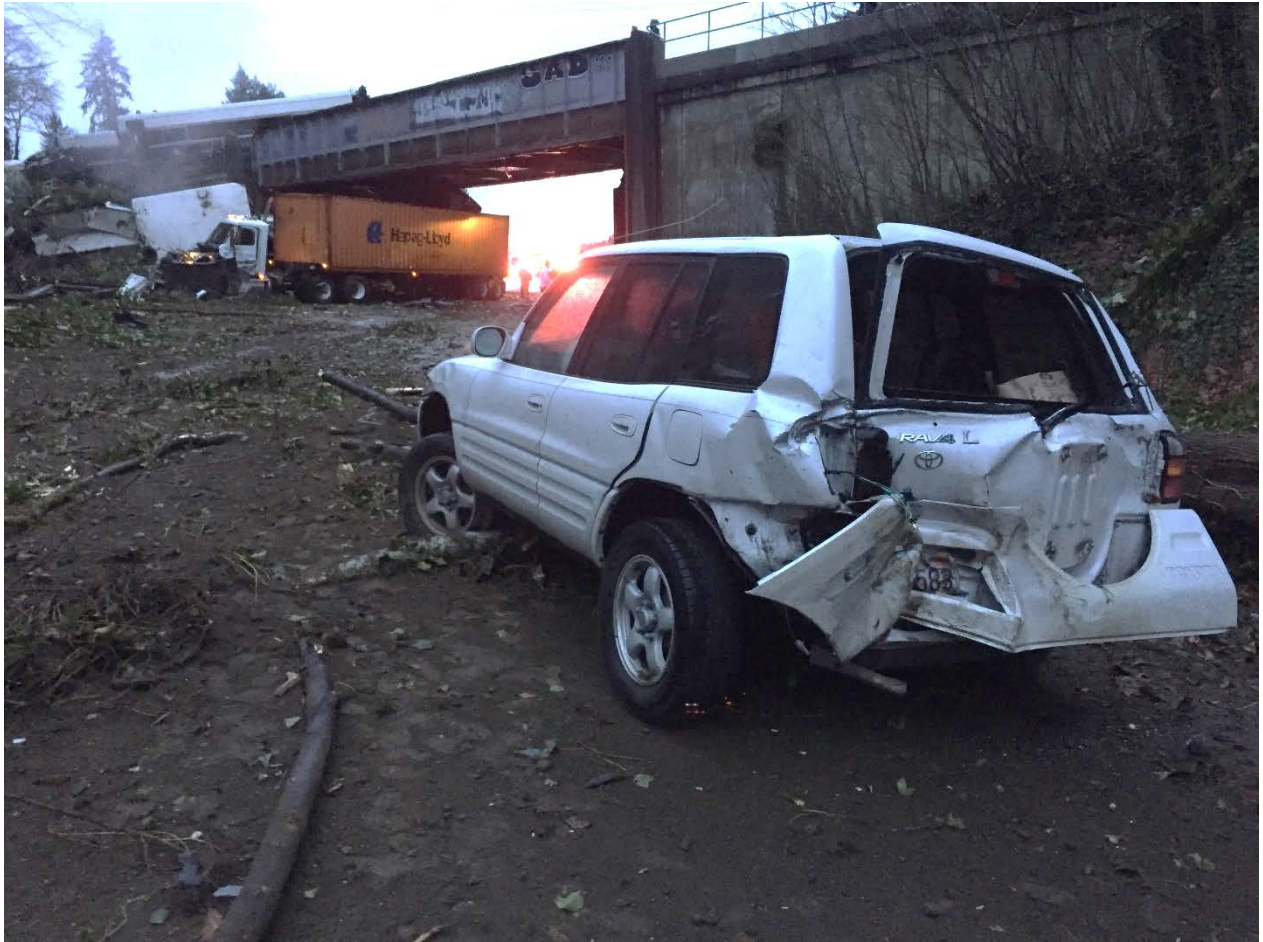
During interviews with highway vehicle operators, a driver of a white Toyota RAV4 said she was traveling southbound in the right lane when her vehicle was struck from behind by the locomotive. The vehicle came to rest on the left side of the roadway, facing north in the southbound lane. (See figure 16.)

**Figure 16.** Highway vehicle struck by lead locomotive. (Photo provided by driver.)

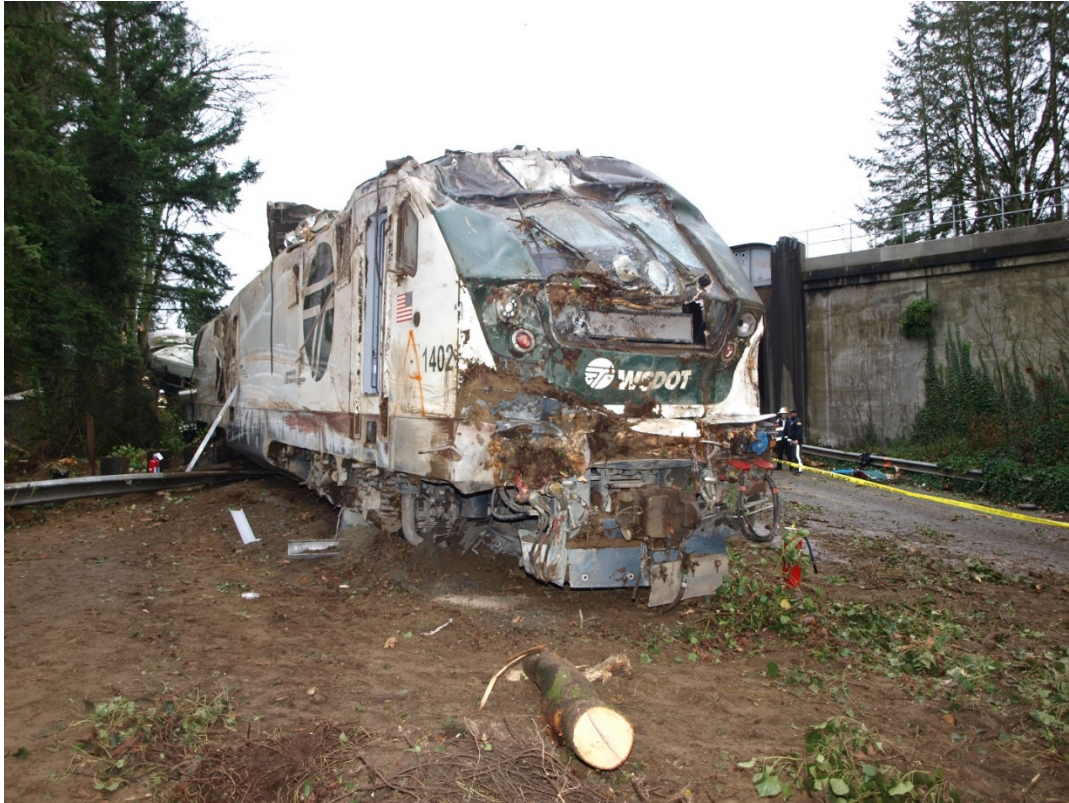
As a result of the derailment, there were some localized deformations at the front of the operating cab above the corner and collision posts. The operating cab windshield was destroyed; however, the laminated safety glass feature prevented the shattered glass from separating into pieces. The right side of the locomotive exhibited nonstructural compromised sidewall damage consistent with the locomotive being on its side. Abrasions were visible along the entire length, from the side sill (lower portion along the floor line) to the roof. The rear-end wall structure was severely loaded during the derailment and was separated from the right-side wall connections. The left-side connections remained intact. Damage along the left side was minimal. The roof panels (three total) were severed from their connections. (See figure 18.)

**Figure 18.** Damage to WDTX 1402 (1).

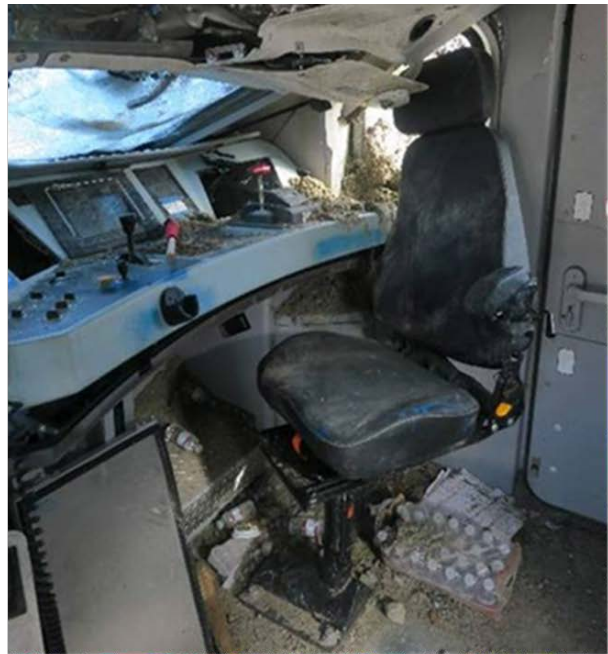
Damage to the interior of the operating cab was constrained primarily to the leading end, most notably at and above the front glazing (windshield). The vertical space of the cab interior was reduced to about 19 inches between the operator's desk and the ceiling, and to 66 inches from the floor to the ceiling. The height above the seats was reduced to 66.5 inches. All doors, both side doors, and the machinery room access door, were fully functional after the accident. The cab ceiling emergency exit hatch was dislodged from the vehicle. The hatch is comprised of two parts; the upper, or outer, part came to rest in the wooded area between the track and the interstate, and the inner portion was inside the cab. Investigators estimated the locomotive lost about 5 percent of its occupied volume in the cab. Figure 19 is a cutaway illustration of the locomotive cab showing the cab design and underlying structure and an interior photograph of the accident cab taken from the left side of the cab towards the engineer's seat on the right.

Photograph of damaged locomotive cab.

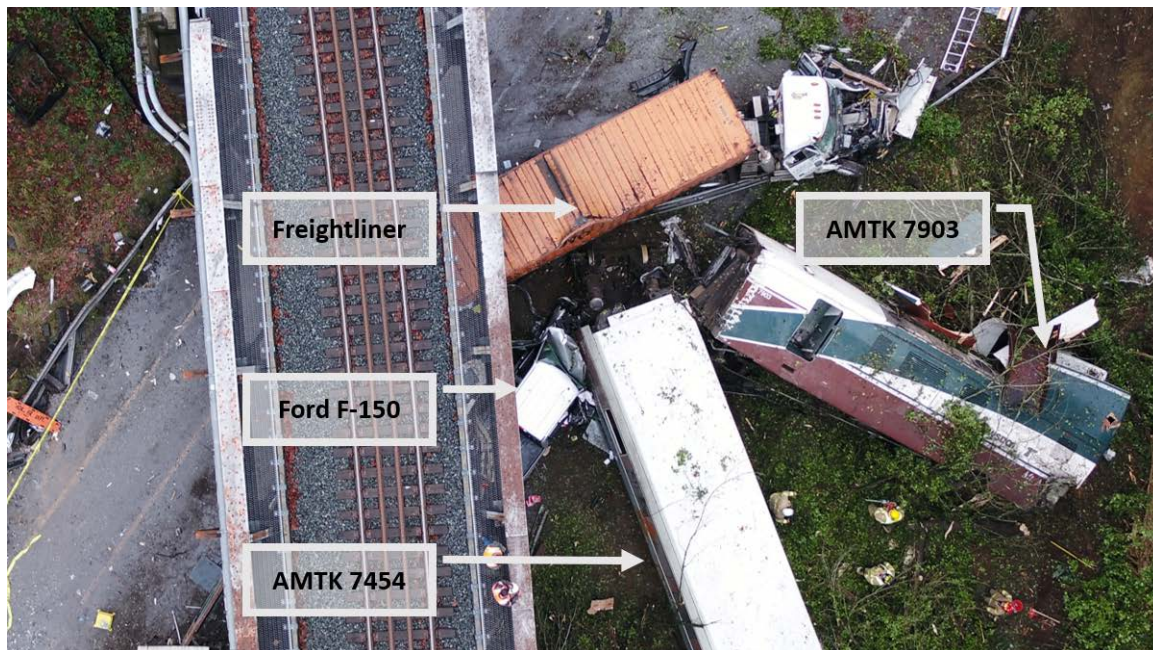
A Ford F-150 pick-up truck was damaged when AMTK 7454 (3) entered the roadway south of the overpass in front of it. The driver reported that he was unable to stop and struck the railcar. AMTK 7424 (8) collided with the rear of the truck as it slid to a stop on the interstate. The driver sustained severe injuries as did the front-seat passenger, who was trapped in the vehicle and had to be extricated by the first responders. (See figure 24.)

**Figure 24.** Final resting position of F150 and Freightliner. (Photo provided by WSP.)

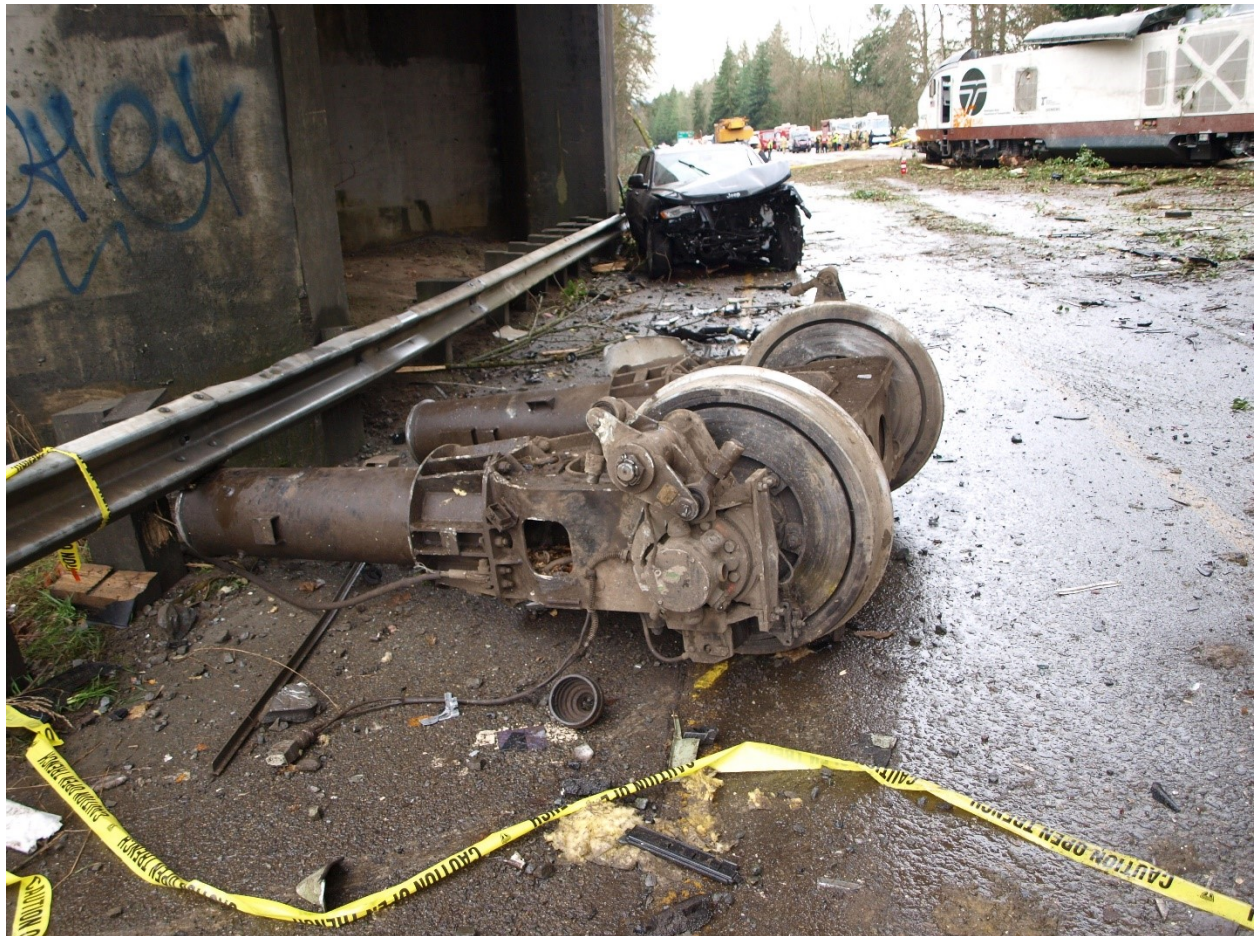
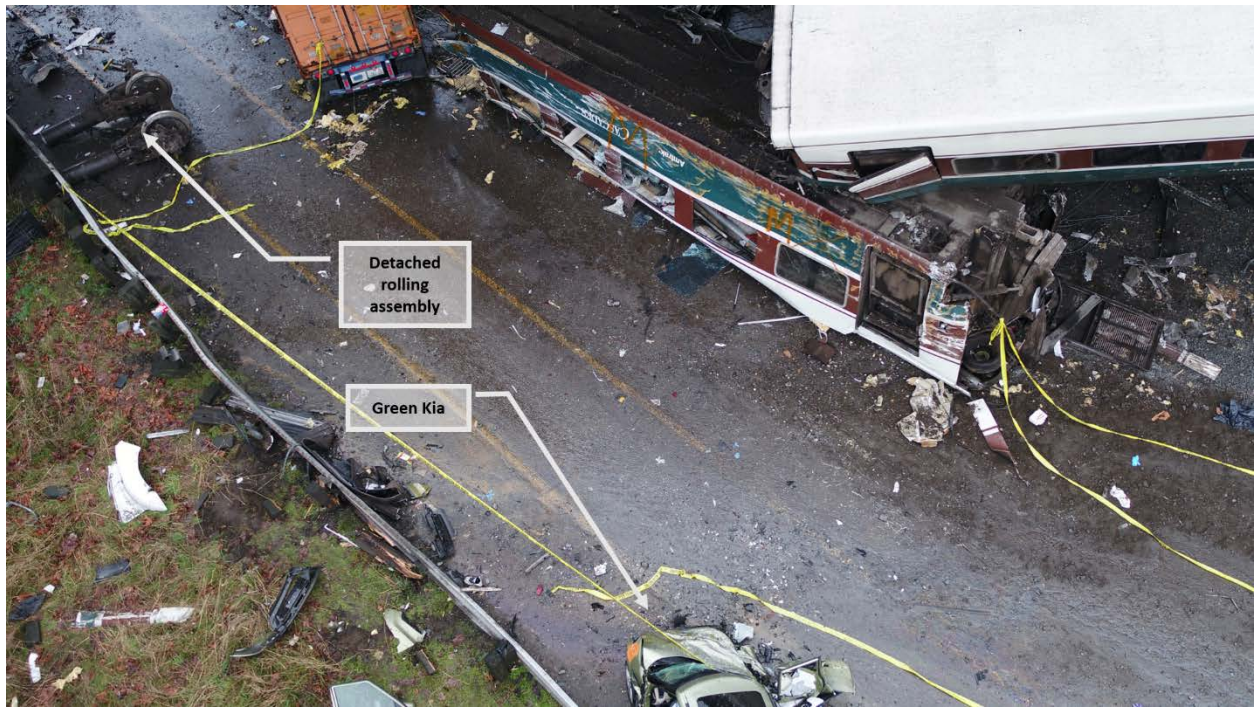
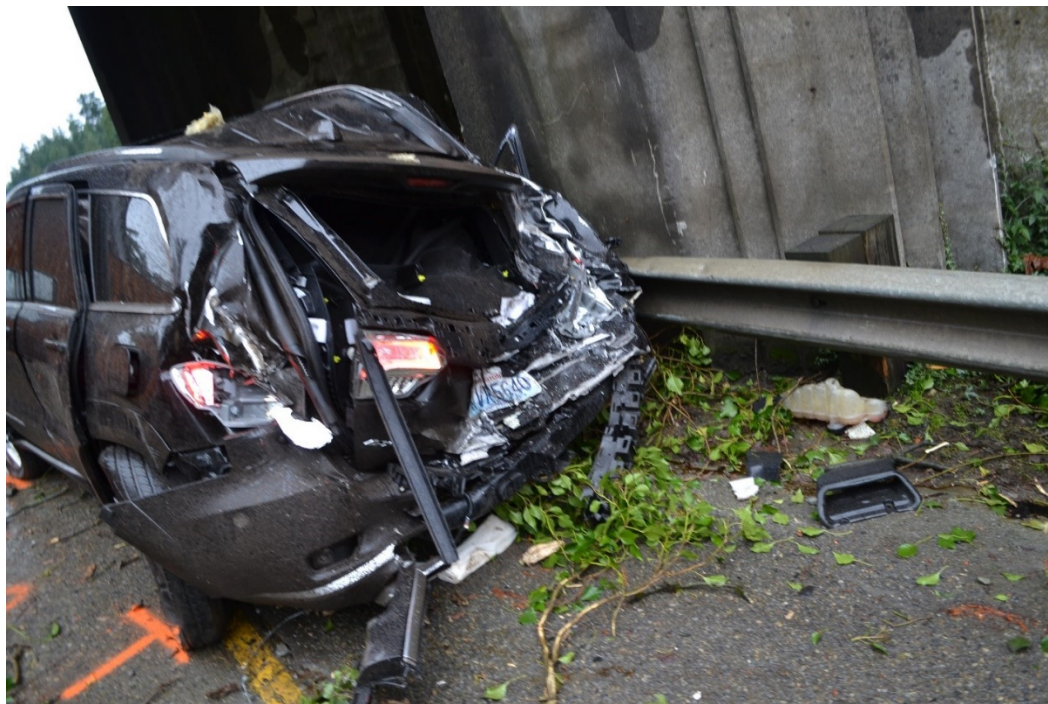
A green Kia Soul (Kia) and a black Jeep Grand Cherokee (Jeep) were struck by the rolling assembly weighing about 4,500 pounds that had detached from AMTK 7424 (8). (See figure 25.) The rolling assembly struck the front hood of the Kia and the rear of the Jeep; causing both drivers to lose control of their vehicles. The driver of the Jeep reported to investigators that AMTK 7424 (8) also struck his vehicle. Both vehicles sustained extensive crush damage resulting from the impact with the rolling assembly. The driver of the Kia was pinned inside of her vehicle when the engine block was shoved rearward, collapsing the dashboard and steering column onto her. (See figure 26.) The driver had to be extricated by first responders but sustained only minor injuries in the accident. After being struck by the rolling assembly, the Jeep rotated 180° striking the metal guardrail before coming to final rest. (See figure 27.) The Jeep occupant also sustained minor injuries in the accident.

**Figure 25.** Detached rolling assembly and Grand Cherokee. (Photo provided by WSP.)

**Figure 26.** Green Kia and rolling assembly on I-5. (Photo provided by WSP.)

**Figure 27.** Damaged Jeep Grand Cherokee. (Photo provided by WSP.)

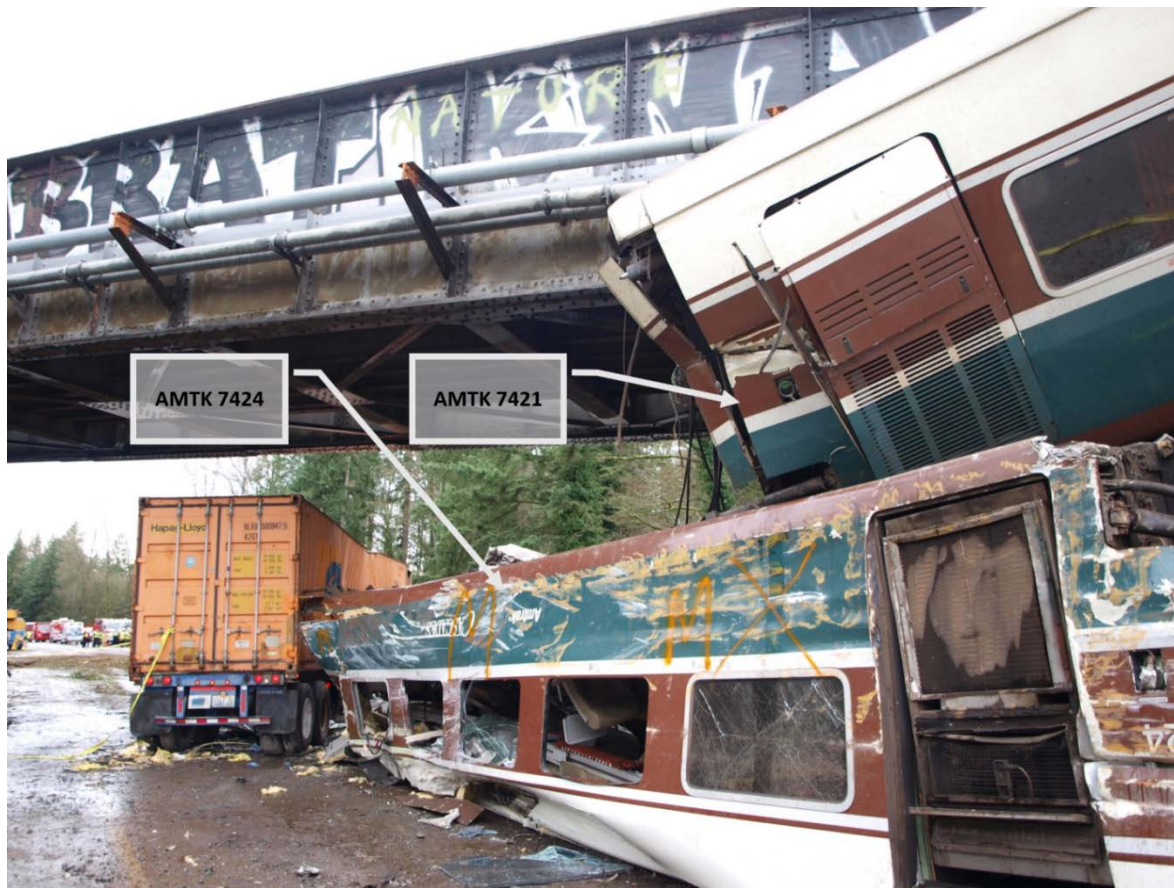
As a result of the derailment, AMTK 7421(11) came to rest hanging from the overpass and resting on top of AMTK 7424 (8). (See figure 28.)

**Figure 28.** AMTK 7421 (11) resting on AMTK 7424 (8). (Photo provided by WSP.)

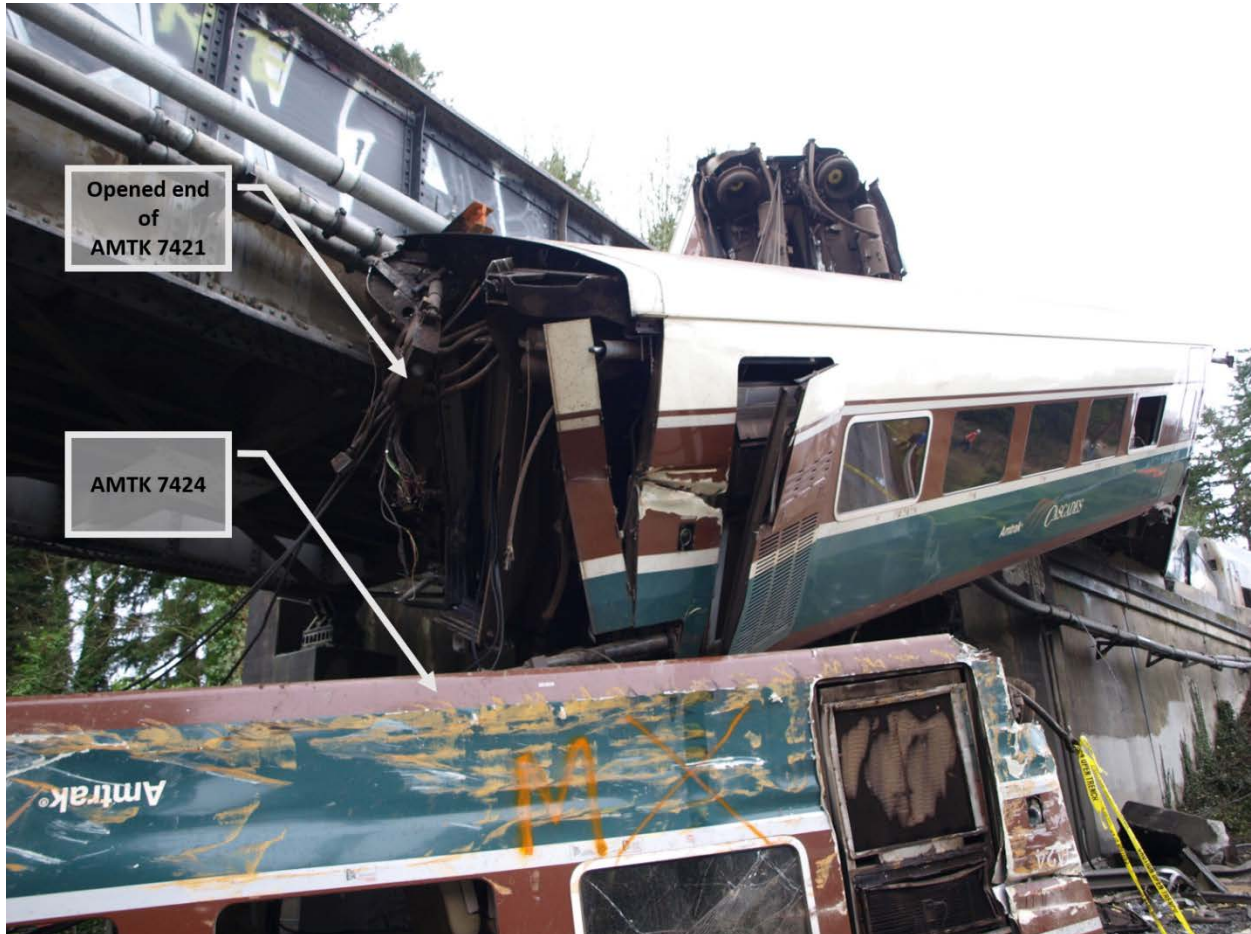
The separation of AMTK 7421 (11) from its lead railcar left an opening at the lowest point of the railcar, where it had been previously coupled. A female passenger sitting near the front of that railcar was thrown from her seat and partially ejected through the opening at the end of the railcar. (See figure 29.)

**Figure 29.** Open end of AMTK 7421 (11). (Photo provided by WSP.)

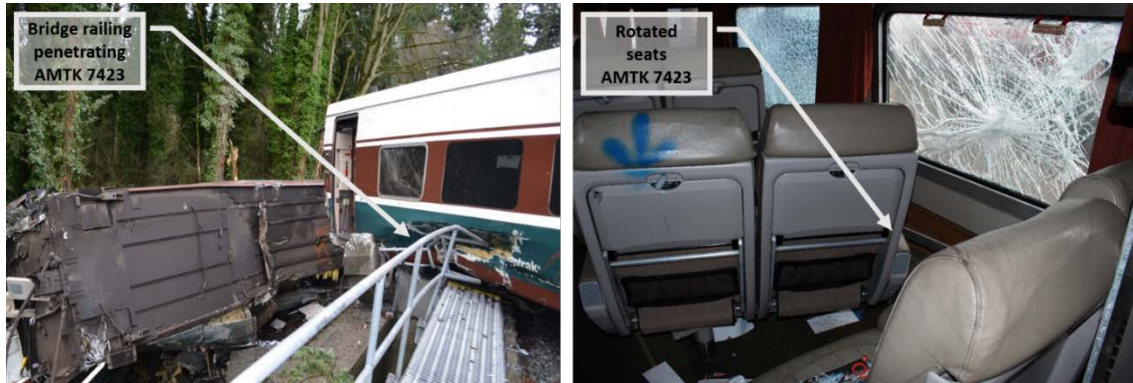
examination of AMTK 7423 (9) revealed that during the derailment, the metal railing on the southside walkway on the overpass penetrated the lower portion of the railcar's sidewall. This resulted in the displacement of the interior sidewall. The three rows of seats were displaced laterally causing the seats to rotate. Figure 31 shows the intrusion by the metal railing into the railcar and shows the displacement of seats.

**Figure 31.** Bridge railing penetrating AMTK 7423 and displaced passenger seats.

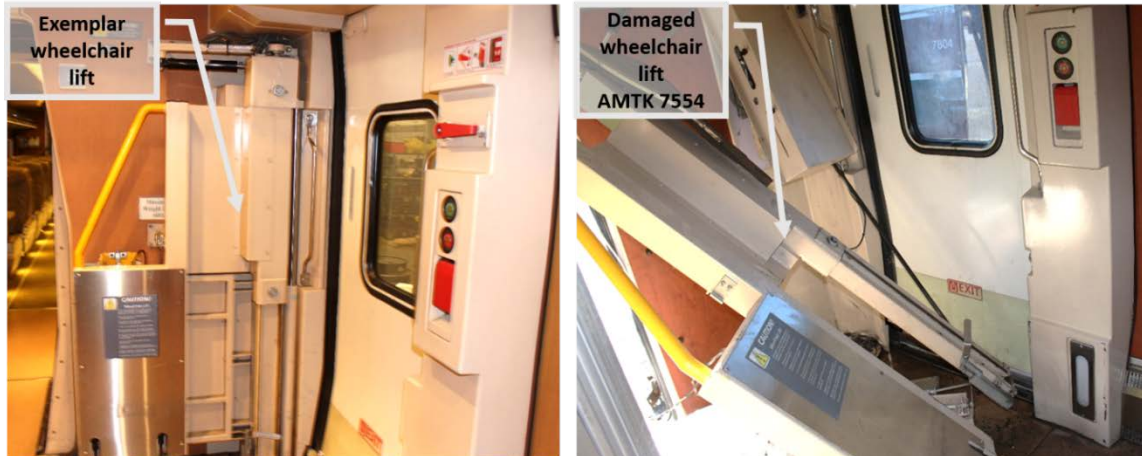
Train 501 was equipped with two handicap-accessible railcars. One was the Business class, AMTK 7554 (4) and one was the Coach class, AMTK 7504 (7). Two wheelchair lifts were provided in each railcar, one on each side of the railcar adjacent to the exterior door. In the stowed position, the lifts were secured by a metal pin that bolted the wheelchair assembly to the overhead frame of the lift and to the floor of the railcar. In AMTK 7554 (4), the right-side wheelchair lift was found to be detached from its securement bracket on the floor and pulled away from the top by a force exerted on the bottom of the lift at the time of the derailment. The wheelchair lift was found partially attached and hanging, obstructing access to the exterior door. On the left side of the railcar, the wheelchair lift was still in place. The lift had sustained damage and the securement latch had been bent but the lift was still functional. A closer inspection of the wheelchair lift assemblies revealed that the structural buckling of the railcar frame allowed the wheelchair lifts to be detached from the floor. The weight of the wheelchair lift pulled the top of the lift away from the railcar structure. (See figure 33.)

**Figure 33.** Exemplar wheelchair lift and damaged lift in AMTK 7554 (4).

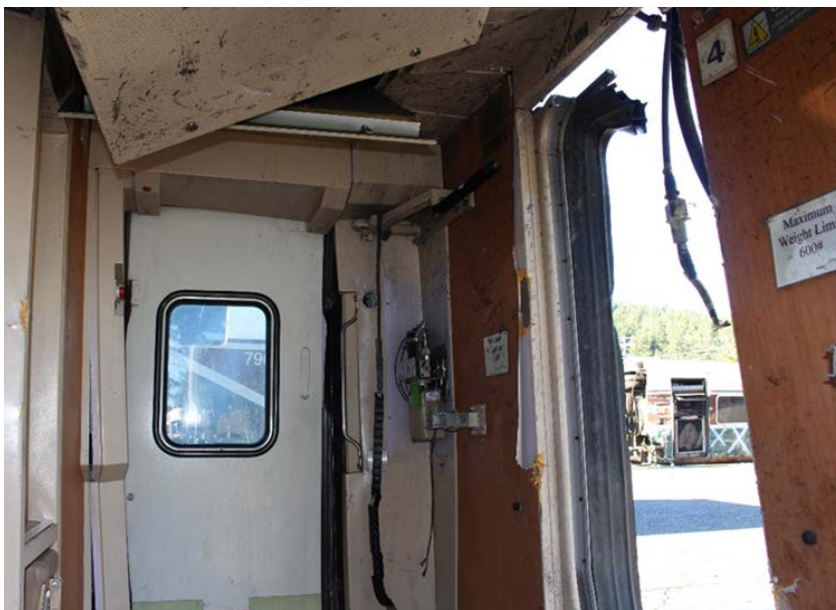
Only one wheelchair lift was recovered from the scene. Components from the second lift were recovered. Due to the extensive damage to the railcar and to the recovered wheelchair lift, it was not possible to determine which wheelchair lift had been recovered from the debris. Figure 34 shows the interior damage to AMTK 7504 (7) and the location where the wheelchair lifts were mounted prior to being torn away from the railcar structure.

**Figure 34.** Photograph of missing wheelchair lift and damage to AMTK 7504 (7).

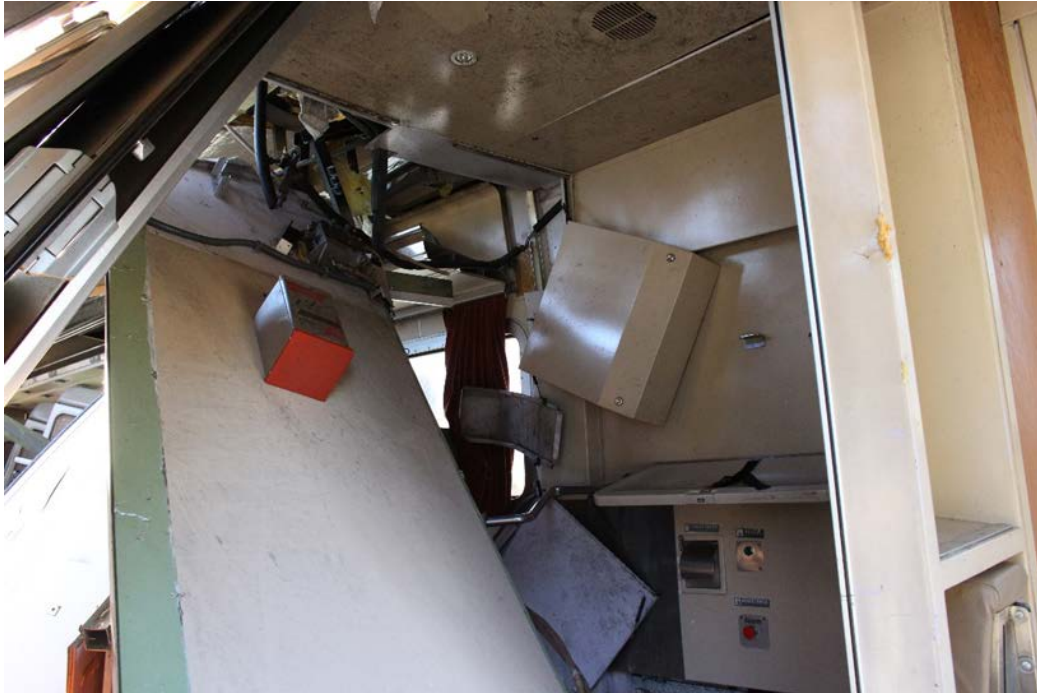
Figure 35 shows the damage resulting from the right-side wheelchair lift being propelled into the exterior lavatory wall in the railcar.

**Figure 35.** Photograph of the interior lavatory damage of AMTK 7504 (7).

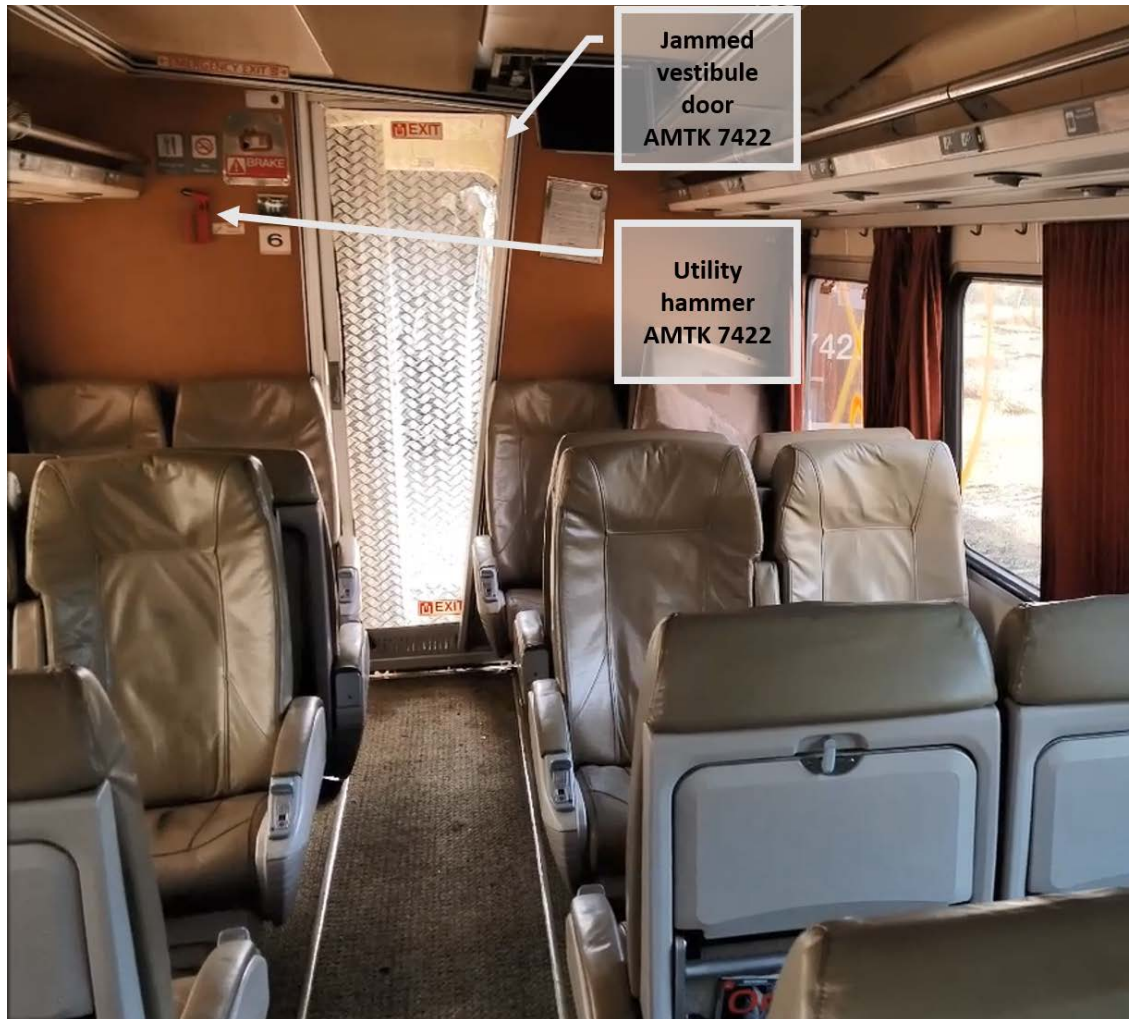
Investigators noted the vestibule door in AMTK 7422 (10) was jammed during postaccident interior examinations. Reasonable attempts were made by investigators to open the door, but it did not move. The utility hammer remained in place. (See figure 36.)

**Figure 36.** Jammed vestibule door, AMTK 7422 (10).
