## Complaint Form Request

## Case 19-077

**Supporting Documentation**  
**Avista vs Neighborhood Fence Complaint**  
**August 21, 2019**

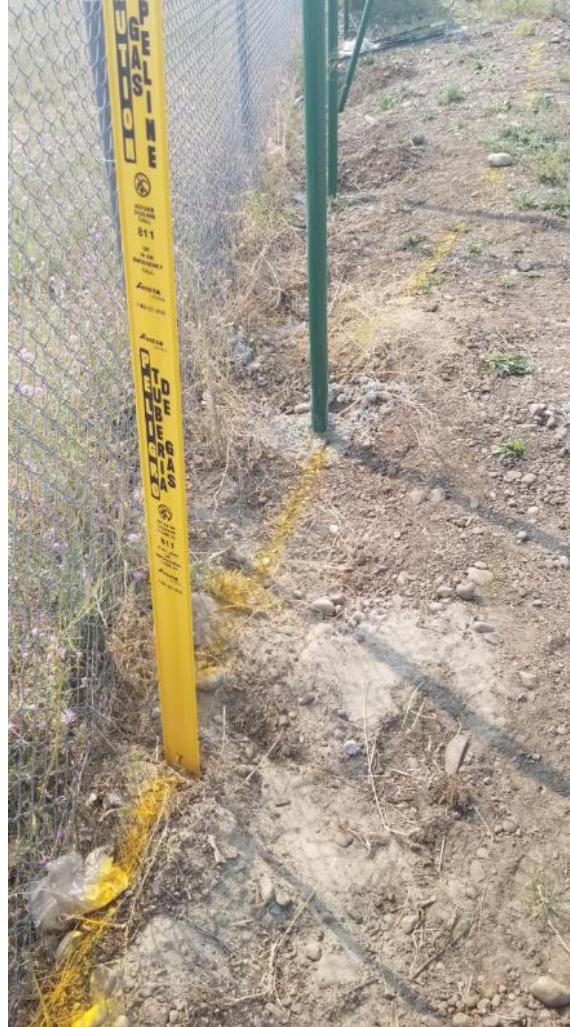
Neighborhood Fence augered directly over Avista's pipeline to install a fence post without having waited the 2 full business days for locate marks. One of the posts was installed within feet of a pipeline marker and should have been a clue to stop and wait for locates **see photo in Attachment #4**. Neighborhood Fence came close enough to the depth of the pipeline to get into the bedding sand on top of the pipeline. Luckily there was no damage done to the pipe; however, if the auger had hit the 160 psig pipeline, there could have been serious consequences.

**Attachment #4** – Photo of fence post in relation to where the 6" high pressure pipeline located out. Also notice the yellow pipeline marker, which should have been a clue to wait for locates.

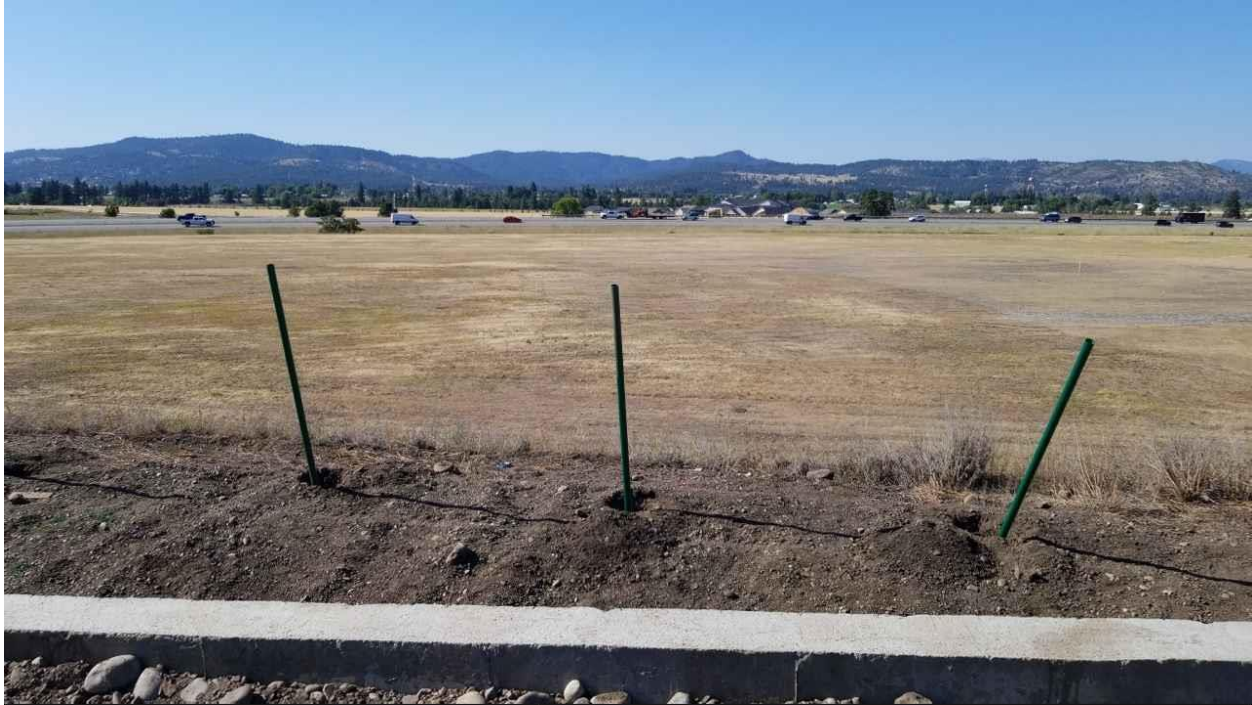
Ticket: 19325869.0 Timestamp: 7/31/2019 4:21:17 PM

**Attachment #5** – 3 Locator's pictures upon his arrival showing that post holes had already been augered

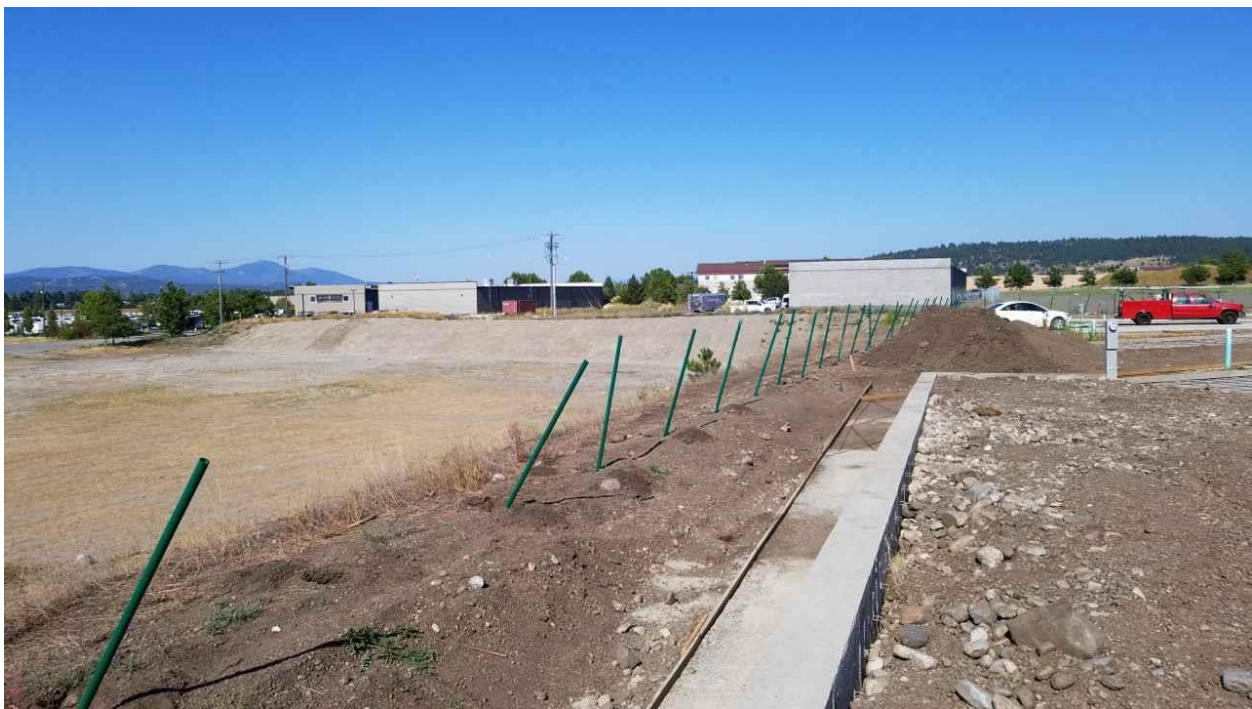
Ticket: 19325869.0 Timestamp: 7/31/2019 4:21:07 PM

**Attachment #6** – 3 Locator's pictures upon his arrival showing that post holes had already been augered

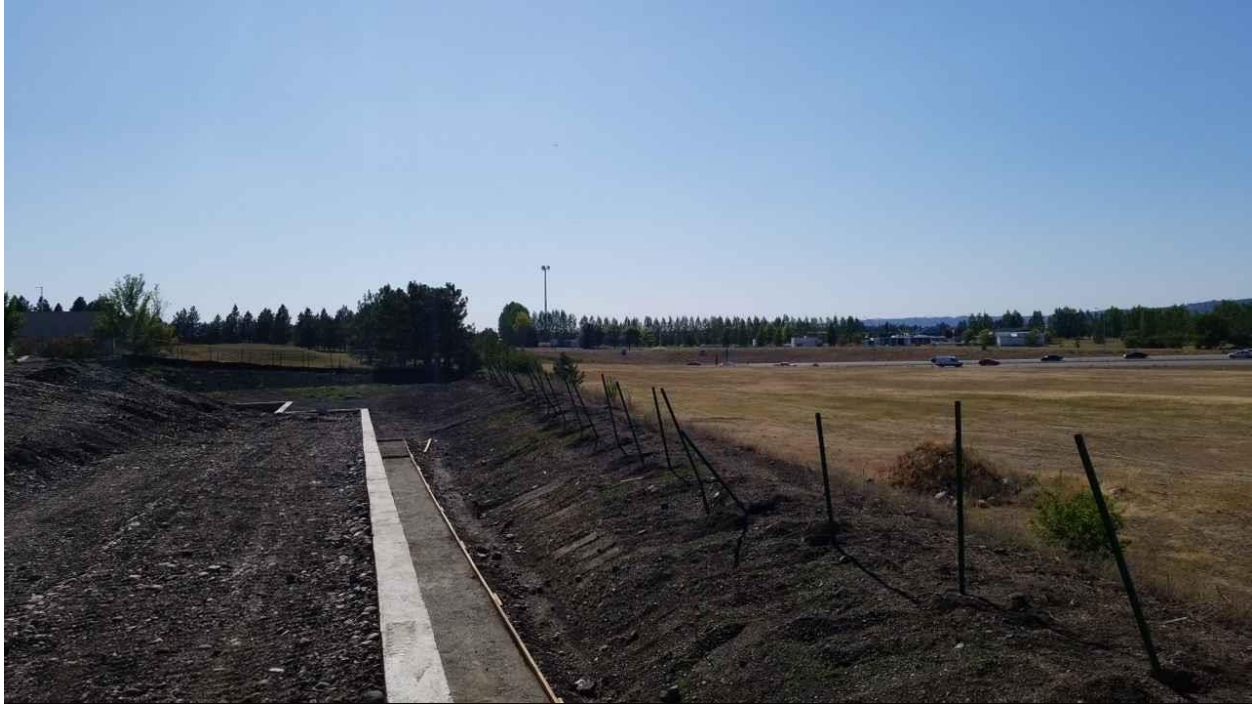
Ticket: 19325869.0 Timestamp: 7/31/2019 4:21:12 PM

**Attachment #7** – 3 Locator's pictures upon his arrival showing that post holes had already been augered

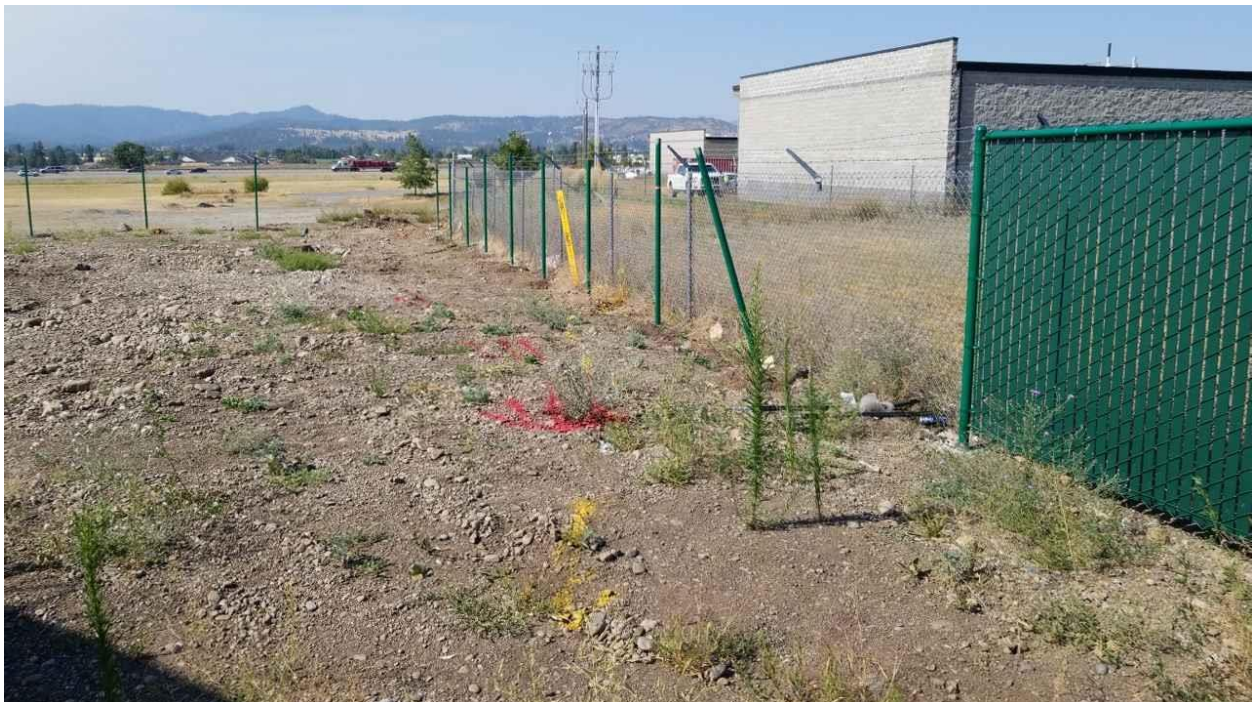
On August 5, 2019 Avista's inspector stopped at the job site because the ticket was flagged as a high consequence ticket due to a high pressure pipeline in the area of the locate ticket and found that the posts were installed and concreted over the top of Avista's 6" steel high pressure pipeline that was operating at 160 psig. Avista's inspector found in talking with the fencing crew that they started work on July 31, 2019 augering all the posts for the fencing. Which was confirmed by the locator, when he showed up late in the afternoon on July 31<sup>st</sup> the post holes had already been augered. **See Attachment #3** for locator's ticket comments and **see Attachments #5 – #8** for locator's pictures.

**Attachment #8** – Photo of locates in relation to fence posts
