Case 19-079 Century Link

On 8/22/2019 JCC crews discovered that a century link duct bank was insufficiently located at the intersection of 8th and Martin Luther King Junior Way in Tacoma Washington. As JCC crews began to excavate for a storm run, the ground man noticed that there was an additional un-located duct running parallel to what communications were located on the ground after further exposing it by hand digging. JCC requested locate tickets through 811 and received tickets #19309370 and #19309336 to dig under.

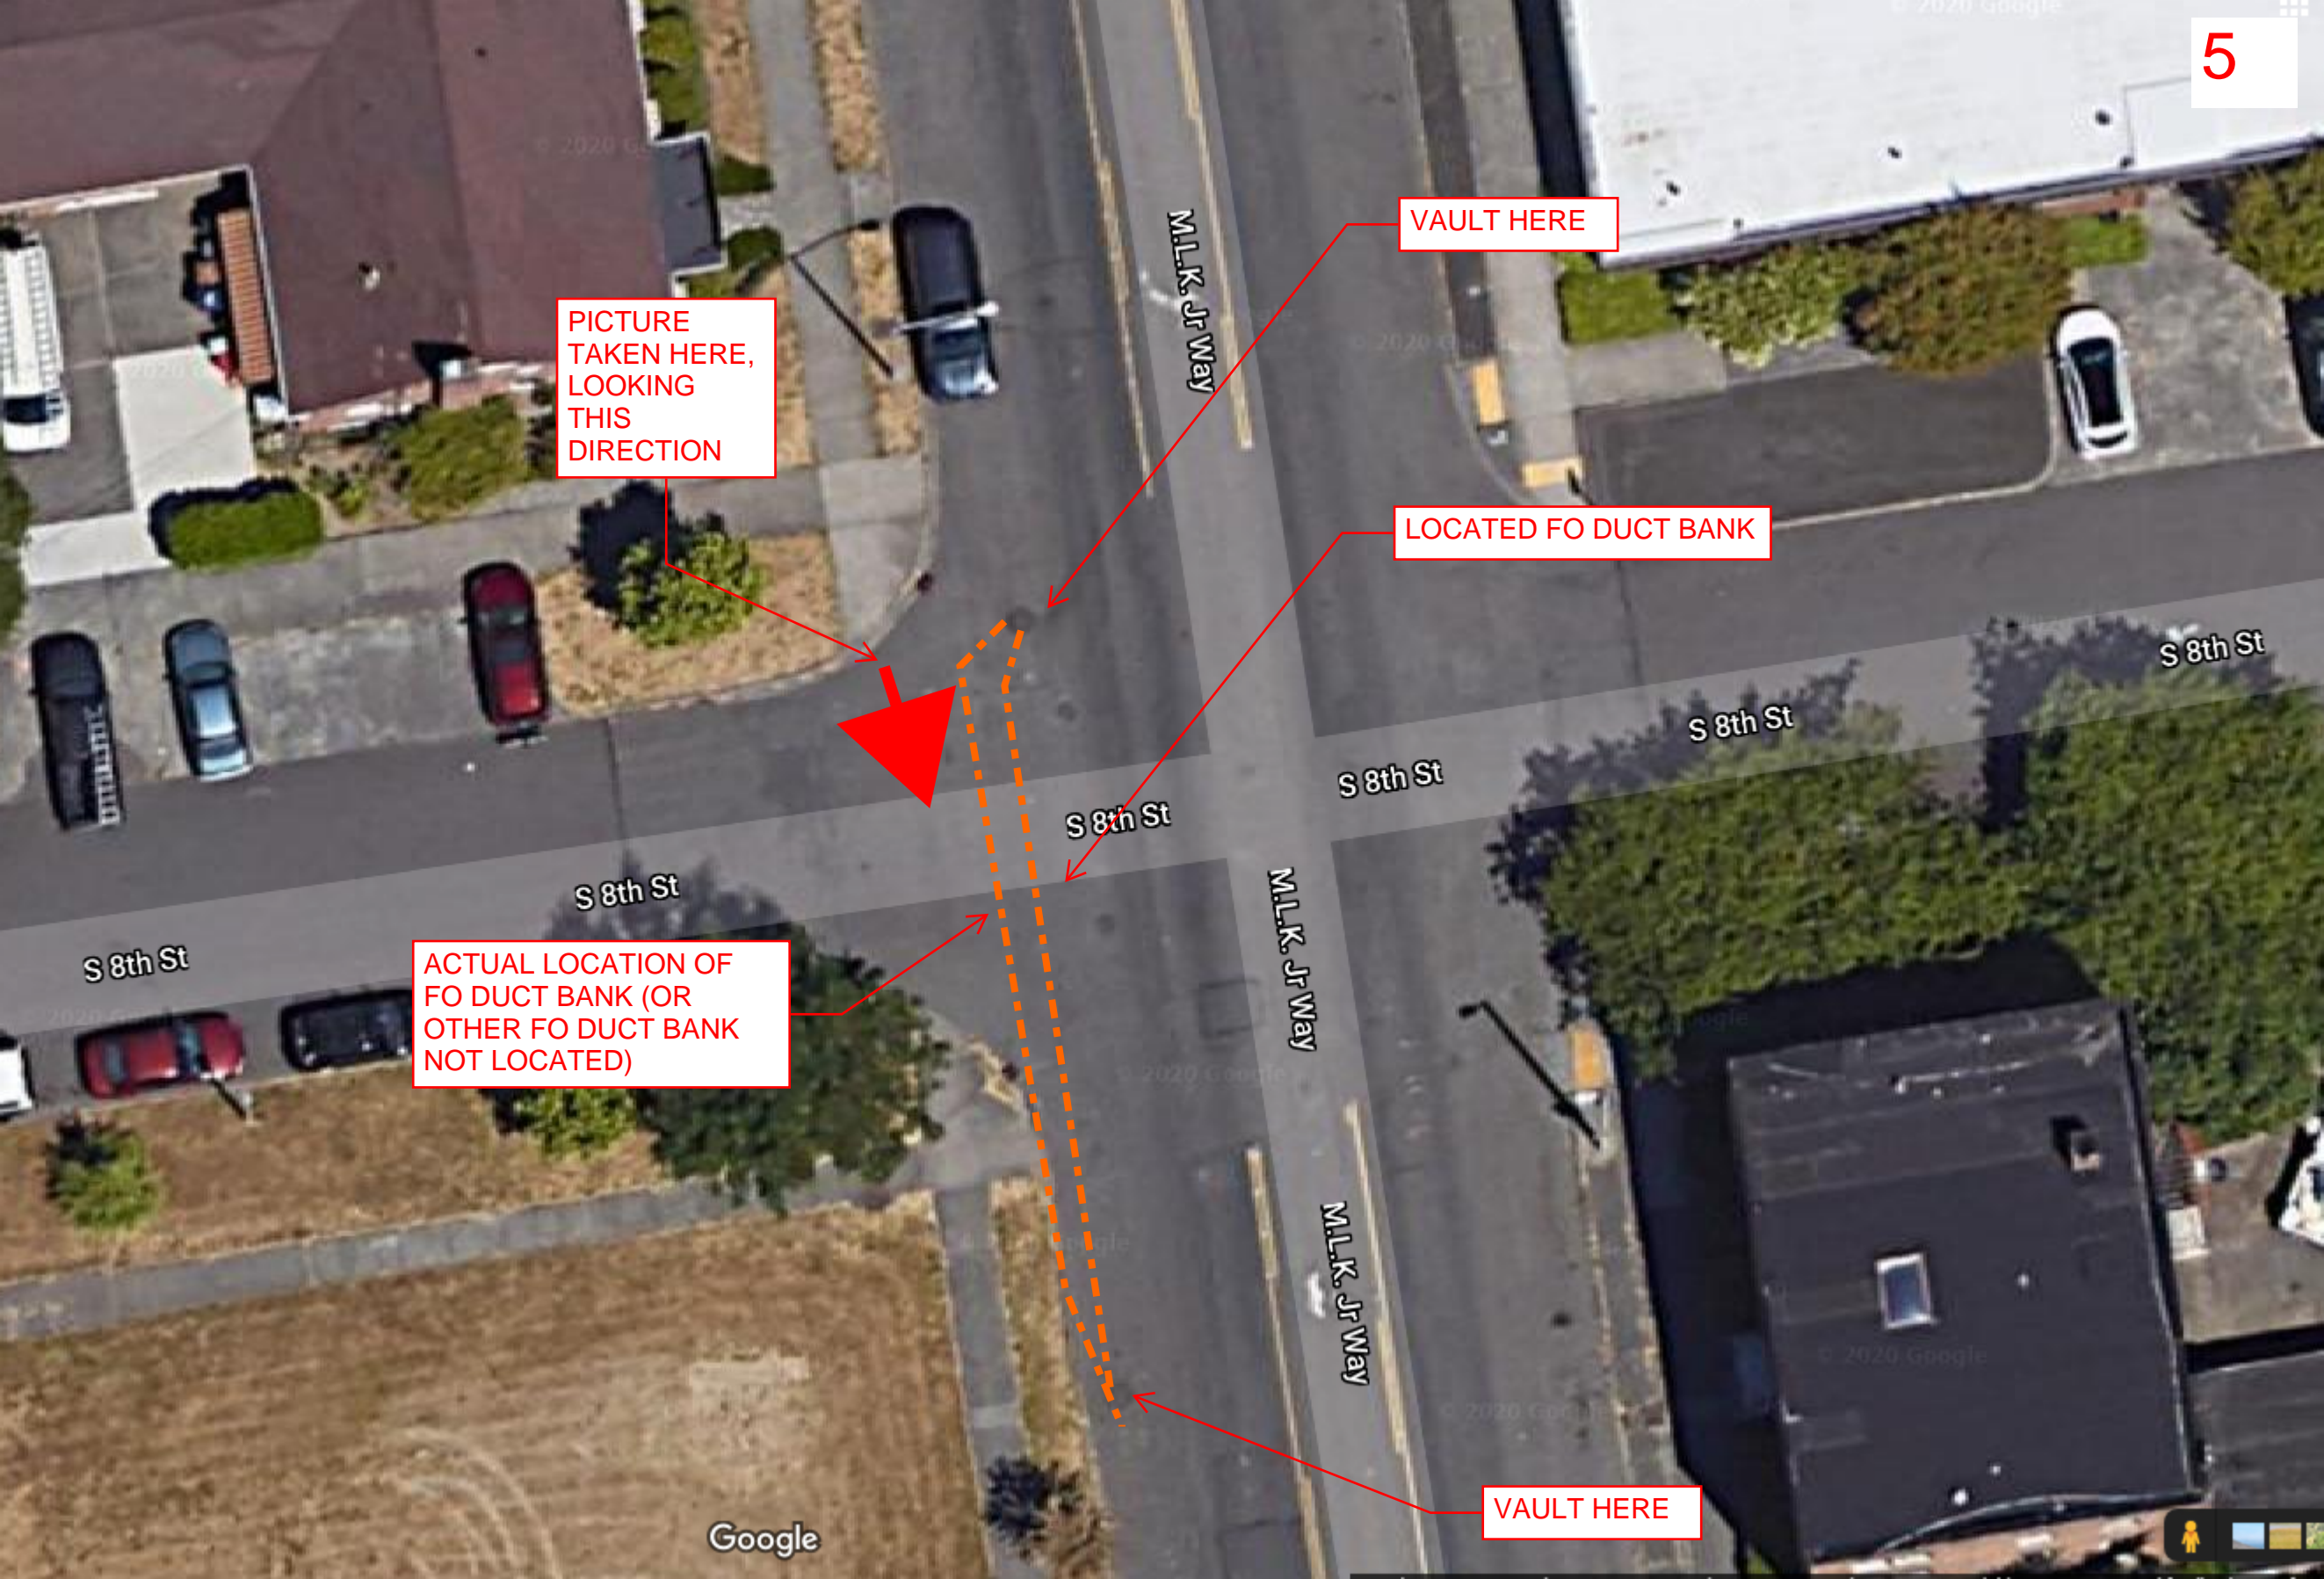
PRE EXCAVATION PHOTO

VAULT HERE

PICTURE
TAKEN HERE,
LOOKING
THIS
DIRECTION

LOCATED FO DUCT BANK

ACTUAL LOCATION OF
FO DUCT BANK (OR
OTHER FO DUCT BANK
NOT LOCATED)

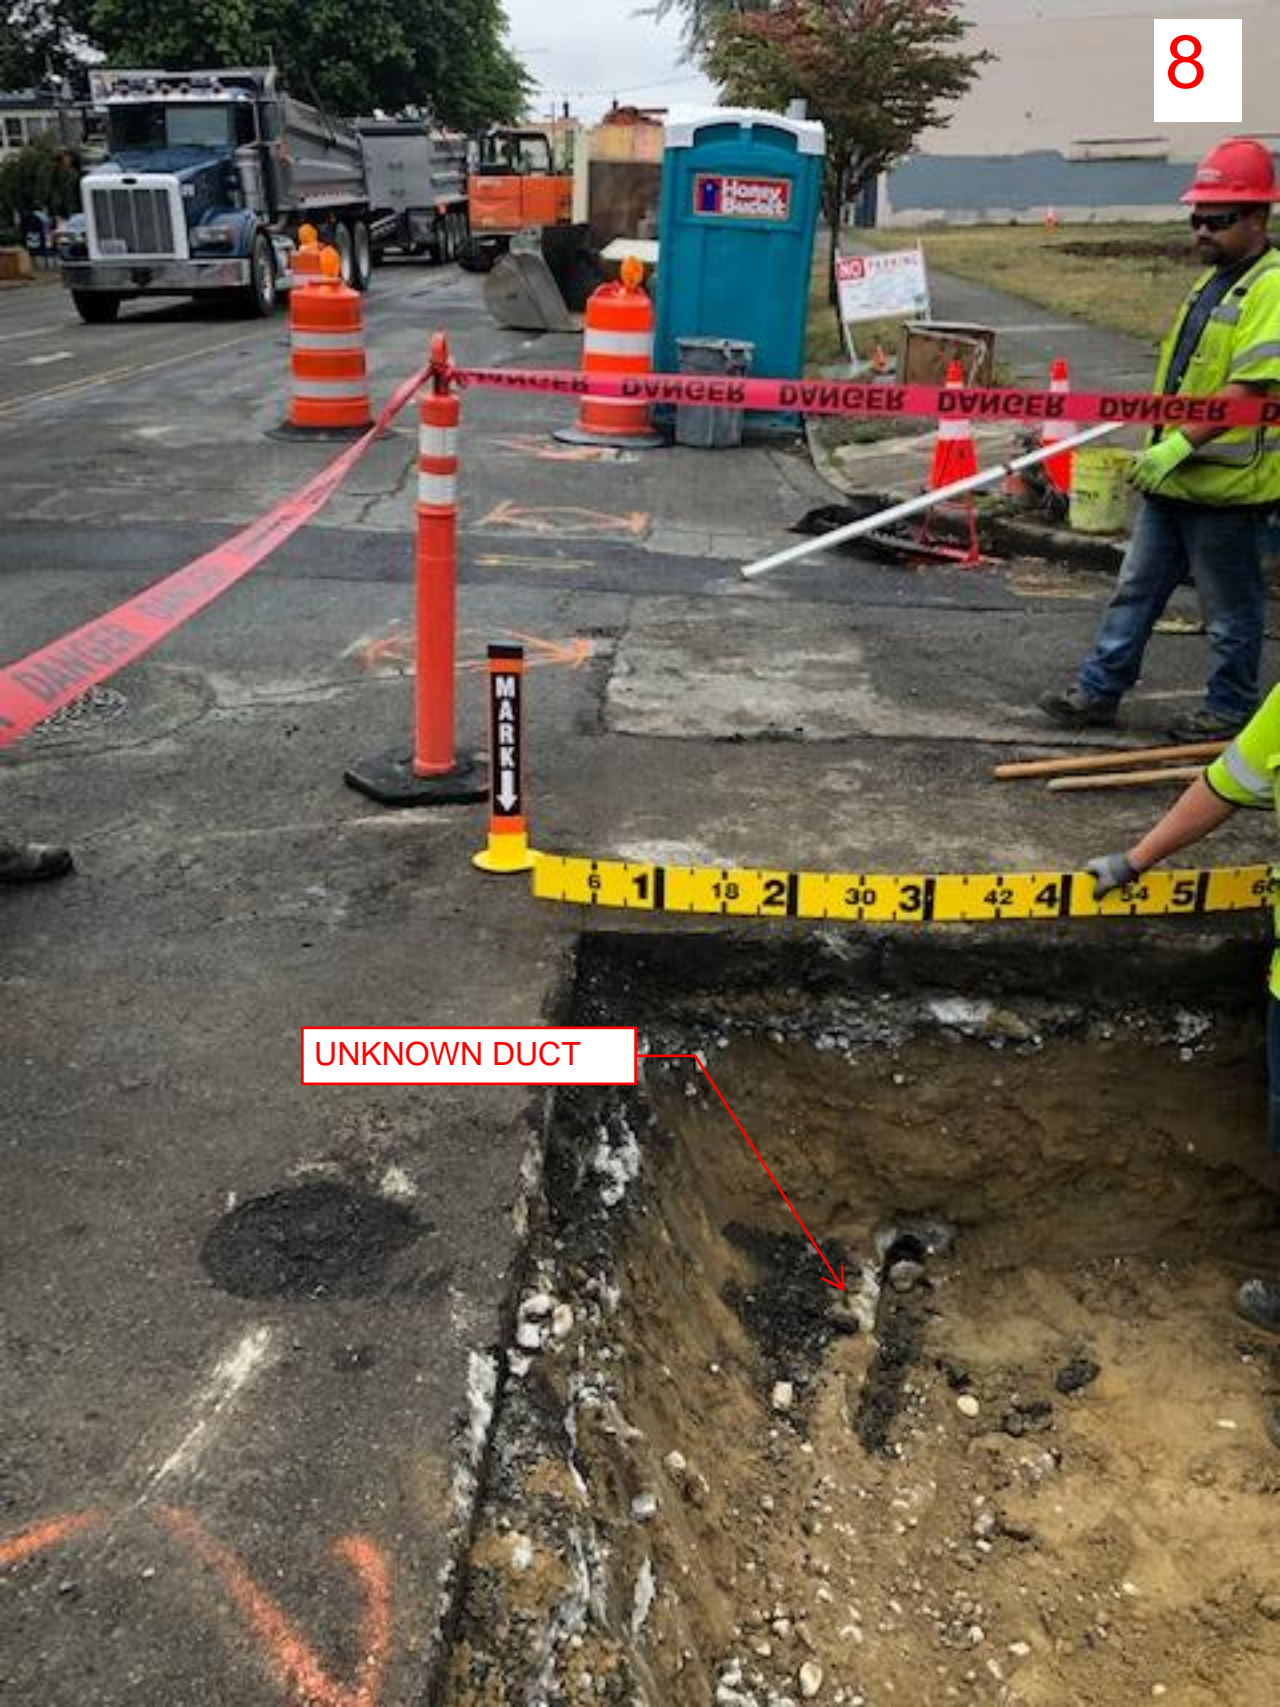
UNKNOWN DUCT
