COMPLAINT FORM

Incident Investigation Report # - 210 S Meridian, Puyallup, WA

REPORT OF DAMAGE TO GAS FACILITIES
PREPARED FOR LEGAL COUNSEL

PSE – Incident Location 210 Meridian Street, Puyallup 6/30/2020

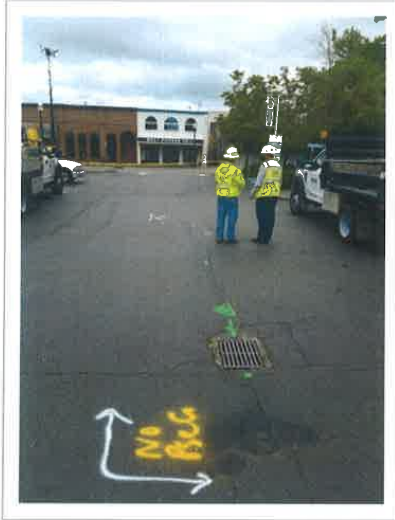
PSE FAILED TO LOCATE. ^{LOCATOR} ~~TO FACE~~, PAINTED "NO PSE E" IN RED & "NO PSE G" IN YELLOW. IN FACT ~~4"~~ "GAS WAS PRESENT & LOCATABLE" ~~4"~~ - THIS SAYS "4 INCH MAIN"

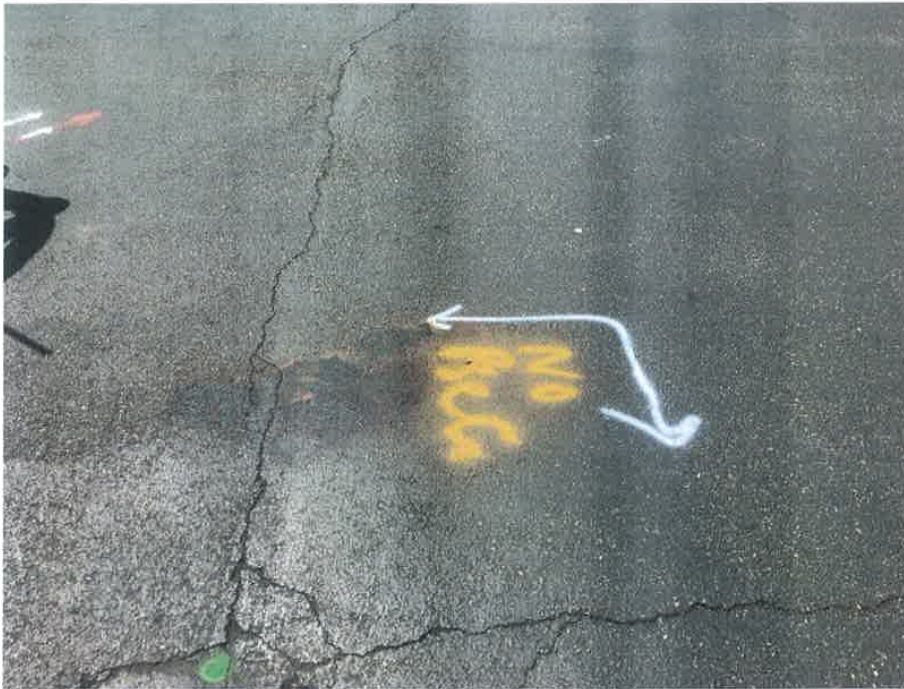
PSE contracts with ELM (ELM or Locator) for natural gas locating services. In this particular case, ELM did not mark the location of PSE's assets at the intersection of W Pioneer and Meridian or along the drill path on W Pioneer per RCW 19.122.030(3)(a)³. As noted on site, there were no conflicting PSE locate marks within the construction limits at the time of the incident--the locate contractor failed to locate PSE assets within the white locate boundary.

1351-looking S in US Bank Parking lot-NO PSEG marking by ELM locator, SEFNCO white locate paint

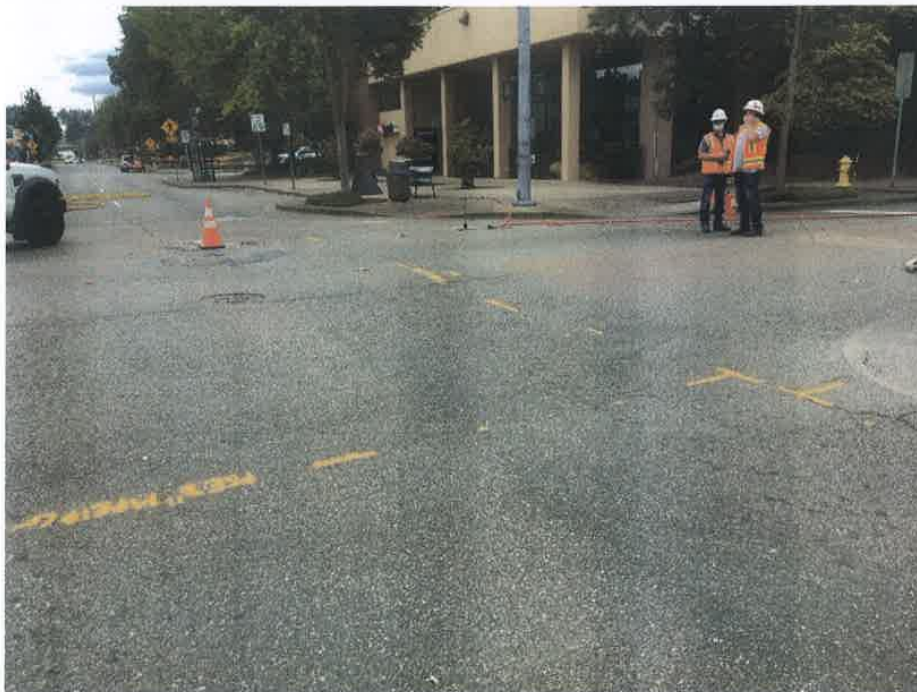
Approximately 1:55-SEFNCO drills into the 4" gas main at the intersection of W Pioneer and S Meridian

1424 looking SW, locates after incident show PSE assets-orange cone is leak location
