Case 22-042  
M&L Construction vs Avista  
Avista Narrative Response

# Case 22-042

M&L Construction vs. Avista Utilities  
23516 N Meadow River Ln. Chattaroy Wa

Avista Response Documentation

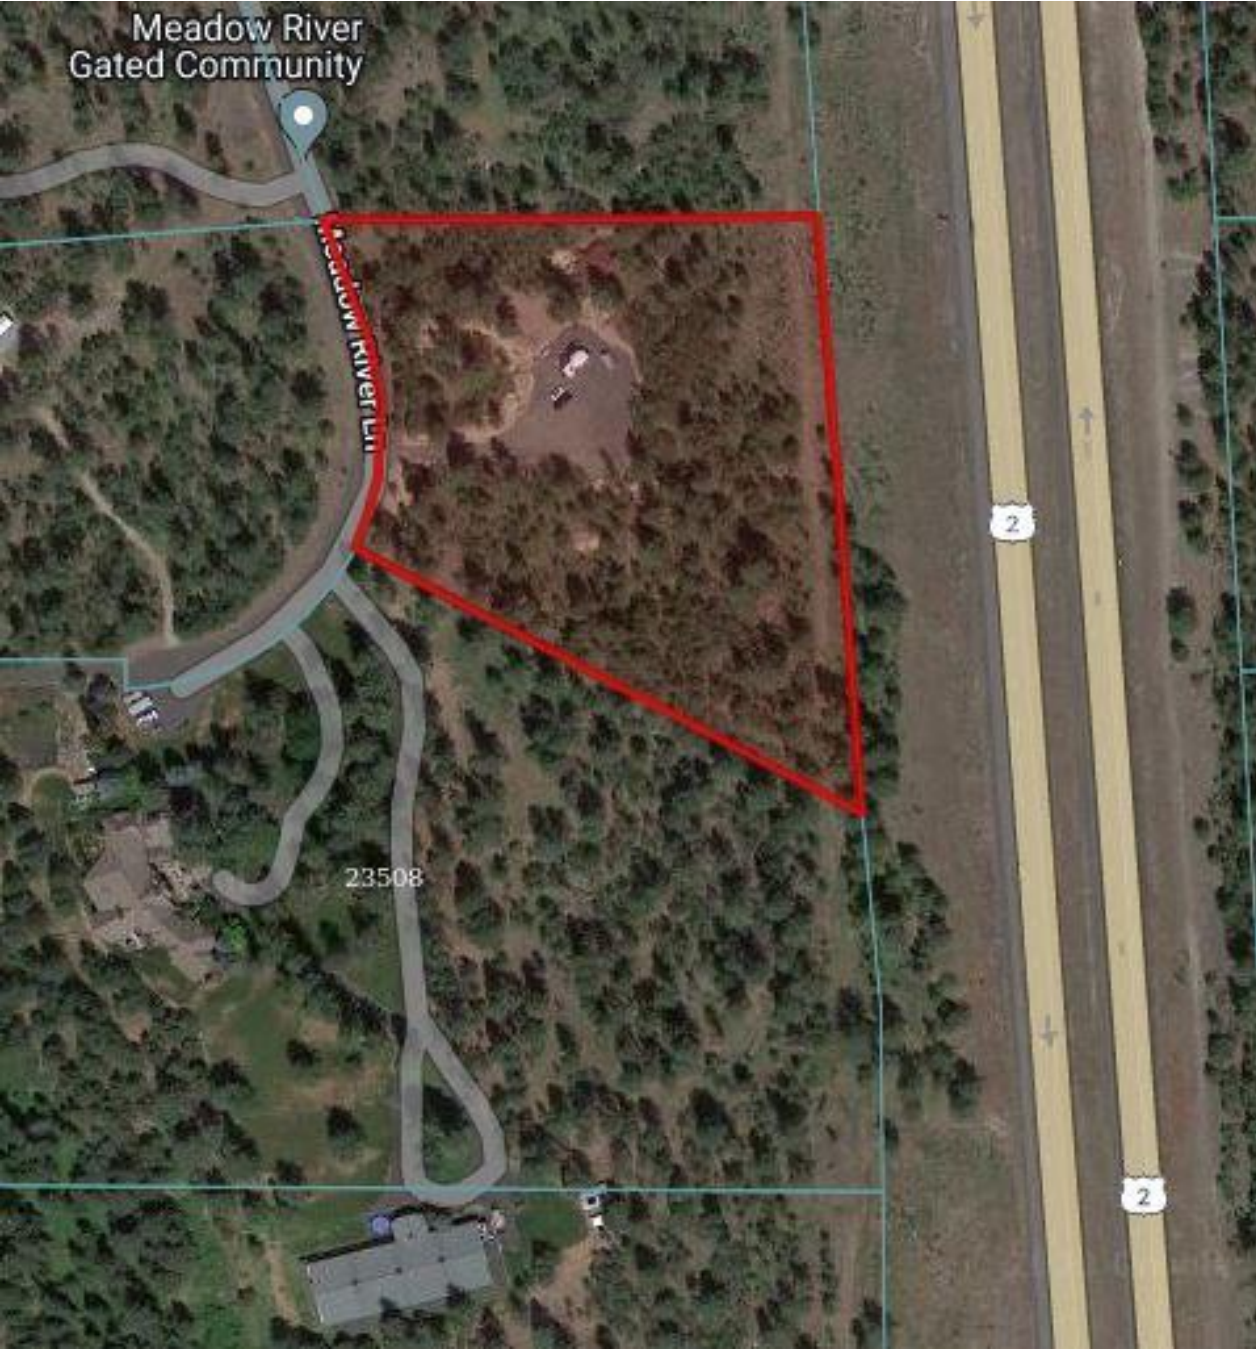
# Ticket 22353243 Dig Area Polygon

Slide 3 – The one call center polygon for M&L’s original locate request.

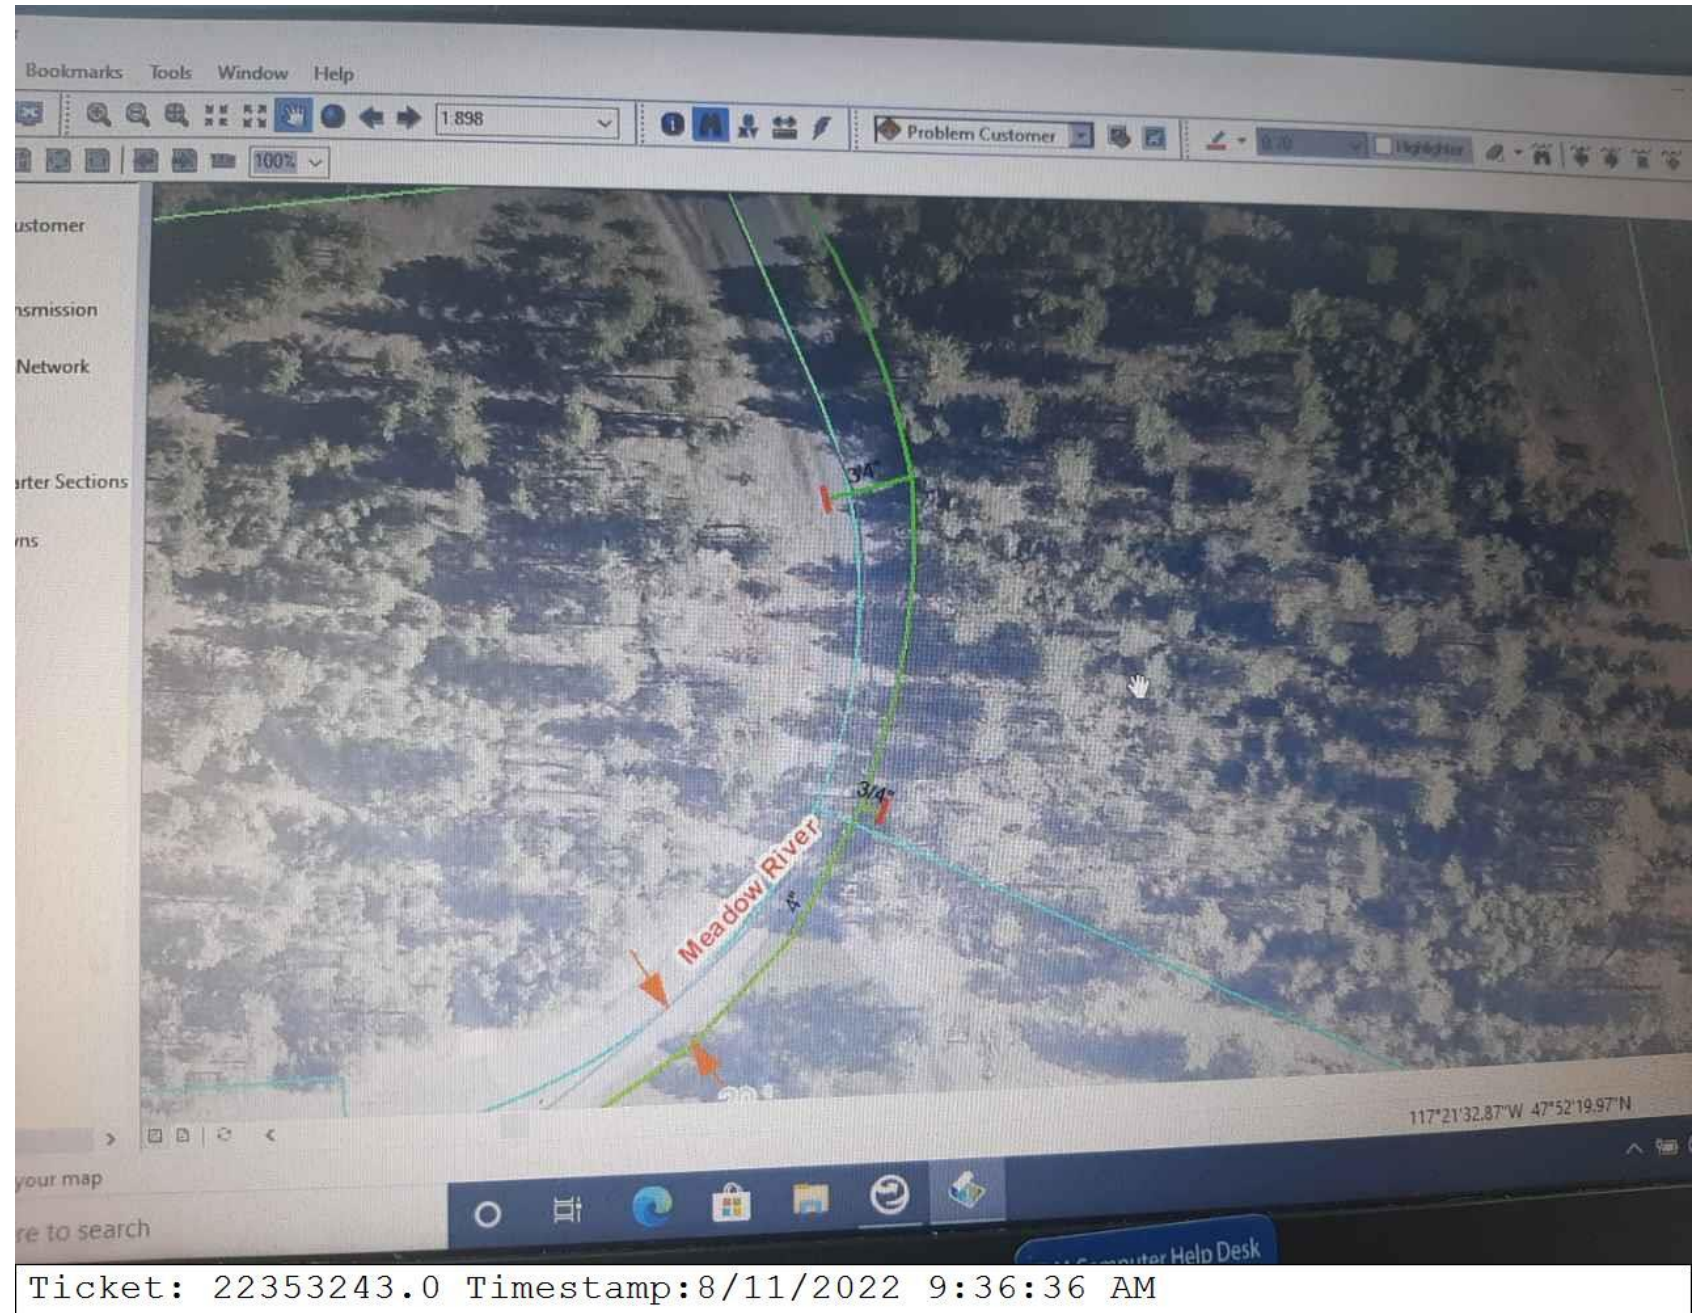
# Mapping Used by ELM on Original Locate

**Mapping Issue:** The original locate technician was using mapping data that had not been updated from the previous gas strike issue. ELM was using a form of “hard copy” files for mapping, requiring individual computers to be updated manually.

Slide 4 – ELM’s time stamped photo of Avista mapping at the time of the original locate.

**Resulting Action:** We have since changed to server-based mapping that gets updated weekly versus two, to four, week intervals. This change has increased our and ELM’s ability to decrease these types of incidents. We are also discussing ways to get newly installed facilities mapped quicker.

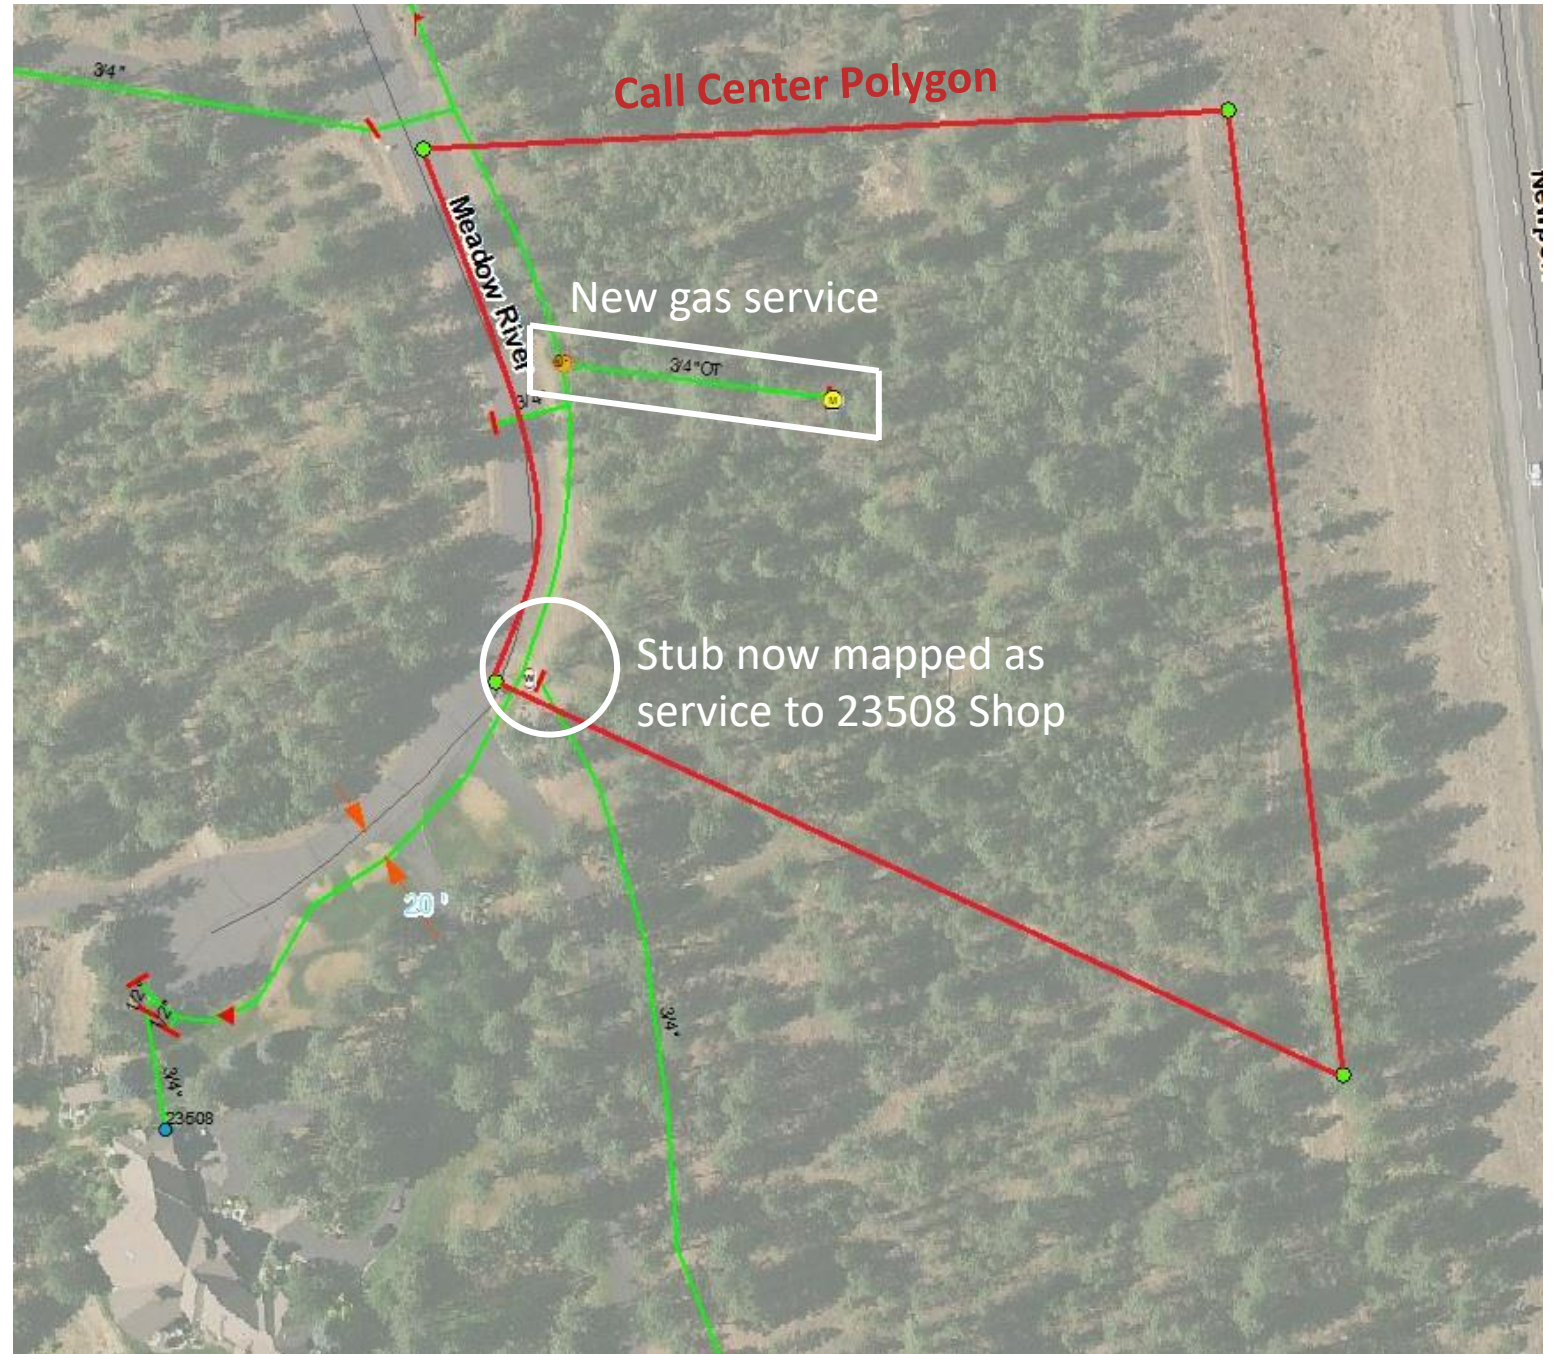
# Polygon with Correct Avista Mapping

Slide 5 – Updated Avista mapping, to include the new gas service to 23516 and the corrected location of the gas service to 23508 Shop, compared to M&L’s original locate request polygon.

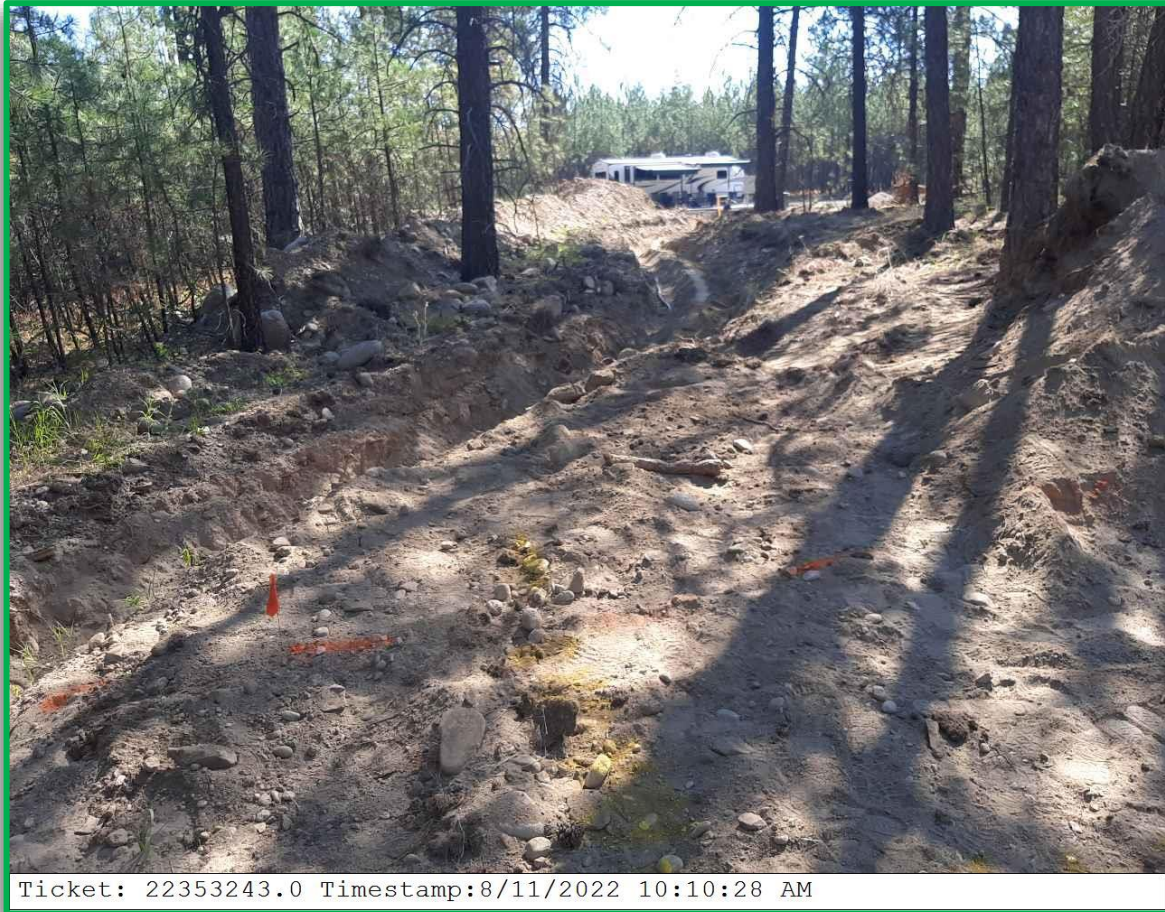
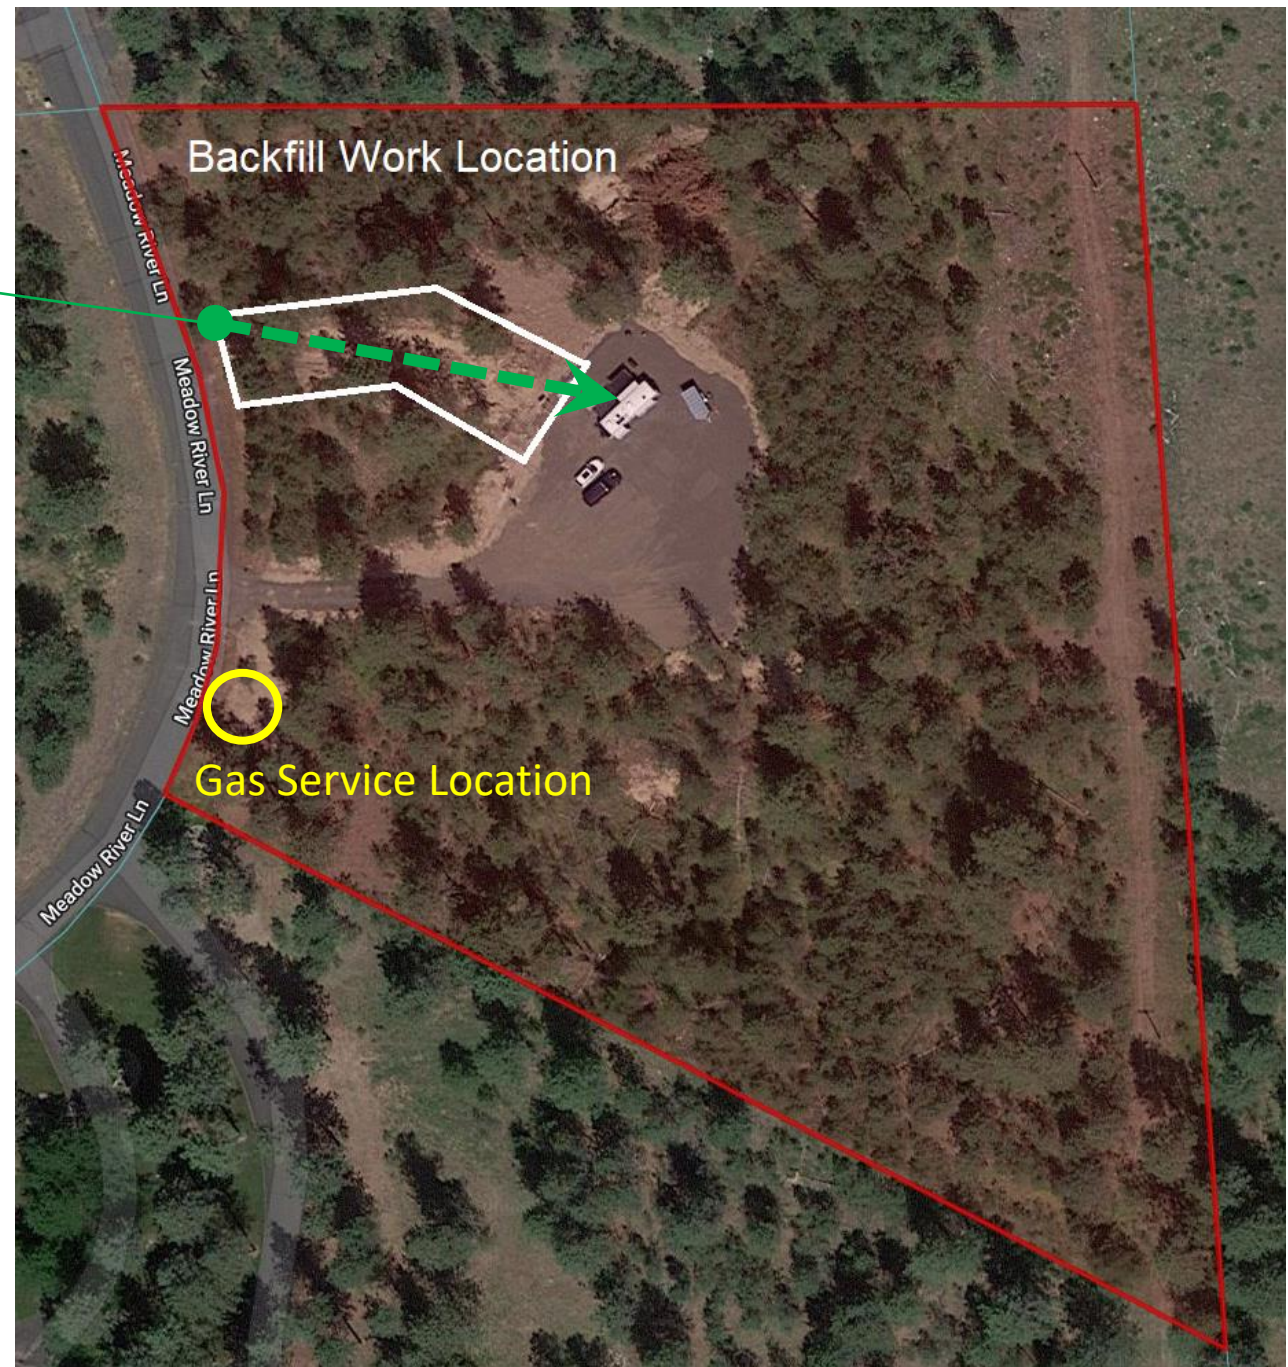
# Backfill Area

**Misunderstanding:** The locator arrived on site to a newly installed gas service to the developing property (23516) and mistook that for “the line to the shop”. The locator matched the type of work on the request, “Backfill”, with the open trench for the newly installed gas line. This made sense to the locator that the work was being performed at the trench, not the SW corner of the property.

Slide 6 – The location of the open trench at 23516 assumed by the locator to be backfilled.

**Resulting Action:** This incident was address at a safety meeting. Technicians reviewed ELM/Avista policies on dig area descriptions, dig area confirmation, call center polygons, and marking standards. ELM has also deployed a “2<sup>nd</sup> Look” program that addresses tickets performed where a technician wants their work double checked by management.
