M&L vs Avista

Case 23-093

8110 N Panorama Dr Spokane WA

Avista Supporting Documentation

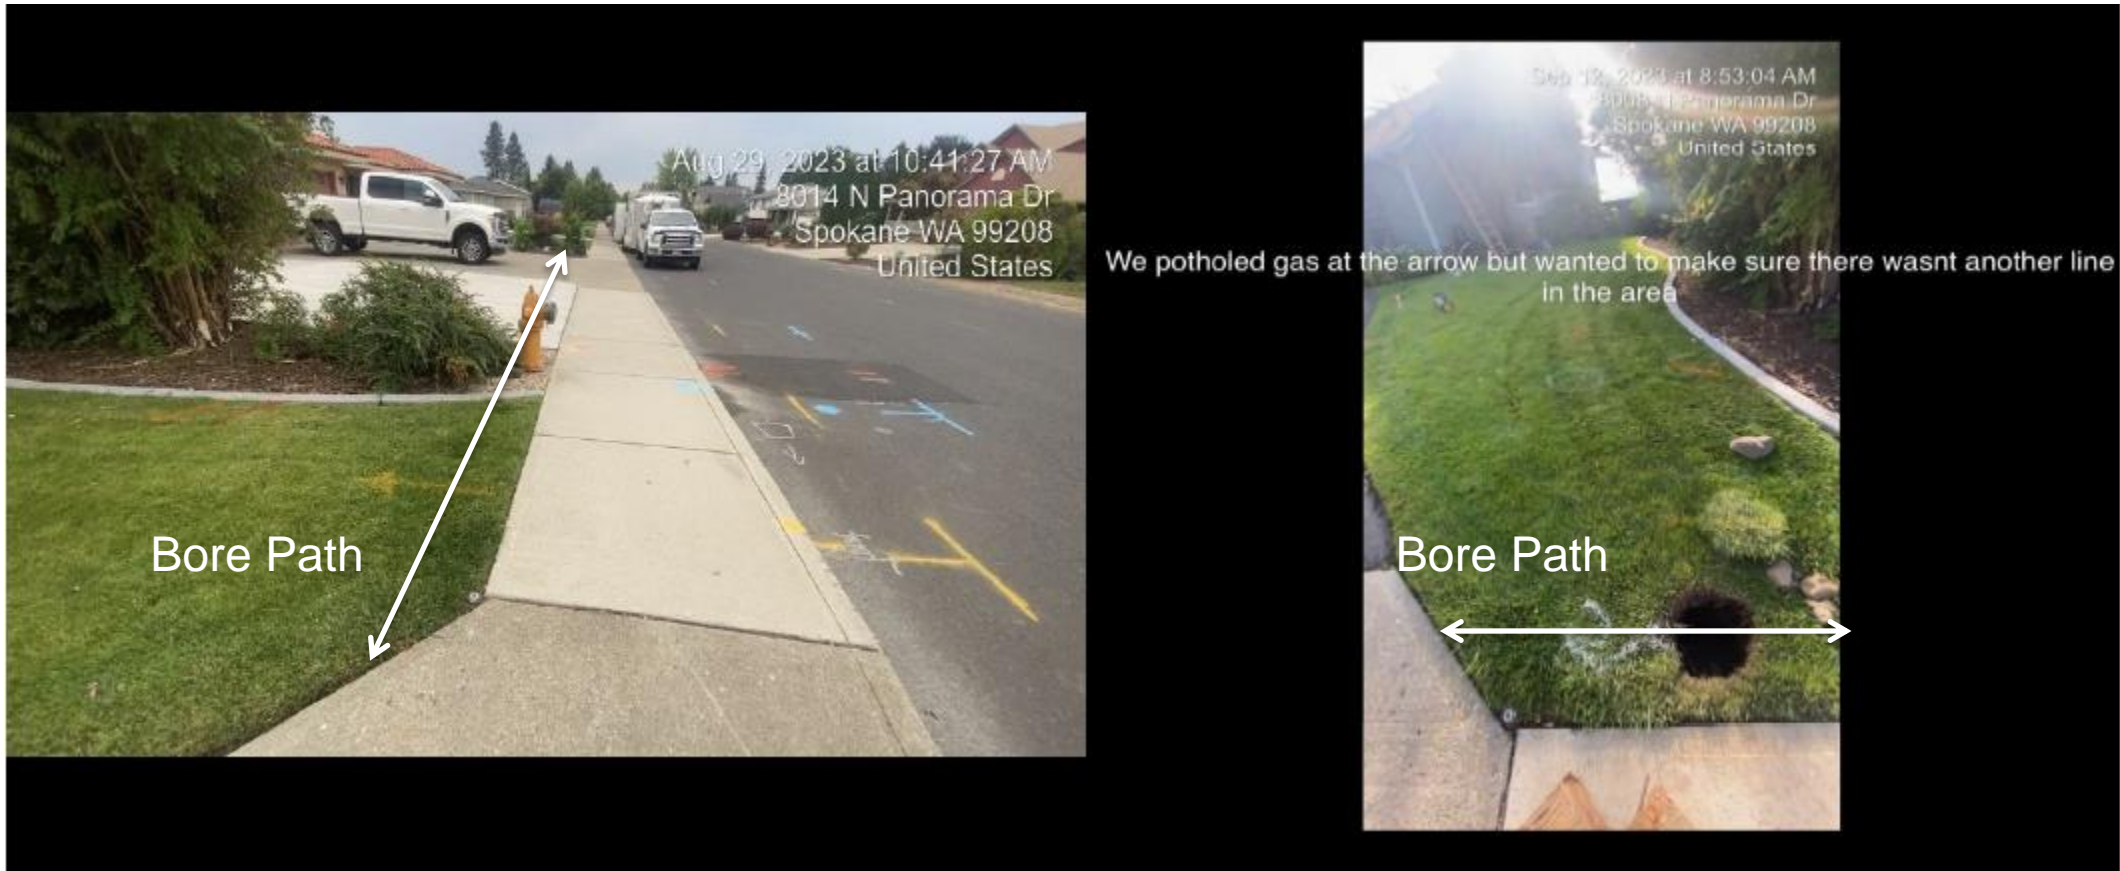
10. Dig Area Was Within Area Marked

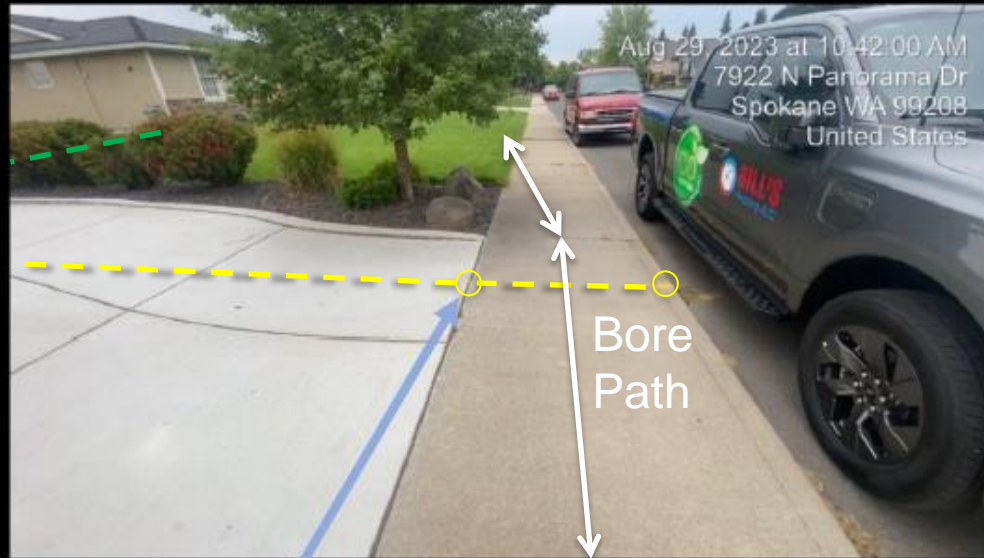
11. M&L Photo with Sketch

Operator was concerned gas tee would be in the grass where equipment would be excavating. I asked tech to mark out to the tee

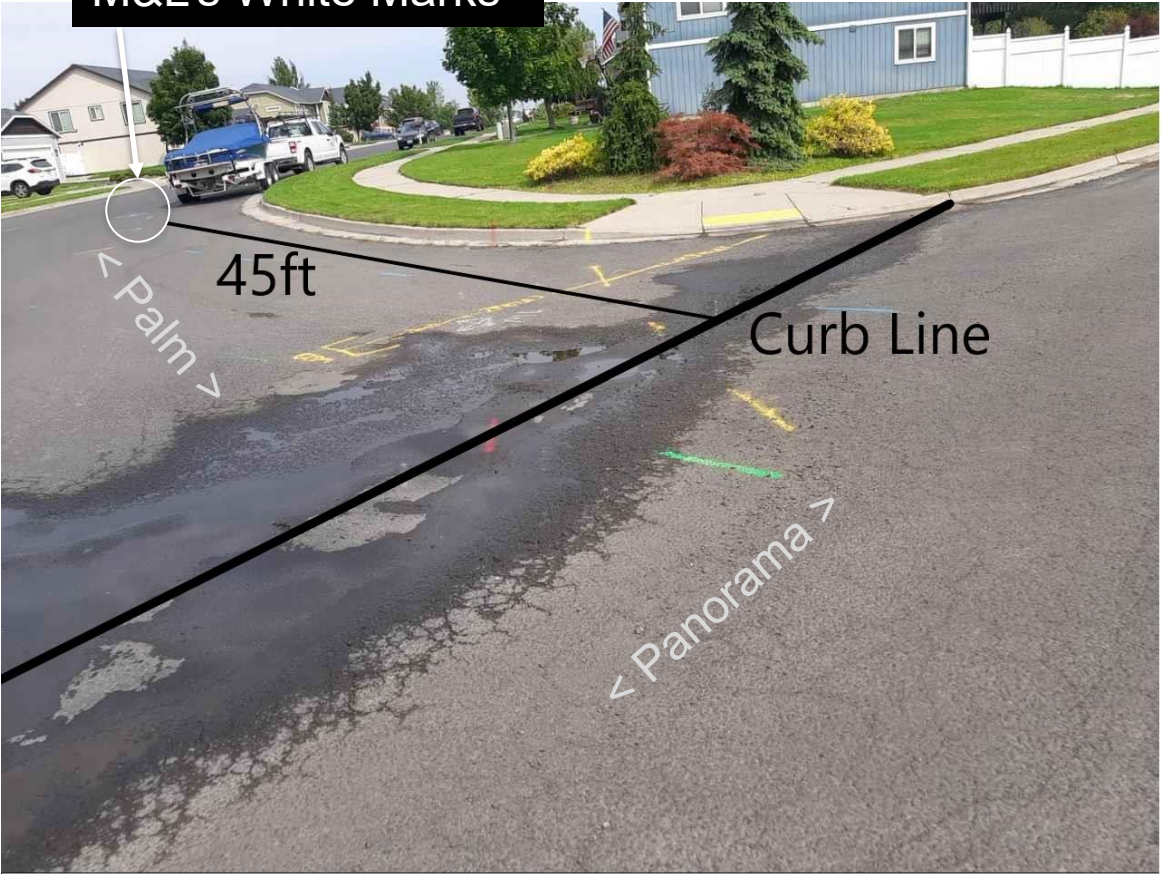
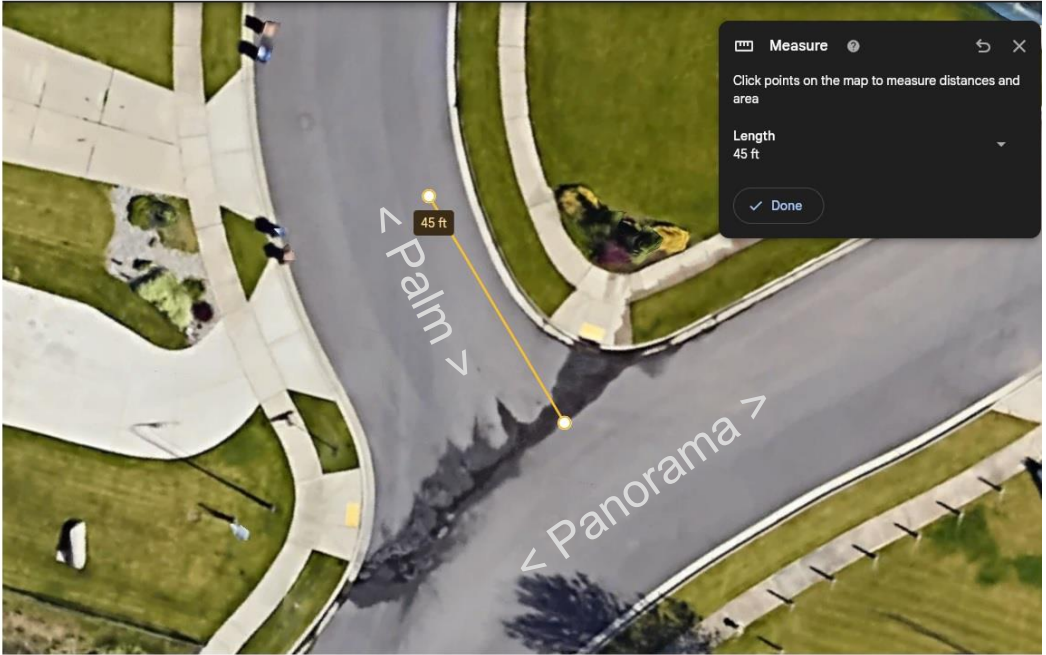
15. M&L White Paint Sketch and Measurement

M&L's White Marks
