ATTACHMENT 1

San Juan Island Fiber Cable Inspection Results

Coriant 7100 Backbone as of 11/08/17

FW7420 Backbone as of 11/08/17

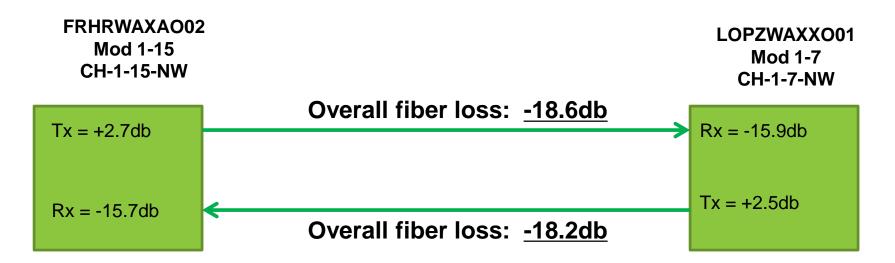
This document describes the "Overall" Fiber loss between the FW7420 located in Lopez Island and Friday Harbor Washington

- Overall fiber loss is calculated as the difference between the Tx level and the Rx levels.
- These levels were taken on the OSC channel in the FW7420.

The fiber loss readings on the Friday Harbor to Lopez Island route changed slightly from 2016 results. The change in dB was expected after cable replacement in July 2017. The changes were negligible.
