Comments on the Colstrip Stage I and II Evaporation Ponds Report

July 24, 2013

Geo-Hydro, Inc (GHI) has reviewed the Stage I and II Evaporation Ponds Report that was prepared for PPL Montana, LLC by Hydrometrics, Inc., dated May 2013. Our specific comments and observations are referenced to sections of that report although many of the comments are in fact applicable to multiple sections.

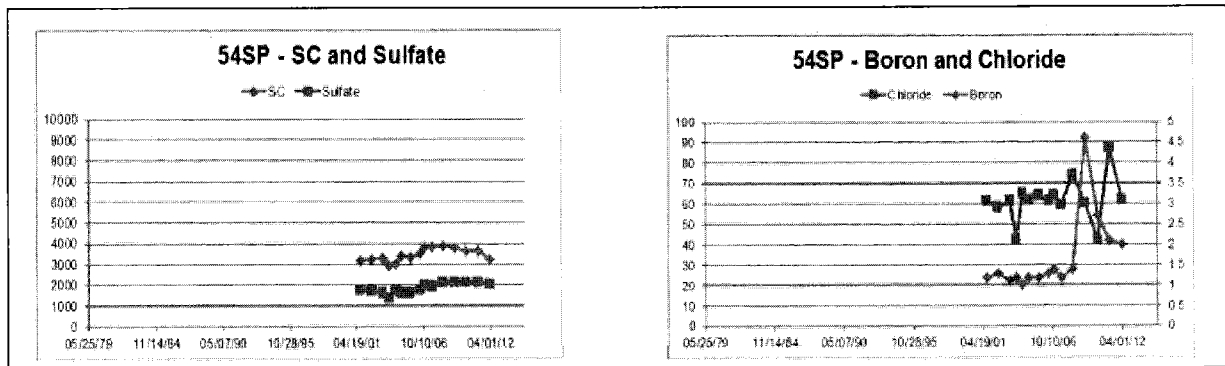
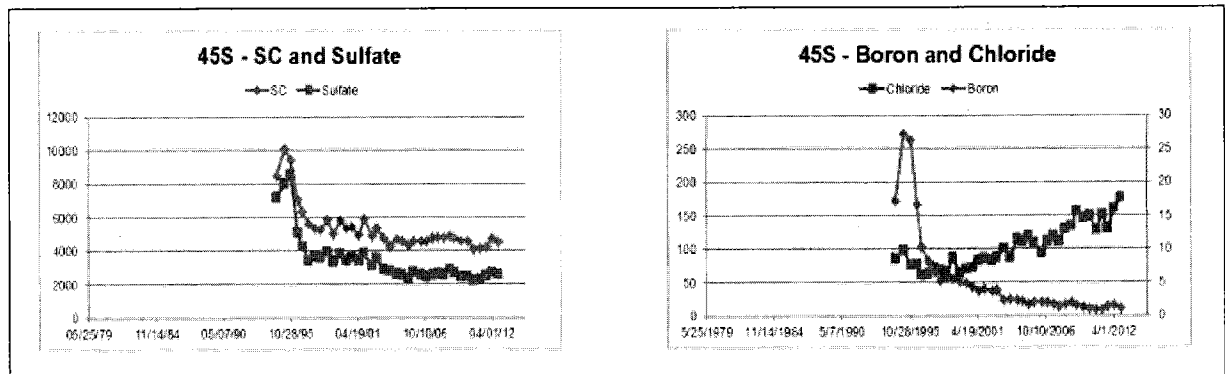
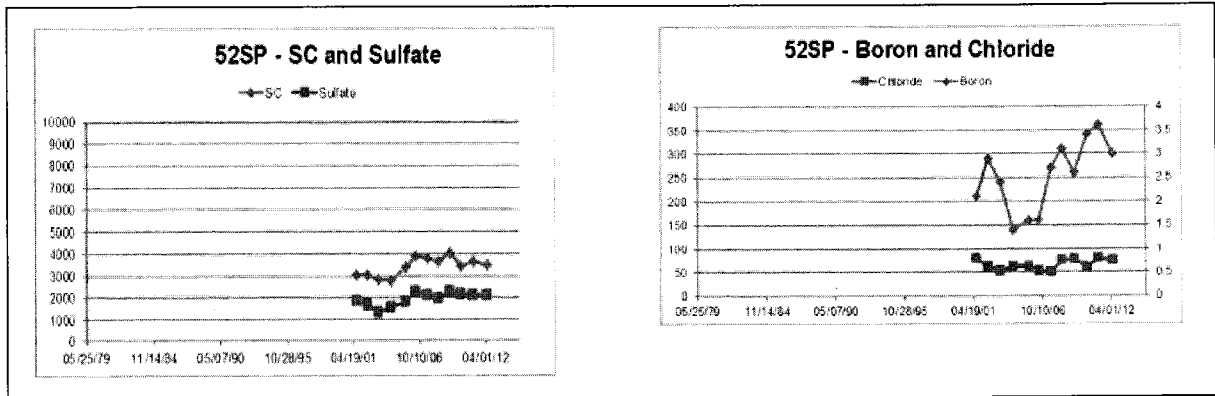
Note: Graphs reproduced from Colstrip 2012 Plant Site Report

9. **Page 3-60, Section 3.6, Effectiveness Assessment of Remedial Action** – The evaluation of remediation effectiveness is based on evaluation of specific conductance rather than evaluating the full suite of indicator parameters. Review of analytical data plots from other plant areas (examples shown below) show many instances where other parameters such as boron, sulfate, or chloride have increased concurrent with steady or declining specific conductance. The specific conductance measured at an extraction well is therefore not necessarily reflective of overall groundwater quality, even at a specific well.

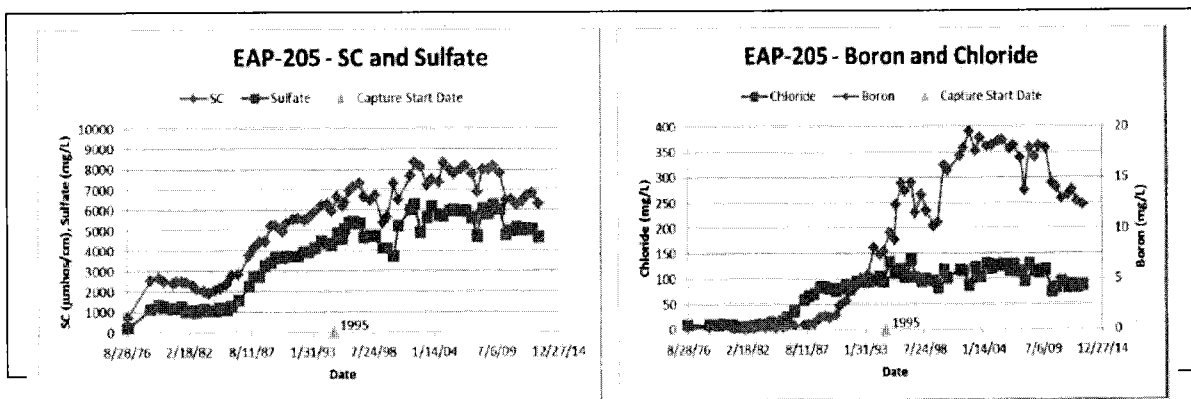
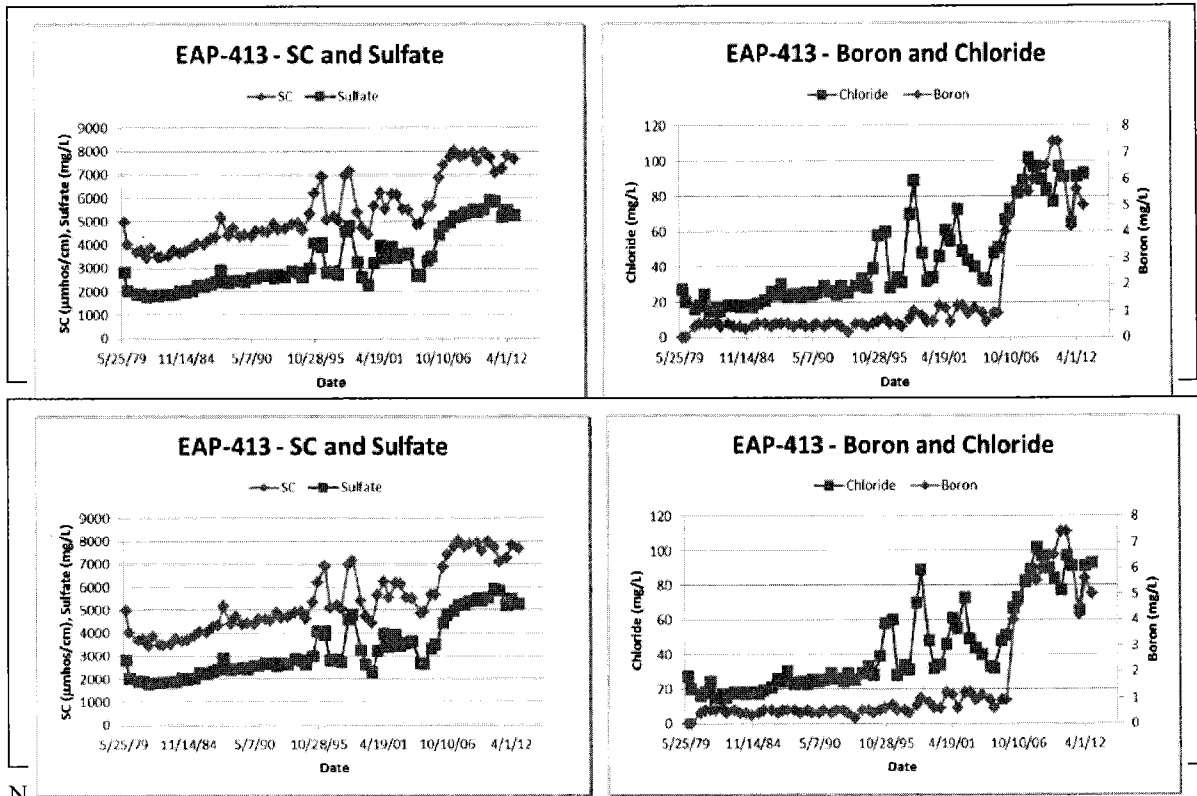
10. **Page 3-60, Section 3.6, Effectiveness Assessment of Remedial Action** – The apparent effectiveness of remedial measures is calculated by comparing recent measurements of specific conductance in SOEP and STEP capture wells to the highest specific conductance ever measured in those wells. Calculated improvements in groundwater quality, based only on specific conductance, are reported to range from 2 to 63 percent. This evaluation can be put in context by examining some of the long-term graphs of indicator parameter data included in the report. The data graphs for EAP-119 (Fig 3-14), EAP-205 (Fig 2-15), and EAP-413 (Fig 3-17A) each show plots of indicator parameter concentrations extending back into the 1970's (below). Each of these long-term data records show that even though the most recent analyses are below the highest concentrations ever recorded at these locations, concentrations of all process water indicator parameters remain very high and in most cases are several times the concentrations measured before operation of the ponds was initiated.
