EXH. HLR-4

Avista Utilities Asset Management

Protocol for Managing Select Aldyl A Pipe in Avista Utilities' Natural Gas System

May 2013

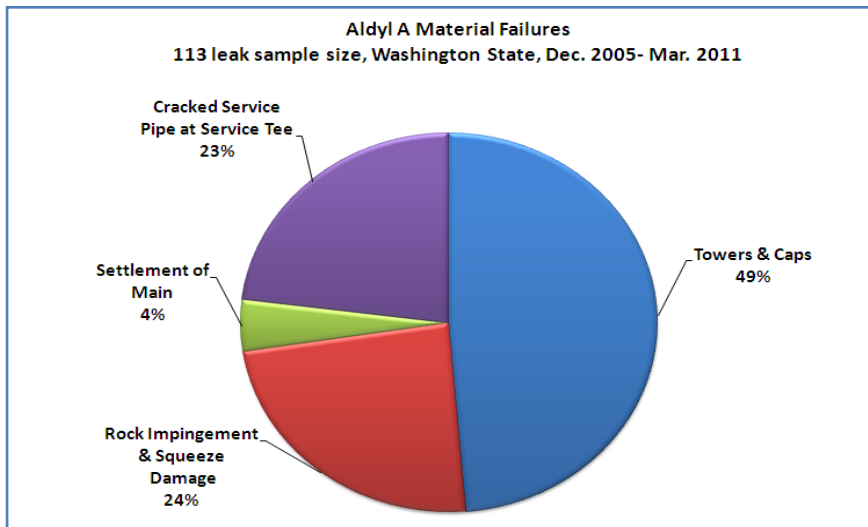
In tackling the first objective of the assessment of its Aldyl A piping, Avista aggregated the gas leaks resulting from Aldyl A material failures found in its gas system in Washington State from late 2005 through March 2011. The sample included 113 material failures that were evaluated and summarized by component to offer an understanding of the specific failure modes for Aldyl A pipe. The 'modes' or types of material failures categorized are shown below in Figure 1.

Figure 1. Modes or types of material failures documented in a sample of 113 leaks in Avista’s Aldyl A piping in Washington State, December 2005 through March 2011.

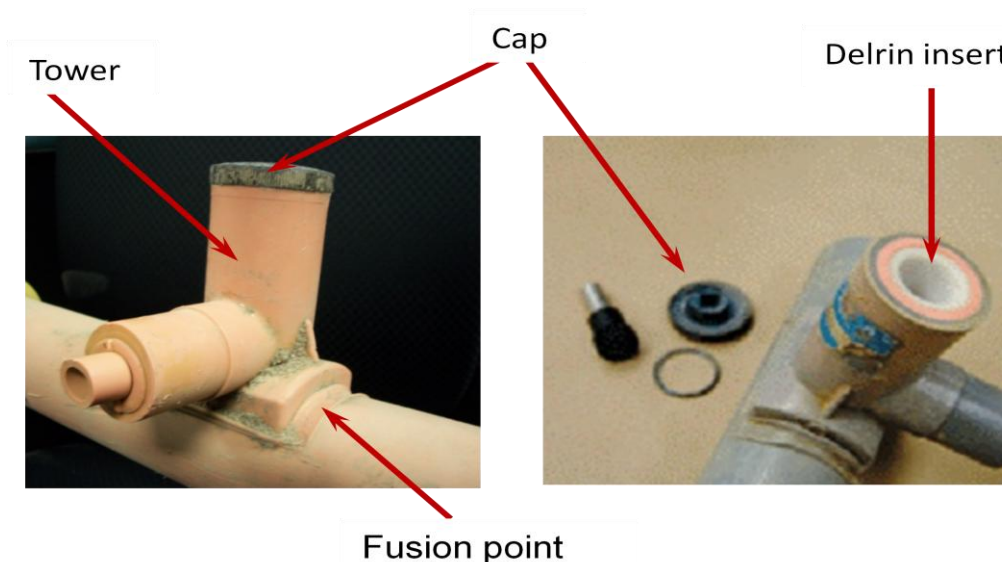
The largest percentage of material failures in the sample occurred in Towers and Caps, referring to failure of the service tapping tee itself, shown below in Figure 2. In these cases, the pressure applied to the tee as the cap was tightened onto the body during initial installation has resulted in slow crack growth and failure of the tower body, the cap, or the Delrin[®] insert many years later. Additionally, the saddle fusion point of the tower to the main pipe is another frequent point of failure in this assembly. The unavoidable stresses created during standard installation (using factory recommended procedures) have led to brittle cracking in these components many years later. This phenomenon clearly demonstrates the susceptibility of certain resins of Aldyl A piping to tend to fail by brittle cracking due to the slow crack growth initiated during installation.

Figure 2. External features and internal components of a typical Aldyl A service tee, as fused to Aldyl A main pipe.

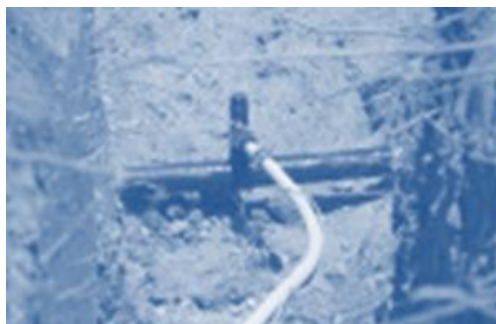
The third most-common failure in Avista's sample occurred where small diameter Aldyl A service pipe is tapped from steel main pipe. In this application, a steel service tee is welded to the steel main pipe and the small-diameter Aldyl A service pipe is then connected to a mechanical transition fitting on the tee, as pictured below in Figure 4.

Figure 4. Typical polyethylene service tapped from a steel main.

It is at this transition point, between the rigid steel fitting and the more-flexible Aldyl A service pipe, that brittle-like cracking has been observed. This failure mode in older plastic pipe is well understood, and was one of the three study objectives reported by the

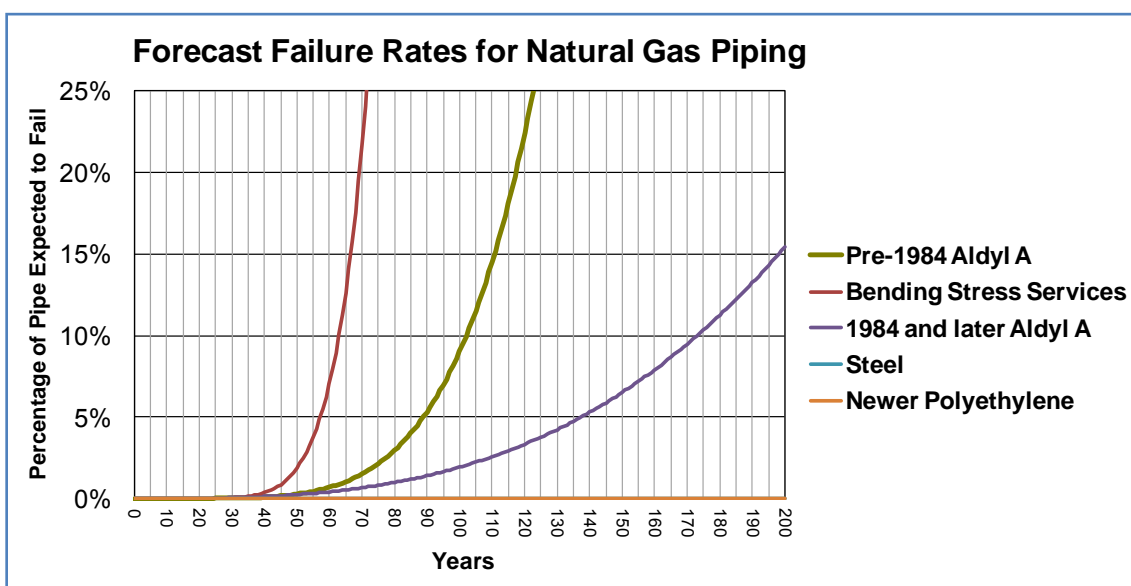
Results of the forecast modeling, for the pipe classes evaluated, are represented as ‘curves’ showing the percentage of the amount of each pipe class that is projected to fail in each year of the forecast time period. The resulting reliability curves are shown in the graph below in Figure 5.

Figure 5. The expected failure rates for several classes of pipe in Avista’s system, as forecast by Availability Workbench Modeling. The “Steel” curve is obscured by the “Newer Polyethylene” curve, both of which are essentially flat lines.

The failure curves show dramatic differences in the expected life for the pipe classes evaluated. The difference in expected life between the Aldyl A products as a group, compared with that of steel and newer-generation plastic pipe, is particularly evident. Striking also, are the expected performance differences among the classes of Aldyl A pipe evaluated, providing some clear trends useful in designing remediation strategies.

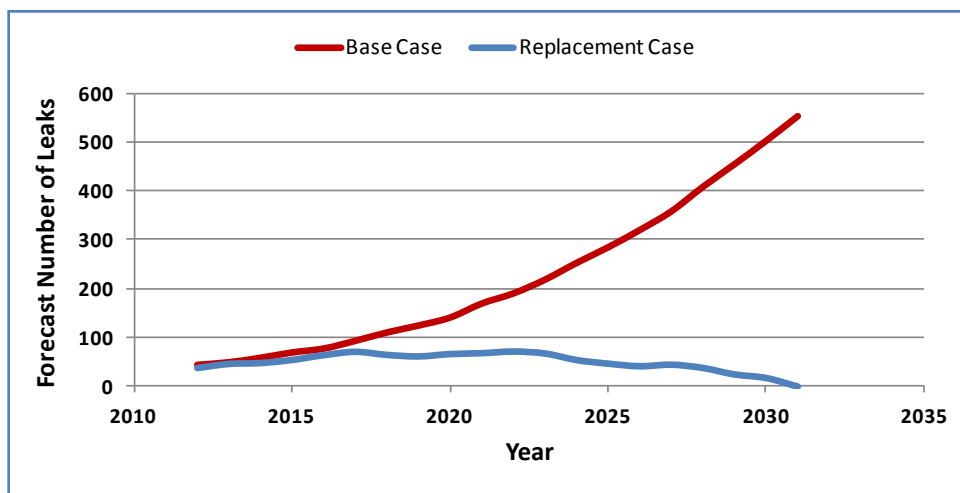
failures each year is expected to increase slightly until 2017, at which time the cumulative effect of priority piping replaced since 2012 begins to check the failure count and then drive it toward zero over the remaining course of the program (Figure 8).

Figure 8. Expected numbers of material failures in Avista's priority Aldyl A piping in two cases: Replacement Case - piping replaced over a twenty year horizon in the manner proposed by Avista in this report, and Base Case - assumed that priority piping was not remediated under any program.
