POST INSPECTION MEMORANDUM

Operator Inspected: ConocoPhillips Pipe Line Company
OPID: 31684 **Region:** Western

Unit Inspected: Yellowstone Pipe Line Company – Spokane & Moses Lake Districts
Unit ID: 515
Unit Type: Interstate
Inspection Type: 107 - IMP Verification Inspection
Record Location: Spokane, WA
Inspection Dates: May 2-5, 2011
AFOD: 4
SMART Activity Number:

ConocoPhillips Pipe Line Company - Yellowstone Pipe Line

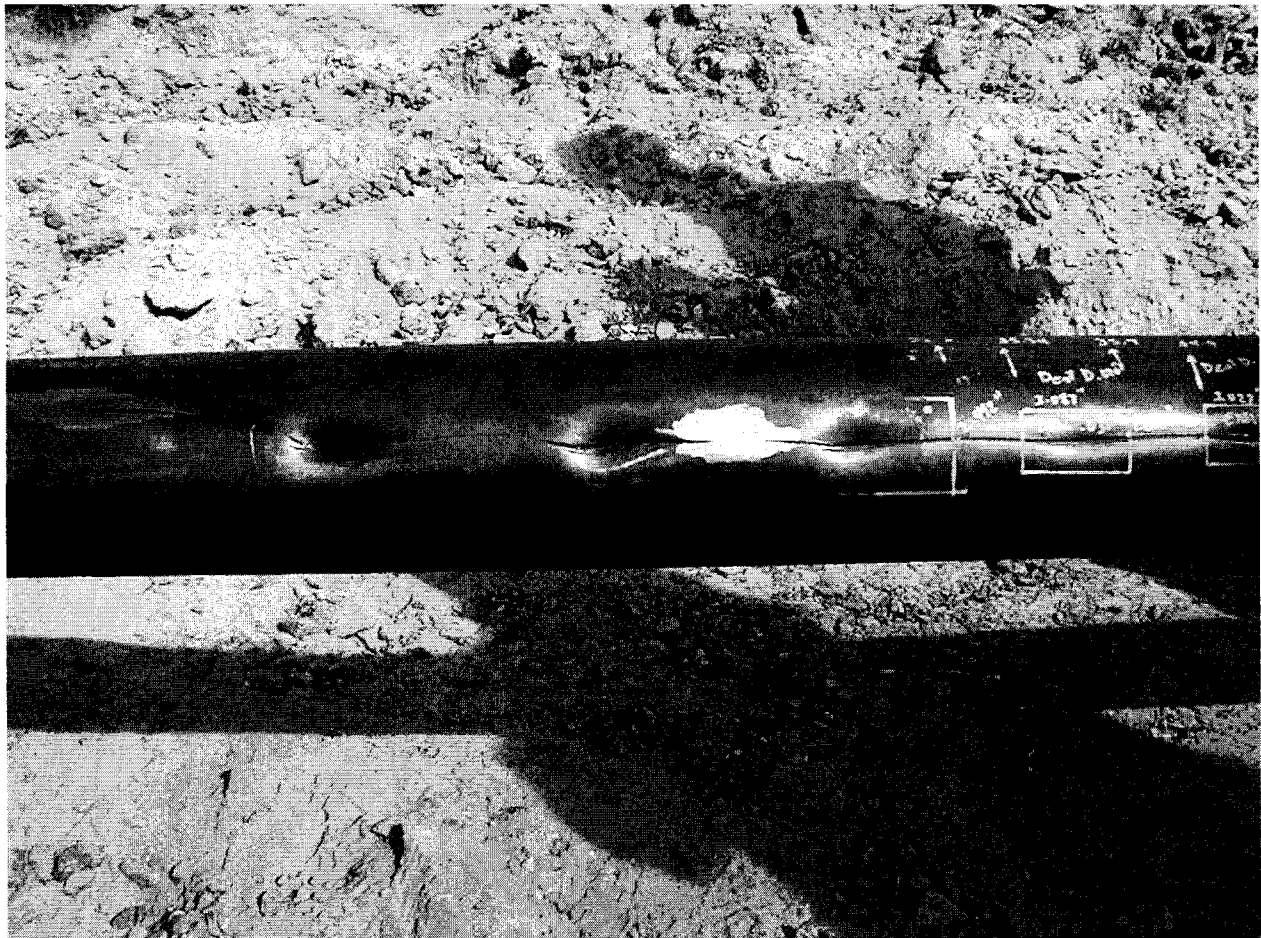
On July 13, 2010, a high resolution MFL and caliber tools were used to evaluate the 6-inch diameter line from Fairchild AFB to Moses Lake (non HCA line). The caliber tool identified multiple "plain" dents located upstream from the Odessa block valve (See attached photo). The anomalies were identified as sixty-day condition for evaluation. The anomalies were evaluated

on August 28, 2010 and discovered that a gouge existed parallel to the dents. The gouge was axial orientated to the pipeline and not identified by the MFL tool. The anomalies were reclassified as immediate repair. The line pressure was lower, by-pass line installed, and about 98 linear feet of pipeline containing the anomalies were removed. Because the MFL tool was designed specifically to identify circumferential anomalies, it is recommended that a Transverse Flux Instrument (TFI) or UT tool be used to identify axially oriented anomalies that might exist on the pipeline at other locations. The majority of Yellowstone Pipe Line is located in agricultural areas subject to damage from farm activities.

Location of Photo: Up stream of Odessa, Washington block valve in a previously cultivated field. Photo of pipe after cut-out.

MFL & Caliber run: 7/13/2010. Dents (4.8%) were discovered with caliber tool at 8:38 PM clock position.

Gouge Discovered: 8/28/2010 when dents were evaluated.

Pipe: API X52, 0.156" wt

Remediation: Pipe segment (98 linear feet) was removed.
