Opening – Avista/ELM responded to the locate request and performed to best of their abilities and knowledge. The issue was the result of a utility mapping error that was immediately corrected upon discovery.

Case 22-020 M&L Construction, Inc vs. Avista Corporation

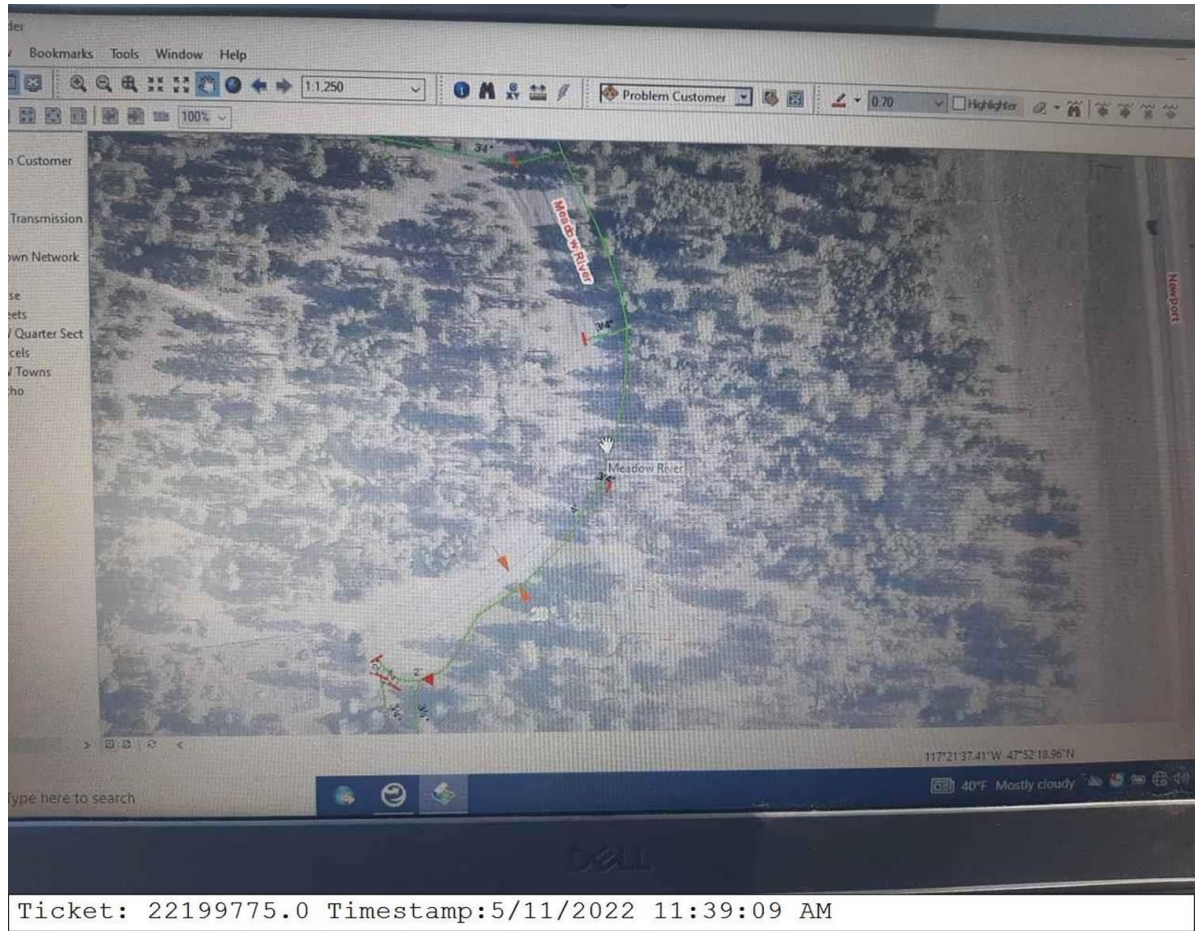
5/12/2022 – ELM performed the gas locates. At the time of locate, Avista’s utility mapping indicated a plastic gas stub in the south end of the dig area and was recorded by ELM. (See Exhibit C for photo of prints and Exhibit D for explanation.) ELM looked for a stub marker (an empty gas pipe sticking out of ground to indicate the end of live gas) and a marker ball (a device, placed underground and attached to the end of live gas, that can be found electronically to indicate the exact end of pipe), but neither were present. The plastic stub was mapped as being only 12 feet long and would not respond to advanced locate methods for electromagnetic locating, which is modern locating equipment. ELM then placed a triangle with a “?” in it at the approximate/best known location of the plastic stub. (See Exhibit E for the original locate photo and Exhibit F for reference.) ELM looked for additional records on the gas stub at the Avista gas office but there were no records readily available. (See Exhibit G for sketch of where the line was compared to where it was mapped.)

ELM's photo of the Avista gas prints at the time of the original locate.

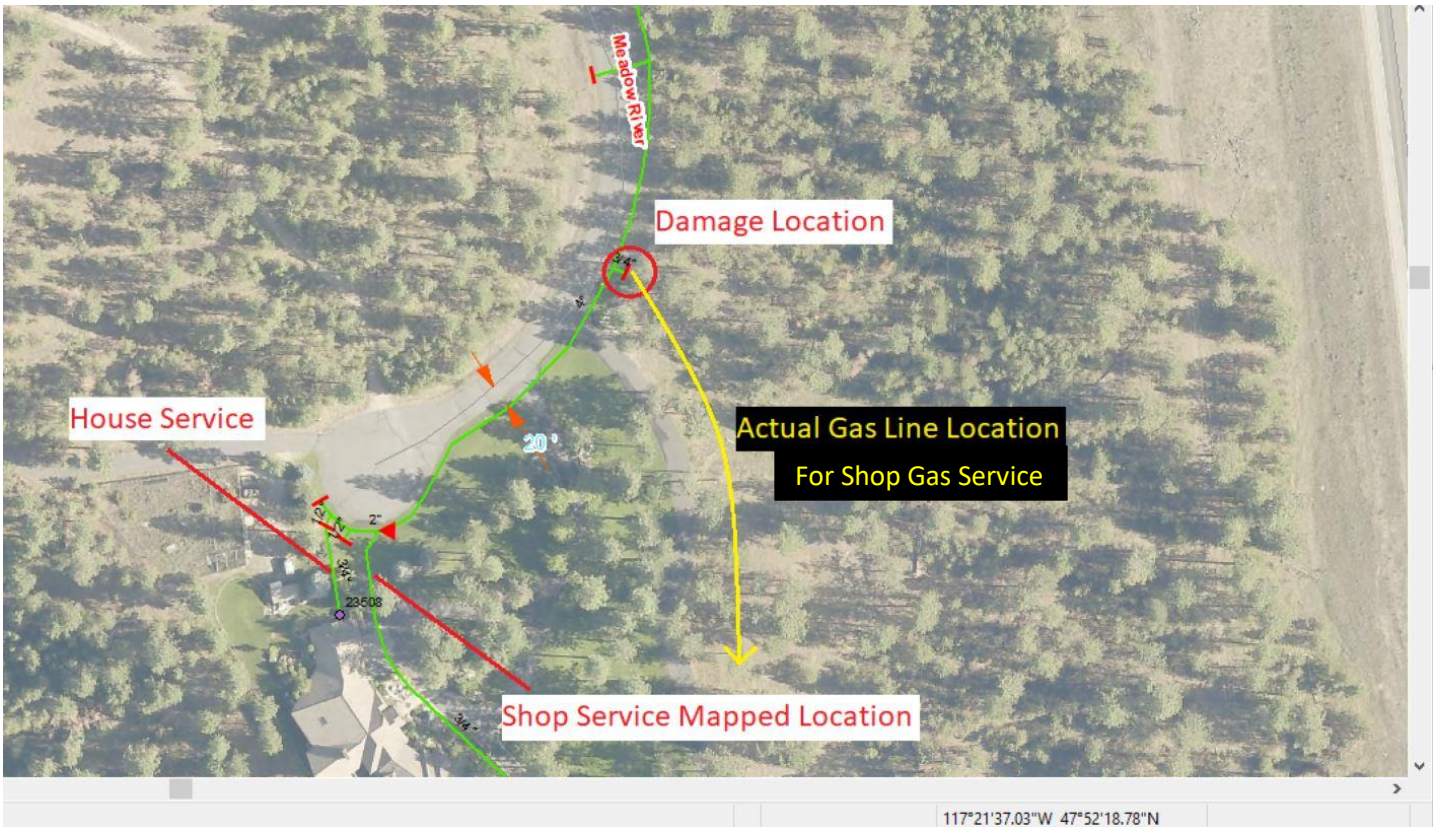
Exhibit D – Sketch/explanation showing damage location and mapping error.

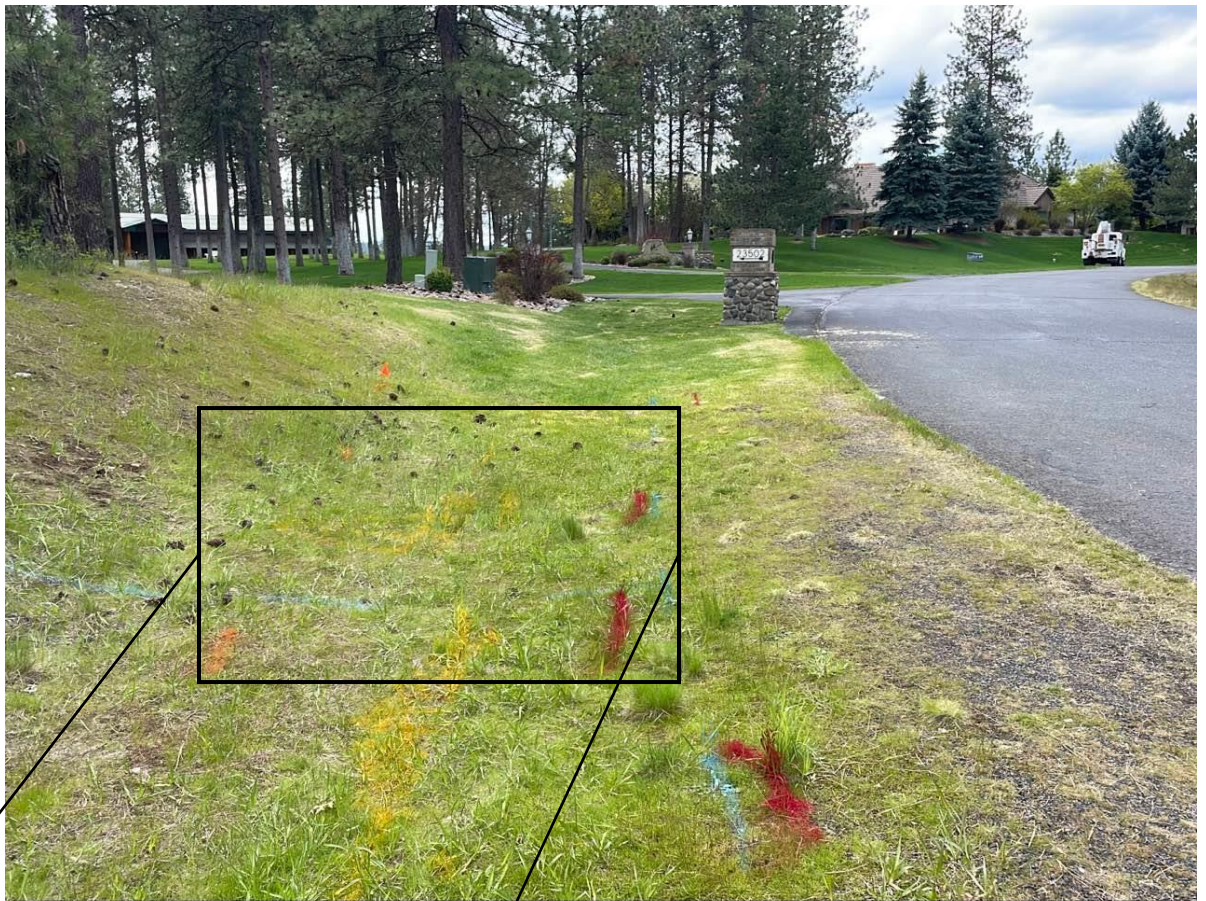
Exhibit E

ELM's photo of the Avista gas main and triangle to the east (left).

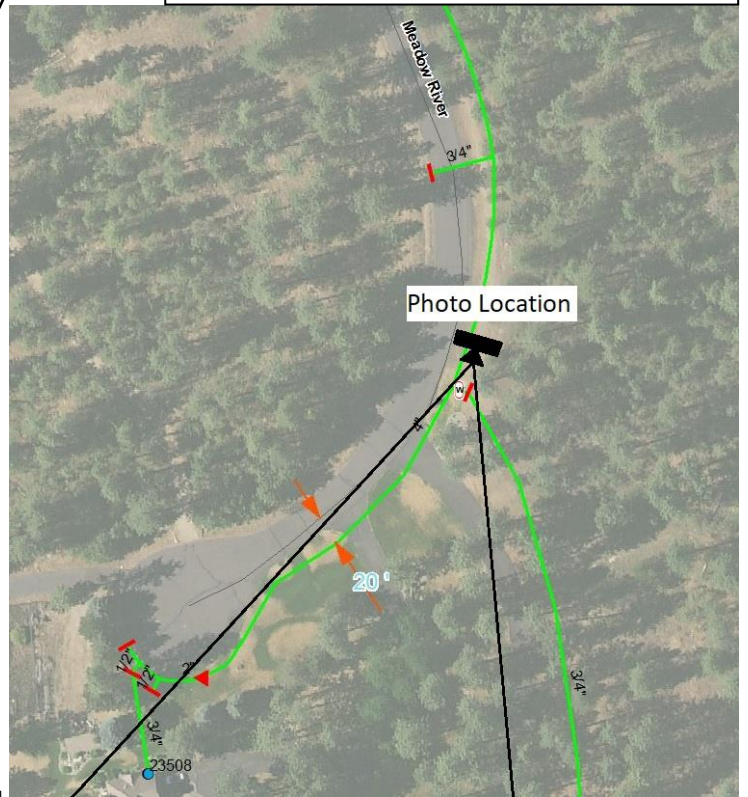
Exhibit F – Perspective of photo for Exhibit E

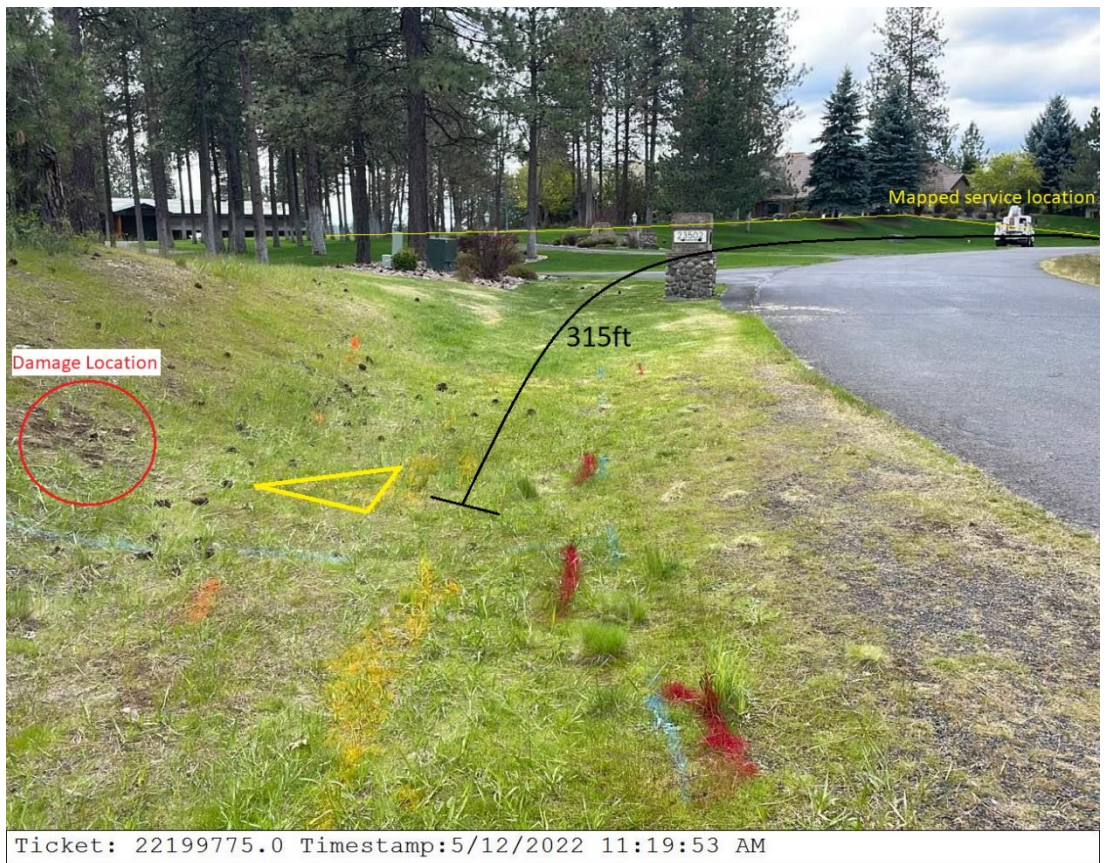
Exhibit G

Sketch of where the gas line was mapped compared to where it was damaged using ELM locate photo.

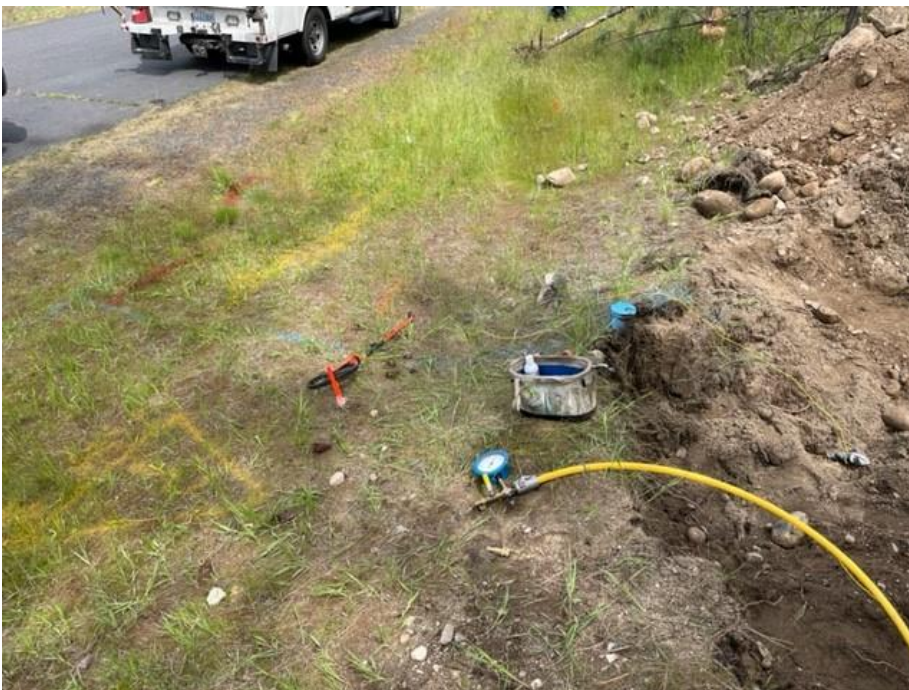
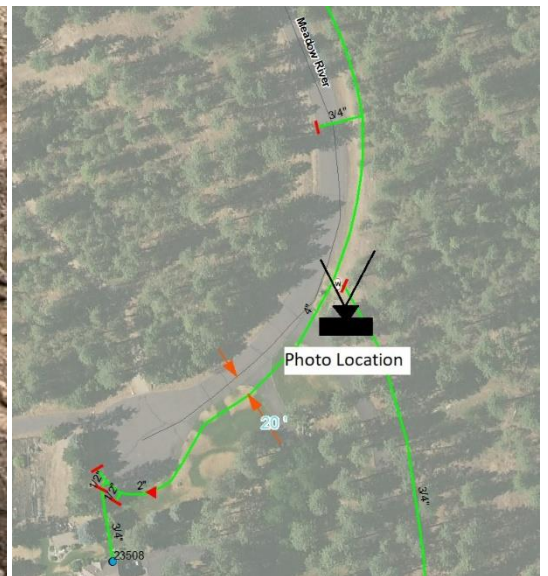
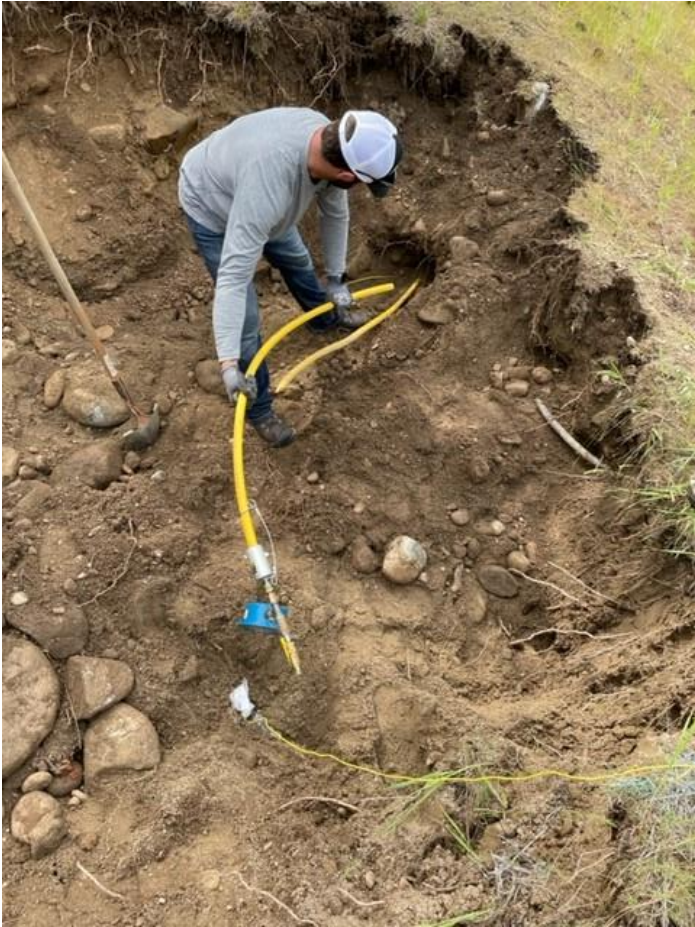
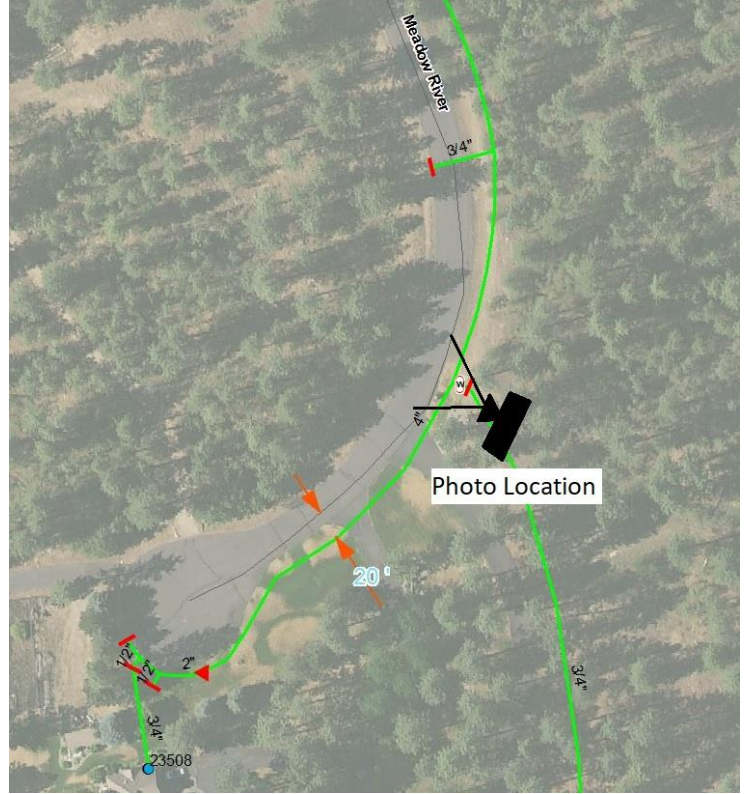
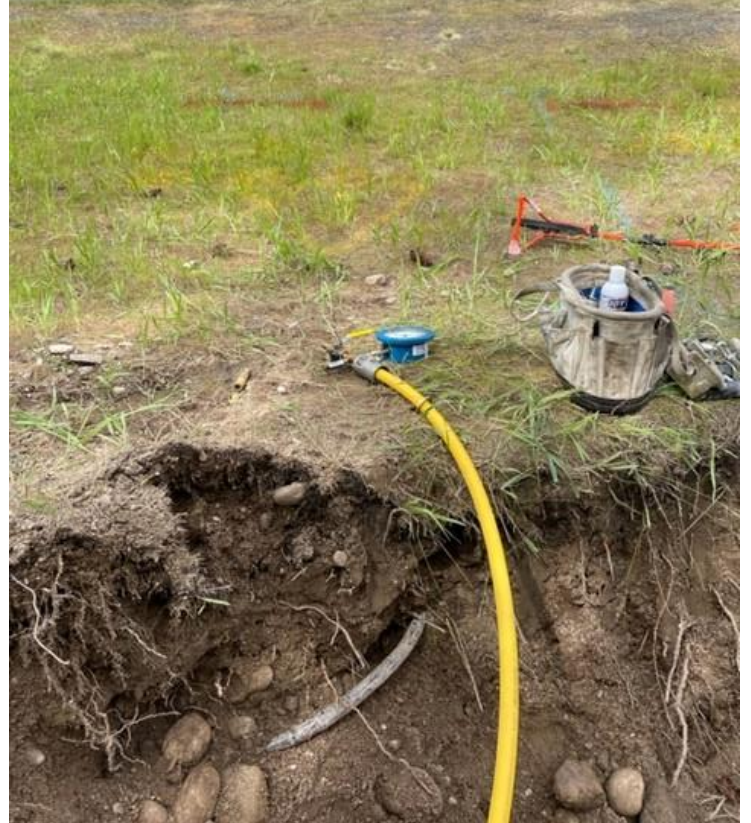
5/24/2022 – M&L was digging on the south end of the locate request, where the triangle with a “?” in it was placed. While digging M&L struck the gas line just east of the triangle. (See Exhibit H to show damage and proximity to unlocatable gas triangle.) Avista was notified of the gas damage at 8:07am. The responding Avista gas serviceman capped what they thought to be a stub, as it was mapped as a stub, and told M&L that there was only a little remaining gas pipe going into the property. M&L continued digging after the Avista gas serviceman left and found additional gas line. Avista was called back on site and discovered that the line damaged by M&L was actually the service line to the shop at the rear of the property at 23508 N Meadow River Ln., nearly 700 feet away from the damage location. (See Exhibit I.) The Avista gas serviceman reported the incorrect gas mapping to the Avista GIS department, and it was updated at 3:24pm the same day. (See Exhibit J.)

Exhibit H - Photos taken by Avista serviceman after damage took place.

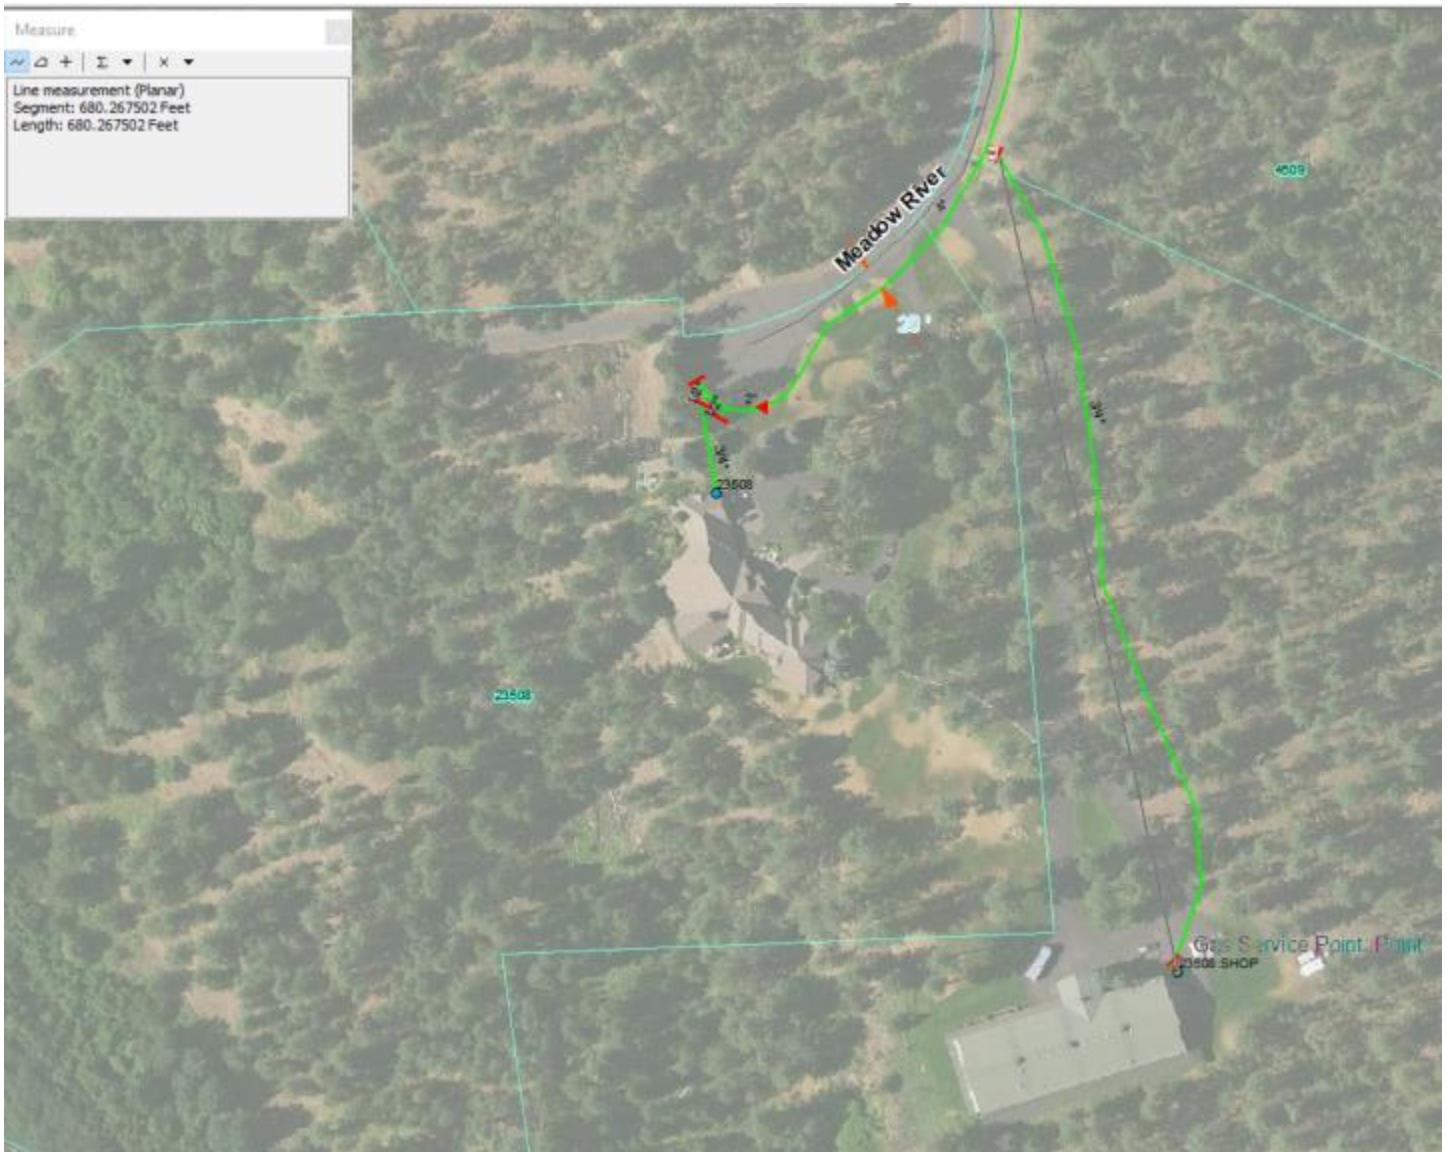
Exhibit I – Avista GIS mapping showing the full service of 23508: Shop and its distance from the damage location.

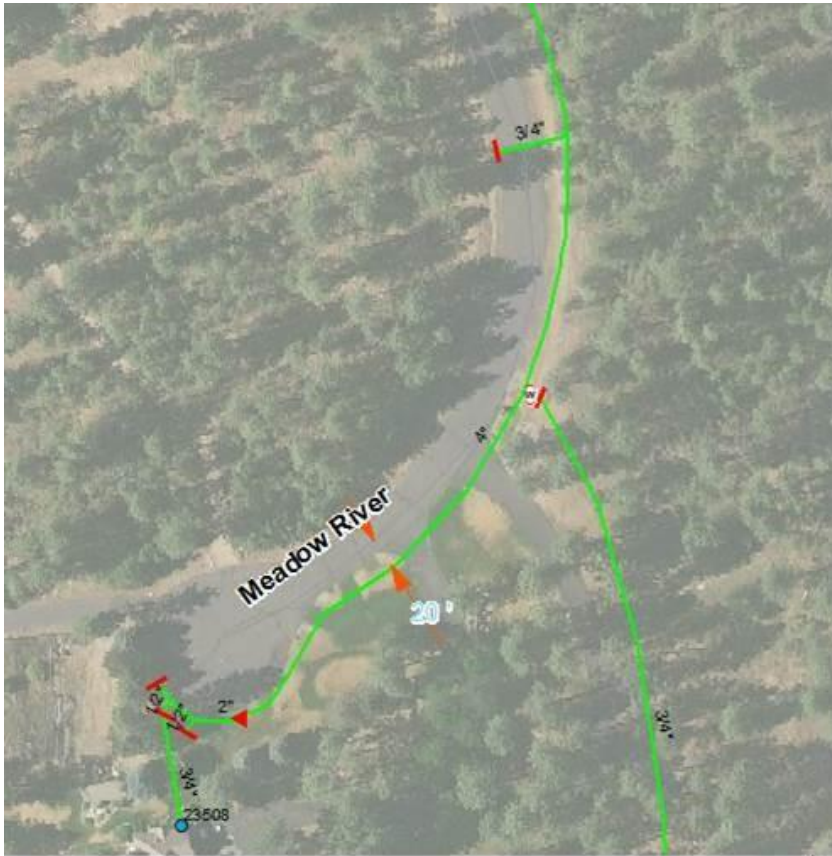
Exhibit J – Avista GIS mapping showing a correction was made.
