# Avista vs M&L

## Case 22-028

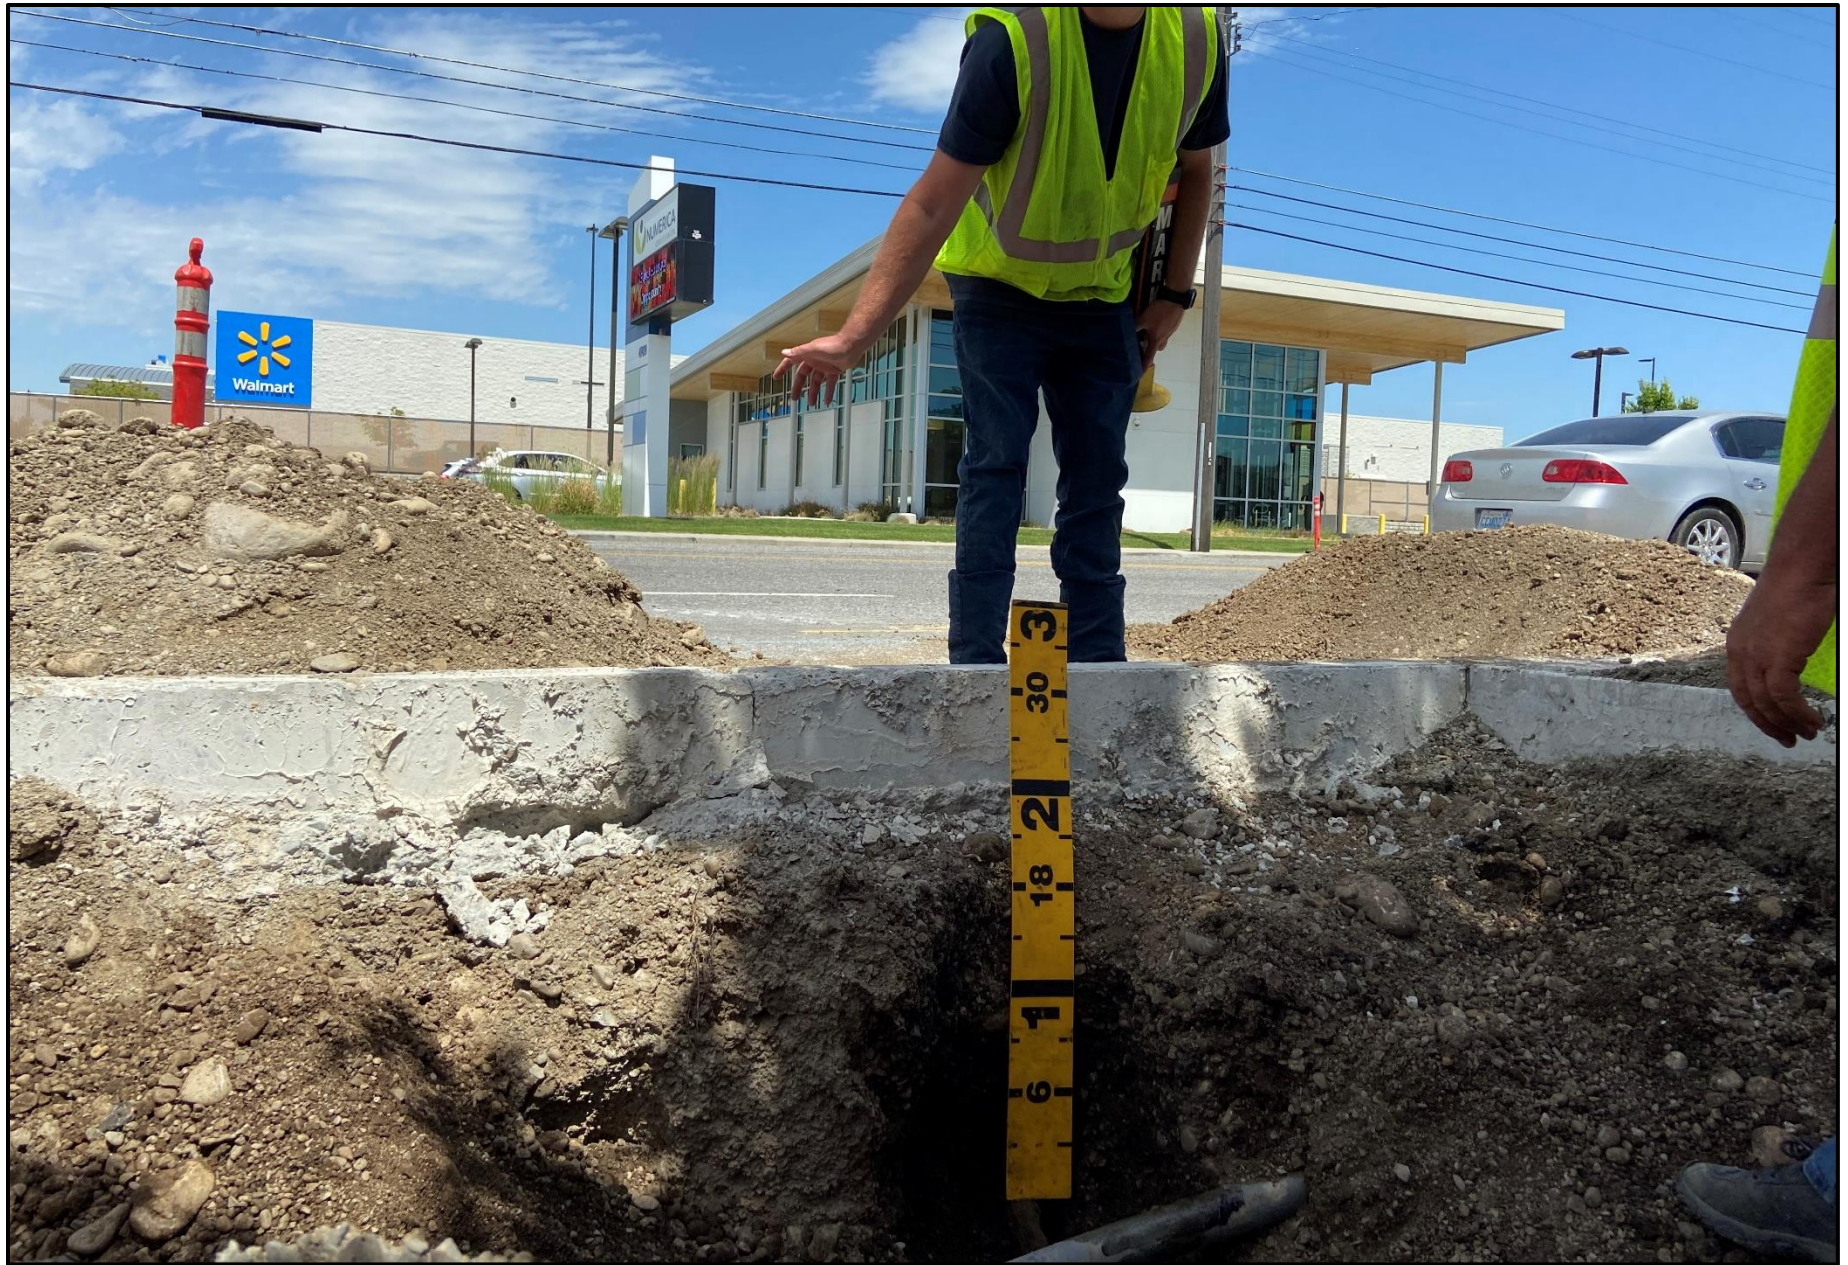
8. **Depth of Utility** – Shows there was roughly 20 inches of dirt cover for the gas line below the bottom of the sidewalk panel.

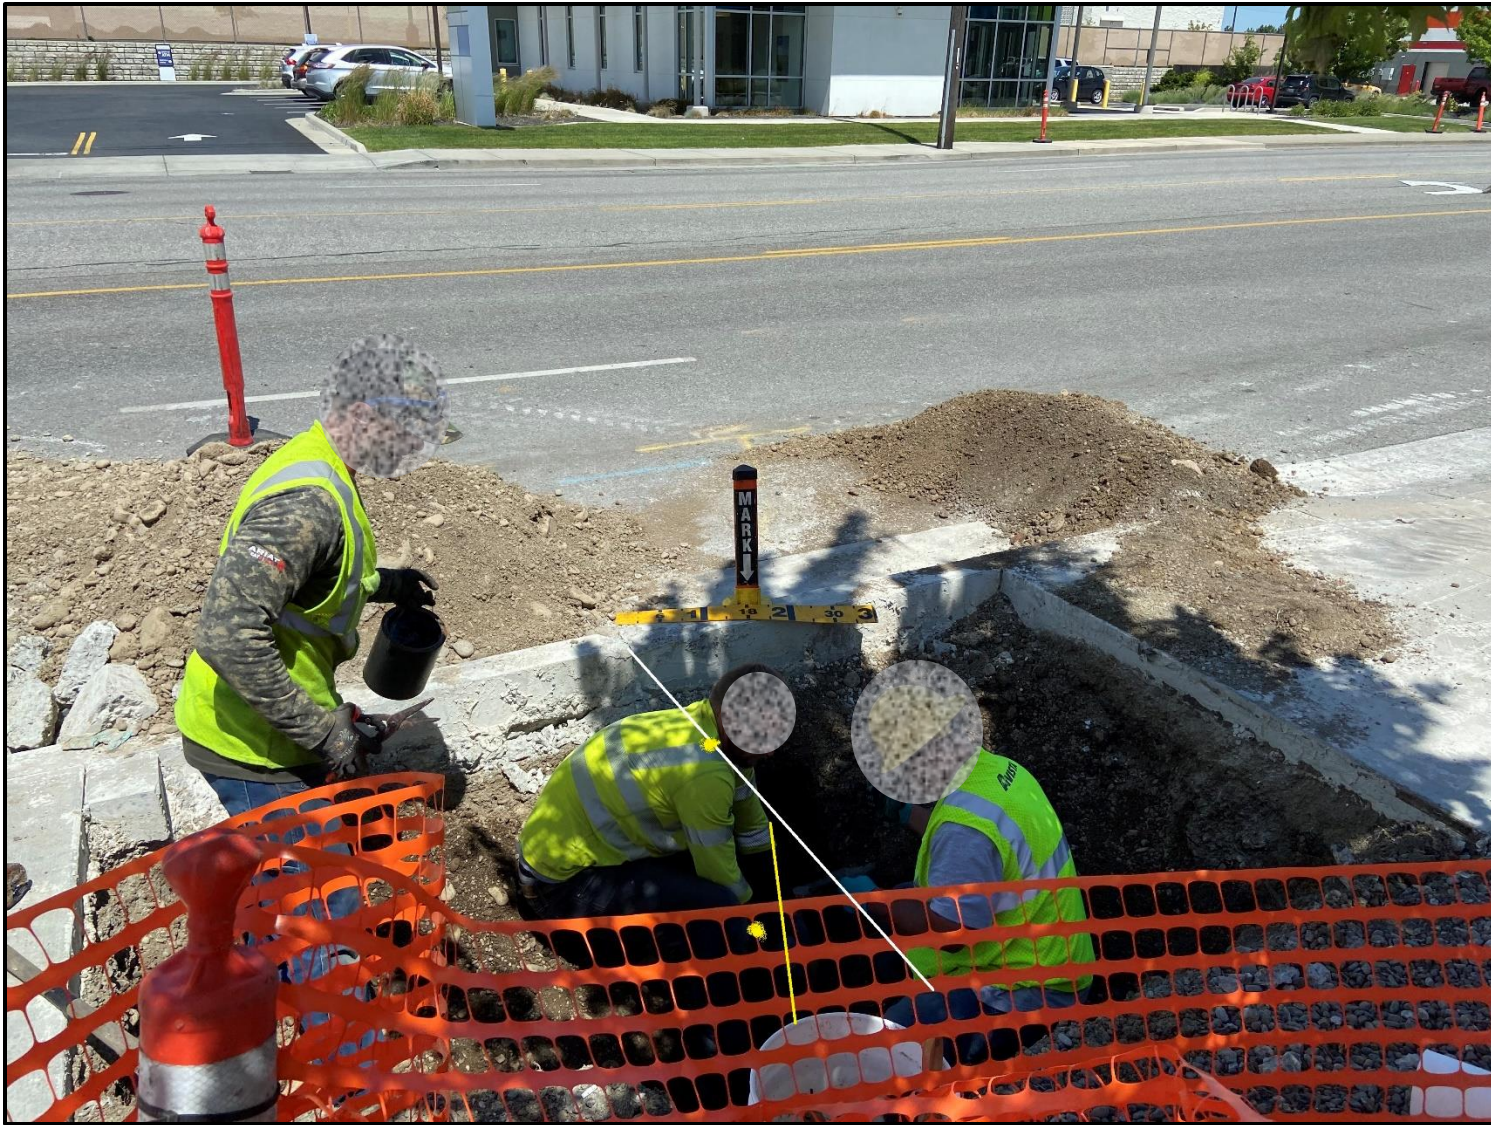
## 9. Damage Sketch

\*Sketch is best information based on original locate photos and matching them up with on-site damage photos. The **white line** is where the sidewalk panel had an expansion joint (seen in the original locate photo). The **yellow line** is where the gas line is running. The **yellow dots** are roughly where the locate marks were on sidewalk panel before it was removed.
