UTC Incident Investigation Form

Notification ID:	3199	Investigation ID:	7508
-------------------------	------	--------------------------	------

Operator:	McChord Pipeline Company, OPID 31049
District/Unit:	McChord Pipeline Company 3001 Marshall Ave, Tacoma, WA 98421
Locations:	100 th St at A St Tacoma, WA
Incident Dates:	August 2, 2017

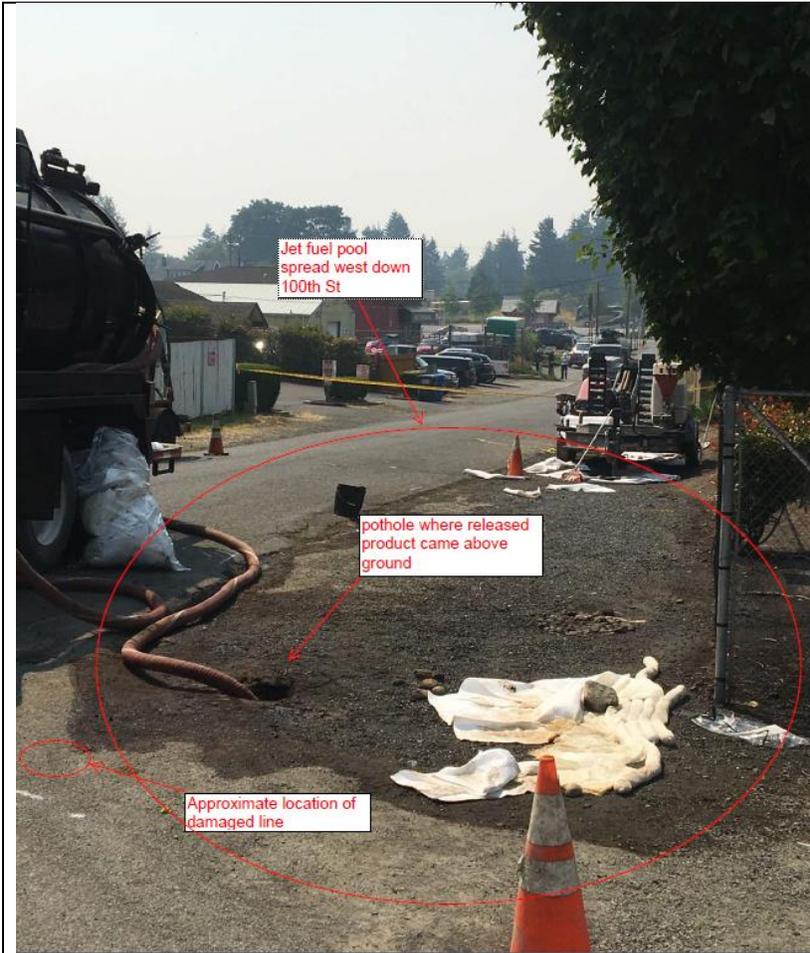
Photo 3—looking west on 100th St at A St. Note location of MPL damaged line in relation to pool spread (down hill).

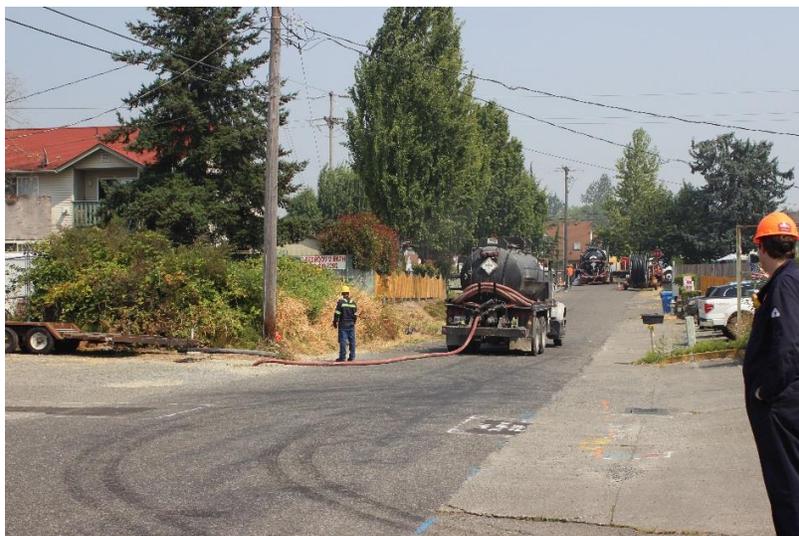
Photo 4—looking east on 100th St. Product recovery efforts using MPL's OSROs.

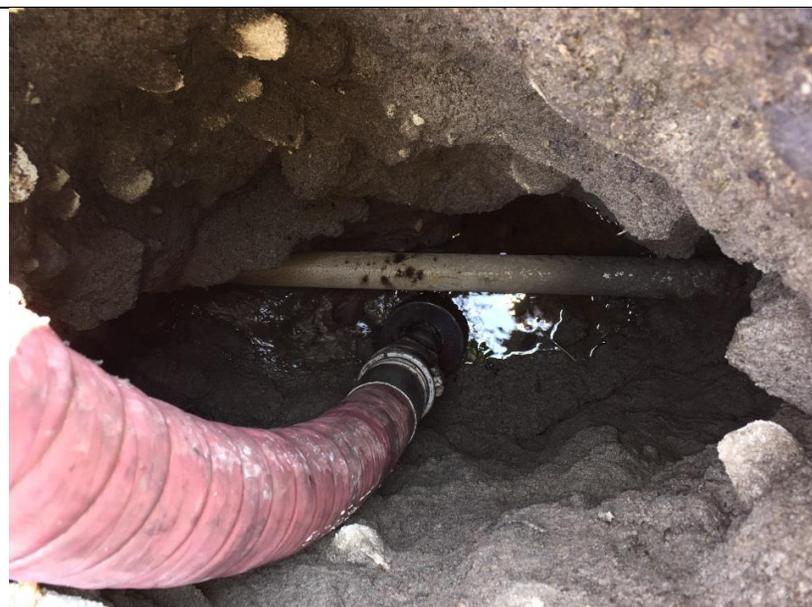
Photo 5—Looking north on 100th St. Leaked product in bell hole approximately 300 feet west of leak site. Hose is removing leaked product.

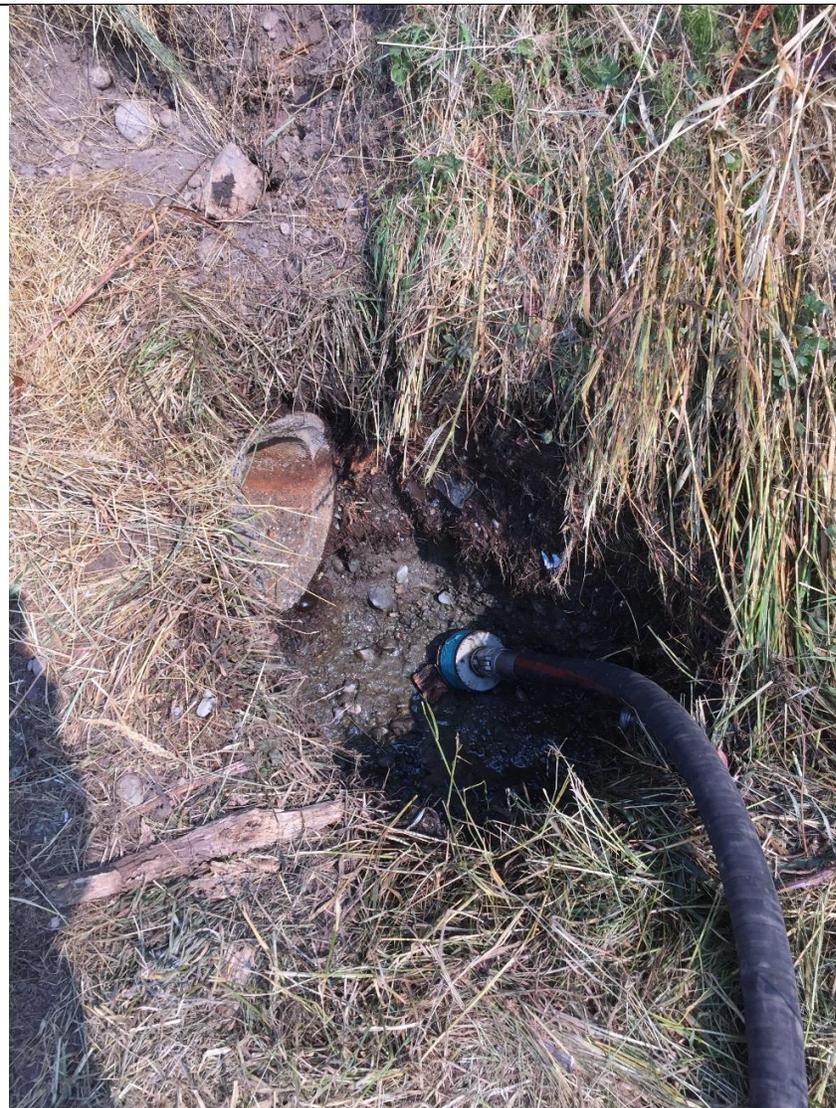
Photo 6—looking north on 100th St. Product recovery efforts in bell hole approximately 200 feet west of leak site.

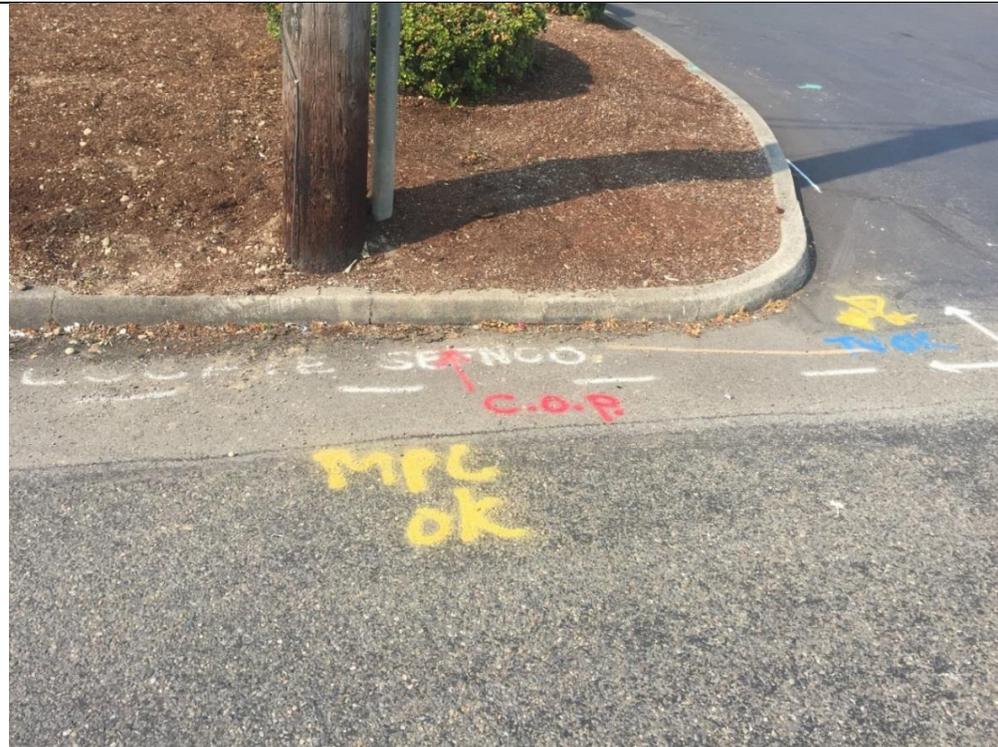
The white paint, as required by RCW 19.122, delineating where to locate, was clearly visible on the west end of 100th St. adjacent to 9911 Pacific Ave (Sound Credit Union). (**Photo 7, 8**).

Photo 7— Looking north 100th St adjacent to Sound Credit Union entrance. SEFNCO white locate boundary with painted locate marks--PSE (yellow), Tacoma Water (blue) and McChord Pipeline (yellow to left of red marks).

The white paint, as required by RCW 19.122.030(1)(a), delineating where to locate, was only clearly visible on the west end of 100th St. adjacent to 9911 Pacific Ave. (**Photo 7 and 8**). McChord Pipeline, Tacoma Water, PSE (ELM), locates were clearly visible at this location and were marked within the required two business days of receipt of the notice. (Note, Parkland Water did not meet the two business day requirement--they stated they did not get the notice until August 29, 2017.

SEFNCO made no attempt to correct the erroneous white painted boundary limits (**Photo 7 and 8**) nor did they call in a new locate. Unfortunately, as they did not call in a new locate, other utility operators in the area did not know the effective construction limits had changed. Instead, SEFNCO called two utilities directly, PSE and Tacoma Water, but failed to call McChord Pipeline. Had the white boundaries showing locate limits been accurate, or a new locate been called in, this incident likely would not have occurred.

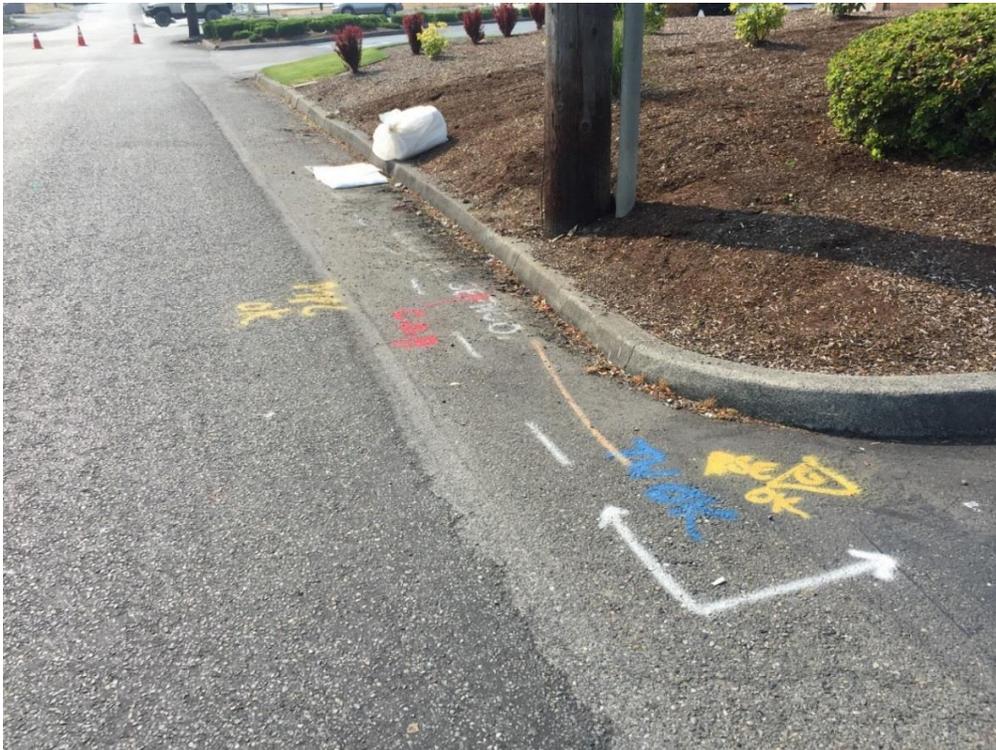
Photo 8— Looking west on 100th St. White SEFNCO locate boundaries with painted locate marks--PSE (yellow), Tacoma Water (blue) and McChord Pipeline (yellow to left of red marks).

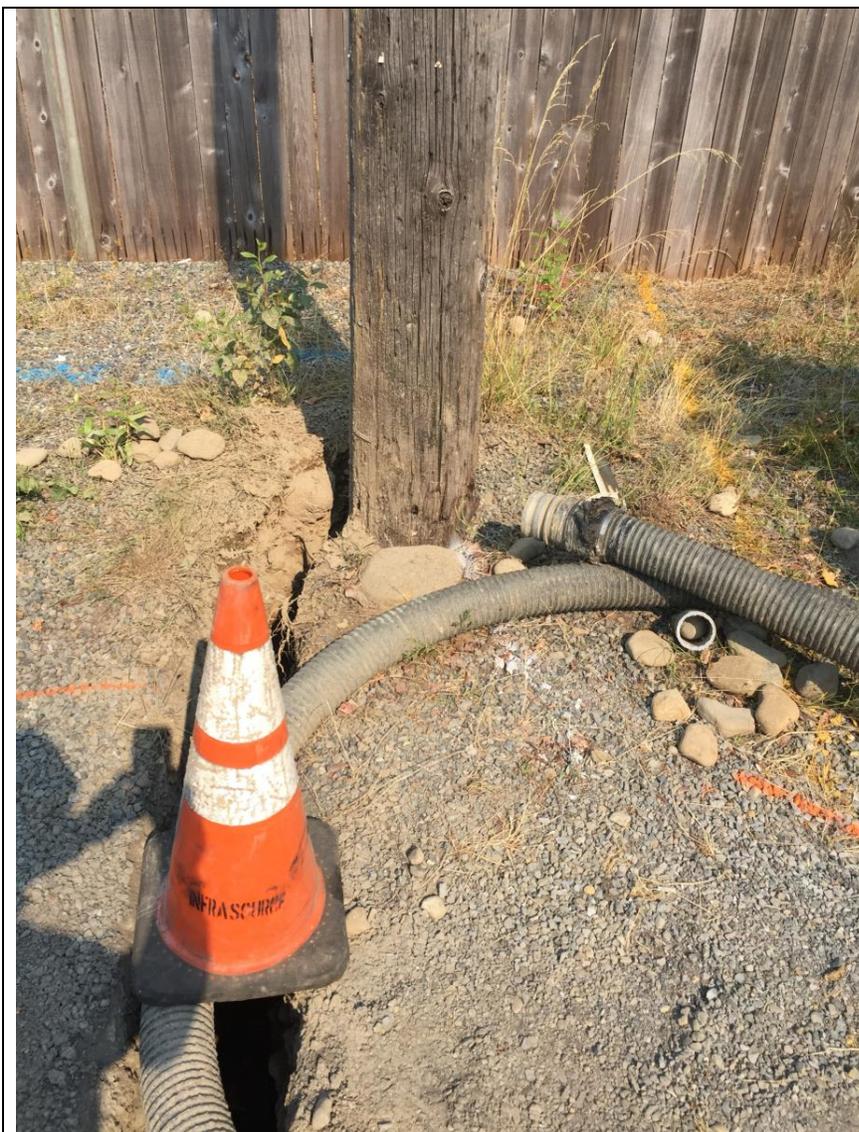
According to SEFNCO Construction Supervisor, Mike Violette, who called in the original locate, the job scope changed. Originally SEFNCO was going to come overhead from Pacific Ave then go underground at the credit union—this is why white paint was originally around the credit union. The project later changed to bring cable in from the east side of A Street approximately 600 feet to the east. According to Violette, he personally put white paint on the ground at the pole near A Street. These marks were not very noticeable while on site (a pot hole was dug near this location and might have damaged marks; however, other locators did not apparently see them either as there were no locates in this area prior to August 1, 2017 (**Photo 9**)).

Photo 9--Looking east at A S. White paint at base of pole barely visible. Other locates were place on August 1, 2017

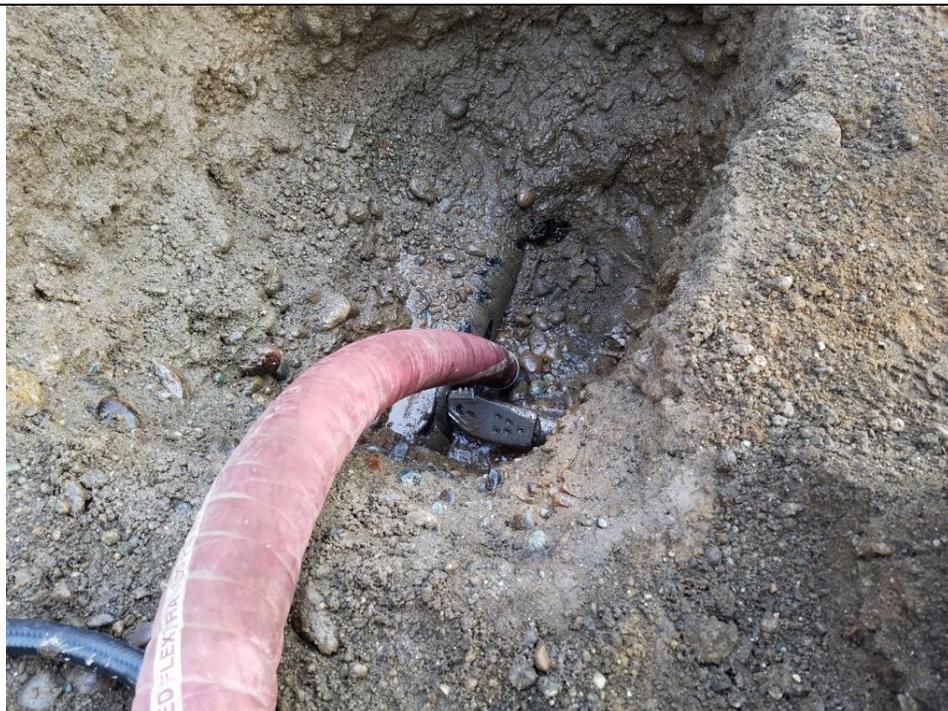
Photo 10—looking south at 100th St and A St. USOR photo showing drill head embedded in MPL pipeline. Hose is removing leaking product.

USOR excavates to damaged pipeline (**Photo 10**).

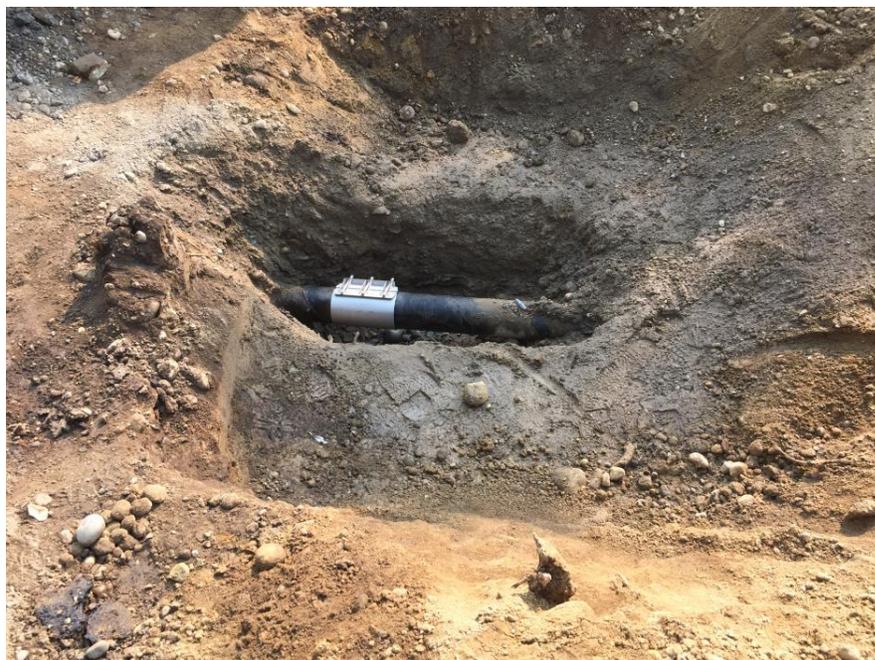
Photo 11--Looking east on 100th St at temporary leak clamp.

At 20:00, USOR has effectively stopped product release by installing a leak clamp over the hole **Photo 11**. Cleanup and product recovery continue.

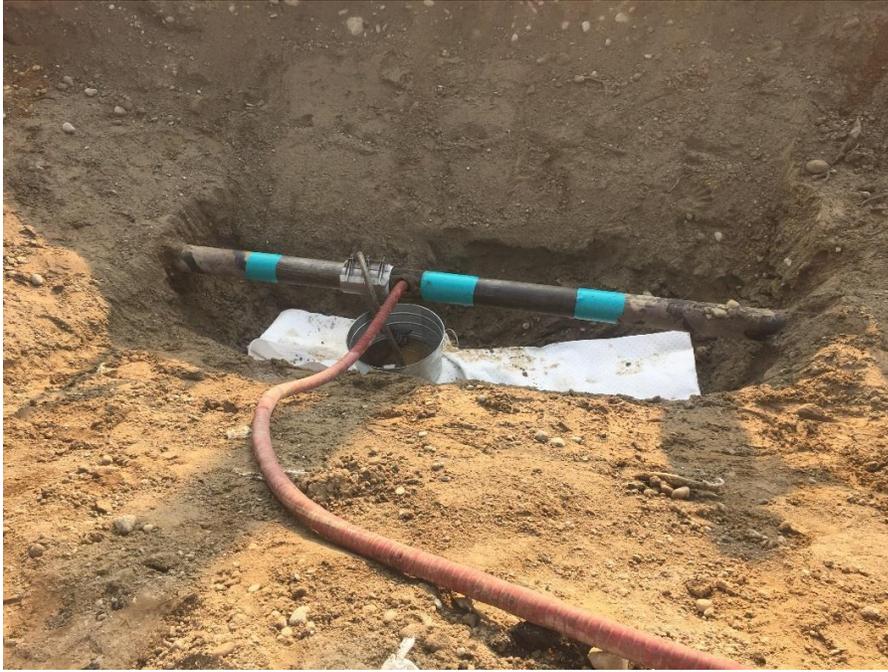
Photo 12--looking east on A St. Drill head removed and hose recovering product from line.

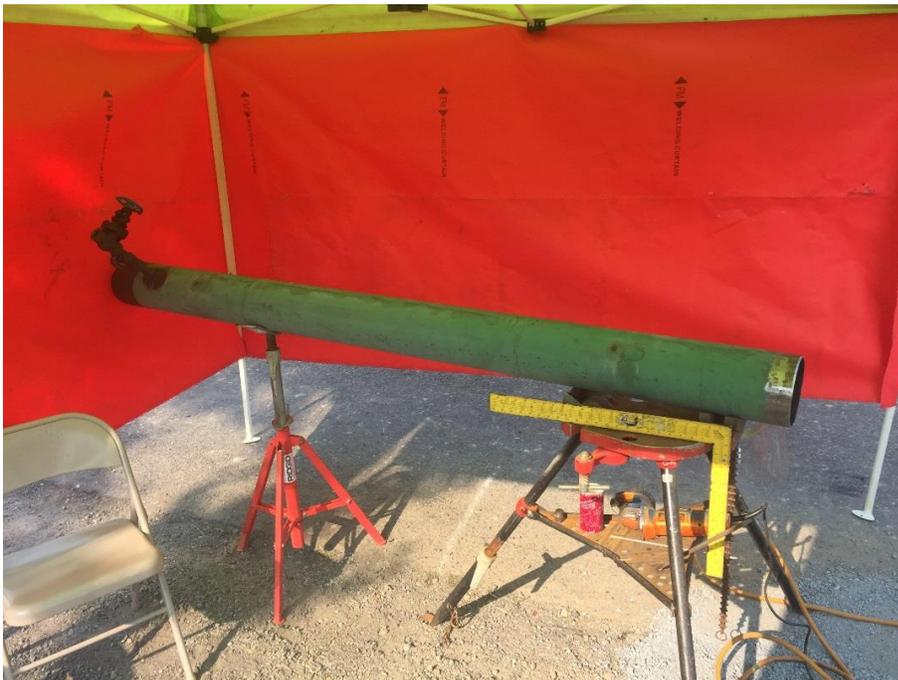
Photo 13--pretested (hydrostatic pressure test) pipe used for repair of damaged section.

USOR repaired the damaged segment on August 4, 2017. They cut out the damaged portion and installed a new section of pre-tested pipe (**Photos 12-18**).

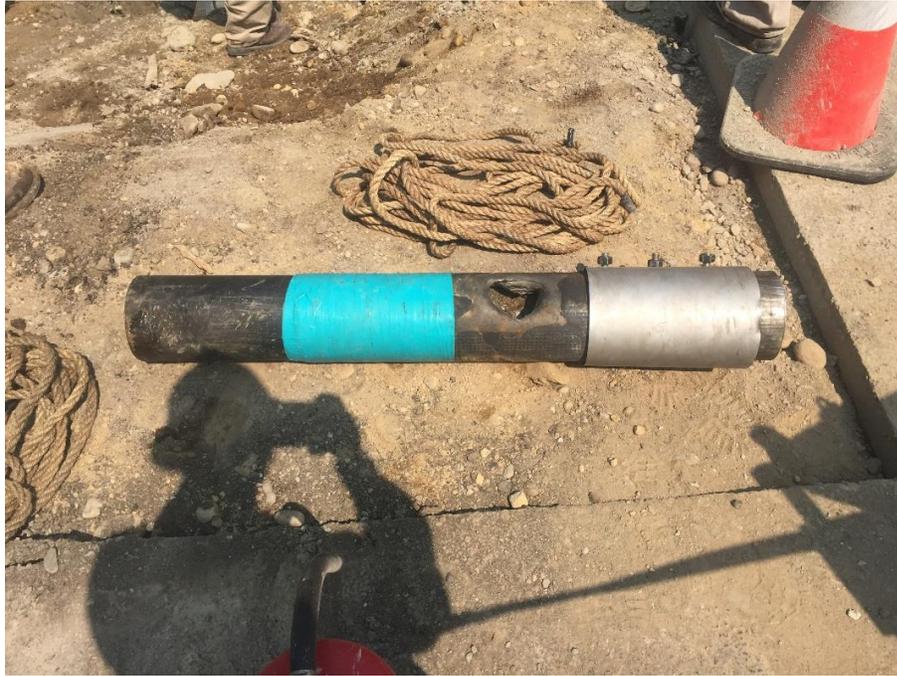
Photo 14—cut-out section of damaged pipe

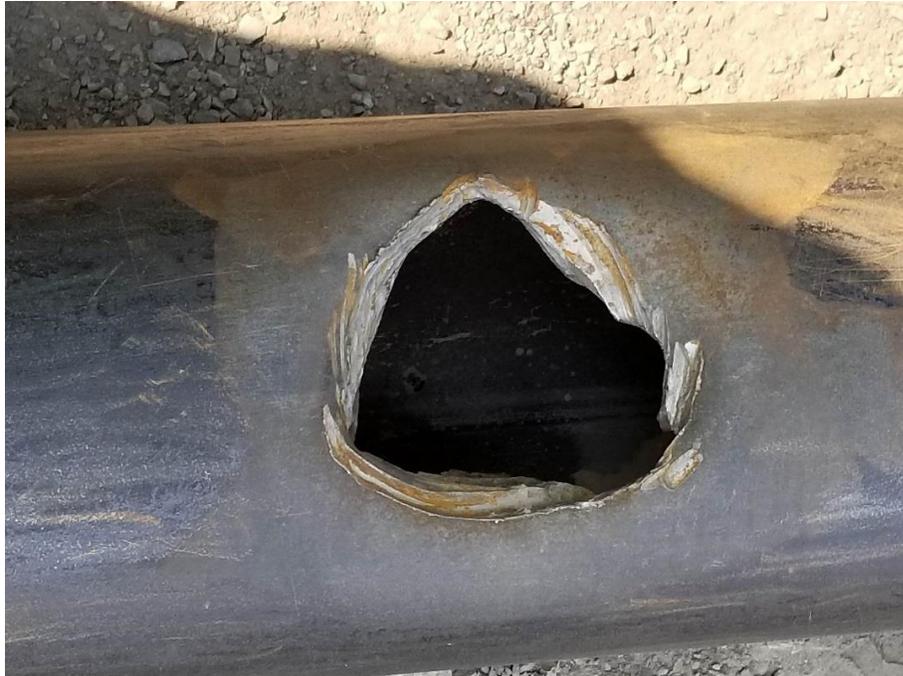
Photo 15—USOR photo of hole punctured in six-inch steel line by directional drill. Note drill head shaped hole.

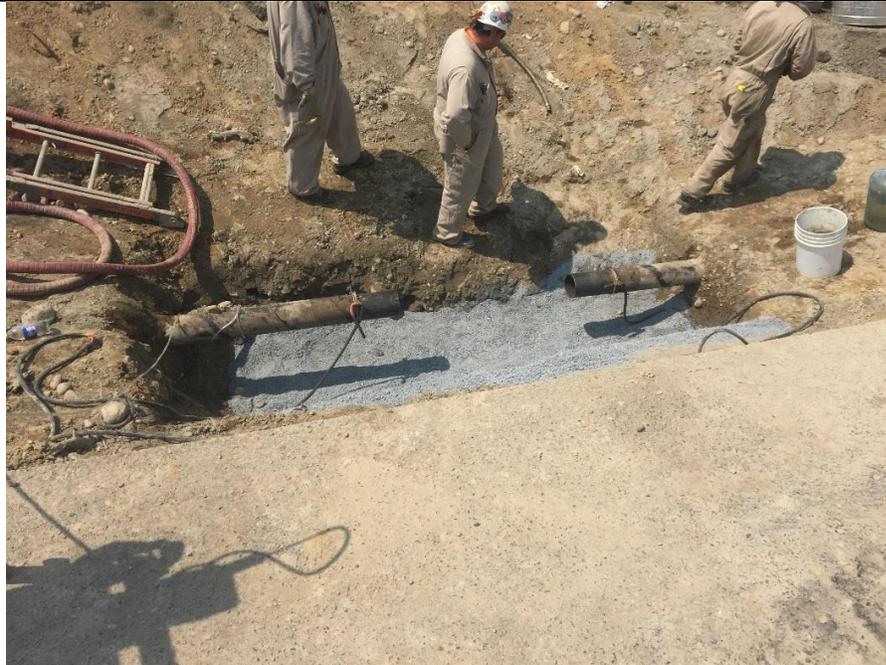
Photo 16—looking west on A St. at MPL line after damaged section removed.

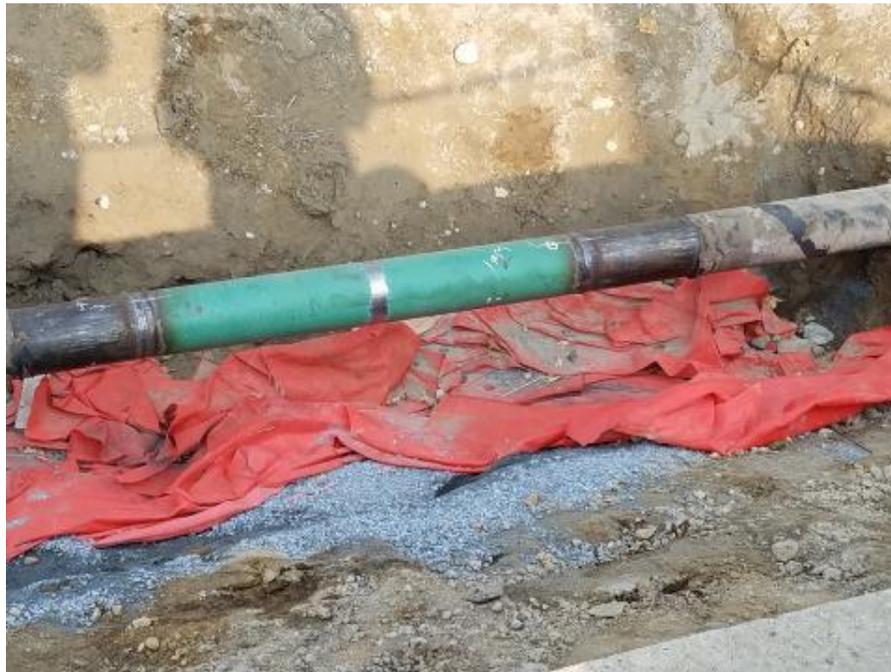
Photo 17—USOR photo of new pup welded in place and x-rayed

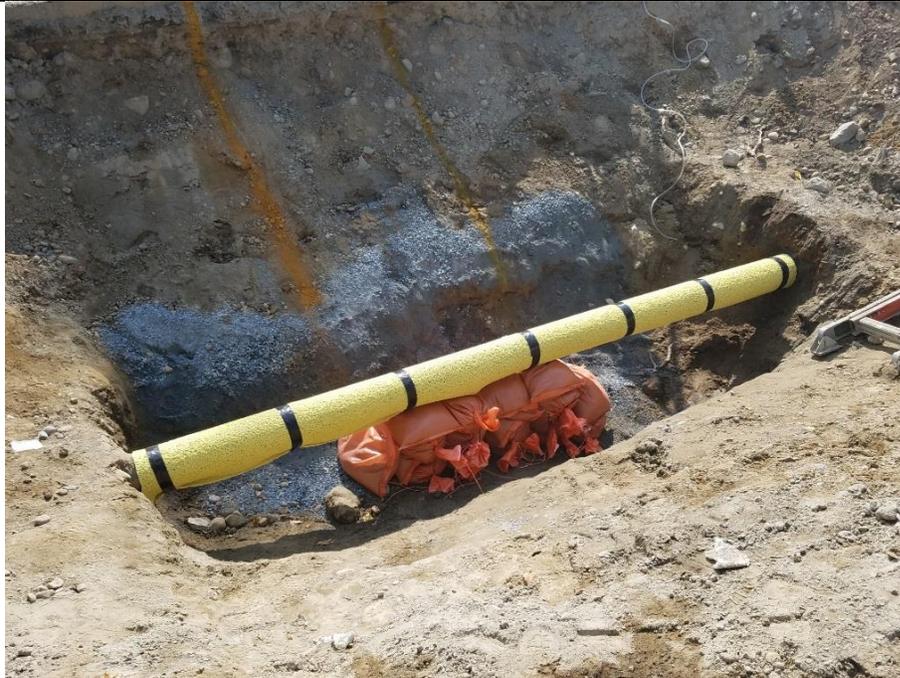
Photo 18—USOR photo of final repair ready for backfill. Yellow wrap is for rock protection
