Exh. RS-8 Docket UW-240151 Witness: Rachel Stark

EXHIBIT TO TESTIMONY OF RACHEL STARK

DOH Letter and Sanitary System Surveys

2023 Sanitary Survey

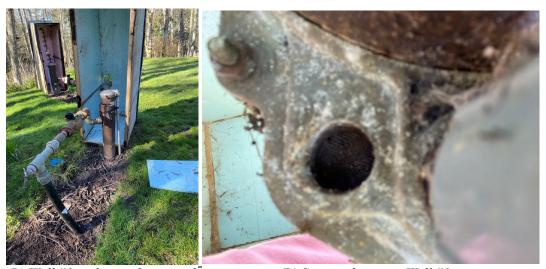
(L) Well #1 with sample tap and source meter (R) Screened vent on Well #1

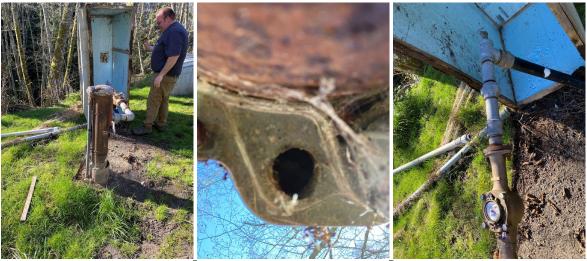
(L) Well #2 (Center) Screened vent on Well #2 (R) Source meter and sample tap

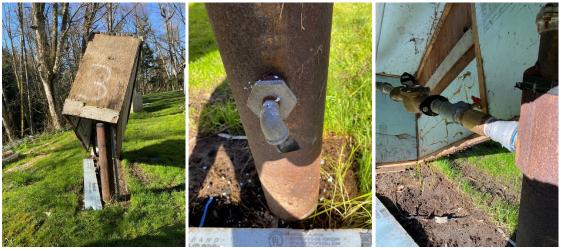
(L) Well #3 (Center) Secondary vent on Well #3 (R) Source meter and sample tap

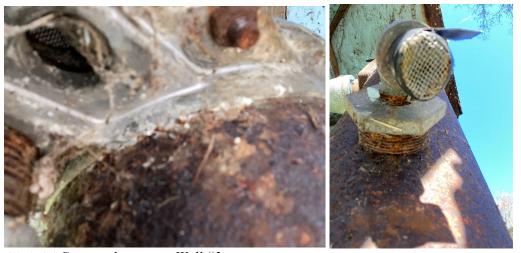
(L) & (R) Screened vents on Well #3

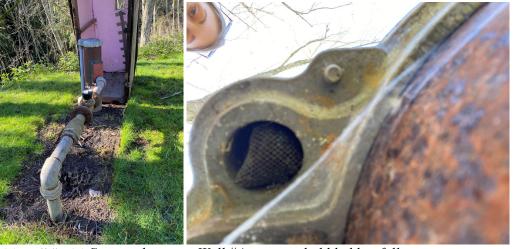
(L) Well #4 (R) Screened vent on Well #4 – screen bubbled but fully intact

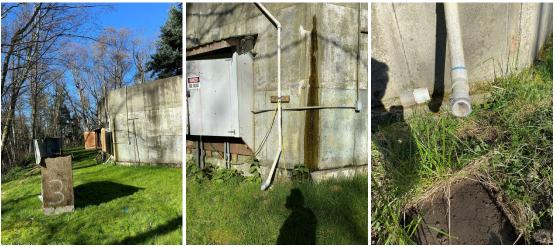
(L) Existing reservoirs with wells nearby (Center) Overflow for reservoir (R) Finer mesh needed for overflow screen

Photos were received on 4/12/2024 of the reservoir appurtenances for both reservoirs. Thank you. The overflow screen on the newer, 50,000-gal tank needs finer 24-size mesh. Please replace the screen and submit photos.

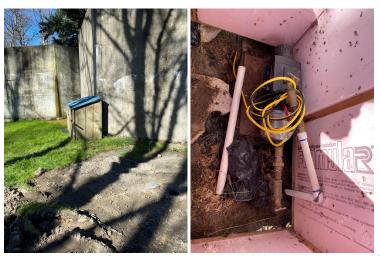
(L) Booster pump housing near reservoir (R) 1-HP Booster pump for 2 connections

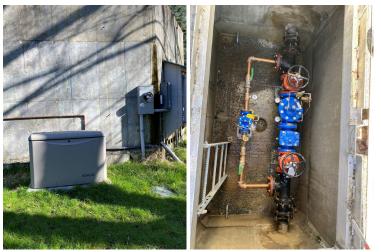
(L) Generator for backup power (R) Newly rebuilt PRV in distribution
