RAILROAD ACCIDENT REPORT

COLLISION OF NATIONAL RAILROAD PASSENGER CORPORATION (AMTRAK)
TRAIN 59 WITH A LOADED TRUCK-SEMITRAILER COMBINATION AT A
HIGHWAY/RAIL GRADE CROSSING IN
BOURBONNAIS, ILLINOIS, MARCH 15, 1999

**RAILROAD ACCIDENT REPORT
NTSB/RAR-02/01 (PB2002-916301)**

**NTSB/RAR-02/01
PB2002-916301
Notation 7168A
Adopted February 5, 2002**

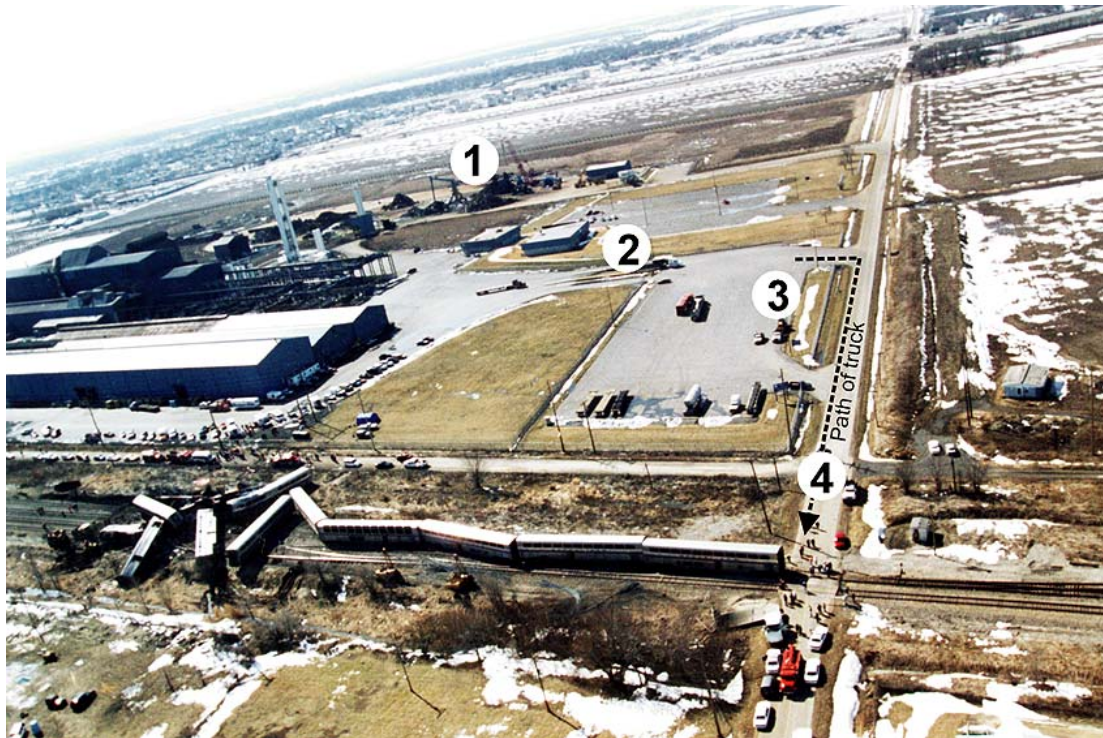
Figure 3. Aerial view of crash scene showing locations of witnesses to accident: 1. crane operator; 2. two people in scale house, 3. truckdriver affixing tarp to his load; and 4. motorist behind accident truck.
