# Investigation Report

## CenturyTel of Inter Island d/b/a CenturyLink

UT-132234

Staff Investigation  
Consumer Protection  
Regulatory Services

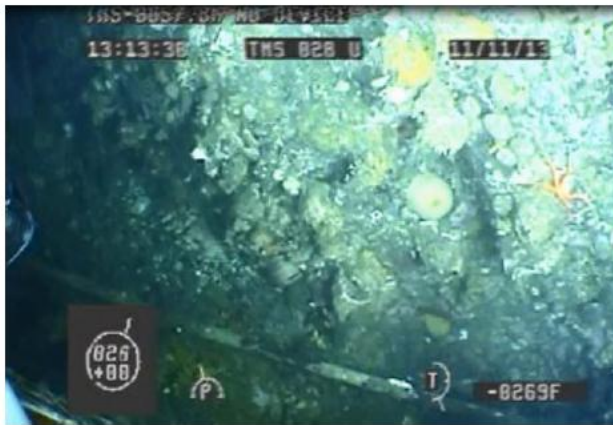
Figure 2 - Cable Wrapped on Rock Feature

Repair operations commenced on November 11, 2013 with a Remote Operated Vehicle (ROV) video inspection of the Century Link cable in the vicinity of the break. The ROV inspection revealed that the cable had been dragged north from its original position and pulled tight up against a rock feature.

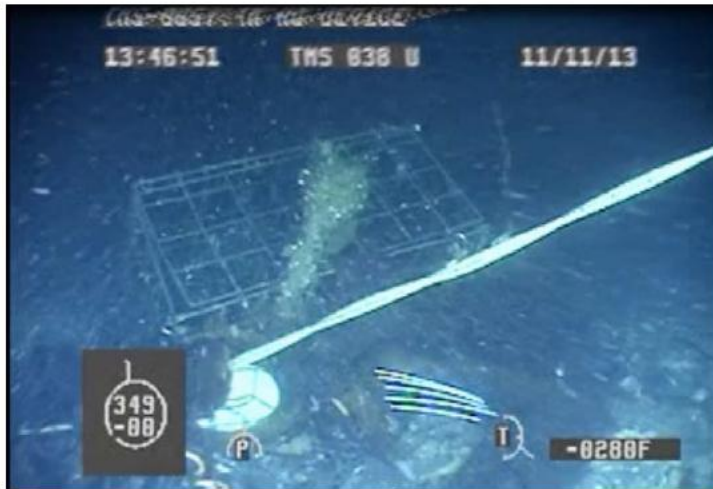
Figure 3 - Crab Pot with Polypropylene Line

A crab pot with polypropylene line was found entangled in the cable 90 feet west of the rock feature.

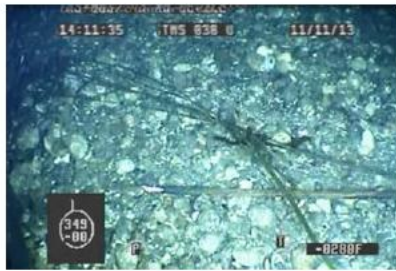
Figure 5 - Parted Cable End Eastern Side

The parted cable end on the eastern side of the break was found approximately 65 feet west of the entangled fishing gear and the end on the western side was found to be approximately 93 feet west of that.

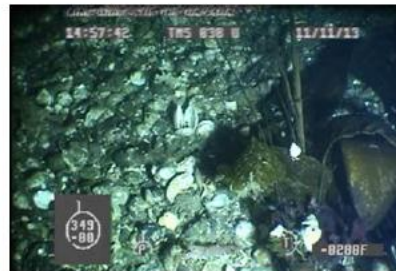
Figure 4 - Parted Cable End Western Side

Visual inspection of the western parted cable end clearly indicated that the cable failed due to a tension break. Armor cable tension breaks are characterized by necking, or a thinning of the armor wires and copper sheath before failure.

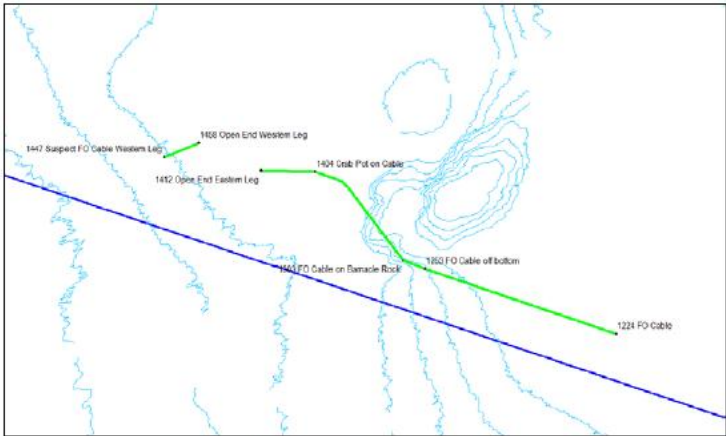
Figure 6 - ROV Inspection Critical Observations

As stated earlier, the cause of the break is still unknown, however, ROV inspection of the two parted cable ends strongly suggests that the cable fault was due to a tension break (as opposed to a localized failure due to abrasion).

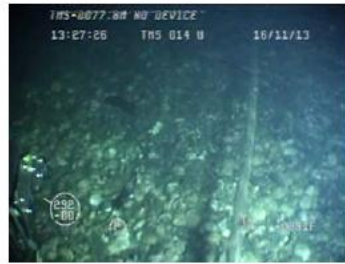
Figure 12 - Cable Suspension

The ROV also conducted video inspection of the Century Link cable starting west of the cable repair splice and then to the east, towards the Fishermen Bay landing. Areas of slight suspensions were found to the west of the cable repair splice.

The suspensions may be problematic over time depending on whether or not the cable settles into the seabed at the touchdown points. If the cable remains suspended for a long period of time, the risk of abrasion failure due to cable strumming in the current should be considered.

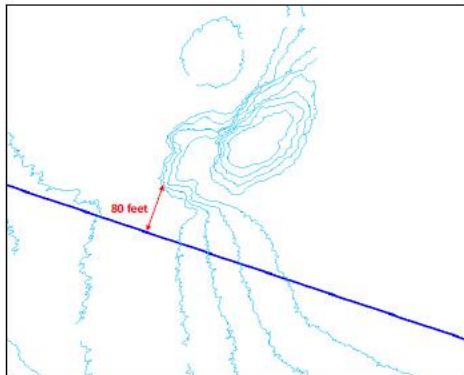
Figure 16 - Cable Route Separation from Rock Feature

Overlaying the 1999 cable route on the 2013 OPALCO survey data, the Century Link cable was installed within 80 feet of the rocky features within the cable corridor.

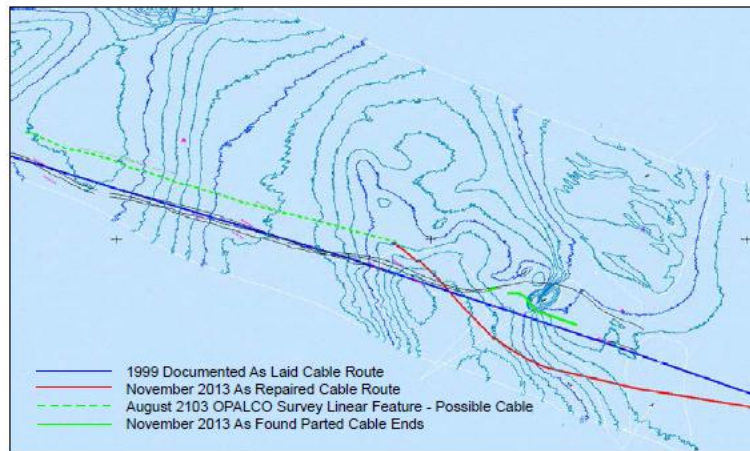
**Figure 18 - Linear Feature Possible Actual As Laid Route**

An observation worth noting is that the 2013 OPALCO route survey identified a linear feature that lines up with the Century Link repair splice position. The broken cable was found approximately 245 feet north of the documented 1999 as laid position. The linear feature (green dashed line in the drawing below) appears to run parallel to the 1999 cable route without any deviations or signs of localized displacement. It is possible that the cable laid in 1999 was actually laid 245 feet north of the documented route position list. This would have routed the 1999 Century Link cable through the rocky areas from the very start.

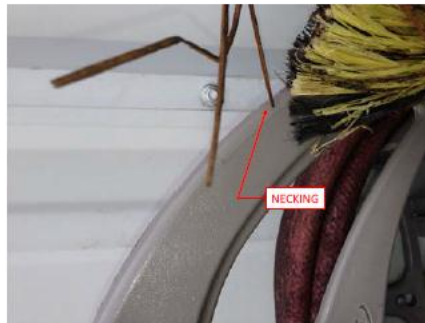
Figure 22 - Necking on Armor Wires

It is of my expert opinion that the cable was dragged along the seabed by an anchor, fishing gear or some other towed device that caused the cable to wrap itself tightly around a large rock feature. The cable broke due to excessive tension over time after multiple entanglements or during a single entanglement event.

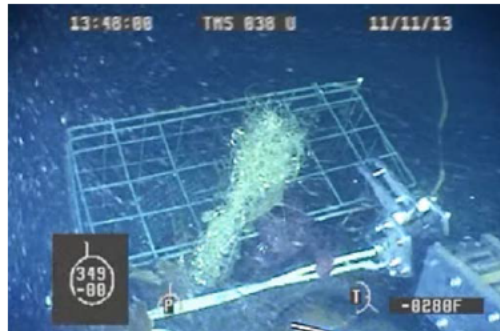
Figure 25 - Crab Pot Entangled with Cable

The ROV inspection shows one crab pot entangled in the cable and another, mostly buried, in a nearby area.

It is possible that a pot was involved in the cable fault, but it may also be a piece of derelict gear entangled in the cable before or after the break. Factors that make it a less likely cause include the fact that crab pots are legally required to be fished with one pot per buoy line. That means that strings of pots on “ground lines” that may be retrieved with grapnels are not used.

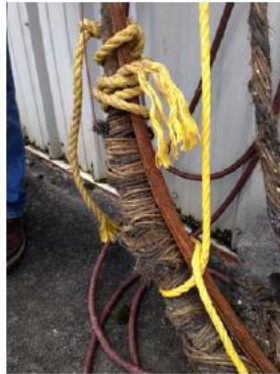
Figure 36 - Balled Up Jute

The 2013 OPALCO survey data indicates that several of cables in the vicinity of the cable break have been dragged to the north into the rocky areas. The 1995 OPALCO Power Cable repair encountered fishing nets entangled with the cable. The 2013 Century Link cable repair encountered a crab pot entangled with the cable and visual inspection of the cable showed damaged sections of jute indicating that the cable had been dragged along the seabed or that an object had been dragged along the cable.

This suggests that vessels have been active in the area and that the cables have been subjected to external aggression from bottom fishing, anchors or towed devices.
