## Case 21-046 M&L Construction vs Avista

Ticket Number: 21470048

Location: 10021 N Orchard Ln

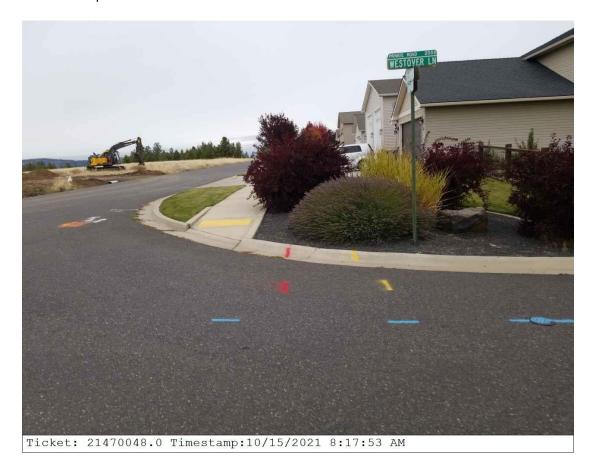
## **Exhibit C** – Locate pictures

**Comments:** AVISTA-E - 10/14 c voelker; AVISTA-G - Out of time; AVISTA-E - 10/15 c voelker Located single phase electric on E side of road to out of the dig area. Dig area not marked for the job. Brian showed me where the dig area was. Only going to the water line in the middle of the street. After talking to someone on the phone he expanded the dig area to past the sidewalk on the E side of the street. Only located the single phase and no services.; AVISTA-G - Located 2" PE main on W side of street from stub to out of the dig area. Located 2" PE main on E side of the street. Did not locate any services.;
