**From:** Dusty H <dusty@mlnorthwest.com>  
**Sent:** Wednesday, September 13, 2023 3:24 PM  
**To:** Proszek, Tyler <Tyler.Proszek@avistacorp.com>; Scot Hattenburg <scot@mandlconstruction.net>  
**Cc:** Schultz, Brian <Brian.Schultz@avistacorp.com>; ray@mlnorthwest.com; 'Stephanie Hattenburg' <stephanie@mlnorthwest.com>  
**Subject:** Re: [External] no locates time loss and elm refusal putting lives in danger.

Complaint 23-093

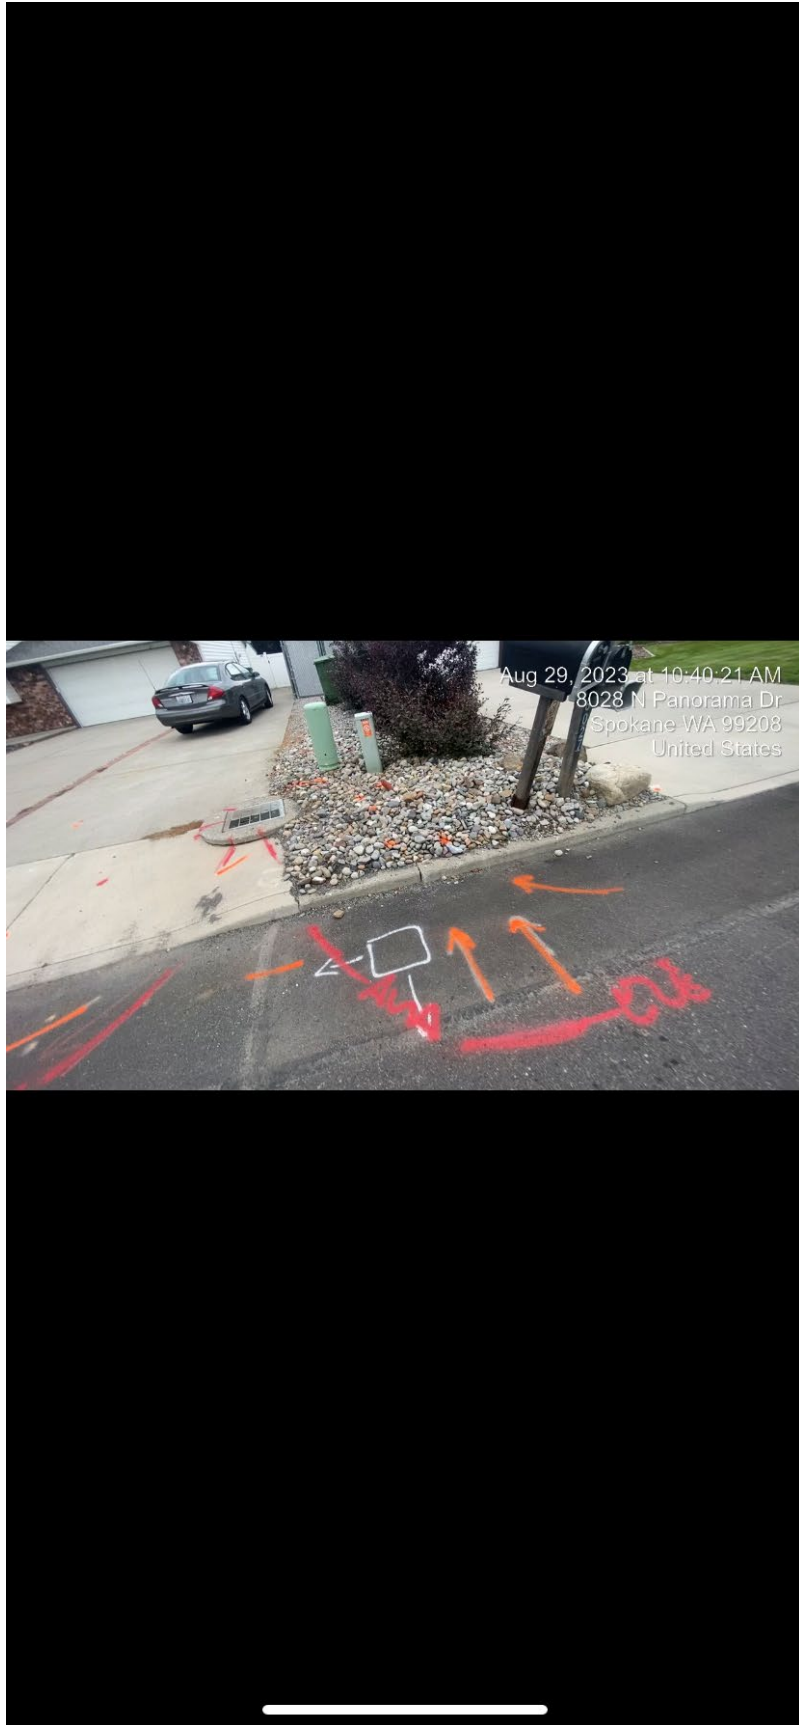
Operator was concerned gas tee would be in the grass where equipment would be excavating. I asked tech to mark out to the tee

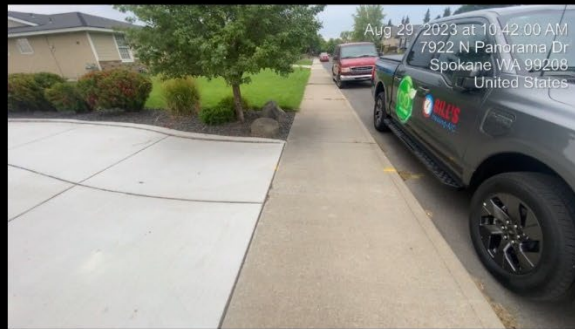
Asked tech to mark out this service to the gas tee because we would have to run behind fire hydrant

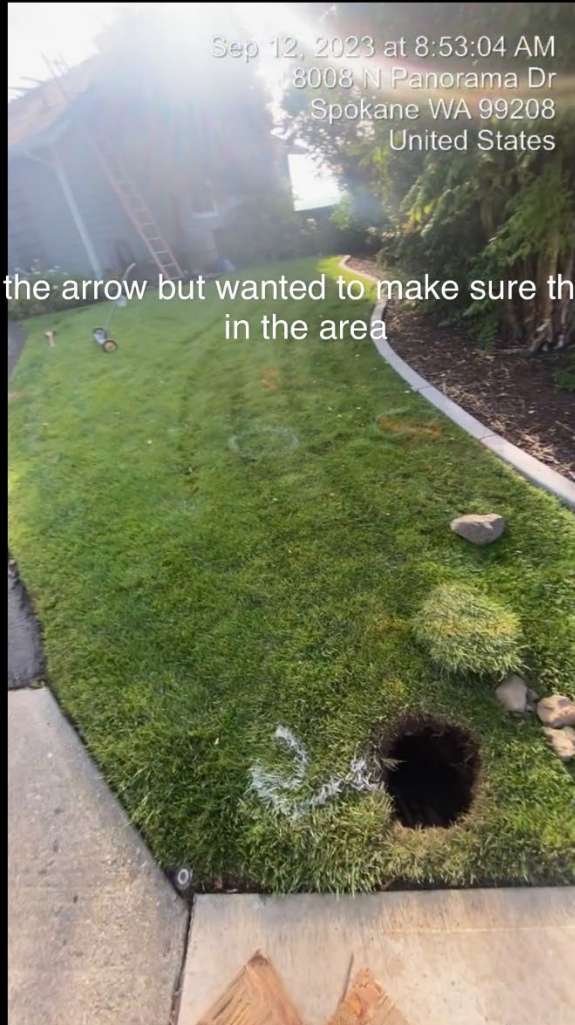
We potholed gas at the arrow but wanted to make sure there wasnt another line in the area
