WA Dig Law Complaint Avista vs M&L Construction

June 11, 2024 – 11911 N Stevens Ct Spokane WA, 99218 – Excavation damage to Avista gas service

Avista Utilities Supporting Documentation

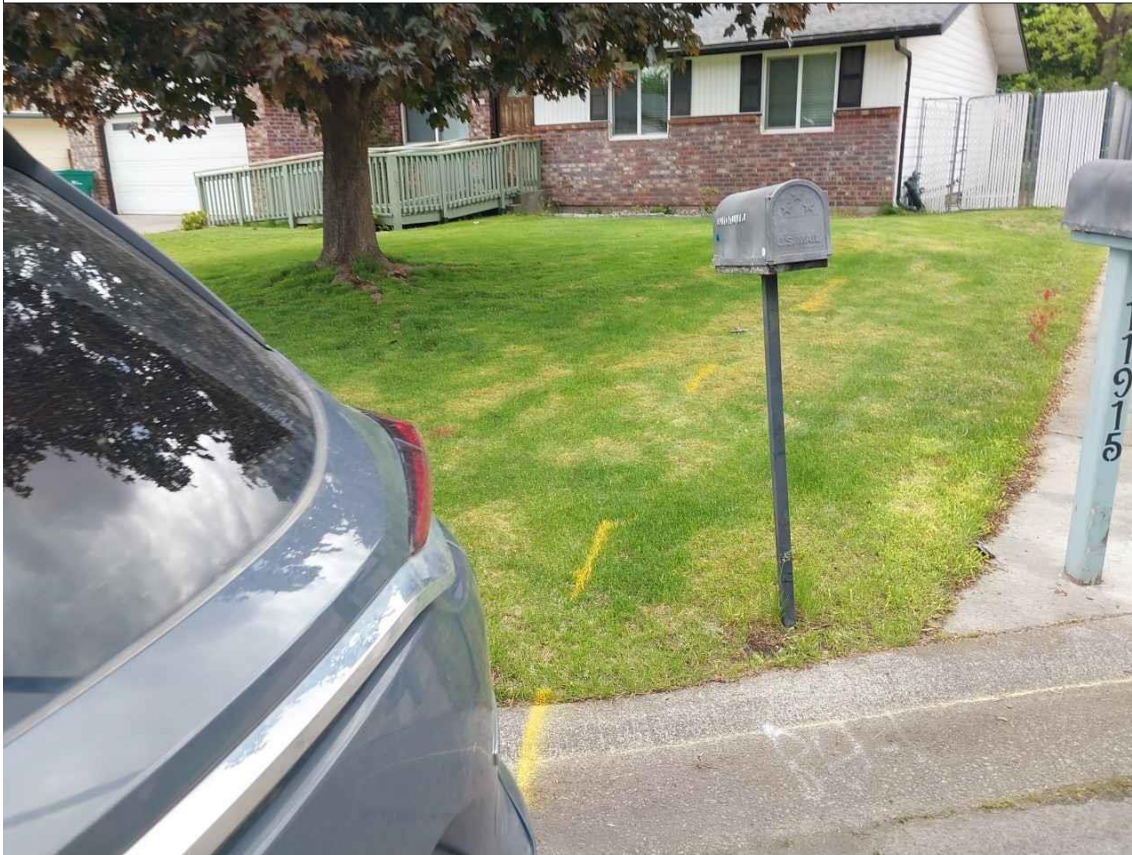
Original Locate Photo

Lat: 47.7661871, Long: -117.4184573, H: Southeast

Ticket: 24205370.0 Timestamp: 5/21/2024 1:55:13 PM

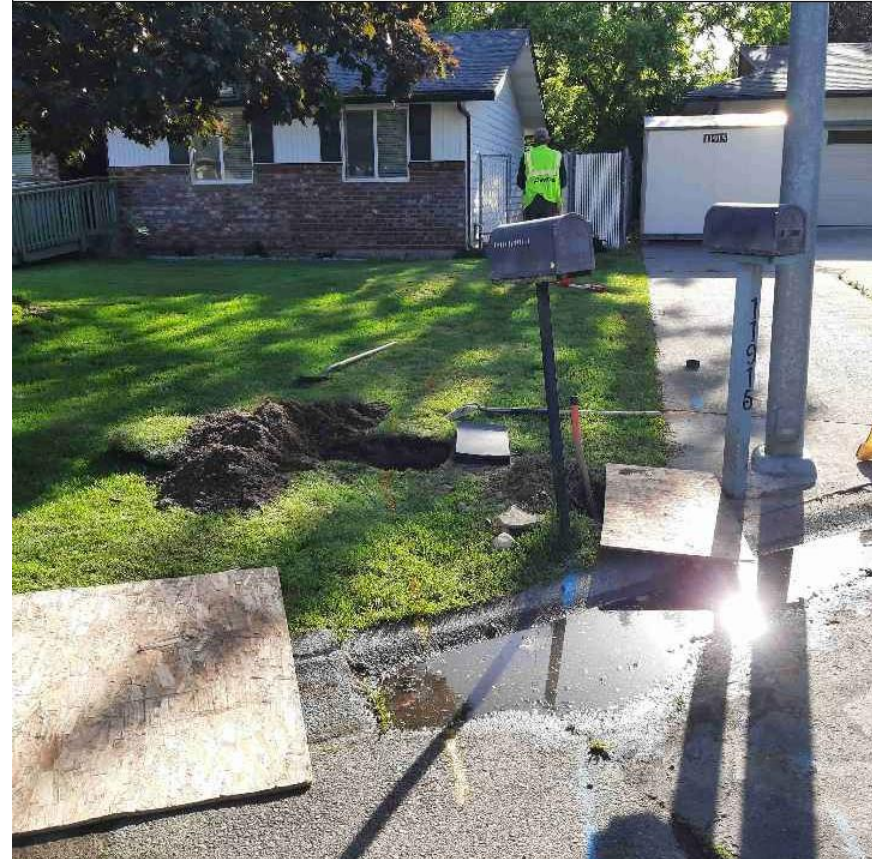
Damage Photo

Lat: 47.7008024, Long: -117.3932899, H: North

Ticket: 24242524.0 Timestamp: 6/11/2024 6:01:29 PM
