WUCC Complaint Form

Alleged Violation/Damage:			
\bigcirc RCW 19.122.030 Must call for marking two (2) full business days prior to digging.			
Other 19.122.030			
Section of Law Violated:		Alleged Violation I	Date:
mis located the gas line by 1	0'	07/07/2022	
Address of alleged violation:			
3423 e 33rd Ave Spokane Wa			
City of Alleged Violation:	State of Alleged Vi	olation:	Zip of Alleged Violation:
Spokane	Washington		99223

5000	
From:	Proszek, Tyler <tyler.proszek@avistacorp.com></tyler.proszek@avistacorp.com>
Sent:	Monday, July 25, 2022 1:02 PM
To:	scot@mlnorthwest.com
Cc:	Schultz, Brian
Subject:	3423 E 33rd Ave Spokane Mislocate
•

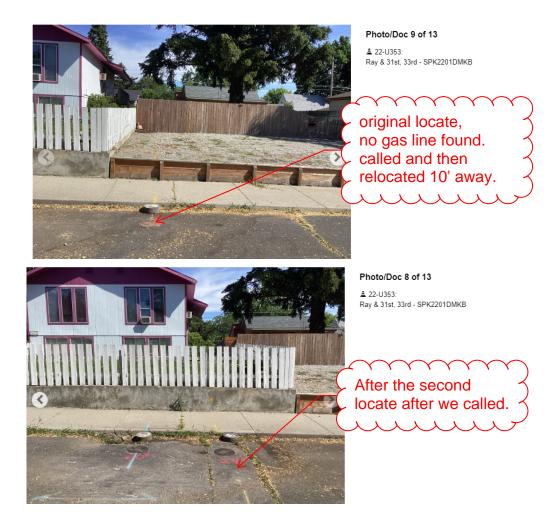
Gas line not located in the tolerance zone. It was approx 10' away.
