SOUTH KING COMPLEX
PUGET SOUND ENERGY
FACILITY CONDITION ASSESSMENT
FINAL REPORT
AUGUST 18, 2016

**PUGET SOUND ENERGY
SOUTH KING COMPLEX
KENT, WASHINGTON**

**June 2, 2016
16-424**

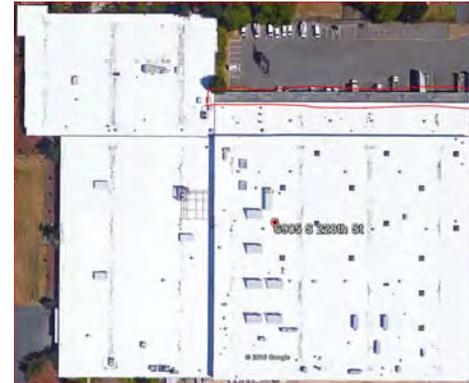
This original 1967 roof area is a strip on the north side of the building that was not addressed when the rest of the entire building was re-roofed reportedly in 2012. While there are no leaks or failures reported in this area, the roofing has far exceeded its normal useful life and should be planned/budgeted for replacement per current energy code, etc. requirements.

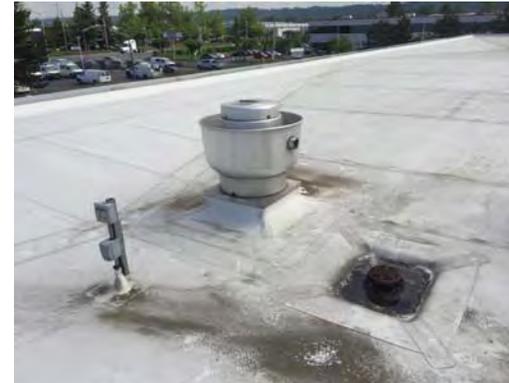
There are no provisions for roof overflow drainage

Add roof overflow drains and/or roof scuppers

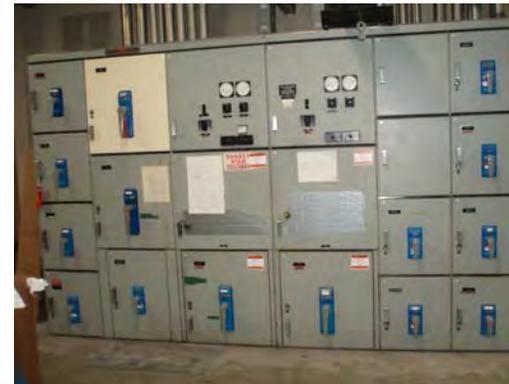
Wiring in motor control centers (MCC#1, #2, #3 and PDP#2) and two 500 kva stepdown transformers id original and should be replaced.

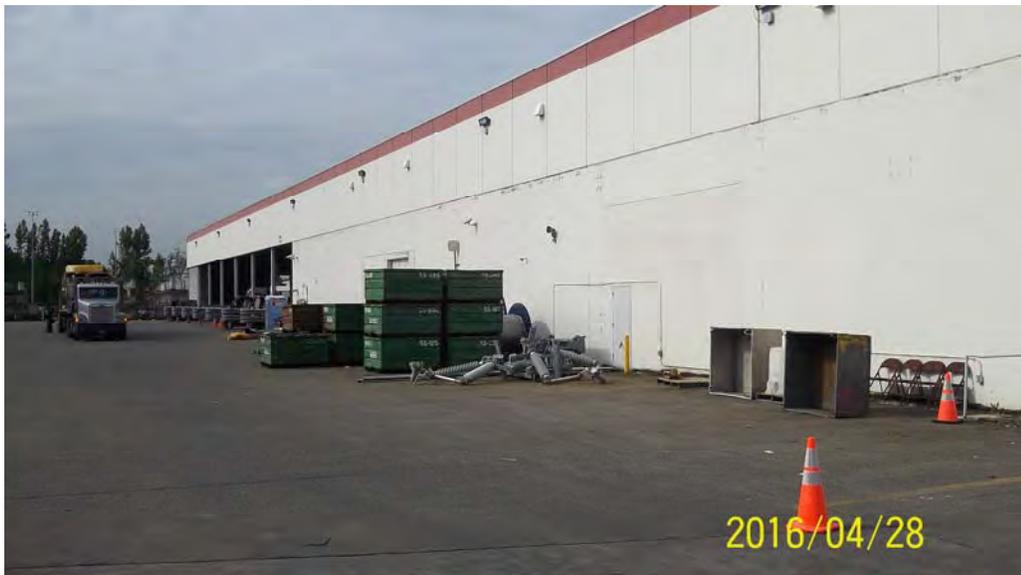
Photo 4: East Exterior Elevation – High Bay Warehouse
(Note: Infill masonry wall below concrete spandrel.)

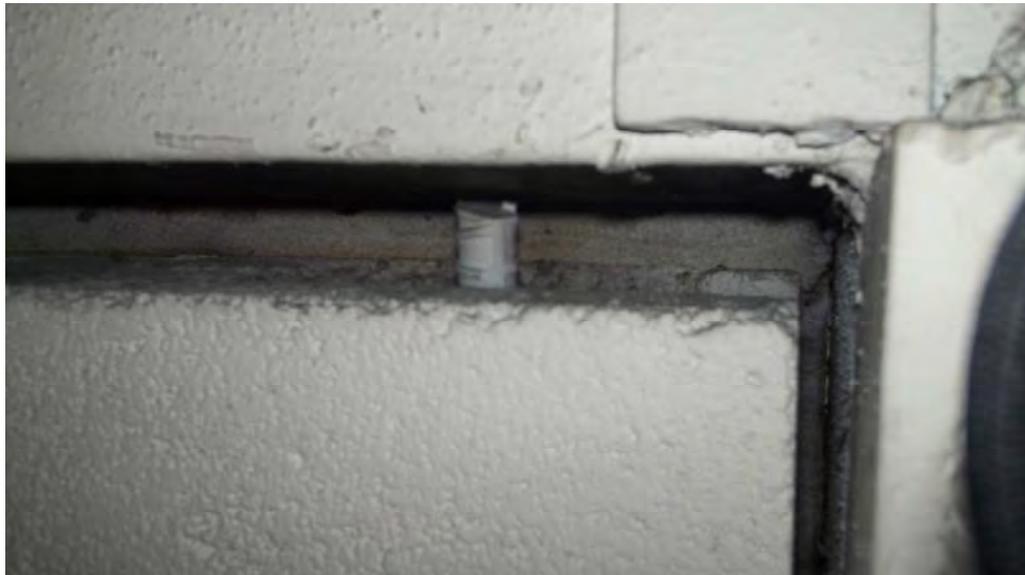
Photo 6: Concrete Spandrel to CMU Wall Interface
(Note: Lack of connection between the masonry below and the ledger angle above.)

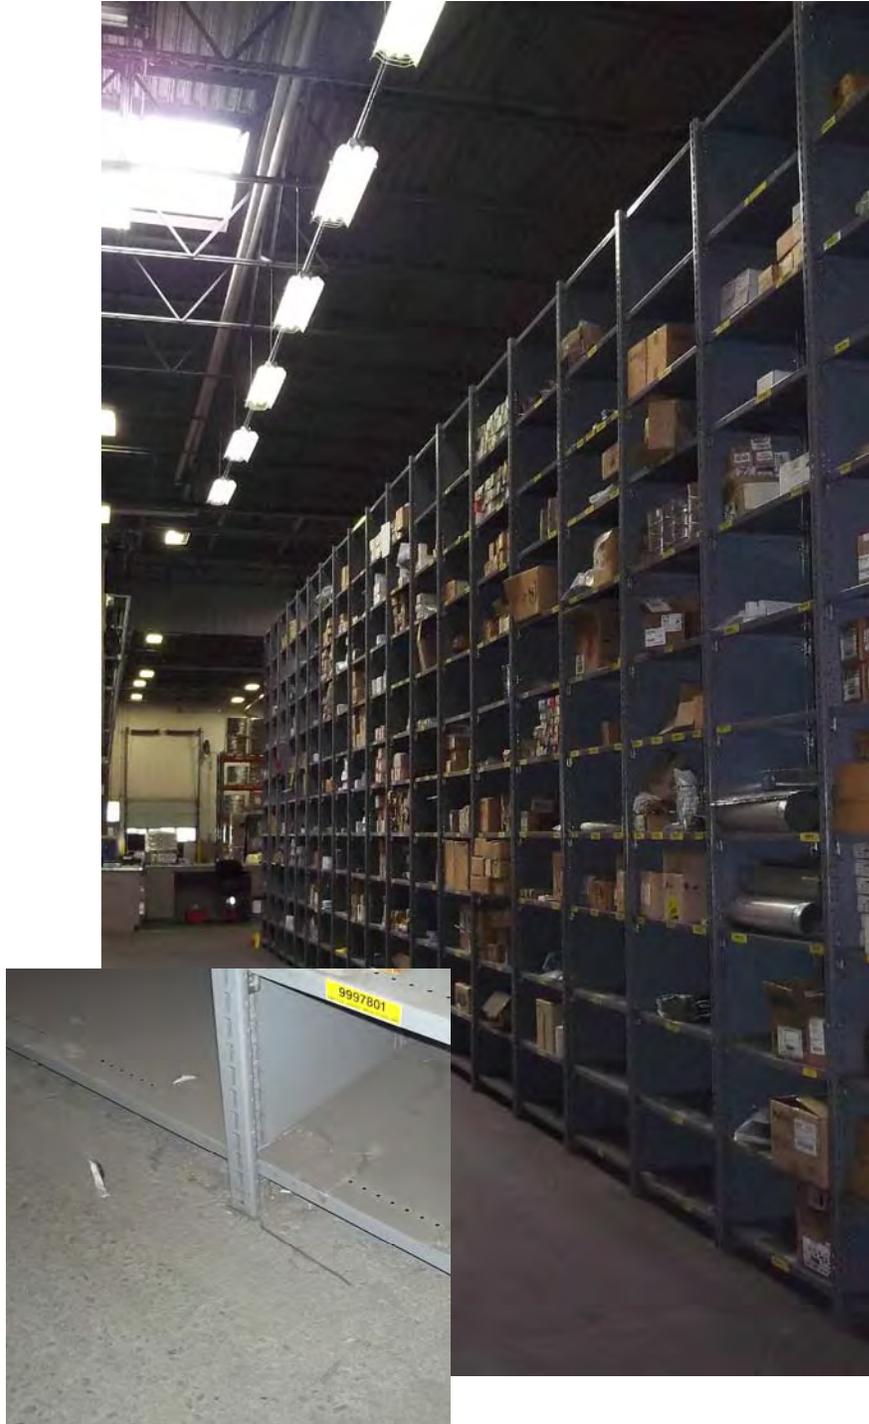
Photo 13: Tall Storage Racks w/ Minimal Base Connection

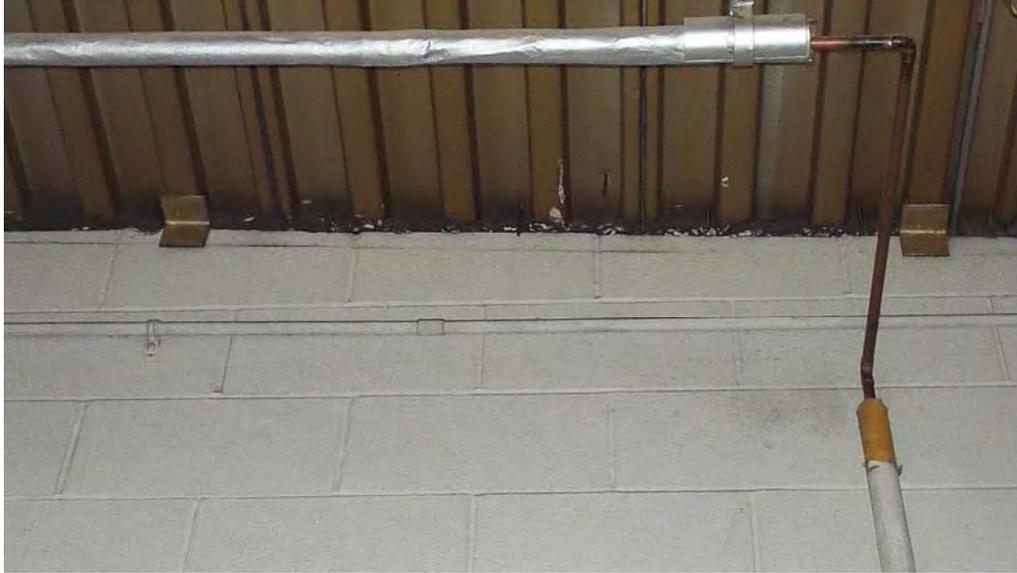
Photo 14: Minimal Clips at Top of Masonry Partition Walls

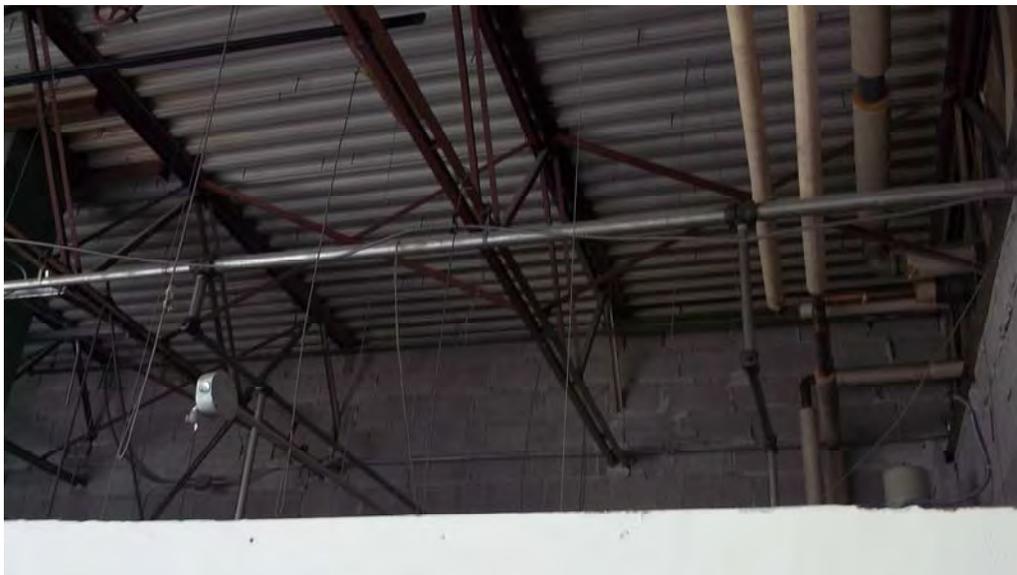
Photo 15: Masonry Partition Framed Around Joist
(Note: How the Masonry is grouted around the Joist,
potentially overstressing the Joist.)

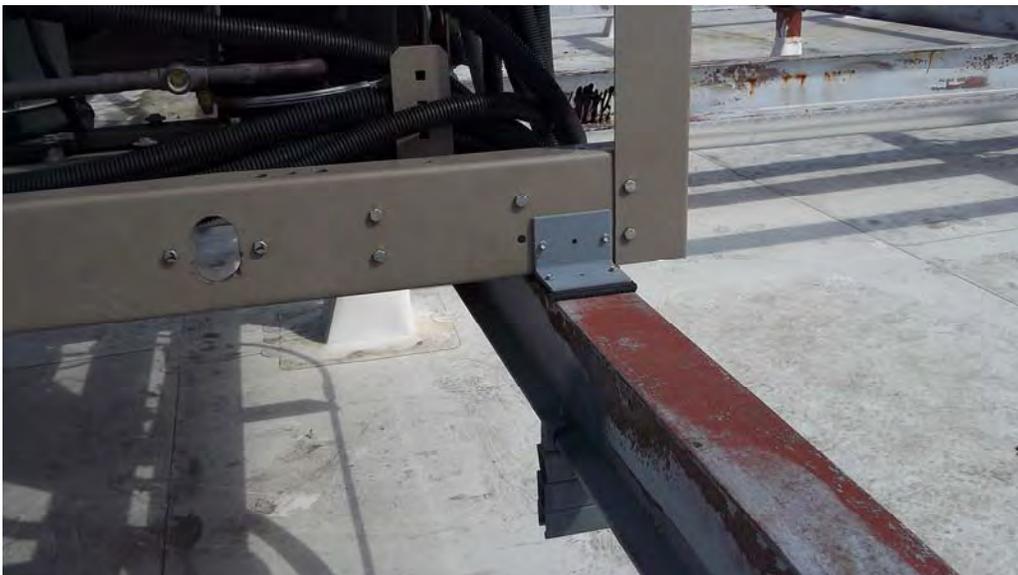
Photo 17: Minimal Equipment Connection

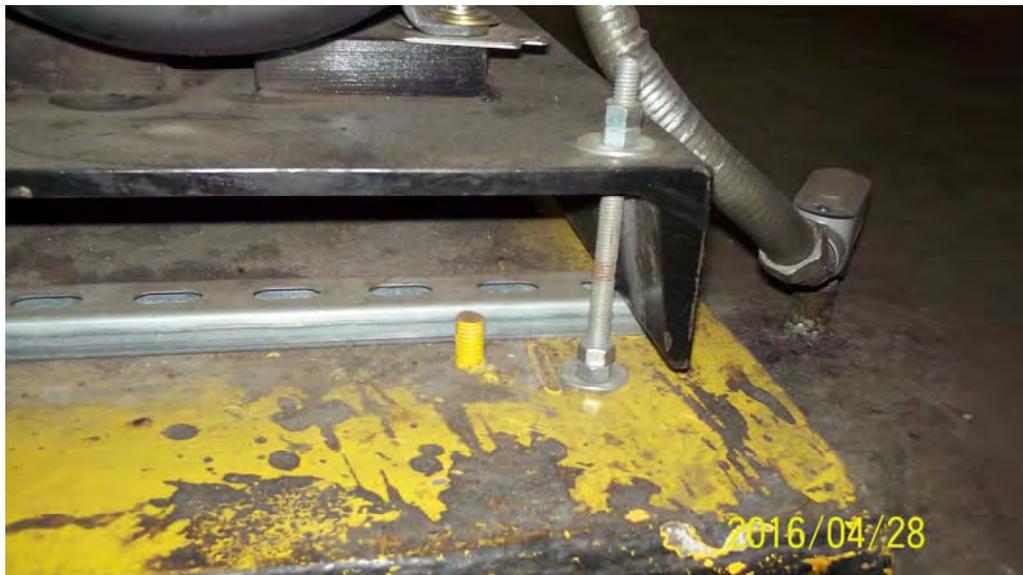
Photo 19: No apparent Lateral Connection of Pump to Base

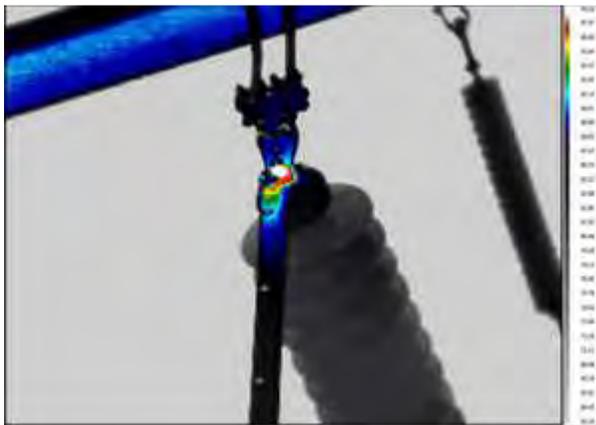
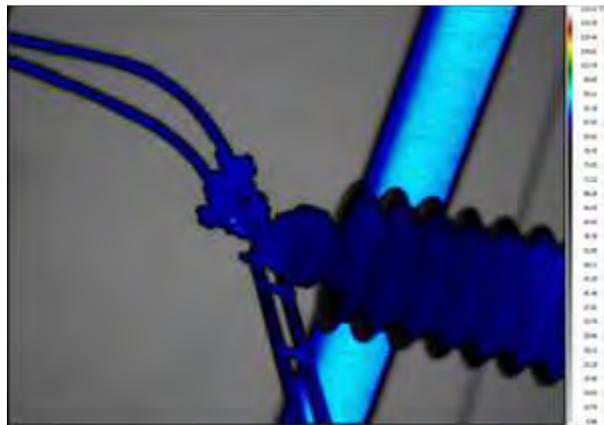
The heating on this outdoor utility switch is likely caused by resistance from a corroded or loose connection.

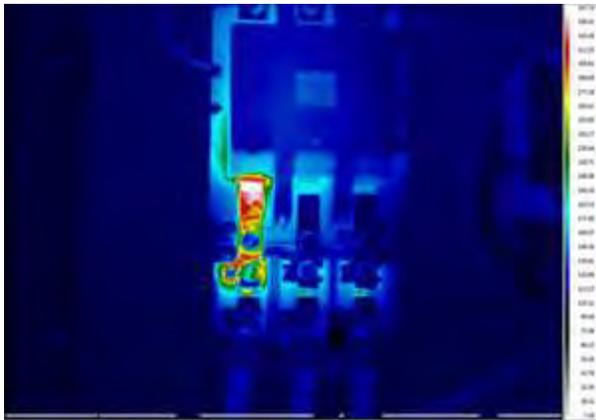
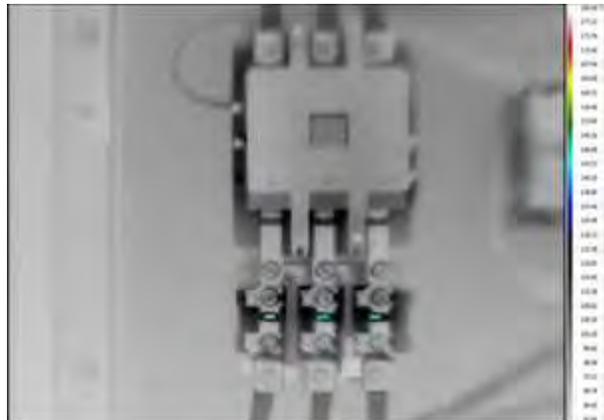
This heat signature suggests that an issue lies in the internal components of the contactor.
