Appendix E  
Revised Bank Assessment of Non-Point  
Source Consequences of Sediment at  
Siltronic Corporation Memorandum  
(January 27, 2022)

To: File Date: January 27, 2022

From: Michael R. Murray, RG, PE Project: 8128.02.04

RE: Revised Bank Assessment of Non-point Source Consequences of Sediment at Siltronic Corporation

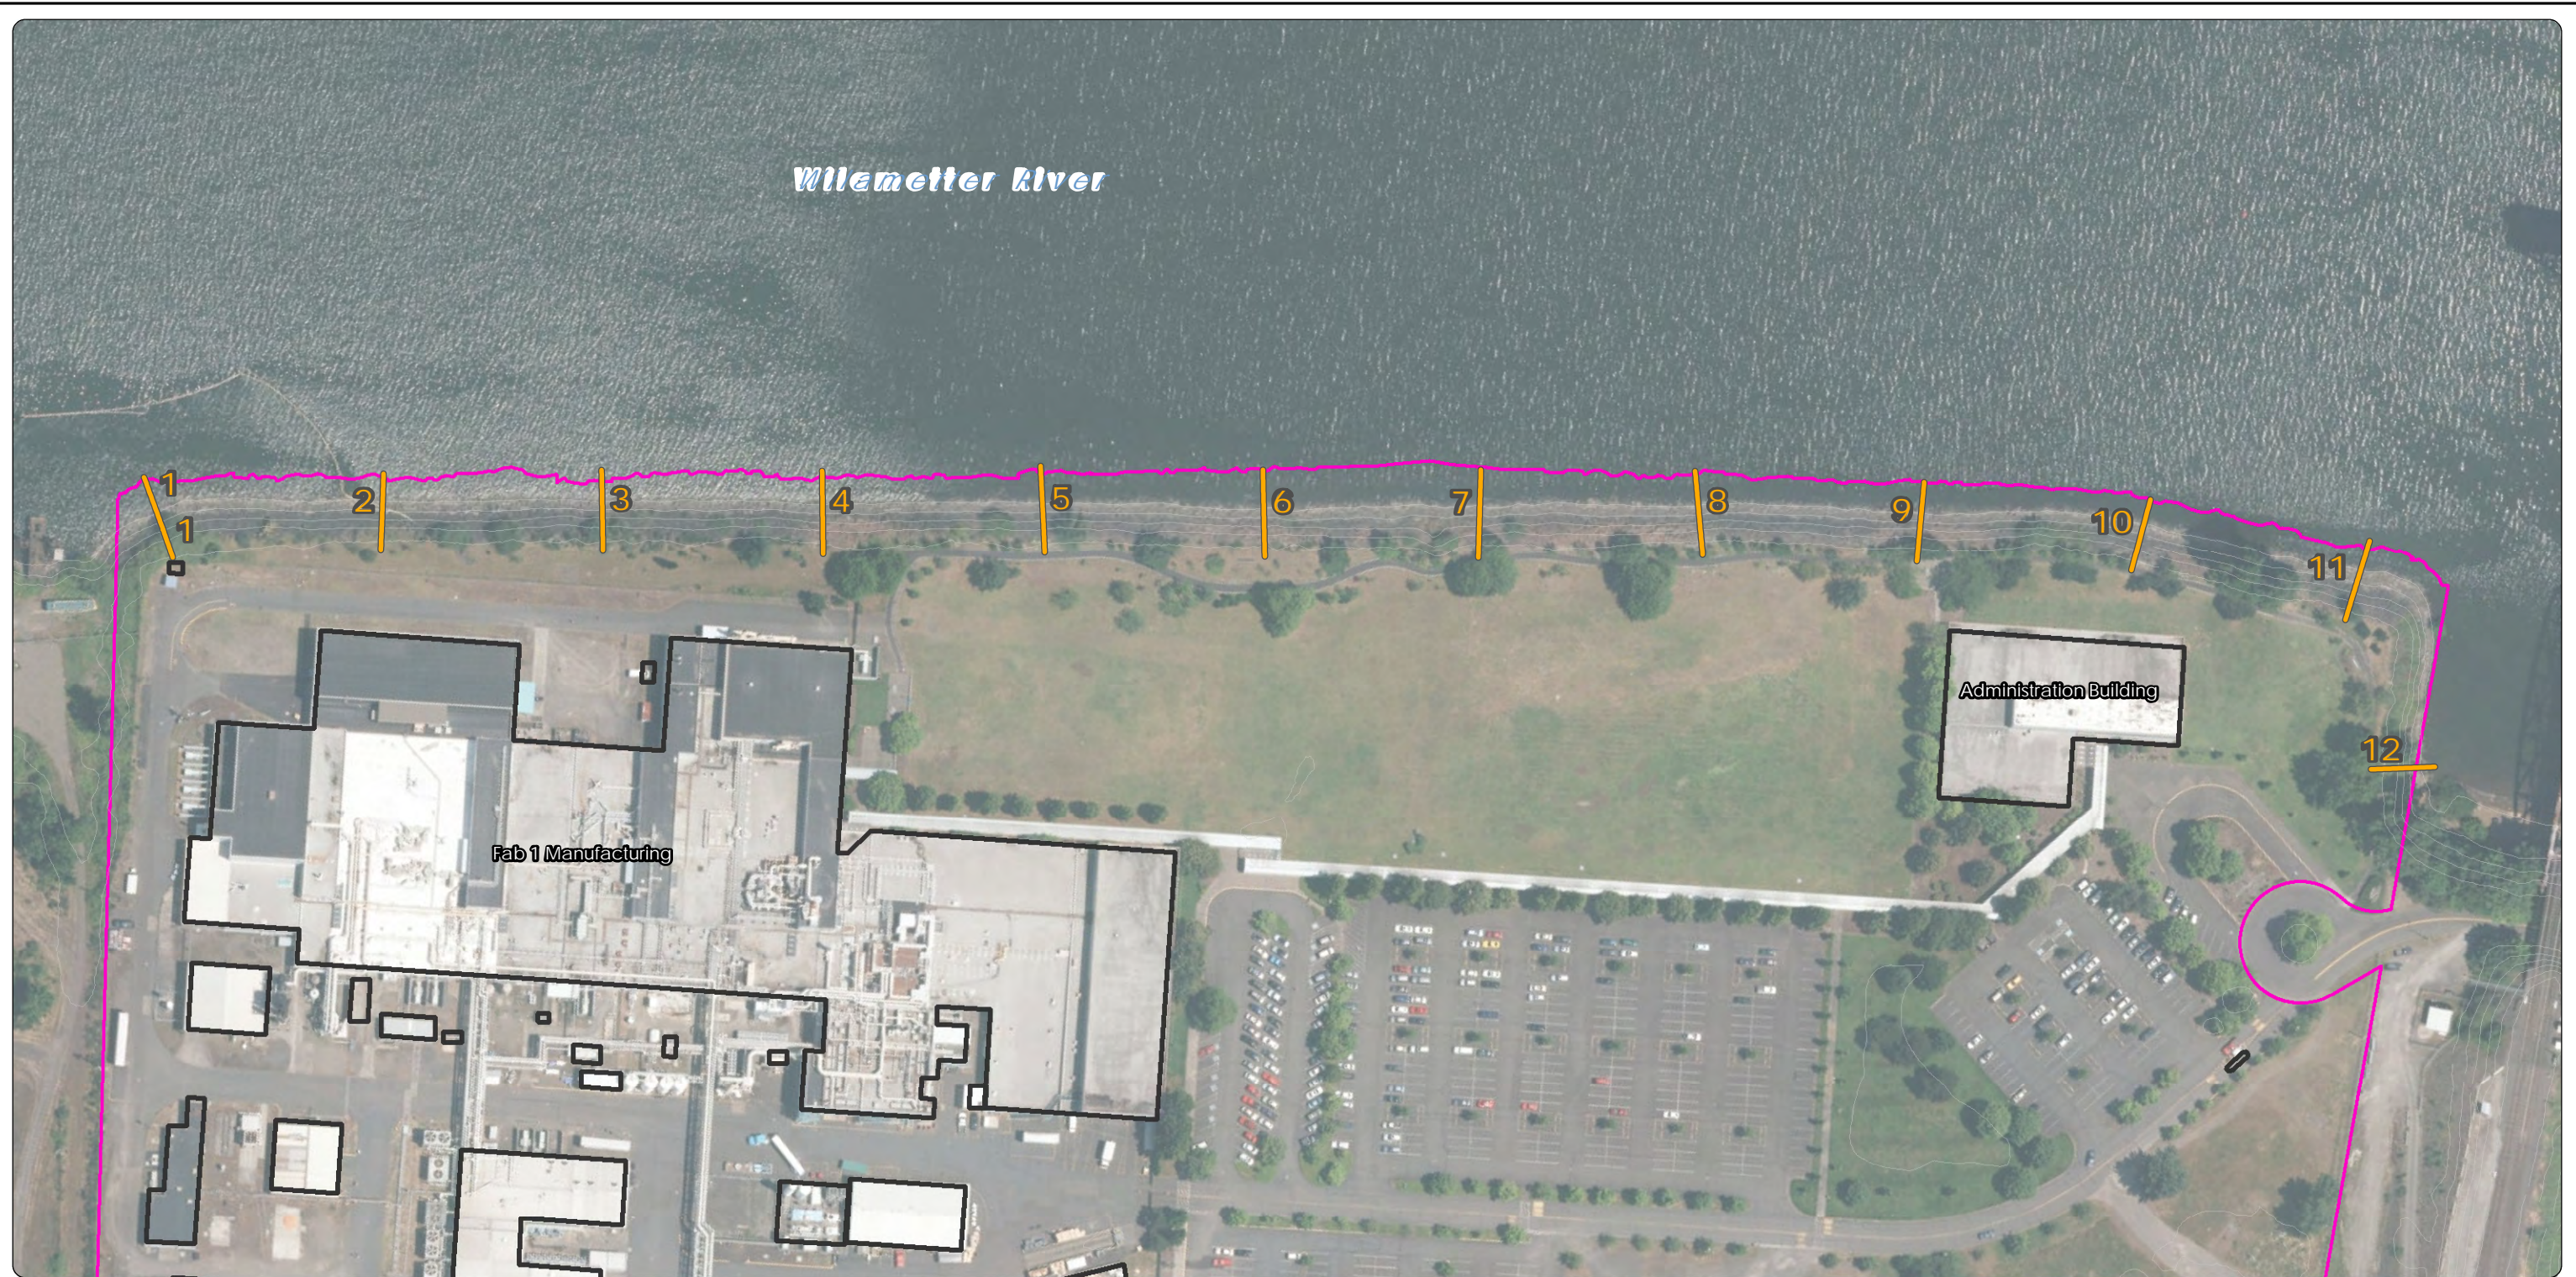
Figure 1  
Riverbank Transect Locations

The BEHI was assessed along 12 transects spaced at 200-foot intervals along the riverbank. Figure 1 shows the location of the 12 transects. The elevation profiles of transects 1 through 4, 5 through 8, and 9 through 12 are presented in Figures 2, 3, and 4, respectively. Representative photographs of the bank conditions are provided in Attachment 1.

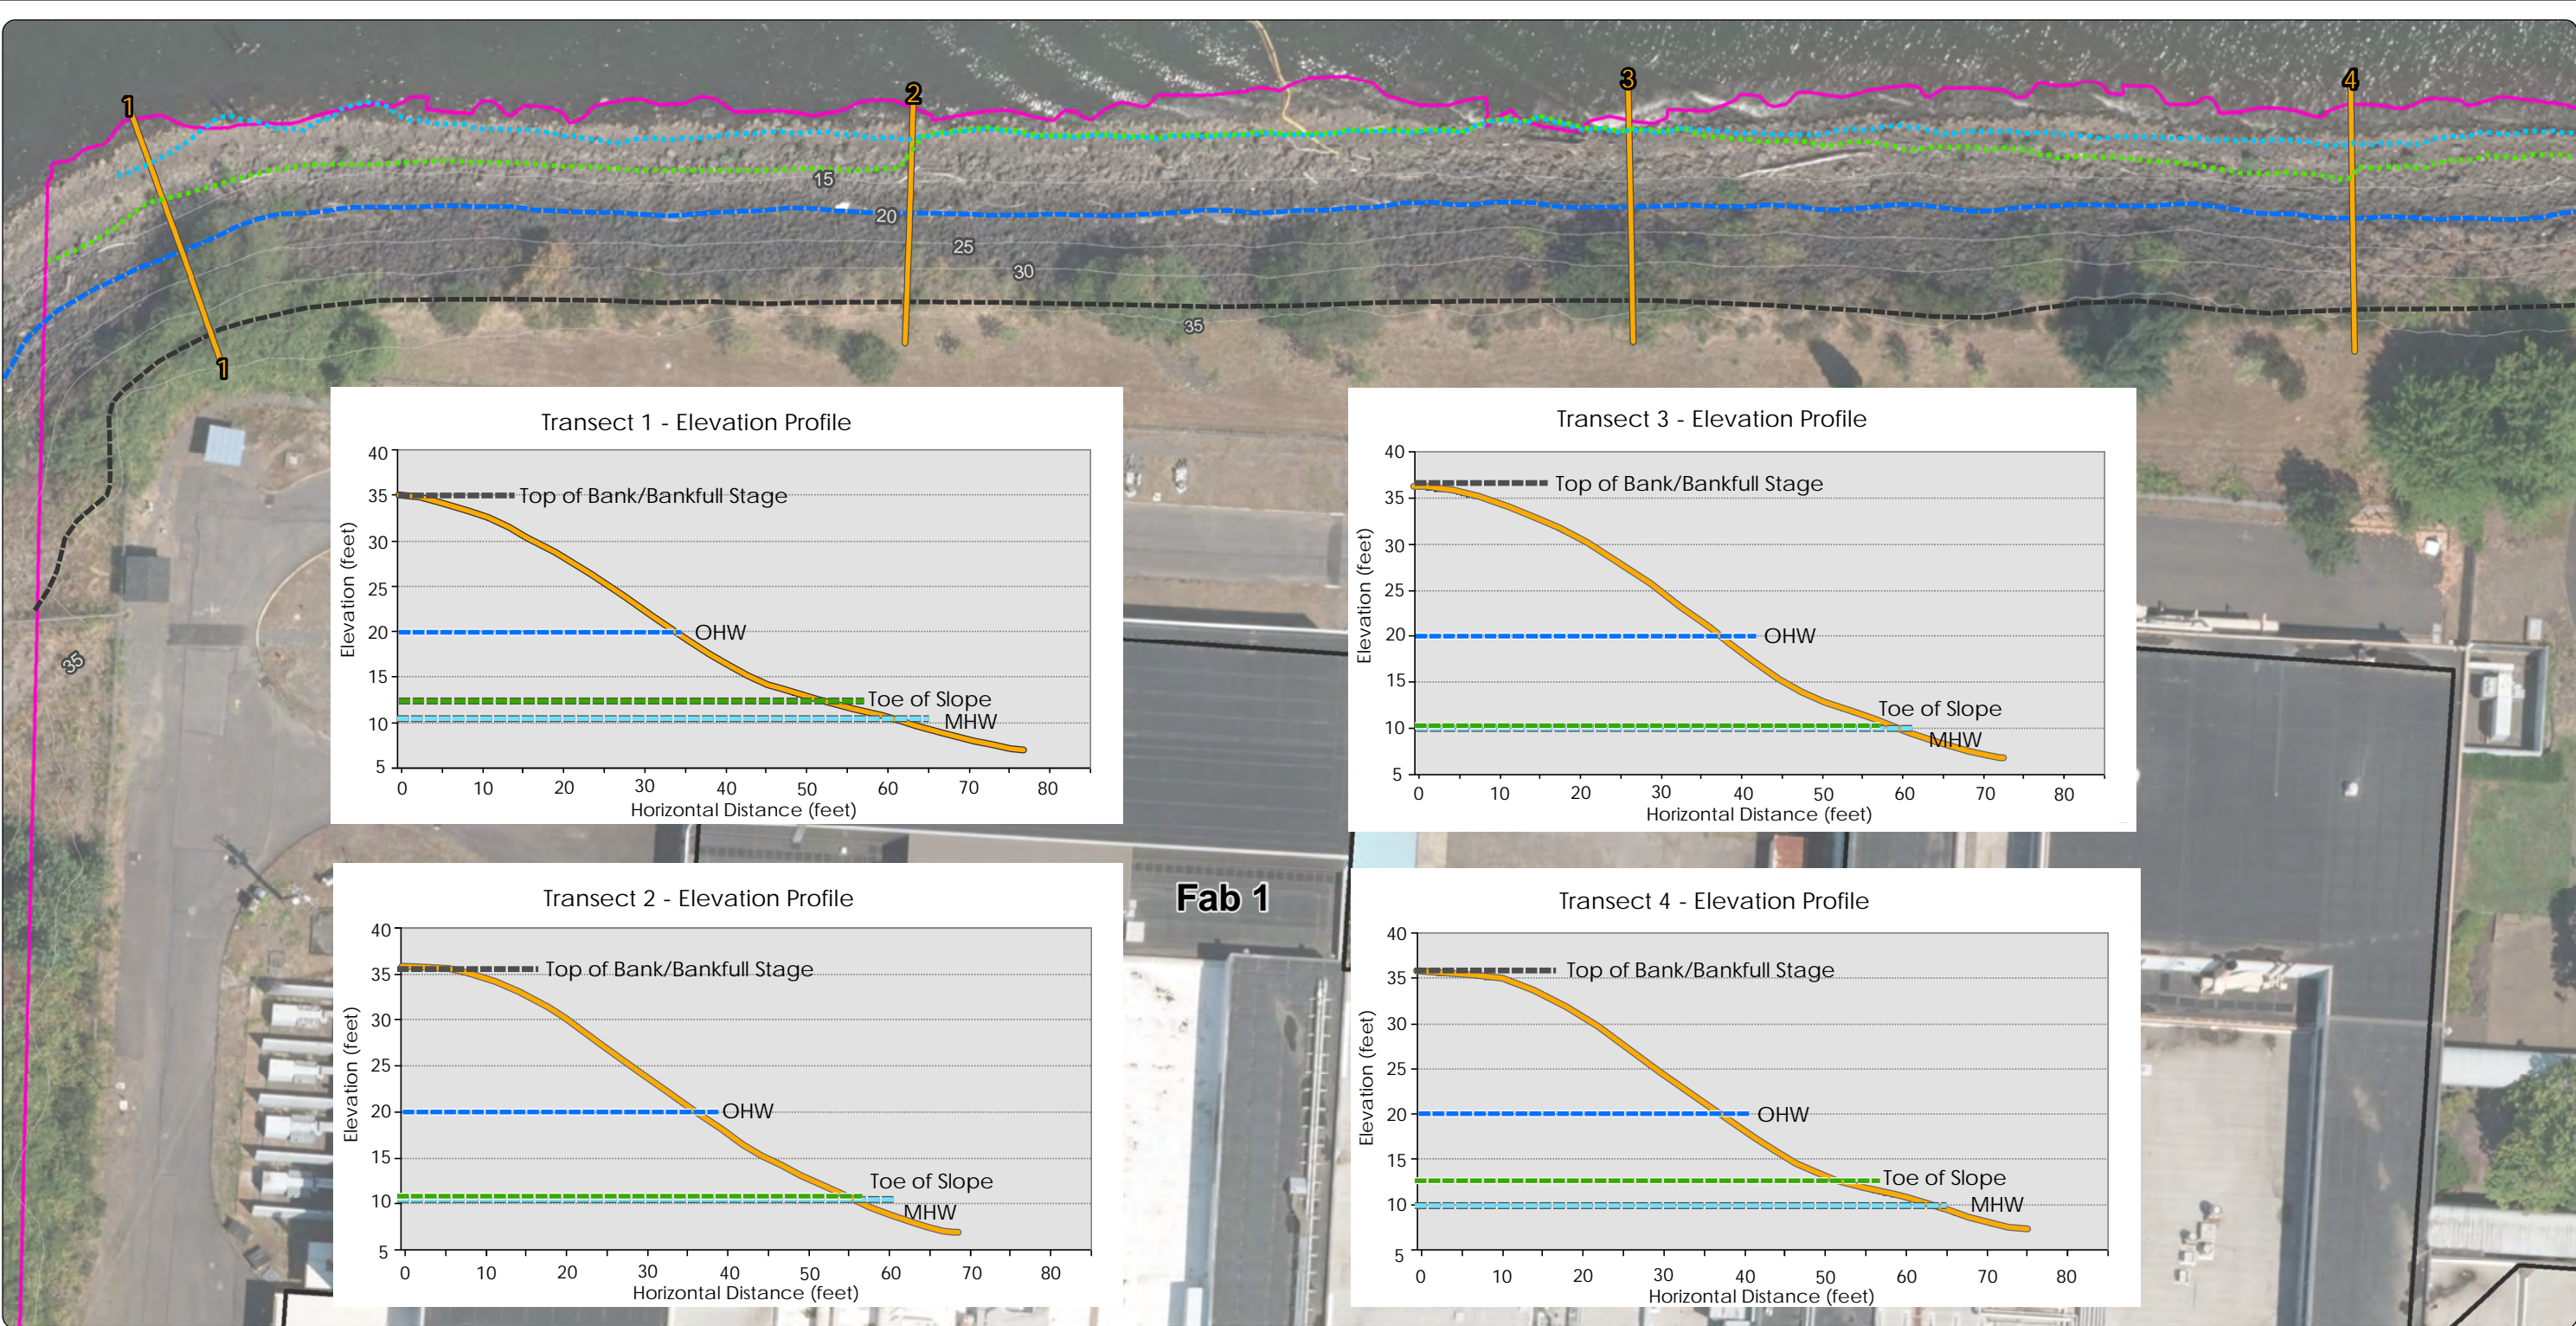
**Figure 2**  
 Riverbank Transects 1 - 4  
 Siltronic Corporation  
 Portland, Oregon

Bank angle is the angle of the bank from the top of bank elevation to the toe of slope elevation. Bank angle was calculated at each transect using the elevation profile of the bank (Figures 2 through 4).

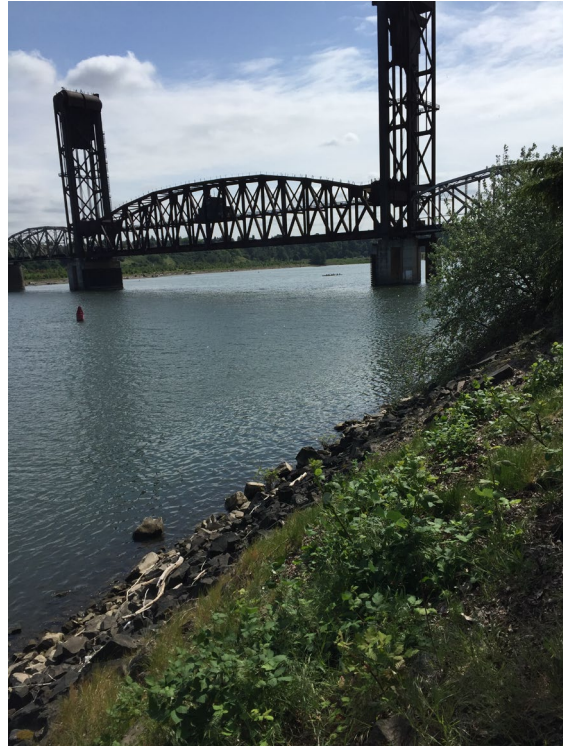
1

Looking southeast on top  
of bank near Transect #9.

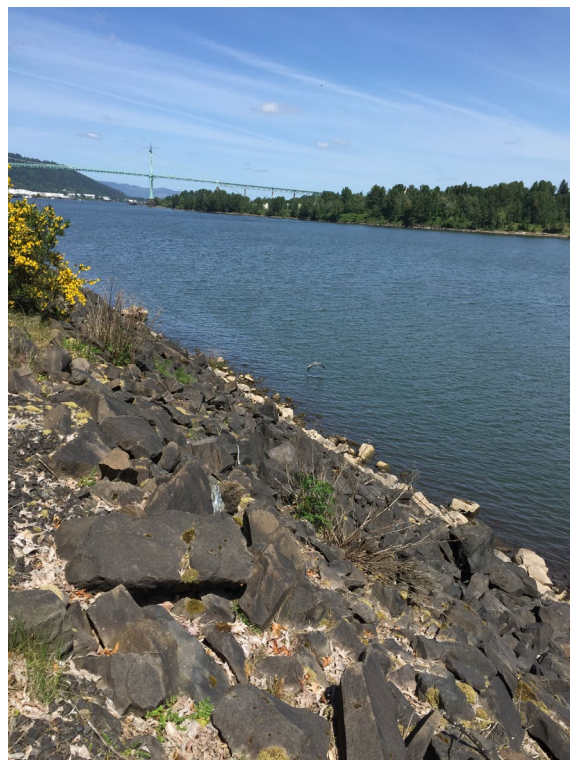
2

Looking northeast on top  
of bank near Transect #4.

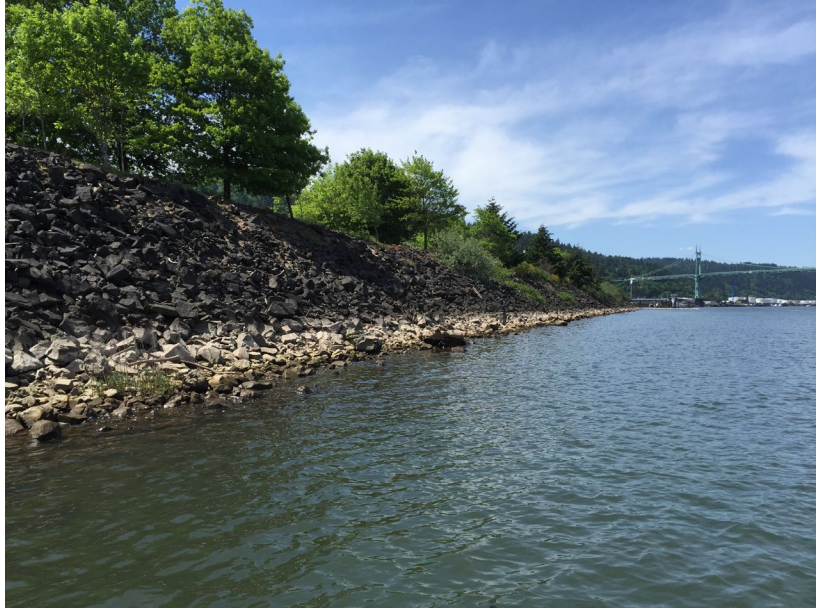
3

Looking northwest from  
water of Transect #10.

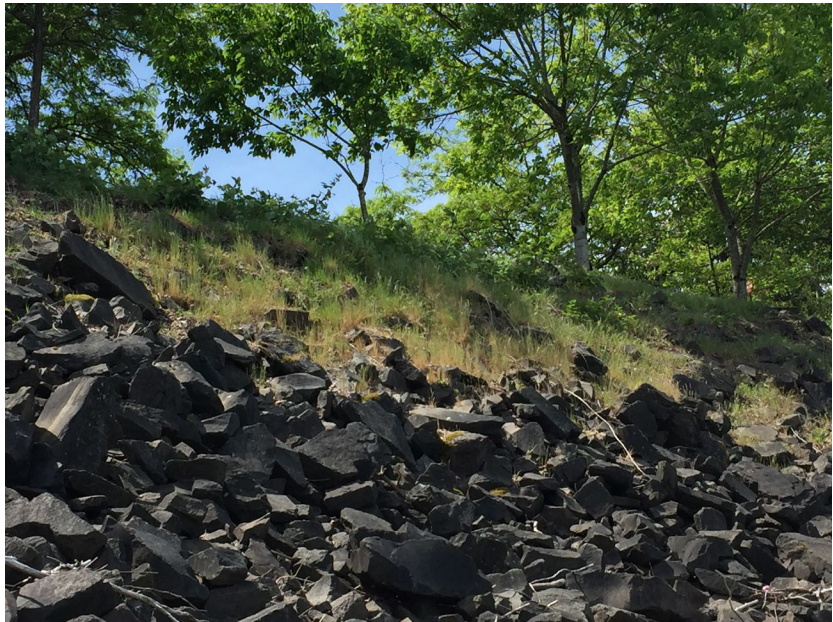
4

Trees on top of bank, looking west  
at Transect #10 from water.

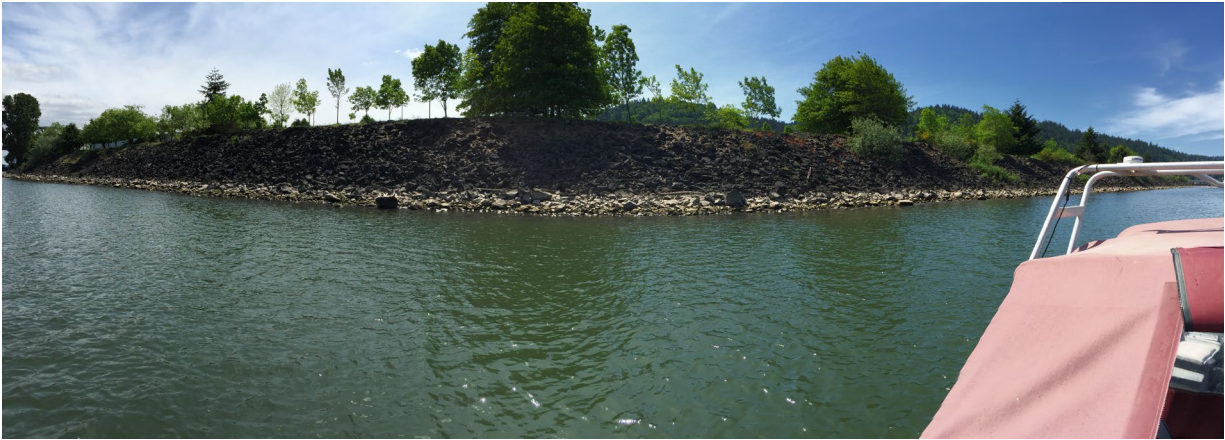
5

Panoramic view of bank.

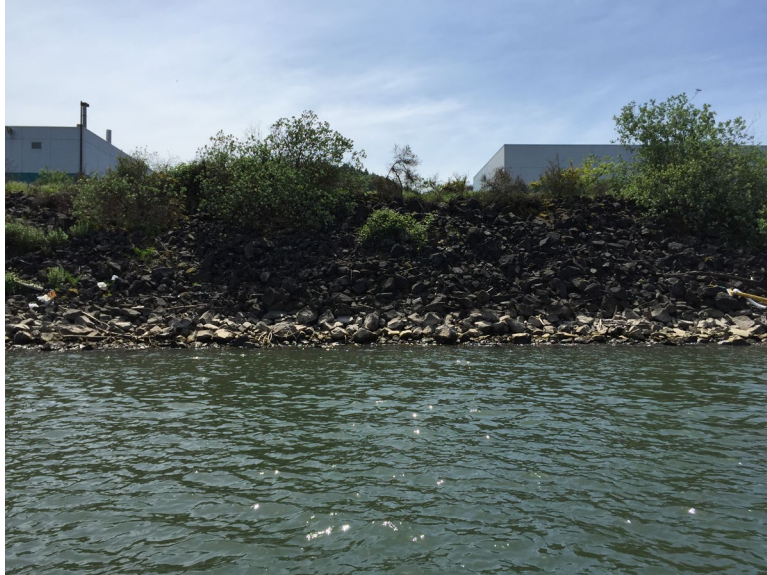
6

Looking west at Transect #3 from water.

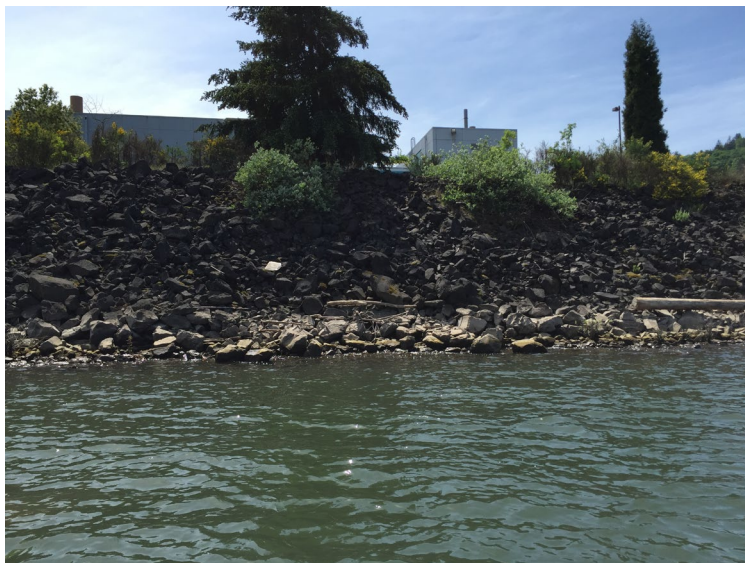
7

Looking west at Transect #5 from water.

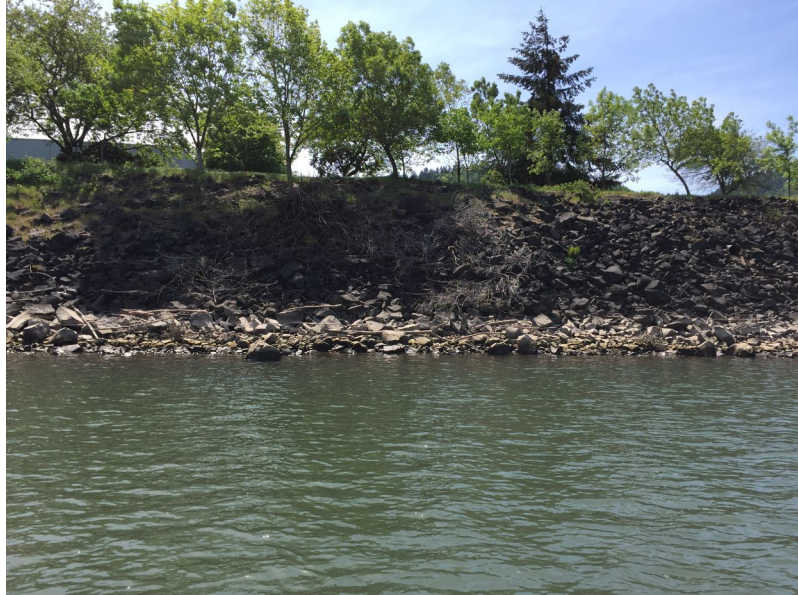
8

Looking west at Transect #9 from water.

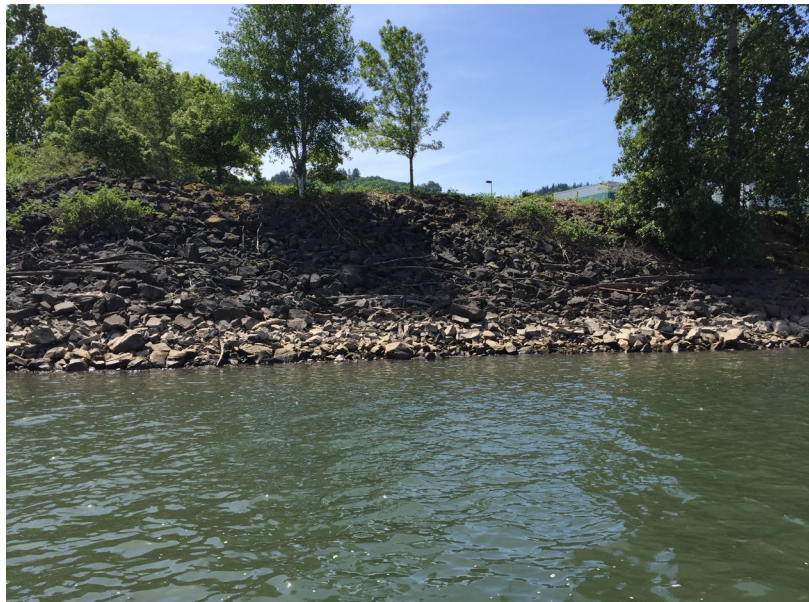
9

Looking west at Transect #11 from water.

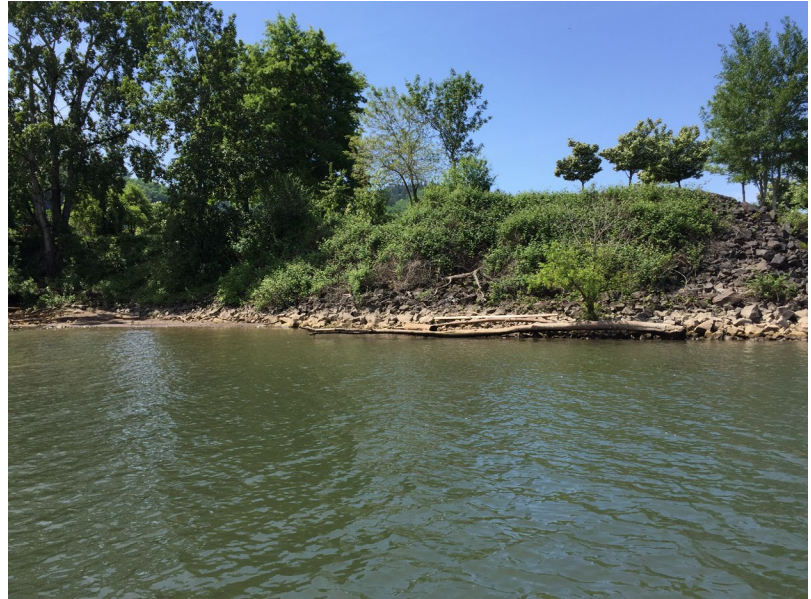
10

Looking west at Transect #12 from water.
