EXHIBIT F
SEAL Laboratories – Final Report (February 16, 2012)

RE: Puget Sound Energy- Ingham Fire
SEAL Job No. 21151.

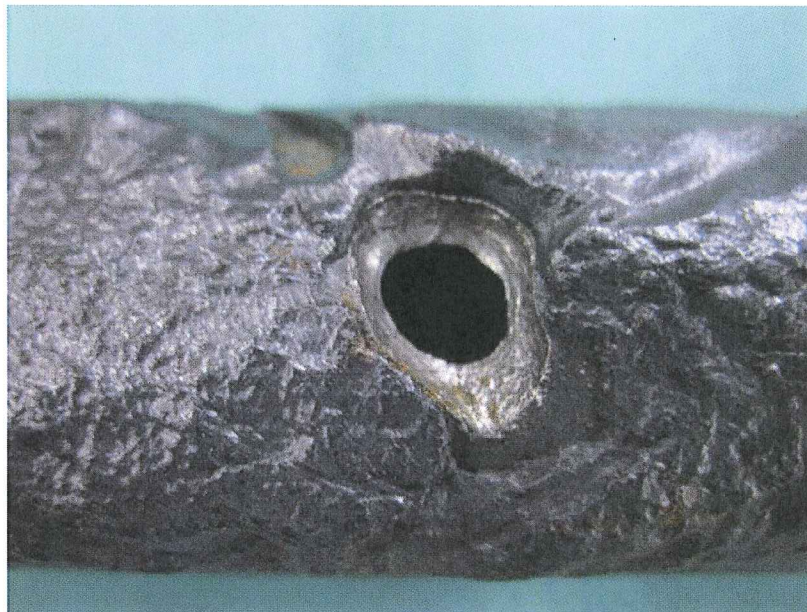
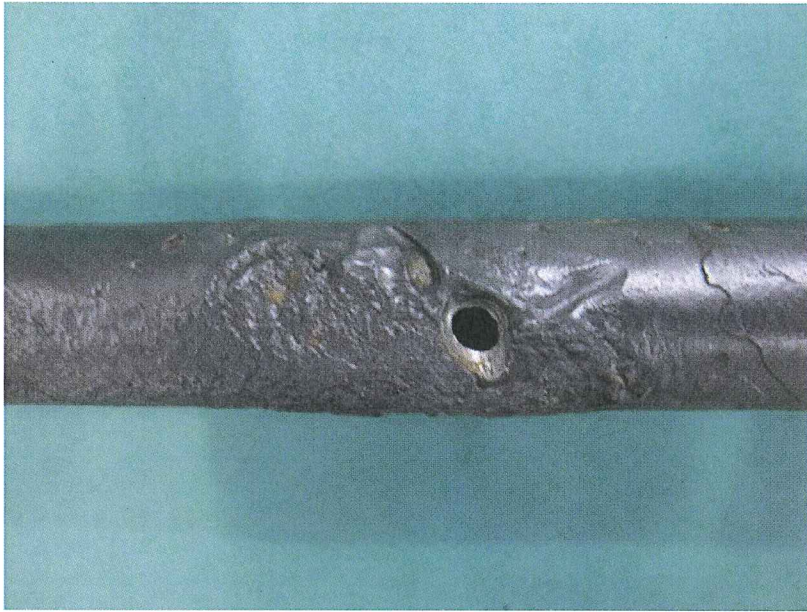
This pipe section was collected by Infrasource on 9-26-11, as evidenced by the tag attached to the rapped pipe section; Figure 1. The gas service line pipe was made from steel, was 42 inches long with 1.2 inch outer diameter and wall thickness of 0.11 inch. The pipe contained a slightly oval hole with major and minor diameters as 0.3 inch and 0.22 inch; Figures 2 and 3. The surface coating on the pipe had melted. A section of the pipe was cut containing ¼ of the hole wall, as shown in Figure 4. The removed section contained the ¼ hole in a corner and is shown from the inner diameter (ID) and outer diameter (OD) side in Figure 5. The hole was clearly created from OD toward the ID, as seen by the missing material at the hole wall. The hole surface appeared smooth with no fracture features; Figure 6.

Figure 2. Detailed color photographs showing a hole in the gas line from 12040 8th Avenue NE.

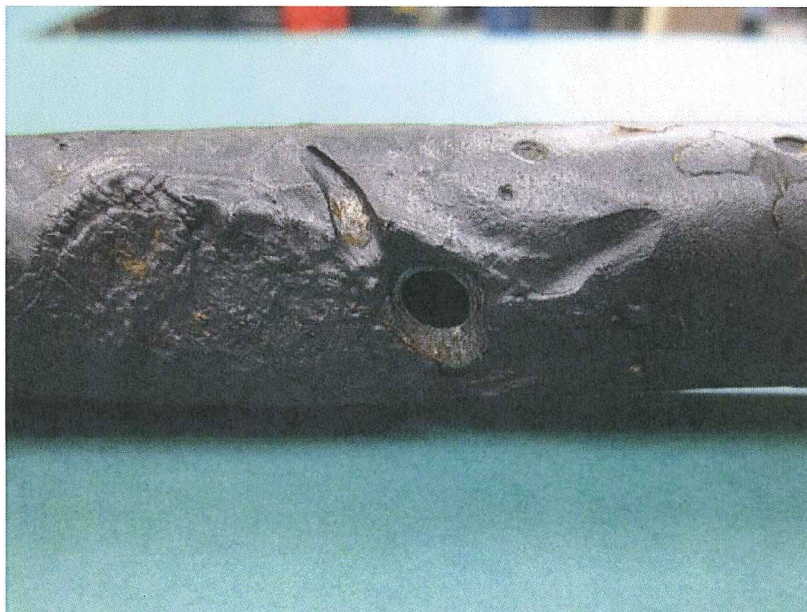
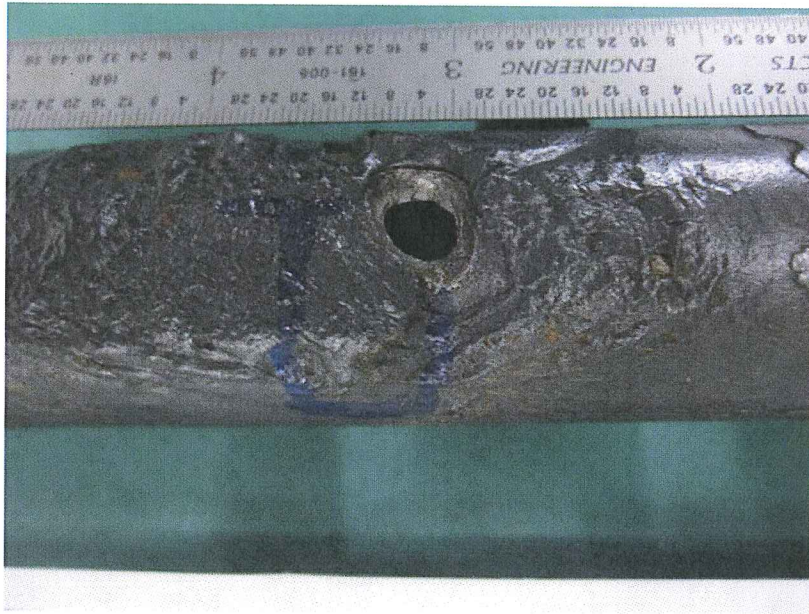
Figure 3. Detailed color photographs showing the hole in the gas line from 12040 8th Avenue NE. The surface coating is melted around the hole.

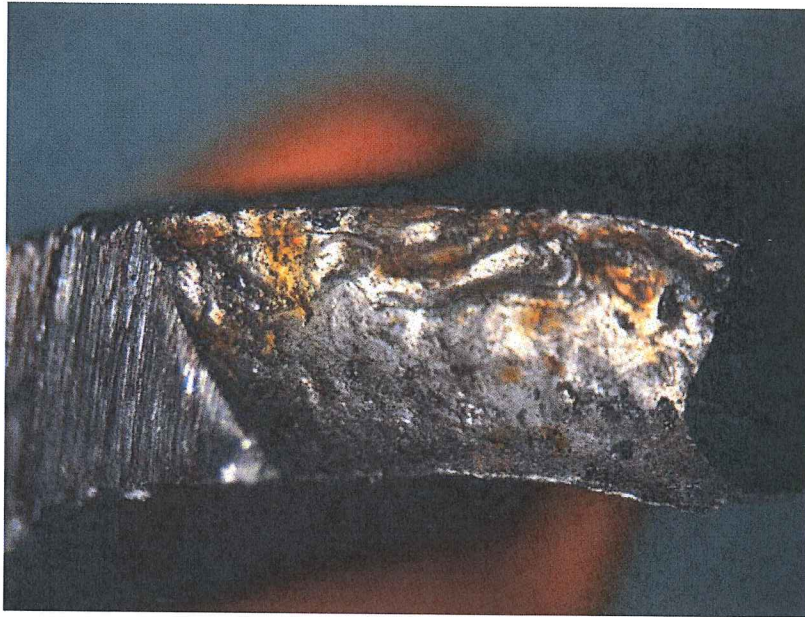
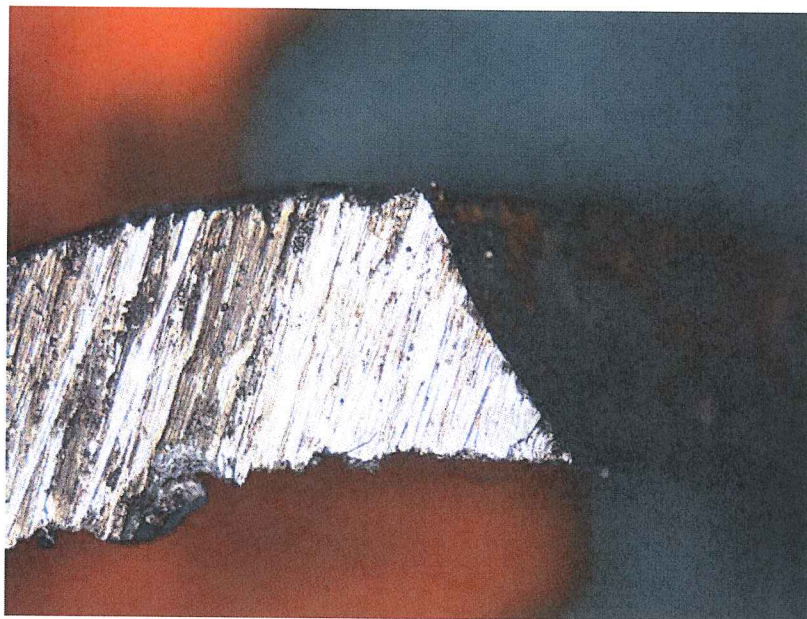
Figure 6. Detailed color photographs showing the hole surface and the hole profile of the section removed from the gas line from 12040 8th Avenue NE. (a) Hole surface, 20X; (b) Hole Profile with OD on top of photo, 20X.

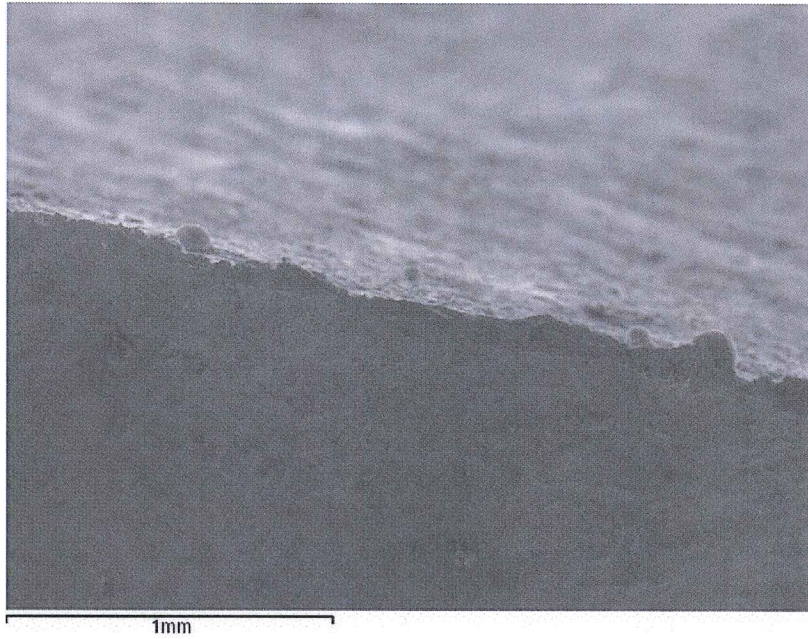
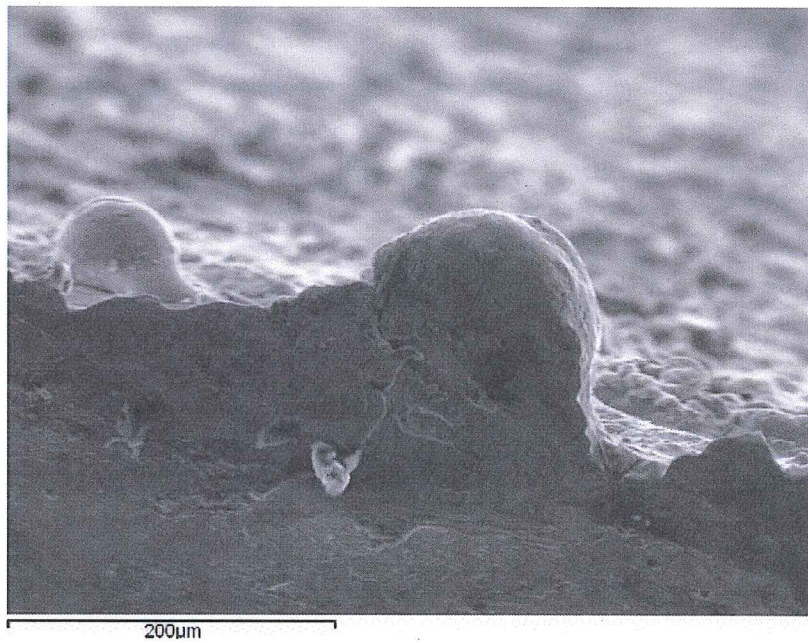
Scanning Electron Microscope (SEM) examination of the hole surface at ID transition revealed melted globules of steel, indicating melting by electrical arcing forming the hole; Figure 7. Energy dispersive X-ray (EDX) analysis of the pipe material indicated a plain carbon steel.

Figure 7. Detailed SEM micrographs showing the hole surface at ID transition from the section removed from the gas line from 12040 8th Avenue NE. (a) ID surface, 50X; (b) ID surface, 250X.

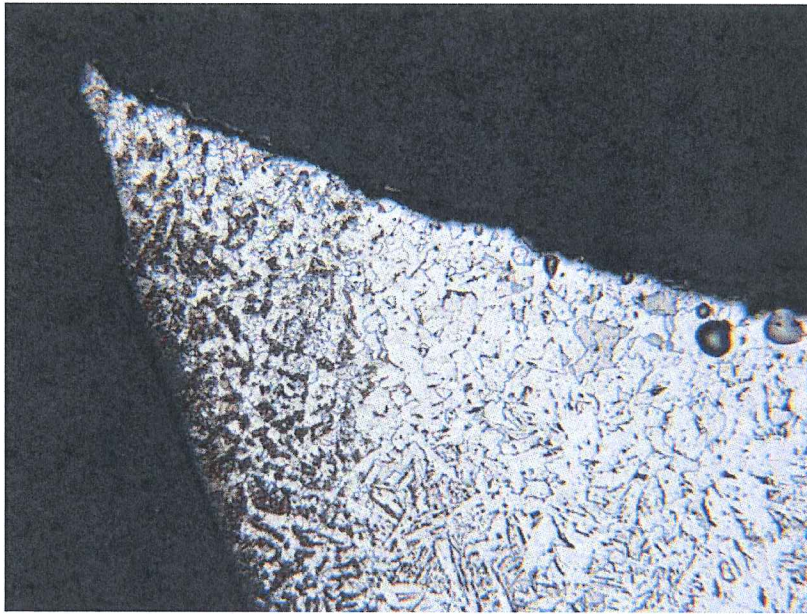
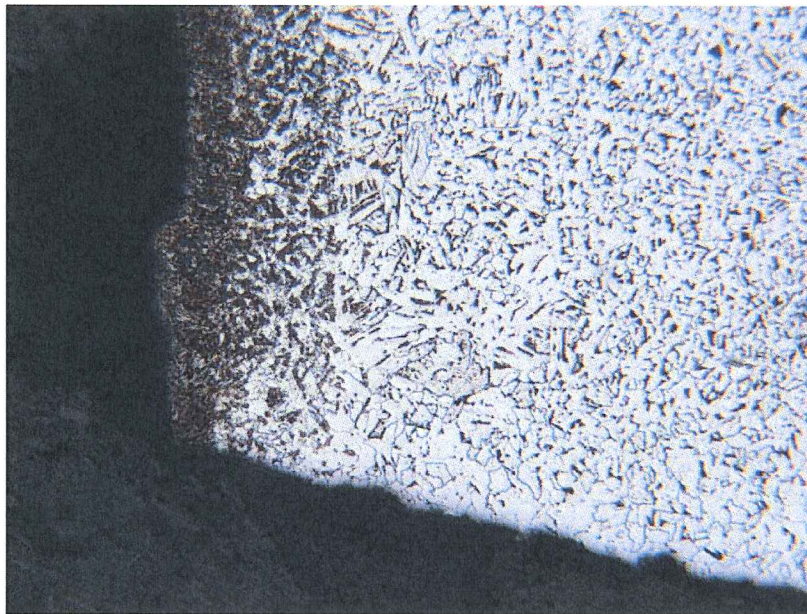
A metallographic mount was made with the hole wall in cross section. The mount was ground, polished and etched using standard metallographic procedures. The etched mount was examined using an optical microscope and the micrographs are presented in Figures 8-11. The surface of the hole from ID to OD revealed an altered microstructure due to melting and re-solidification of the surface; Figures 8-10. The hole surface also revealed a small void; Figure 10(a). The general microstructure of the steel indicates a low to medium carbon steel; Figure 11.

Figure 8. Detailed optical micrographs showing the hole surface in cross section of the sample removed from the gas line from 12040 8th Avenue NE. (a) ID surface, etched, 50X; (b) OD surface, etched, 50X.

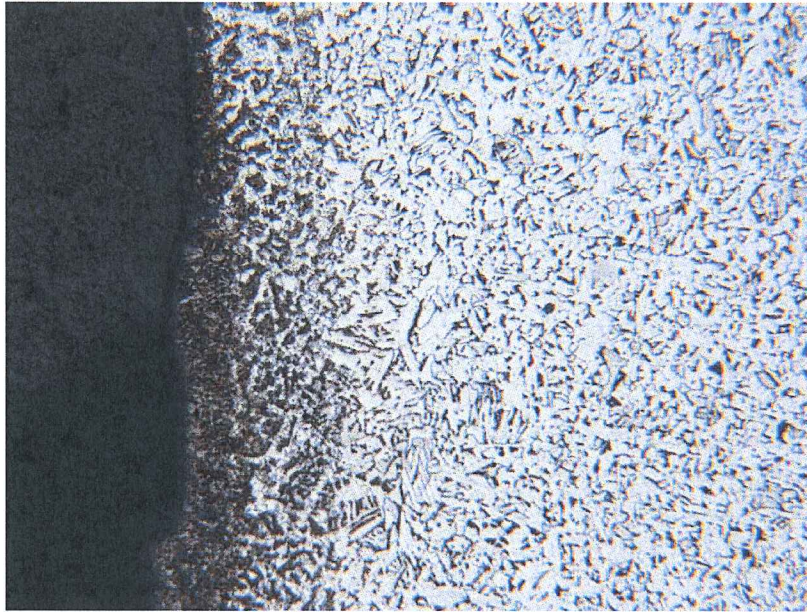
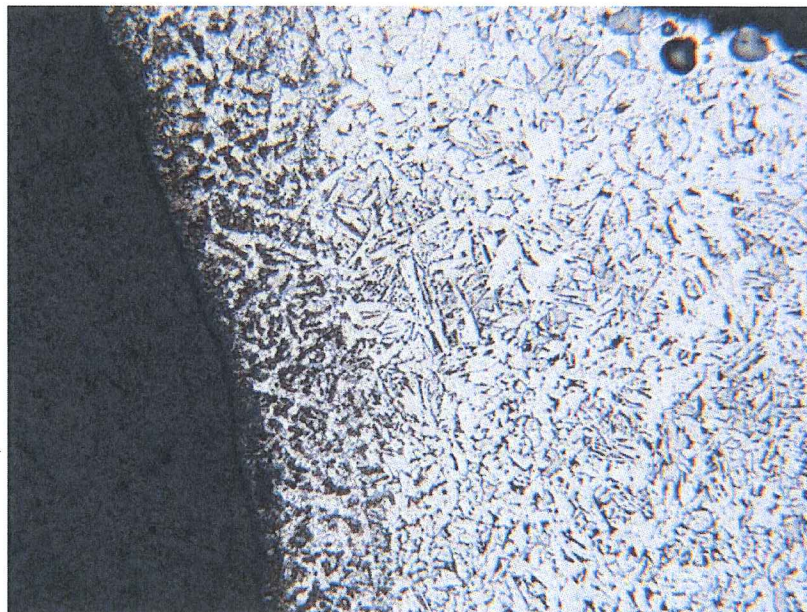
Figure 9. Detailed optical micrographs showing the hole surface in cross section of the sample removed from the gas line from 12040 8th Avenue NE. (a) Near OD surface, etched, 50X; (b) Away from OD surface, etched, 50X.

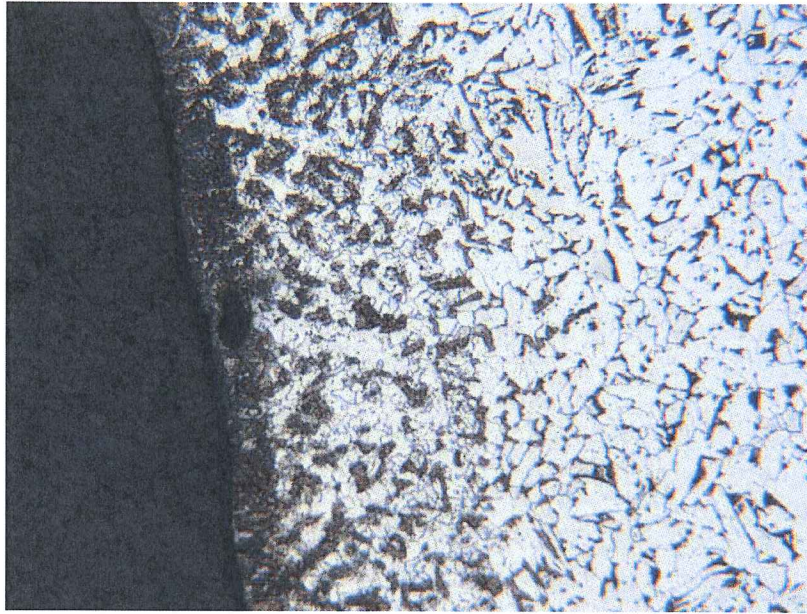
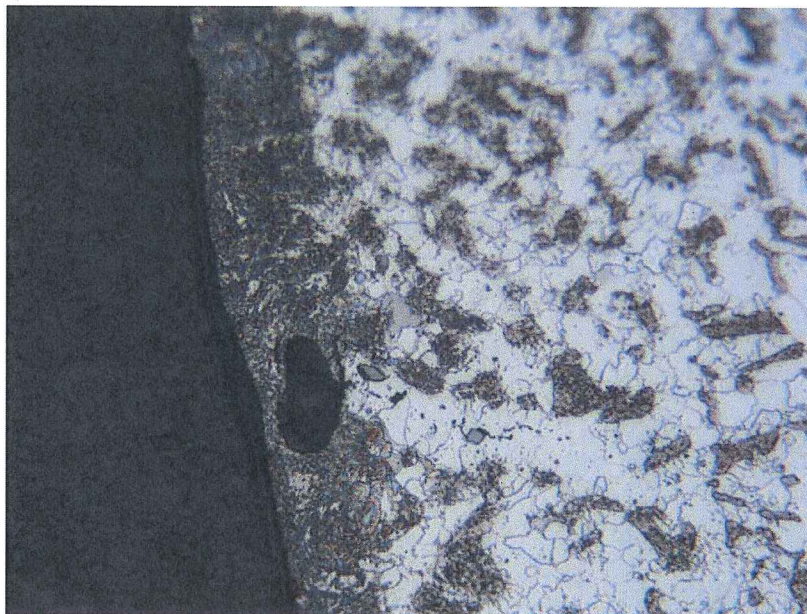
Figure 10. Detailed optical micrographs showing the hole surface in cross section of the sample removed from the gas line from 12040 8th Avenue NE. (a) Midway between OD and ID, etched, 100X; (b) Midway between OD and ID surface at void, etched, 200X.

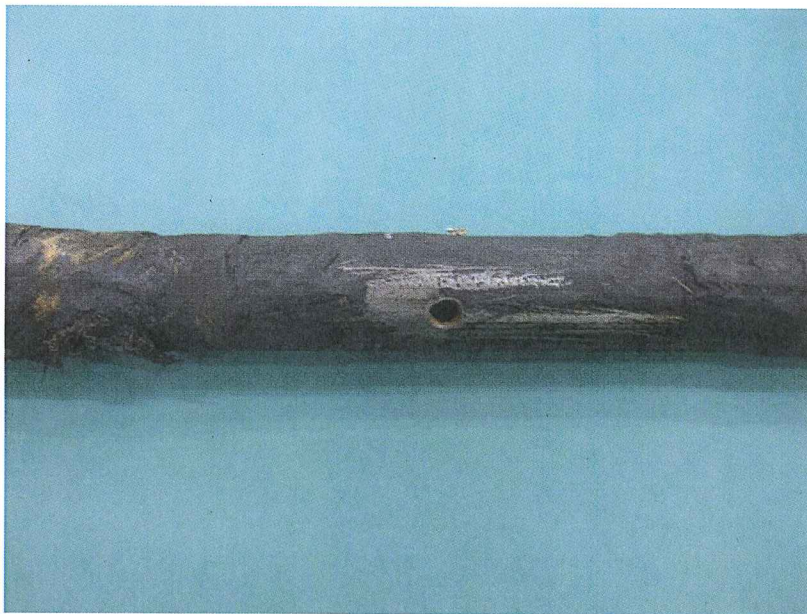
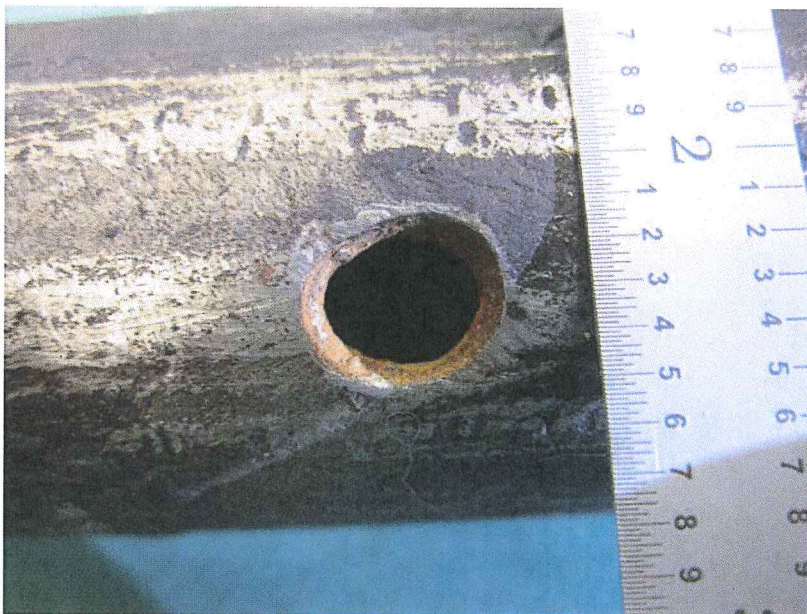
This pipe section was collected by Infrasource on 9-27-11, as evidenced by the tag attached to the pipe section; Figure 12. The gas service line pipe was made from steel, was 53 inches long with 1.69 inch outer diameter and wall thickness of 0.135 inch. The pipe contained a slightly oval hole with major and minor diameters as 0.48 inch and 0.40 inch; Figure 13. A section of the pipe was cut containing $\frac{1}{4}$ of the hole wall, as shown in Figure 14. The removed section contained the $\frac{1}{4}$ hole in a corner and is shown from the ID and OD side in Figure 15. The hole was clearly created from OD toward the ID, as seen by the missing material at the hole wall. The hole surface appeared smooth with no fracture features and re-solidified surface; Figure 16.

Figure 13. Detailed color photographs showing a hole in the gas line from 913 NE 122nd Street.

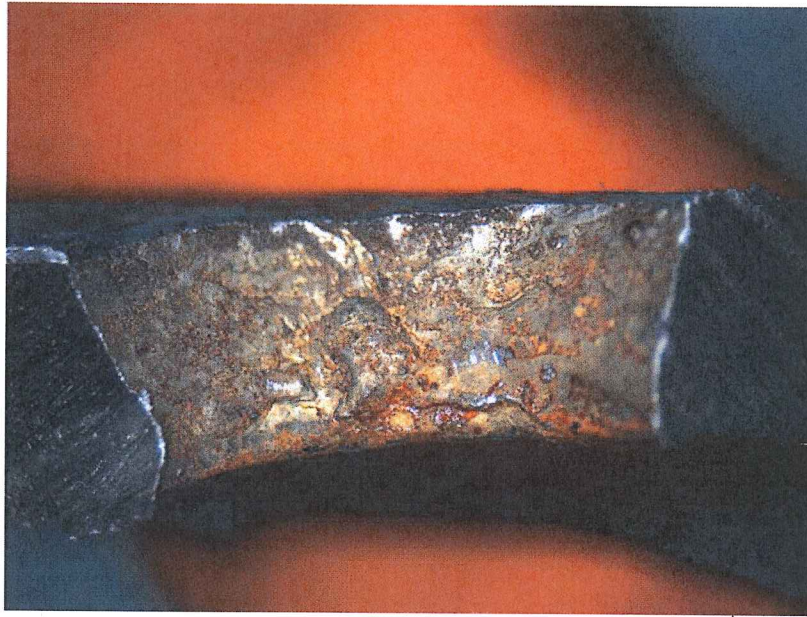
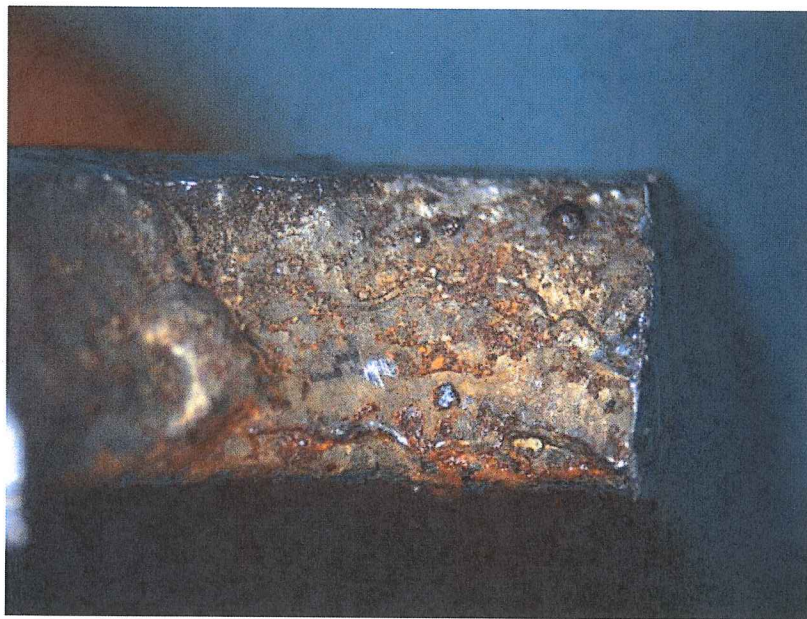
Figure 16. Detailed color photographs showing the hole surface of the section removed from the gas line from 913 NE 122nd Street. (a) Hole surface, 15X; (b) Hole Surface, 20X.

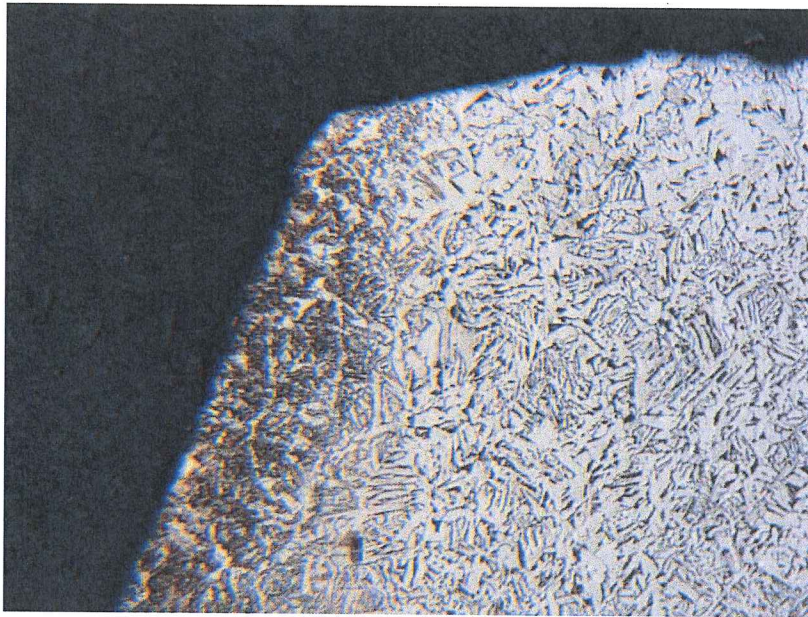
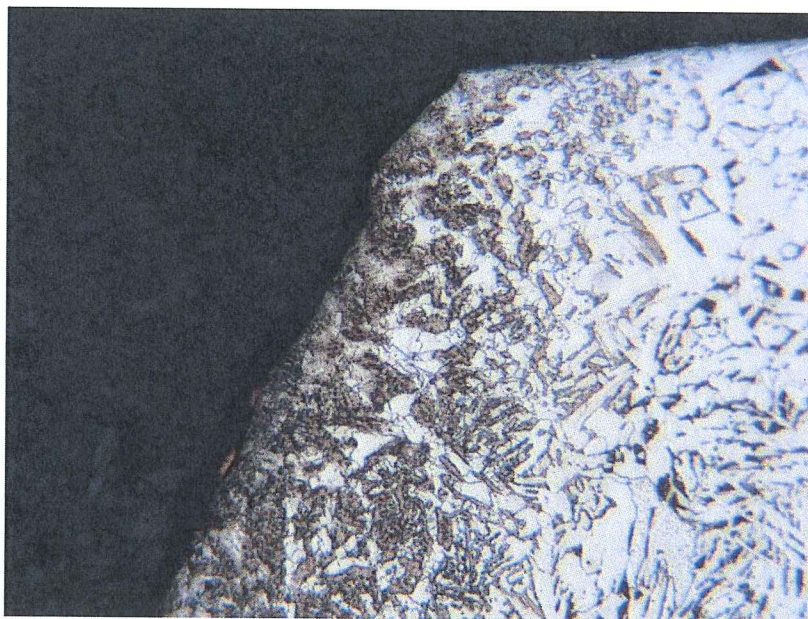
A metallographic mount was made with the hole wall in cross section. The mount was ground, polished and etched using standard metallographic procedures. The etched mount was examined using an optical microscope and the micrographs are presented in Figures 17-20. The surface of the hole from ID to OD revealed an altered microstructure due to melting and re-solidification of the surface; Figures 17-19. The general microstructure of the steel indicates a medium carbon steel; Figure 20.

Figure 17. Detailed optical micrographs showing the hole surface in cross section of the sample removed from the gas line from 913 NE 122nd Street. (a) OD surface, etched, 50X; (b) OD surface, etched, 100X.

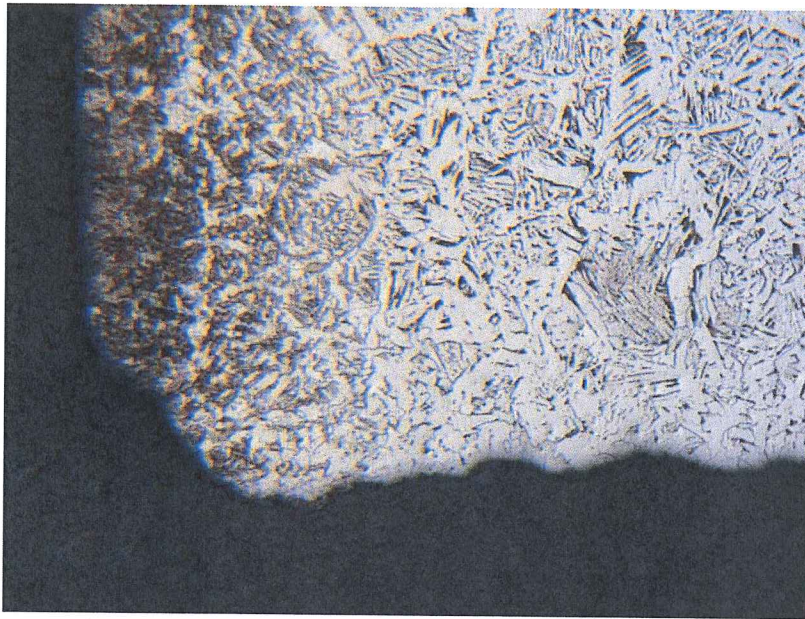
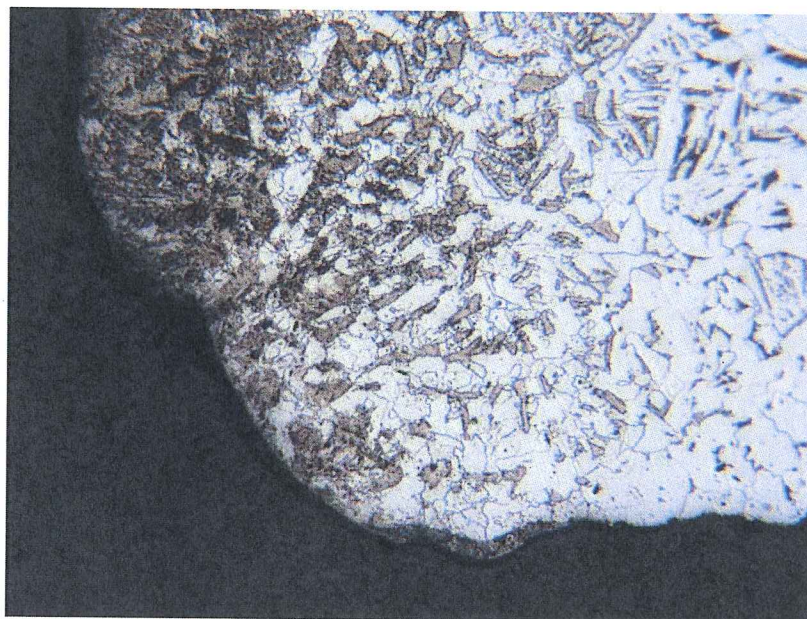
Figure 18. Detailed optical micrographs showing the hole surface in cross section of the sample removed from the gas line from 913 NE 122nd Street. (a) ID surface, etched, 50X; (b) ID surface, etched, 100X.

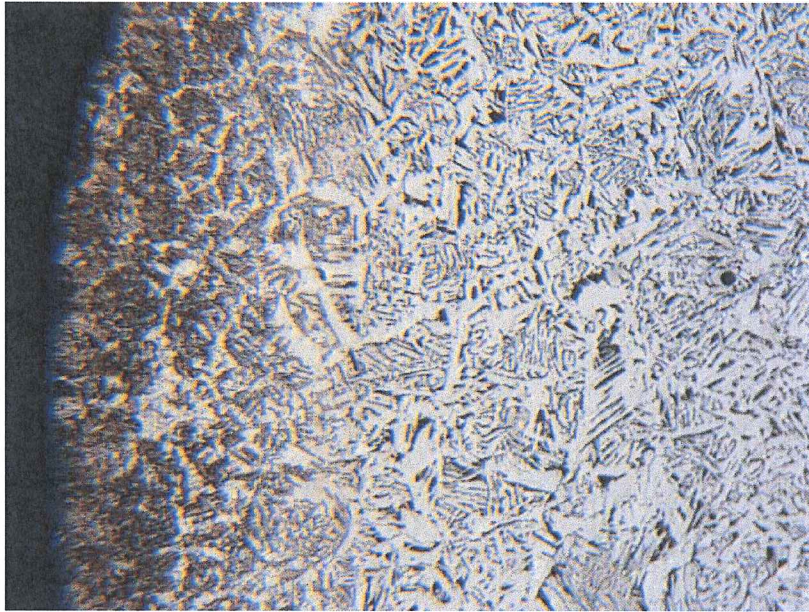
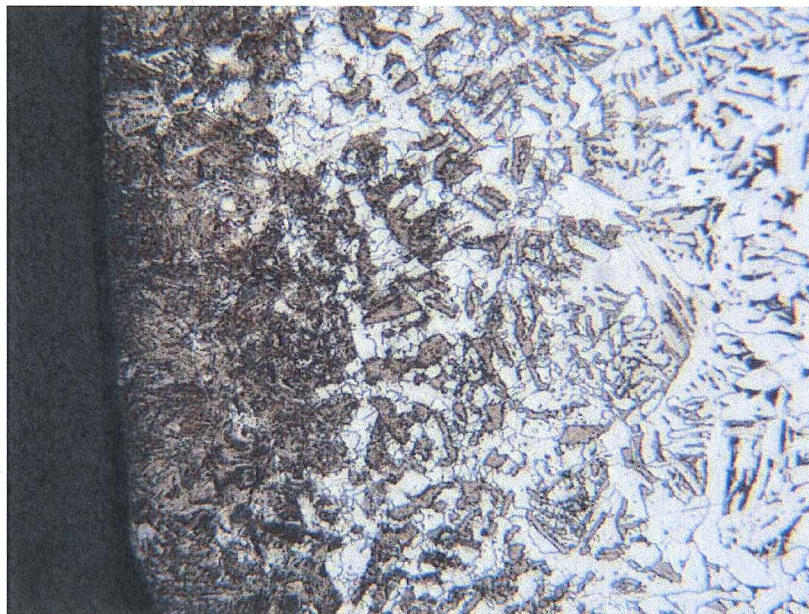
Figure 19. Detailed optical micrographs showing the hole surface in cross section of the sample removed from the gas line from 913 NE 122nd Street. (a) Near ID surface, etched, 50X; (b) Near ID surface, etched, 100X.

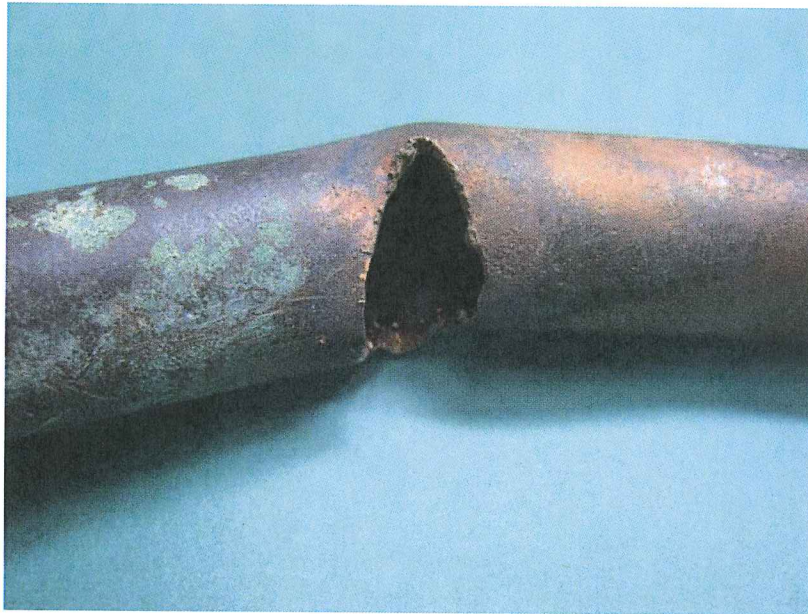
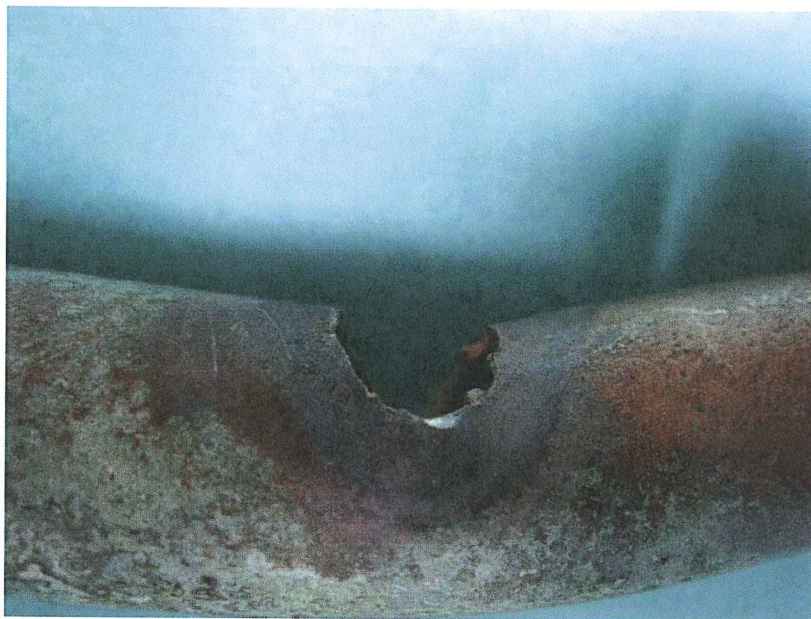
The copper water line that was allegedly in contact with the gas line is shown in Figure 21(a). The attached tag to the water line is shown in Figure 21(b). The periphery of the hole in the copper line shows melted copper balls, indicating it is caused by arcing; Figures 22 and 23. The line was clamped and pinched at a location adjacent to the hole; Figure 24.

Figure 22. Color photographs showing the hole in the copper water line from 913 NE 122nd Street.

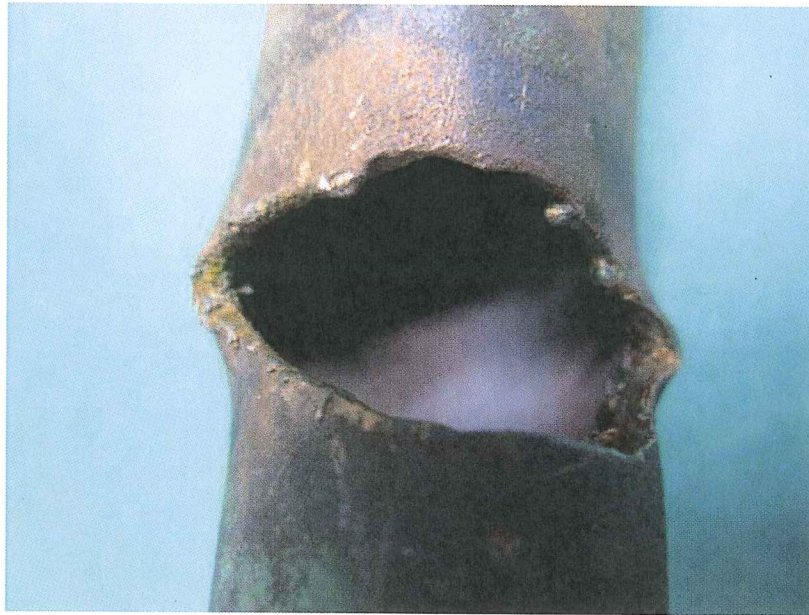
Figure 23. A detailed color photograph showing the hole in the copper water line from 913 NE 122nd Street.

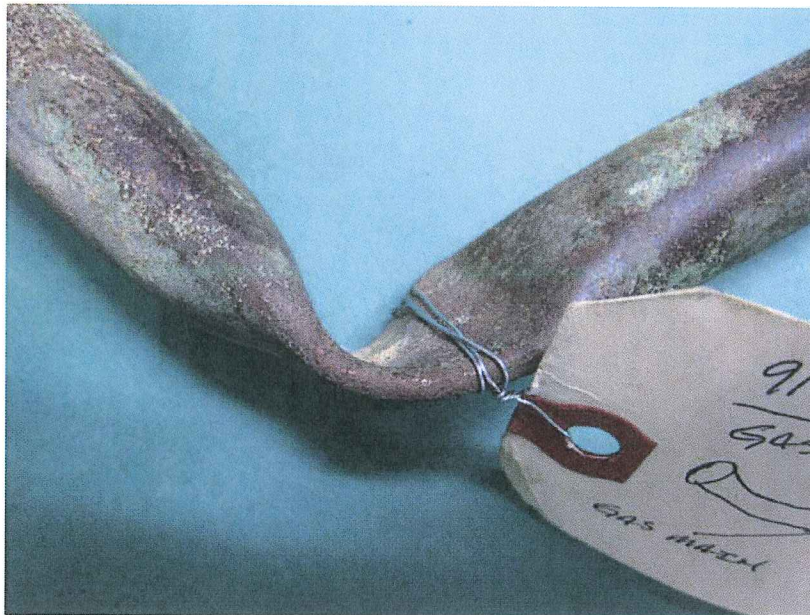
Figure 24. A detailed color photograph showing the pinched area in the copper water line from 913 NE 122nd Street.

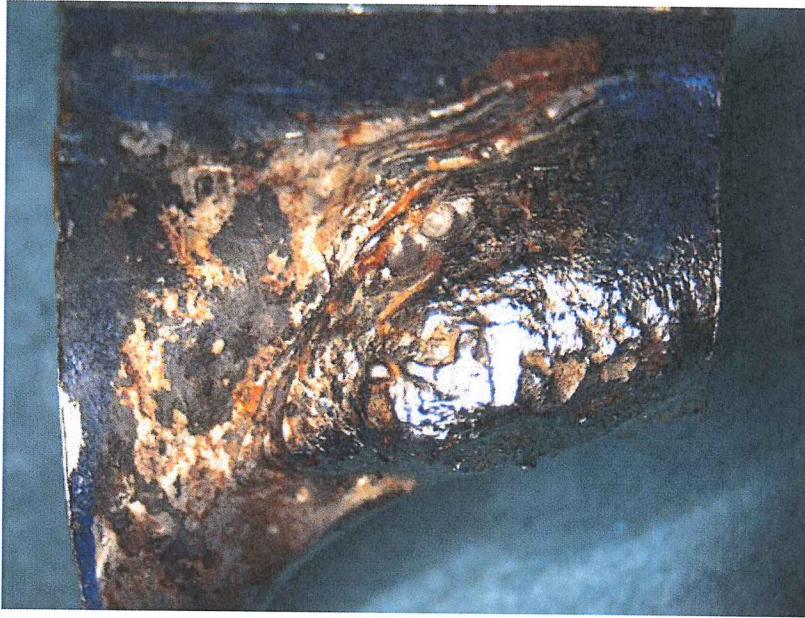
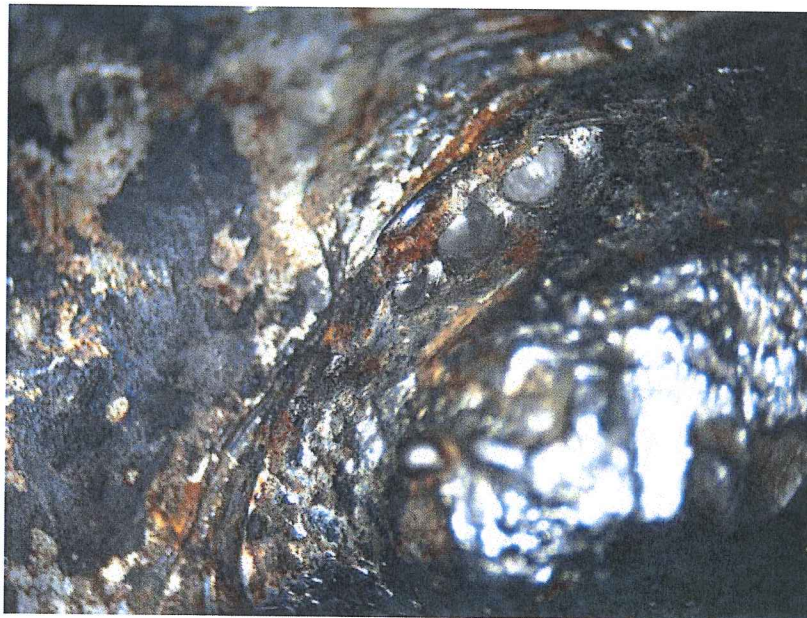
This pipe section was collected by Infrasource on 9-26-11, as evidenced by the tag attached to the pipe section; Figure 25. The gas service line pipe was made from steel, coated with green epoxy Scotchkote 101, was 158 inches long with 1.15 inch outer diameter and wall thickness of 0.11 inch. The pipe contained an irregular shaped oval hole with major diameter as 1.0 inch and minor diameter as 0.6 inch; Figure 26. The green coating had melted and evaporated or flaked off around the hole. A section of the pipe was cut containing $\frac{1}{4}$ of the hole wall, as shown in Figure 27. The removed section contained the $\frac{1}{4}$ hole in a corner and is shown from the ID and OD side in Figures 28-30. The hole was clearly created from OD toward the ID, as seen by the missing material at the hole wall. The hole surface appeared smooth with no fracture features and re-solidified surface; Figure 30.

Figure 30. Detailed color photographs showing the OD surface near the hole of the section removed from the gas line from 1016 NE 127th Street. (a) OD surface, 10X; (b) OD Surface, 20X.

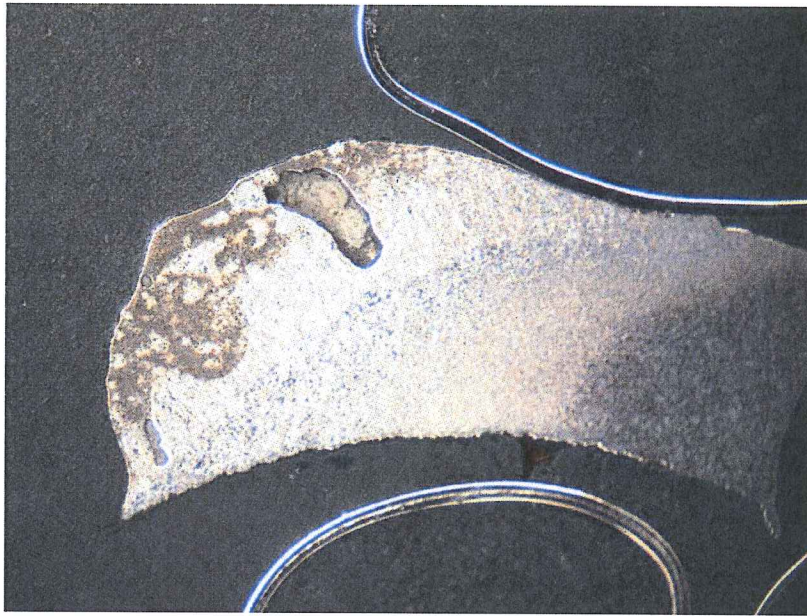
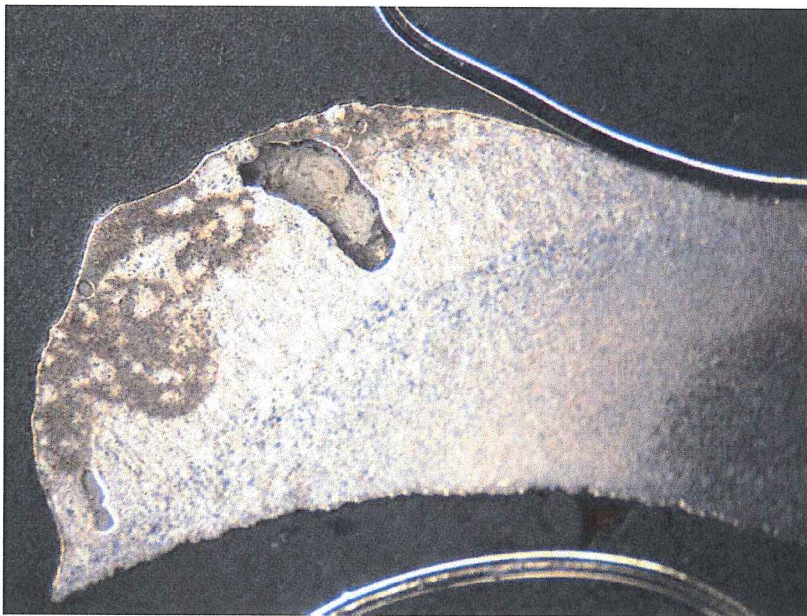
A metallographic mount was made with the hole wall in cross section. The mount was ground, polished and etched using standard metallographic procedures. The etched mount was examined using an optical microscope and the micrographs are presented in Figures 31-33. A large void (gas bubble) was present near the hole surface that was created during the arcing, melting and re-solidification process; Figure 31. The surface of the hole from ID to OD revealed an altered microstructure due to melting and re-solidification of the surface; Figure 32. The general microstructure of the steel indicates a medium carbon steel; Figure 33.

Figure 31. Optical micrographs showing the hole surface in cross section of the sample removed from the gas line from 1016 NE 127th Street. (a) Overall, etched, 15X; (b) Overall, etched, 20X.

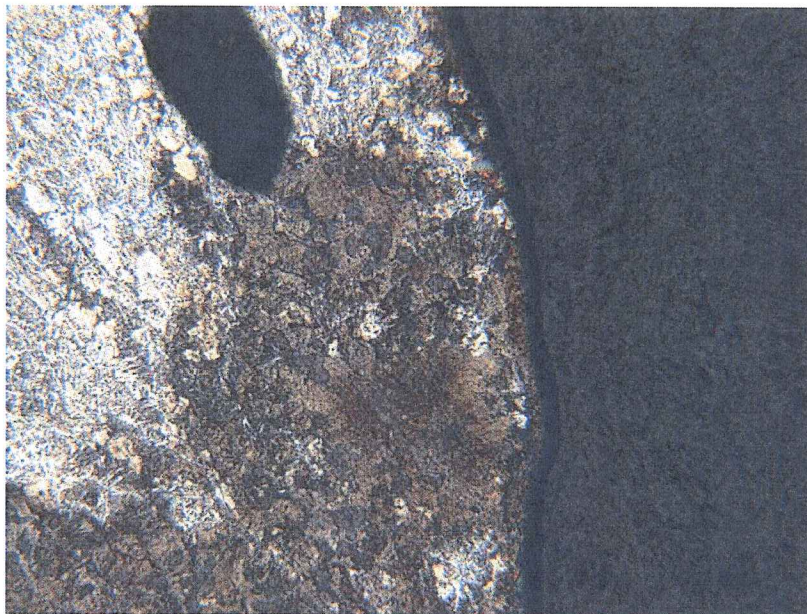
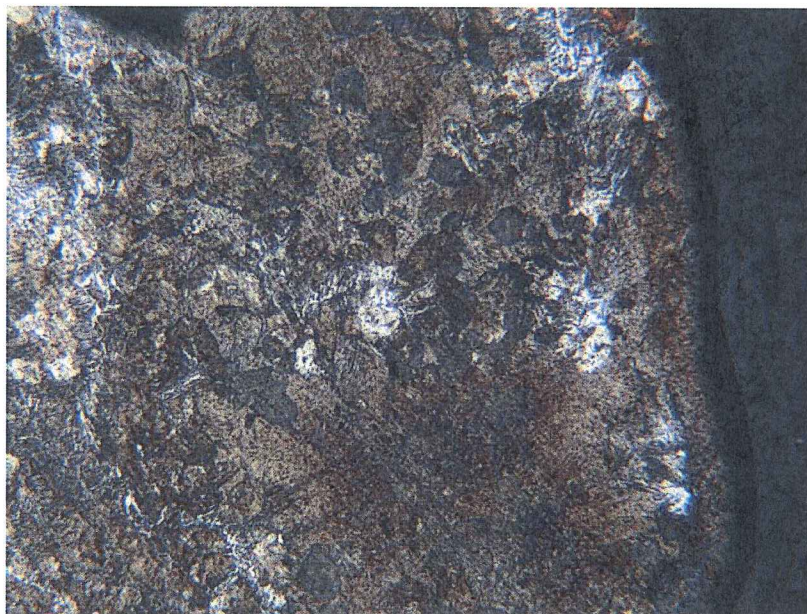
Figure 32. Detailed optical micrographs showing the hole surface in cross section of the sample removed from the gas line from 1016 NE 127th Street. (a) ID surface, etched, 50X; (b) ID surface, etched, 100X.

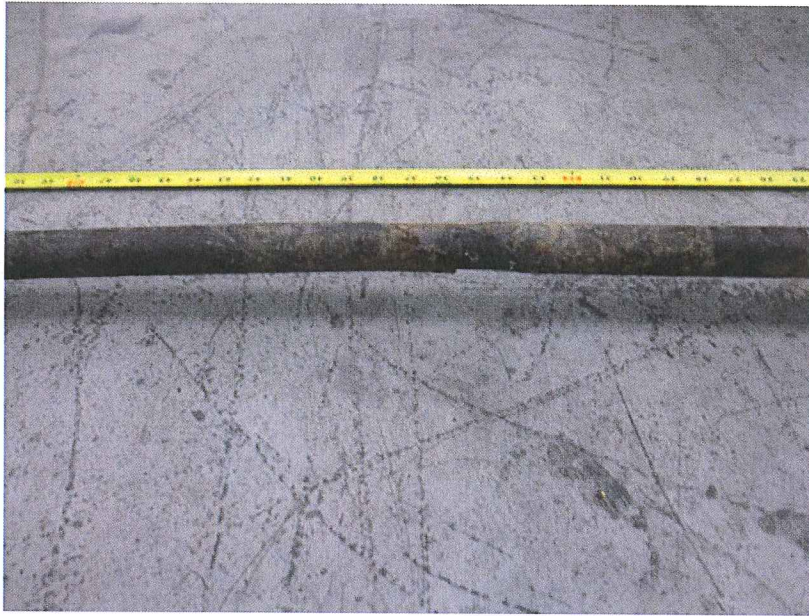
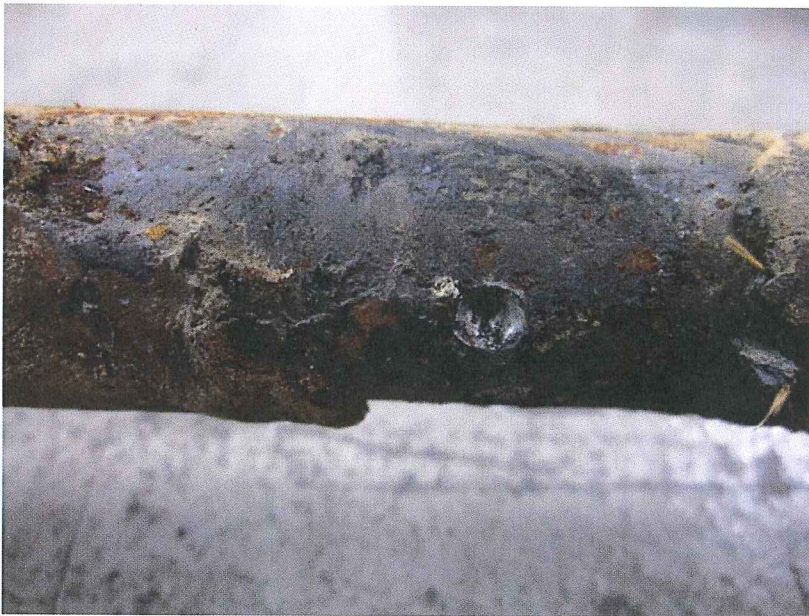
This pipe section was collected by Michael Radcliff on 9-26-11, as evidenced by the tag attached to the pipe section; Figure 34. The gas service line pipe was made from steel, surface coated, was 225 inches long with gas meter attached to one end of the pipe. The pipe has 1.08 inch outer diameter and wall thickness of 0.11 inch. The pipe contained a round hole on the bottom of the pipe with an average diameter of 0.25 inch on the OD surface. A small section of the pipe containing the hole was sectioned; Figure 35. Another section of the pipe containing the hole was marked and cut as shown in Figure 36. The removed section was further cut to expose the hole on the ID surface as shown from the ID and OD side in Figures 37. The hole surface on the OD appeared smooth with no fracture features and re-solidified surface.

Figure 35. Detailed color photographs showing a hole in the gas line from 12312 5th Avenue NE.

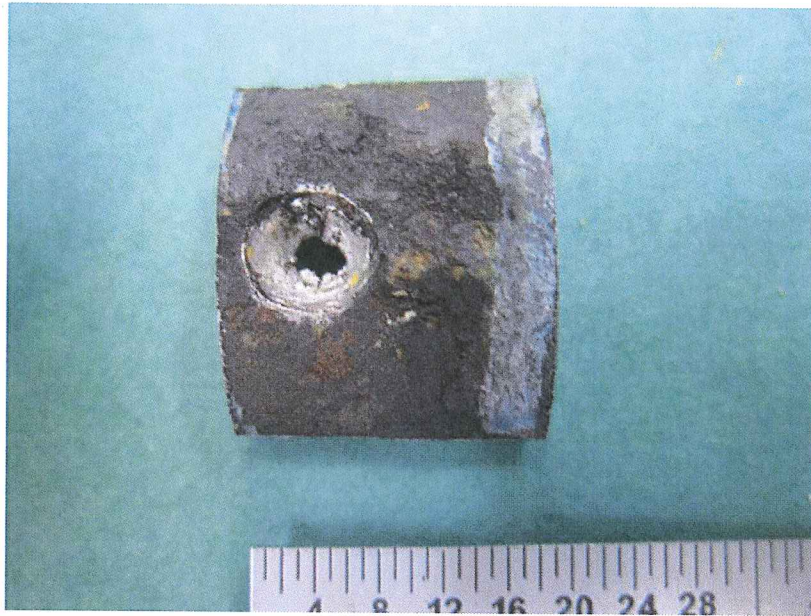
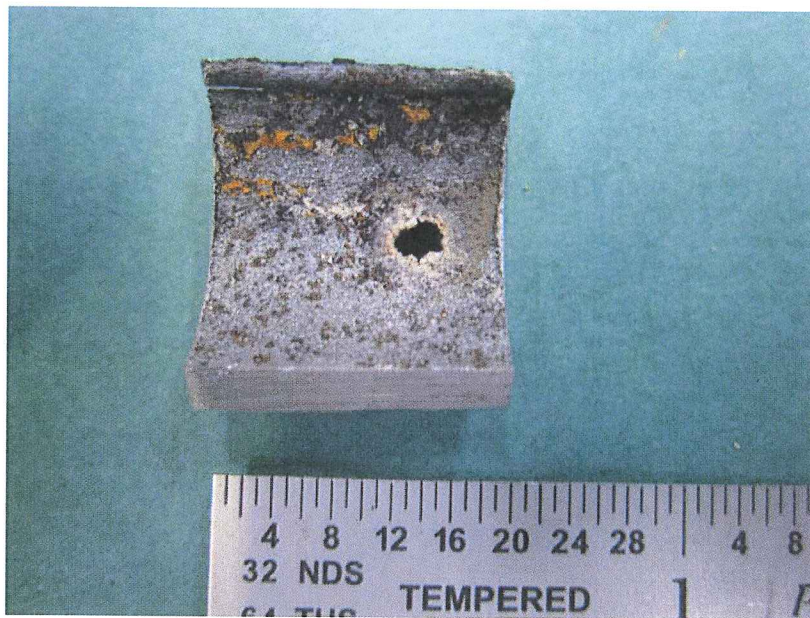
Figure 37. Detailed color photographs showing the hole removed from the gas line from 12312 5th Avenue NE. (a) ID surface; (b) OD surface.

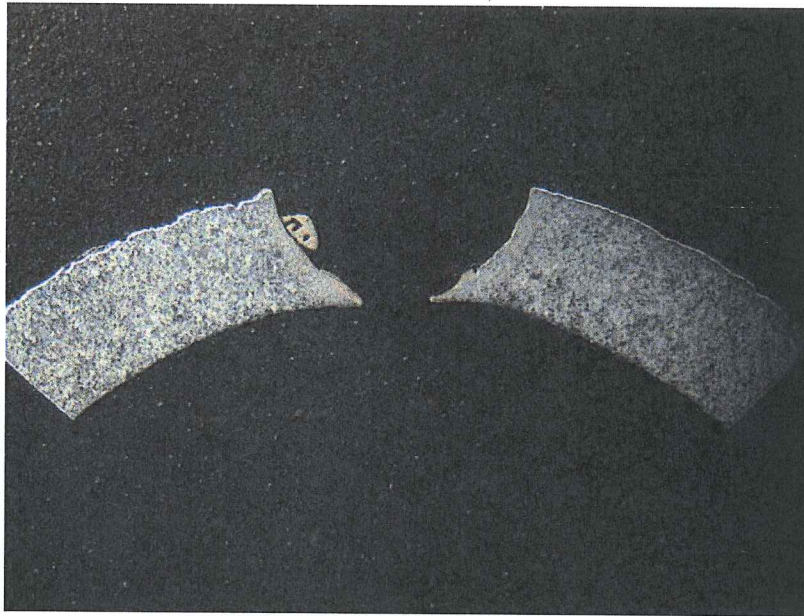
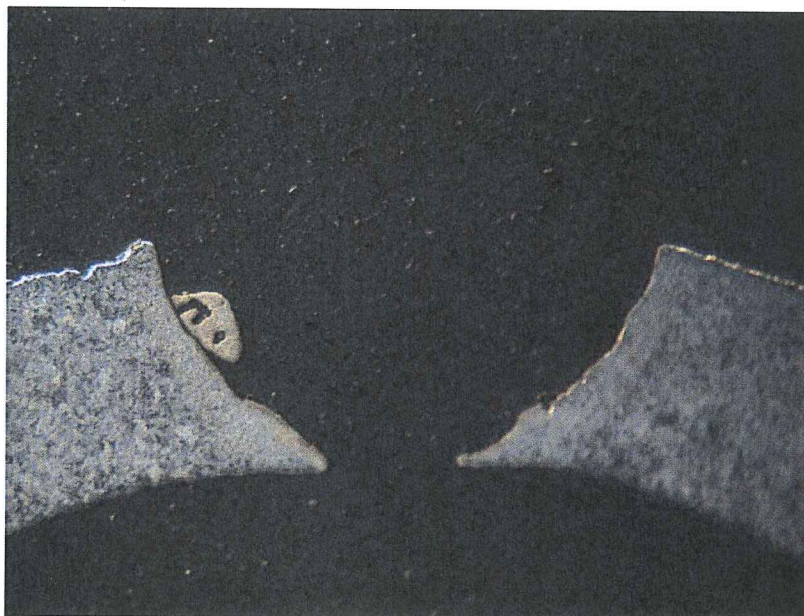
A metallographic mount was made with the entire hole in cross section. The mount was ground, polished and etched using standard metallographic procedures. The etched mount was examined using an optical microscope and the micrographs are presented in Figures 38-41. The hole was clearly created from OD toward the ID, as seen by the missing material; Figure 38. The surface of the hole from ID to OD revealed an altered microstructure due to melting and re-solidification of the surface. The general microstructure of the steel indicates a medium carbon steel; Figure 41.

Figure 38. Optical micrographs showing the hole in cross section of the sample removed from the gas line from 12312 5th Avenue NE. (a) Overall, etched, 10X; (b) Overall, etched, 20X.
