EXHIBIT F
SEAL Laboratories – Final Report (February 16, 2012)

RE: Puget Sound Energy- Ingham Fire
SEAL Job No. 21151.

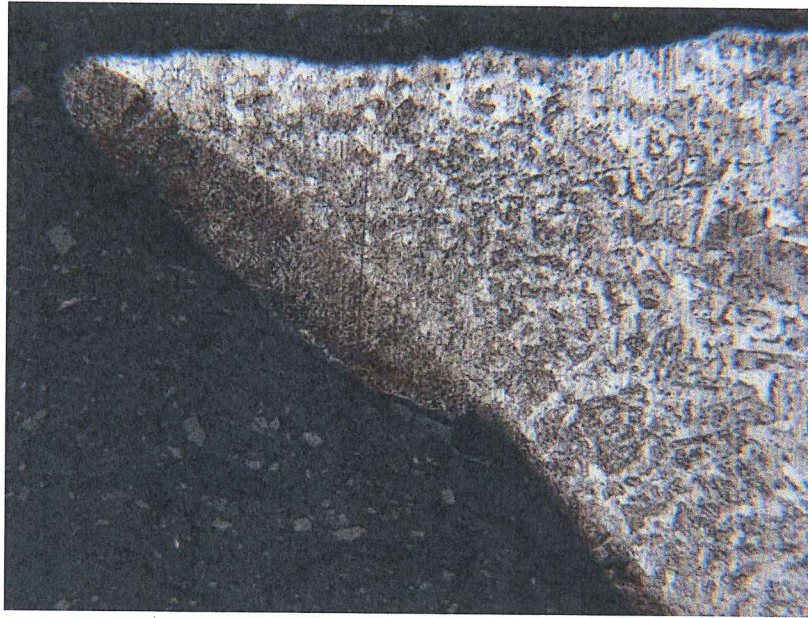
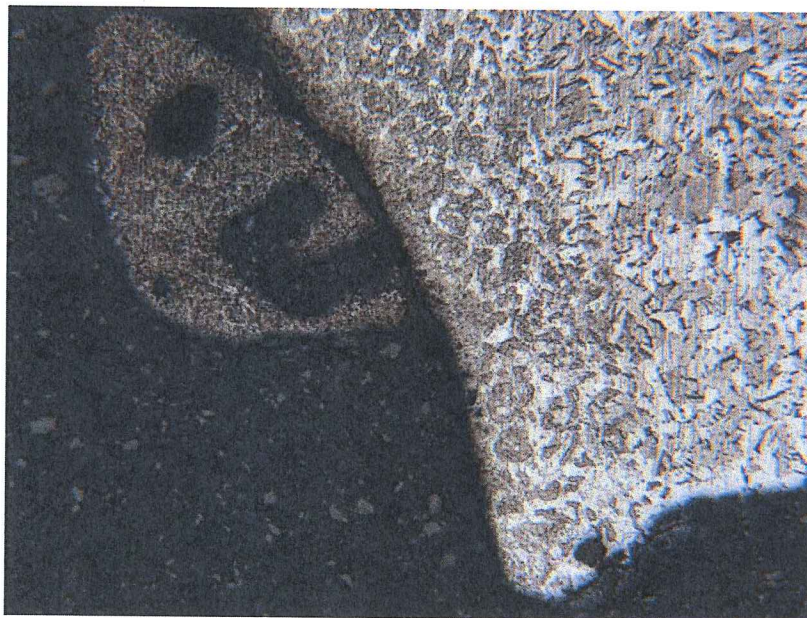
A metallographic mount was made with the entire hole in cross section. The mount was ground, polished and etched using standard metallographic procedures. The etched mount was examined using an optical microscope and the micrographs are presented in Figures 38-41. The hole was clearly created from OD toward the ID, as seen by the missing material; Figure 38. The surface of the hole from ID to OD revealed an altered microstructure due to melting and re-solidification of the surface. The general microstructure of the steel indicates a medium carbon steel; Figure 41.

Figure 39. Detailed optical micrographs showing the hole surface in cross section of the sample removed from the gas line from 12312 5th Avenue NE. (a) ID surface, etched, 50X; (b) OD surface, etched, 50X.

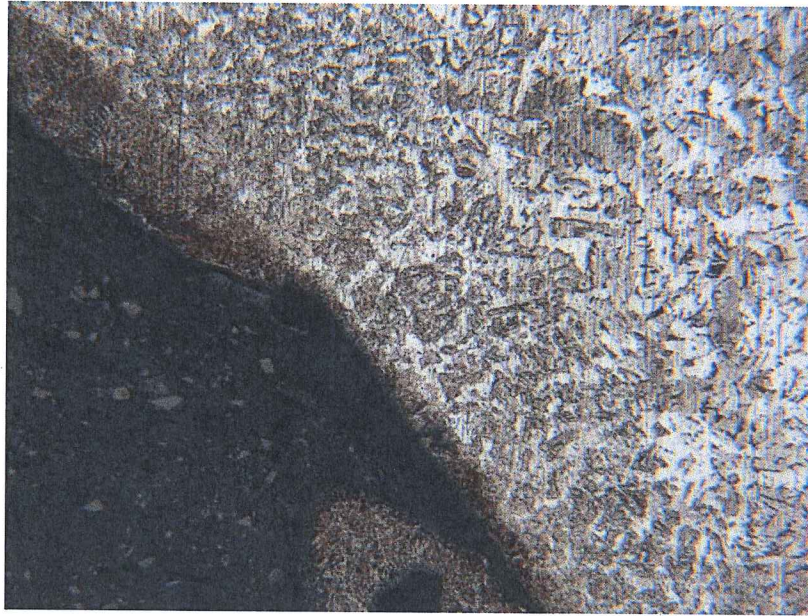
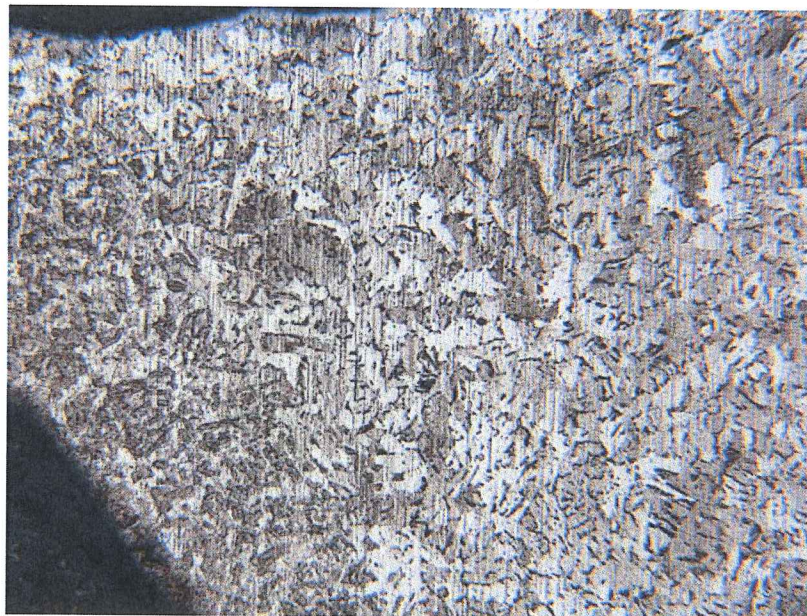
Figure 40. Detailed optical micrographs showing the metallurgical microstructure of steel section removed from the gas line from 12312 5th Avenue NE. (a) At the hole surface, Etched, 50X; (b) At the hole surface, Etched, 50X.
