Seattle Fire Department Fire Investigator's Scene Report

DATE: 9/26/11
TIME: 06:04 HRS

SFD INC#: 11-089814
SPD INC#:

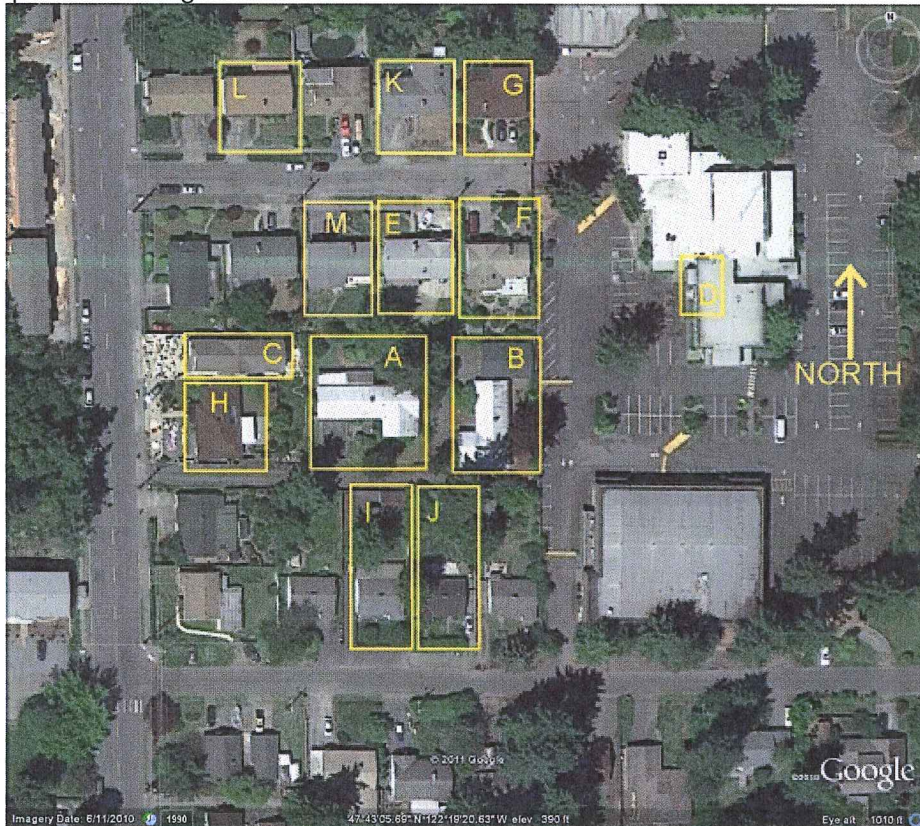
confined to the original residence, 12312 5th Ave. NE. This report will only provide preliminary damage observed to the other residences. Further detailed inspections by homeowners and their insurance agencies will undoubtedly uncover more extensive damage to the respective structures and property. There will most likely be some residences where damage was not visible/reported at the time of this initial investigation. Damages range from complete destruction (A) to the structure moved ajar from the foundation (M) to just broken windows (L). The photo below shows the initial reports of damaged structures.

This investigation will primarily address the fire at the initial residence "A" shown in the above photo. There were reports of this explosion being heard in Bothell and the percussive wave being felt on 36th Ave. NE. in the Lake City neighborhood which is approximately 2 miles away. The explosive damage to the home was extensive and upon arrival at the scene, all that was left standing was a portion of the garage which was also in the state of collapse. The roof and walls of the house were not in place with many portions being blown into surrounding yards. The pile of debris where the house was located was smoldering amidst various sections of the ground floor. The main floor (the floor itself) had also been blown in a downward motion, forcing large pieces of it into the crawl space beneath. Shortly after the explosion, the male occupant of the home heard his wife screaming for help and found her in the crawl space and suffering serious burns on a large part of her body. Fire crews could only apply hose streams to the garage and the pile of debris where the footprint of the house was. Everything else had been blown into neighboring yards. The roof was constructed of a thick, rolled tar paper material. A large portion of the roof was blown eastward into the yard of 12314 5th Ave. A section (approximately 3ft. X 6ft.) of the same roofing material was observed in a large tree about 75 feet off the ground on the north side of the home. There was no structure left to conduct an actual fire investigation. Investigators could only photograph and document some of the damage to the house and the surrounding area. The best and most logical way to convey the devastation of this explosion is to illustrate the damage with scene photographs. The next several following pages will contain photographs taken of the scene and accompanying descriptions.

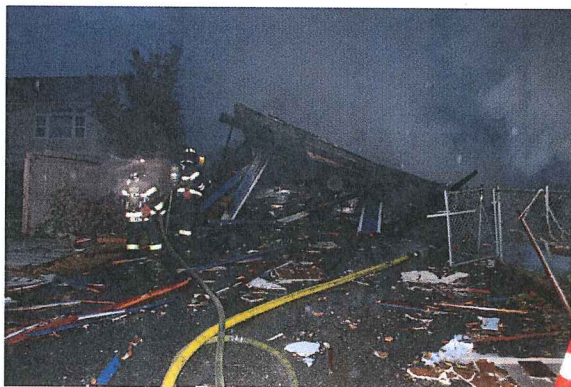
1. Garage – looking northbound from alley

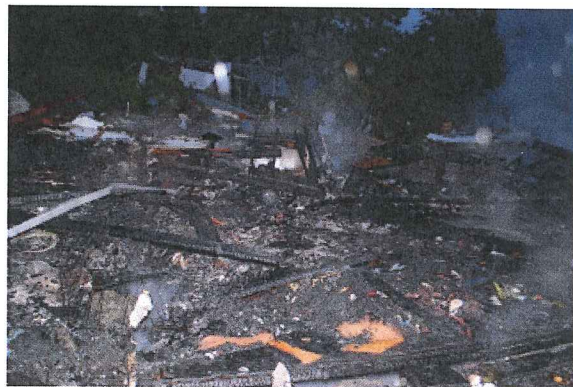
2. The remaining footprint of house ---> north

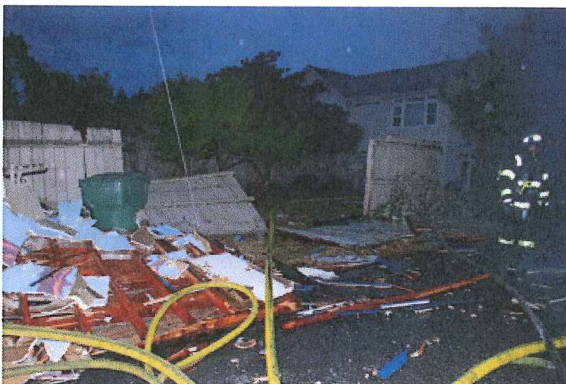
3. west side of driveway – portions of interior walls

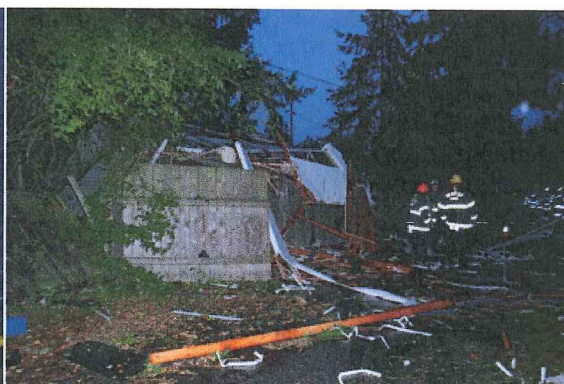
4. "alley" ->west – damage to s. neighbor fence

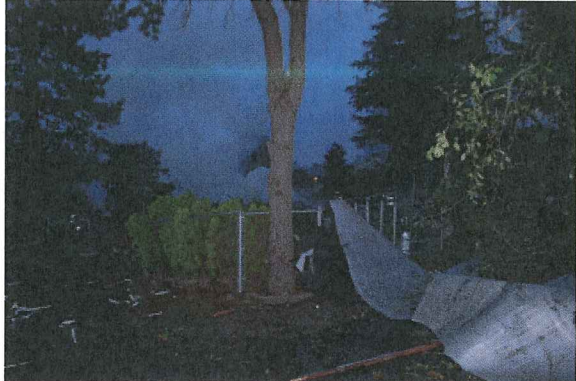
5. portion of roof – in east neighbor's yard-> NW

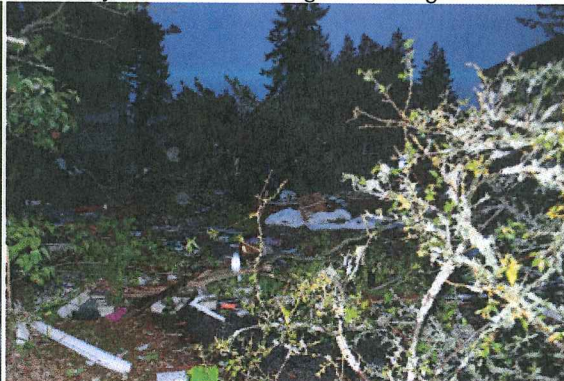
6. Debris blown into east neighbor's yard

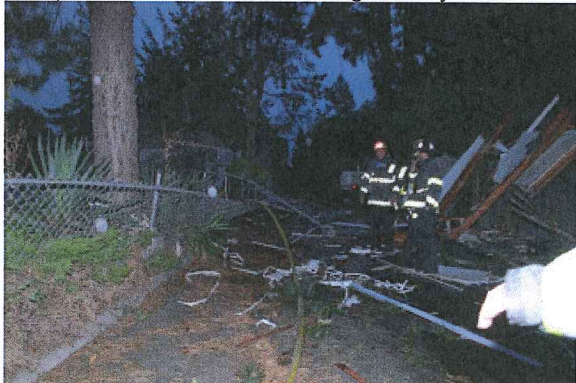
7. alley- looking east

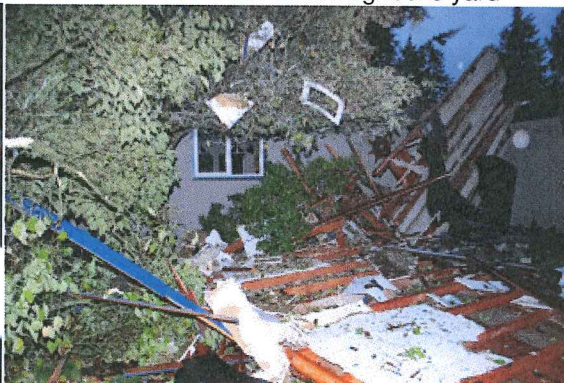
8. east neighbor – note large wall sections

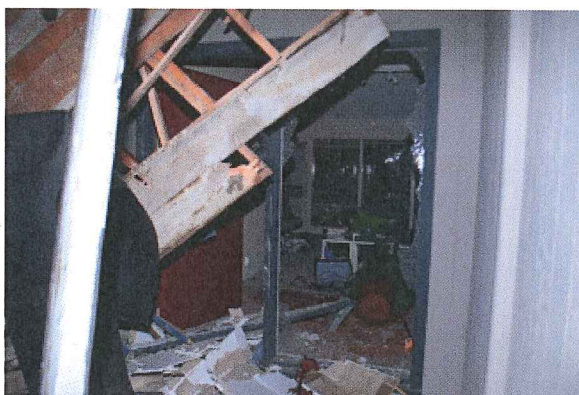
9. east neighbor (e.n.) front door → east

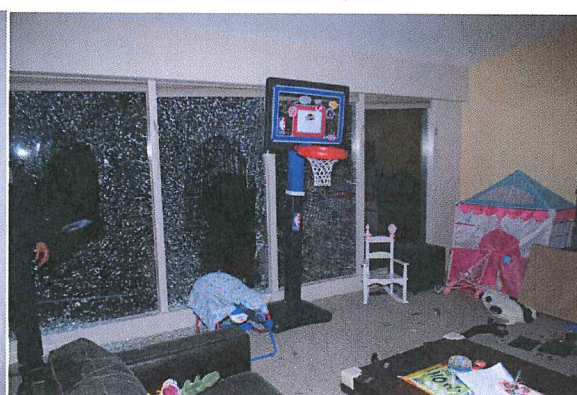
10. e.n. – family room → east

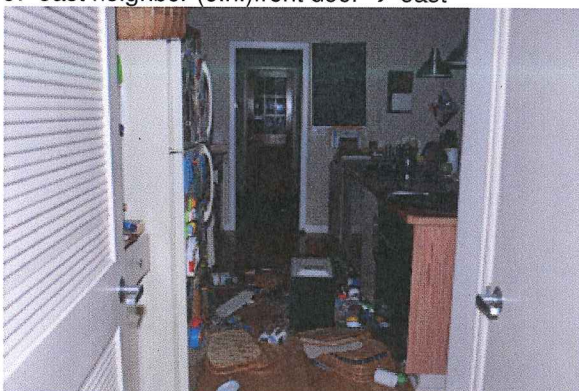
11. e.n. → north in kitchen – microwave on floor

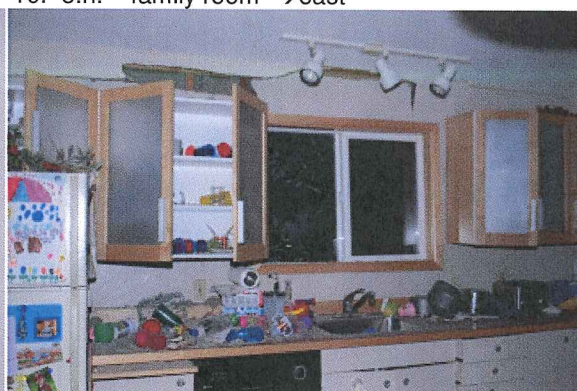
12. east wall of kitchen – note visible studs

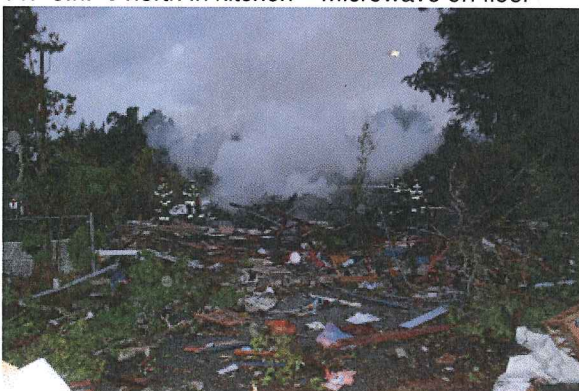
13. explosion site → west from e.n. yard

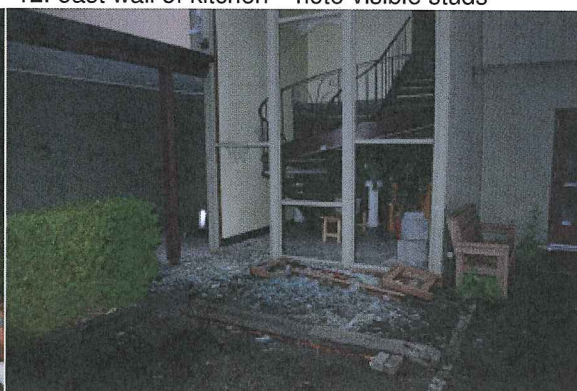
14. West exterior – 122345 8th Ave. NE.

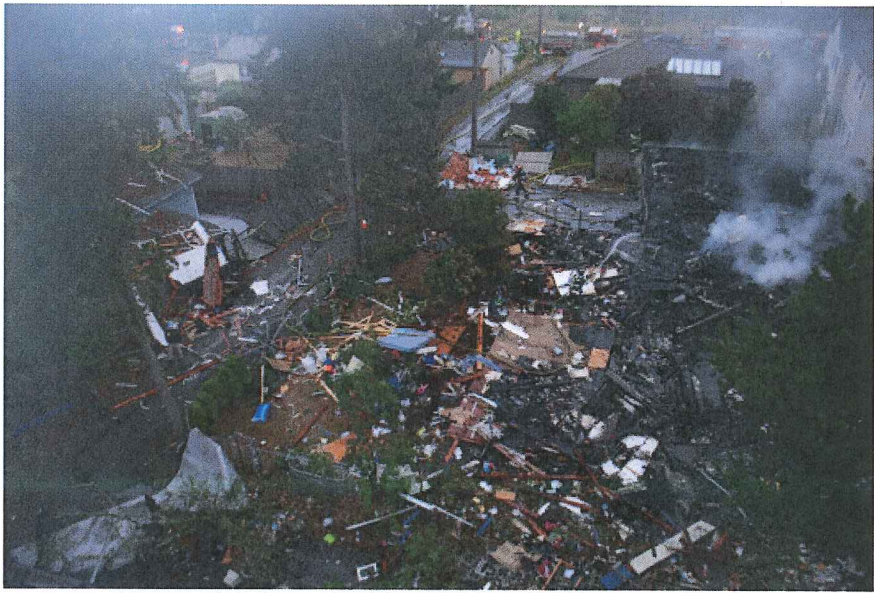
15. aerial view – looking west – slightly to south

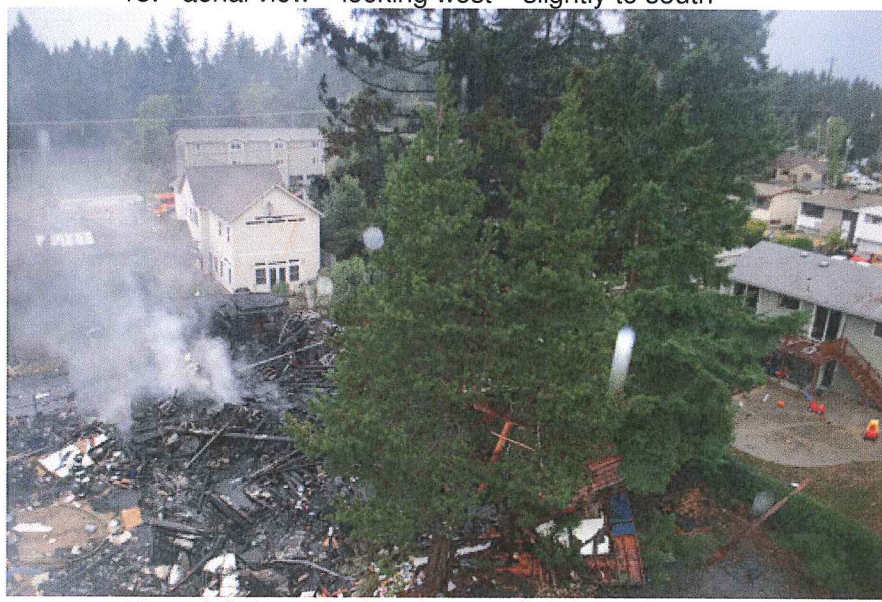
16. aerial view – looking west – slightly north

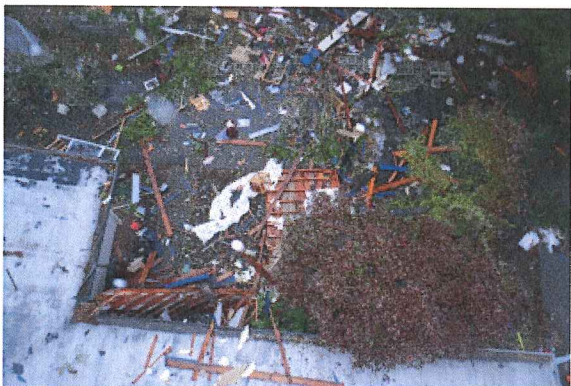
17. aerial view – debris blown into e.n. yard

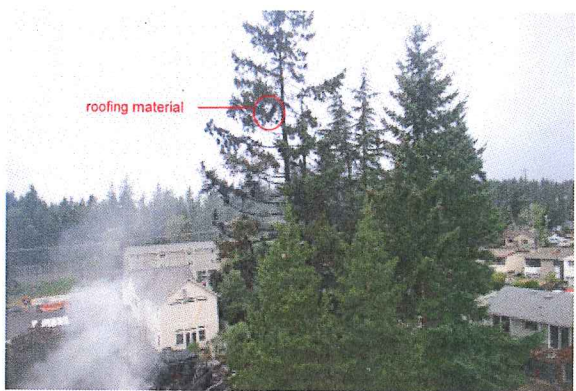
18. roofing material- approx. 75 ft. from ground

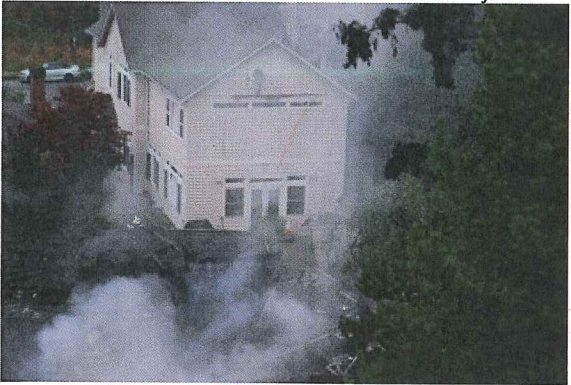
19. aerial view of west neighbor – looking west

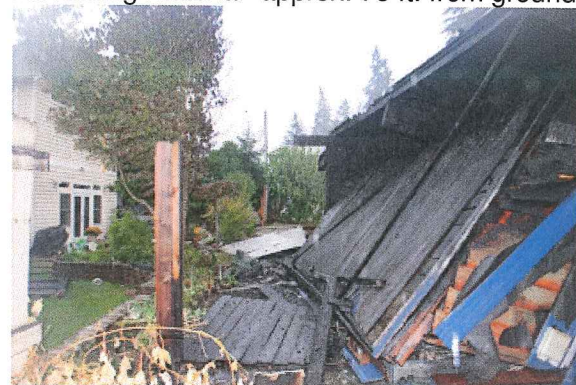
20. west side of garage – looking north

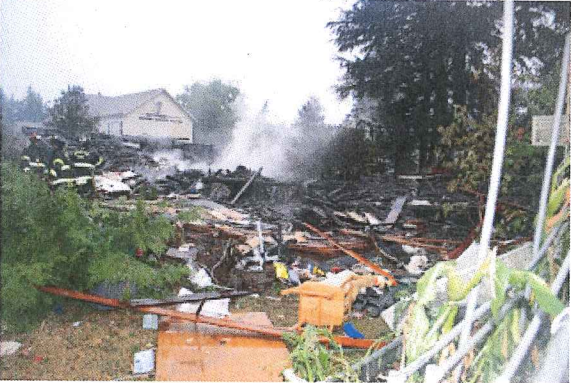
21. explosion site – from s.e.corner →n.w.

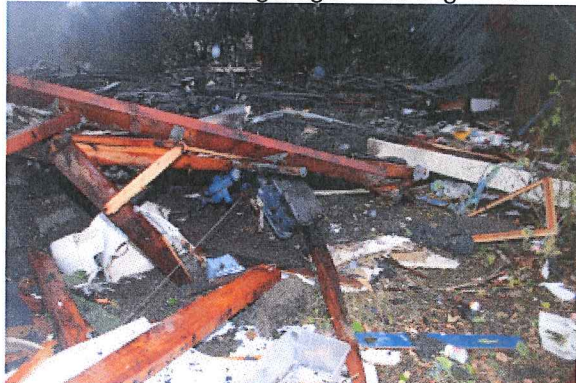
22. gas meter – s.e. corner of house →north
