POST INSPECTION MEMORANDUM

Operator Inspected:

Unit Inspected: OPL North and OPL South

Inspection Dates: November 15 - 19, 2010

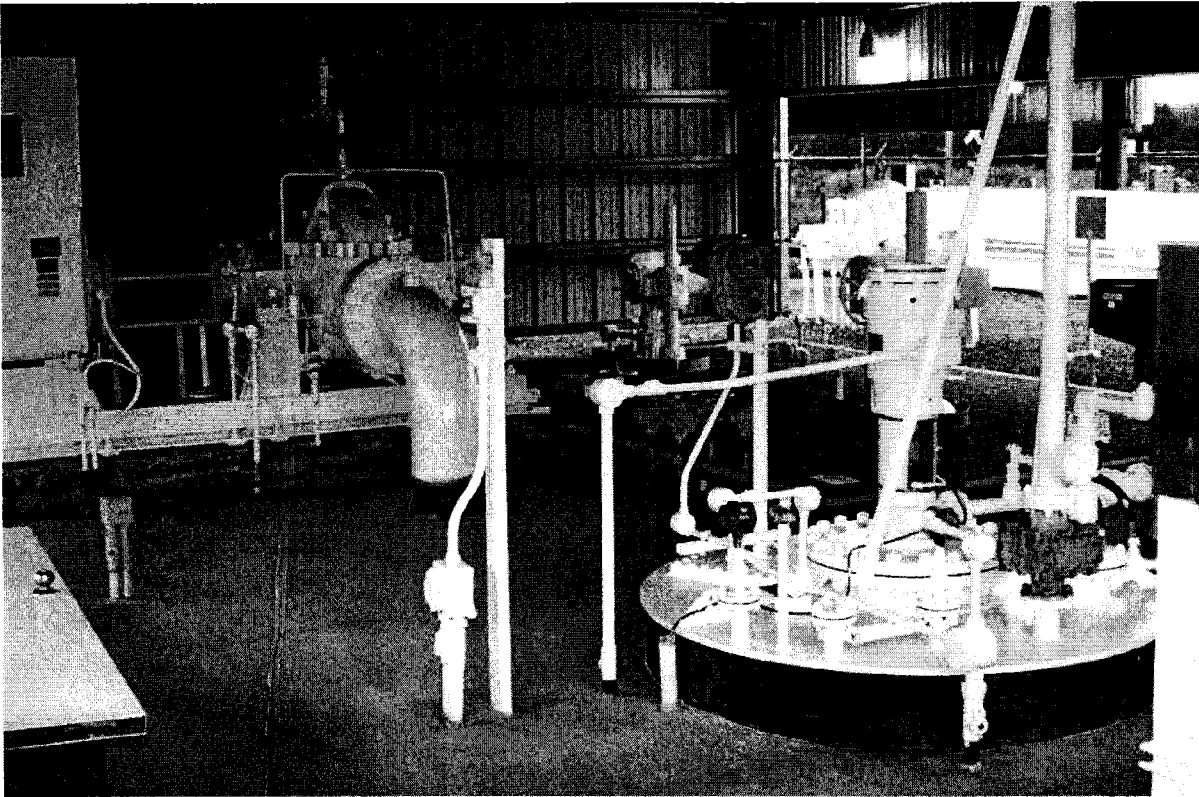
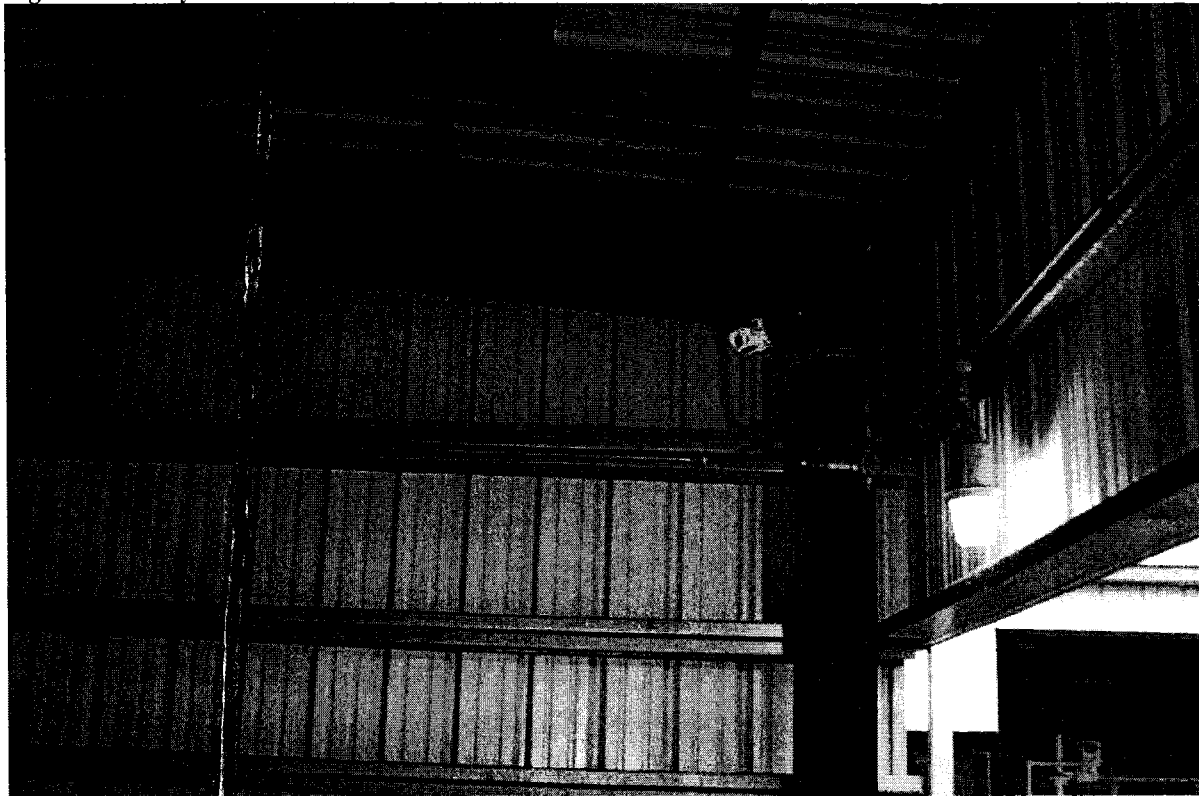
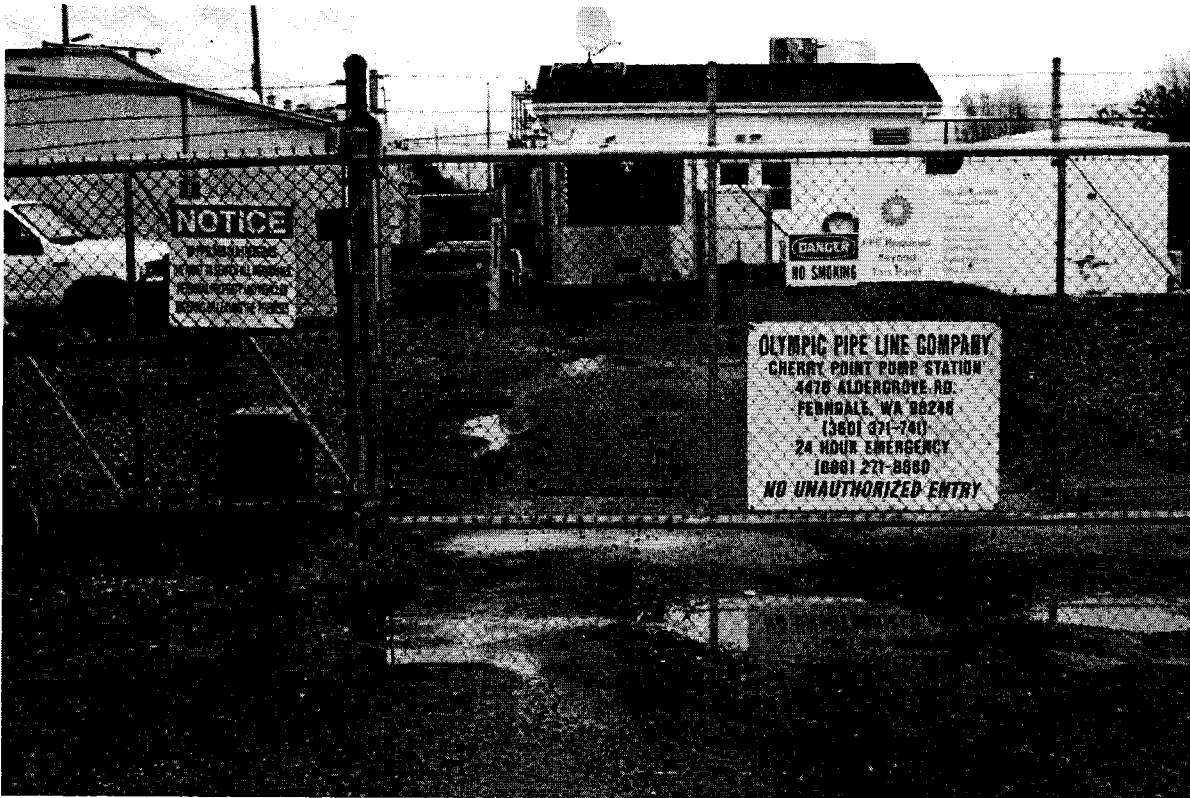
- 1) Visited Cherry Point Booster Station (see pictures # 1, #2, and #3). Cathodic protection readings were taken at an incoming pipeline from the refinery (-1.428v), station pipe (-0.992v), and pipe (-2.482v) with casing (-0.950v) outside of the Cherry Point Pump Station.

Figure 1: Cherry Point Booster Station

Figure 2: Fire eye at the Cherry Point Booster Station

Figure 3: Signage at the Cherry Point Booster Station

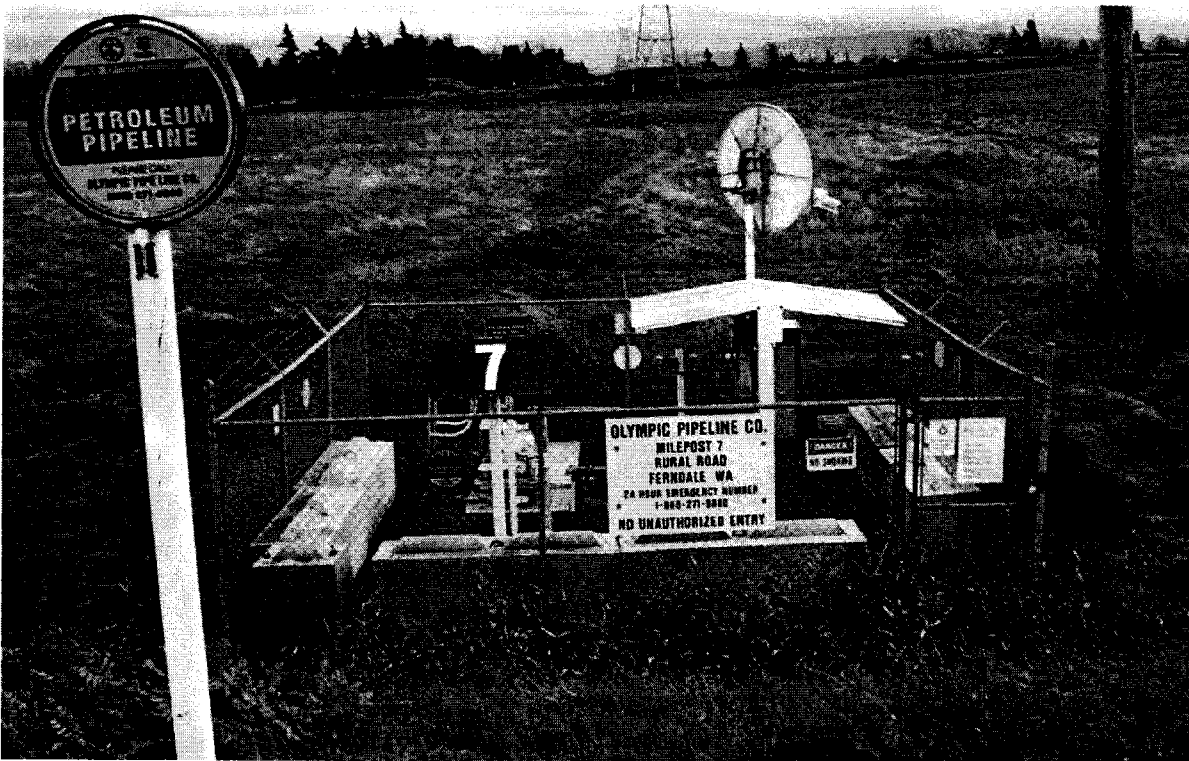
Figure 4: Mainline Valve at MP7

- 2) Cathodic protection readings were taken at the MP7 Mainline Valve for a 16" pipe (-1.500v) with the casing (-0.511v) (see picture #4).
- 3) Visited Anacortes Pump Station (see pictures #5 and #6). Cathodic protection readings were taken at an outgoing pipeline (-1.300v) and Breakout Tank # T-107 (-1.645v). According to the Area Team Leader, Dennis Johnston, the tank is scheduled for repainting in two (2) years.

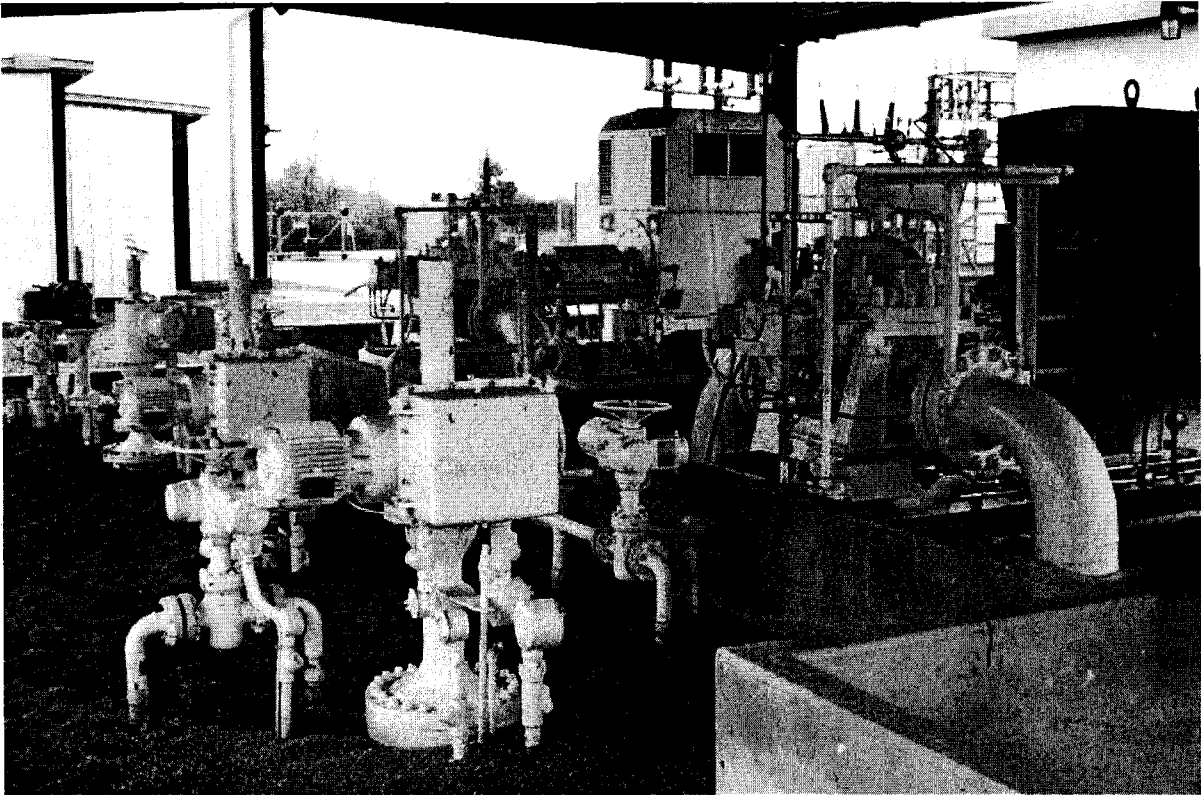
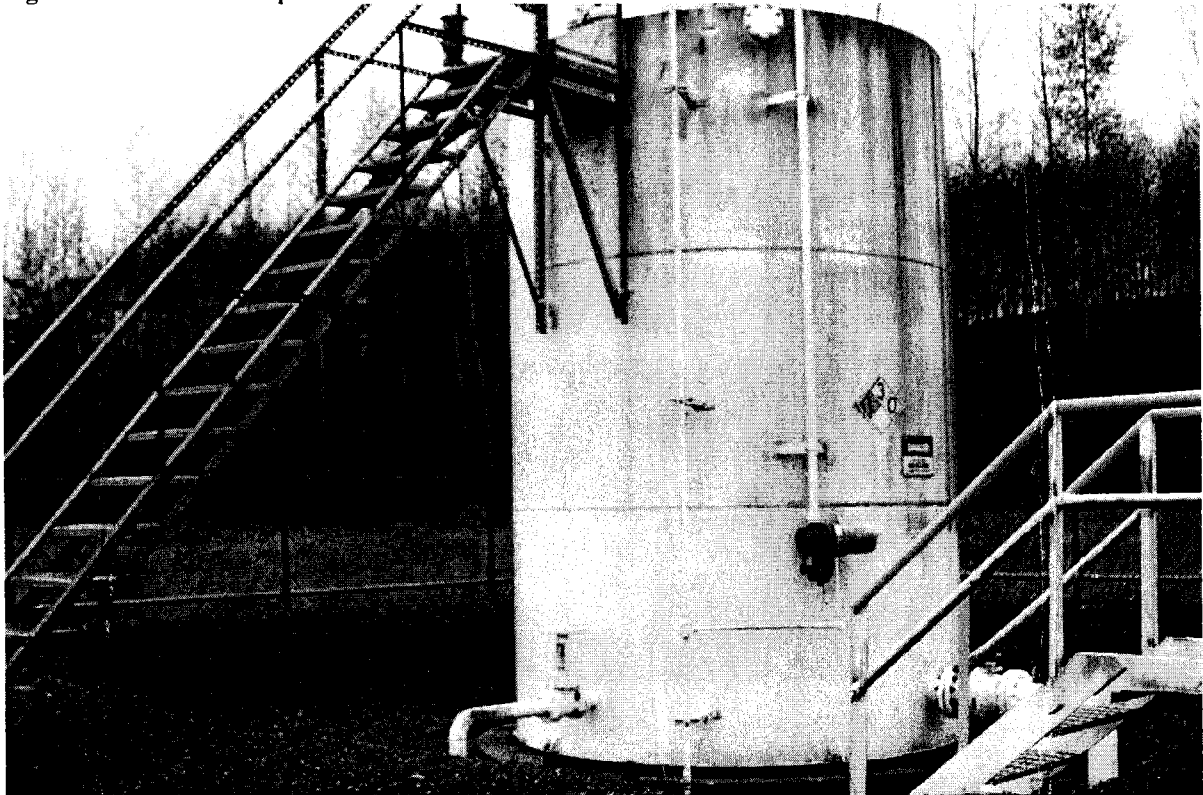
Figure 5: Anacortes Pump Station

Figure 6: Breakout Tank at the Anacortes Pump Station

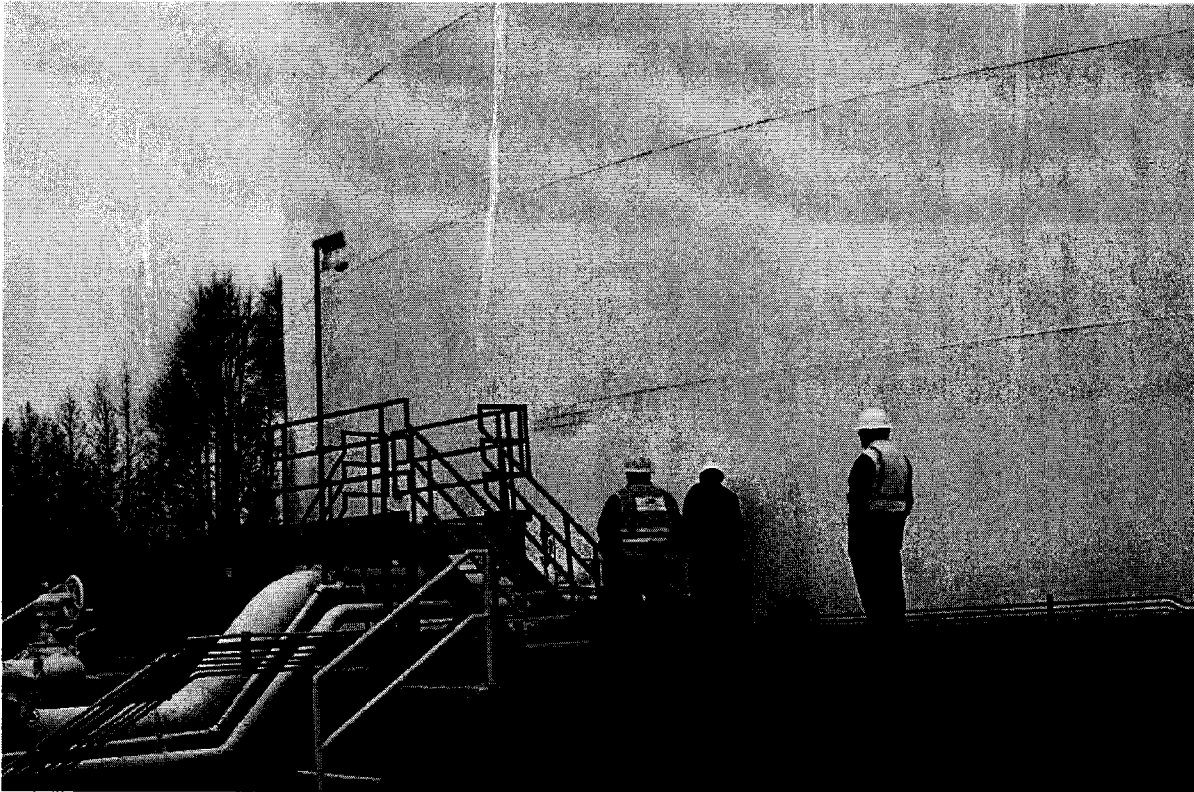
- 4) Visited Bayview Terminal (see pictures #7 and #8). Performed a visual inspection of six (6) Breakout Tanks at the terminal (Tanks # T-202, T-203, T-204, T-205, T-206, and T-209) and it appears that minor paint patch work is needed. Rectifier readings were taken at Rectifier B (14.6v/7.76amp).

- There were few isolated paint spots appeared to be peeling off on the tank shell for some breakout tanks at the Bayview Products Terminal. A remediation should be conducted during the next available opportunity.

Figure 7: Breakout Tank at the Bayview Terminal

Figure 8: Tank T-205 at the Bayview Terminal

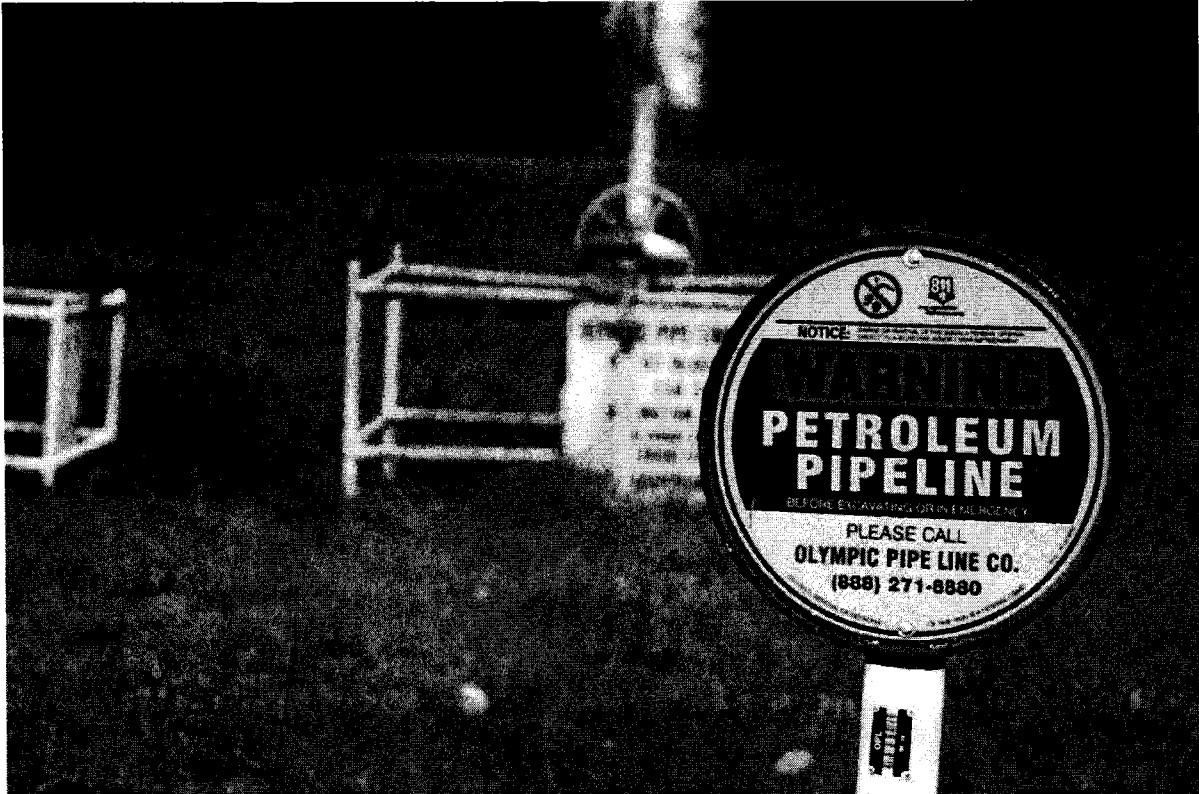
- 6) Visited mainline valves (16" and 20") at MP57 (see picture #9). Observed one (1) OQ covered task of Mr. Dennis Johnston for manually operating a 20" mainline valve.

- The 16" and 20" lines are running parallel within the ROW between Allen Station and Renton Station. It is recommended that identification of each valve be posted at the mainline valve stations and CP test stations, i.e. MP 57 and Woodinville Pump Station.

Figure 9: 16" and 20" Mainline Valves at MP57

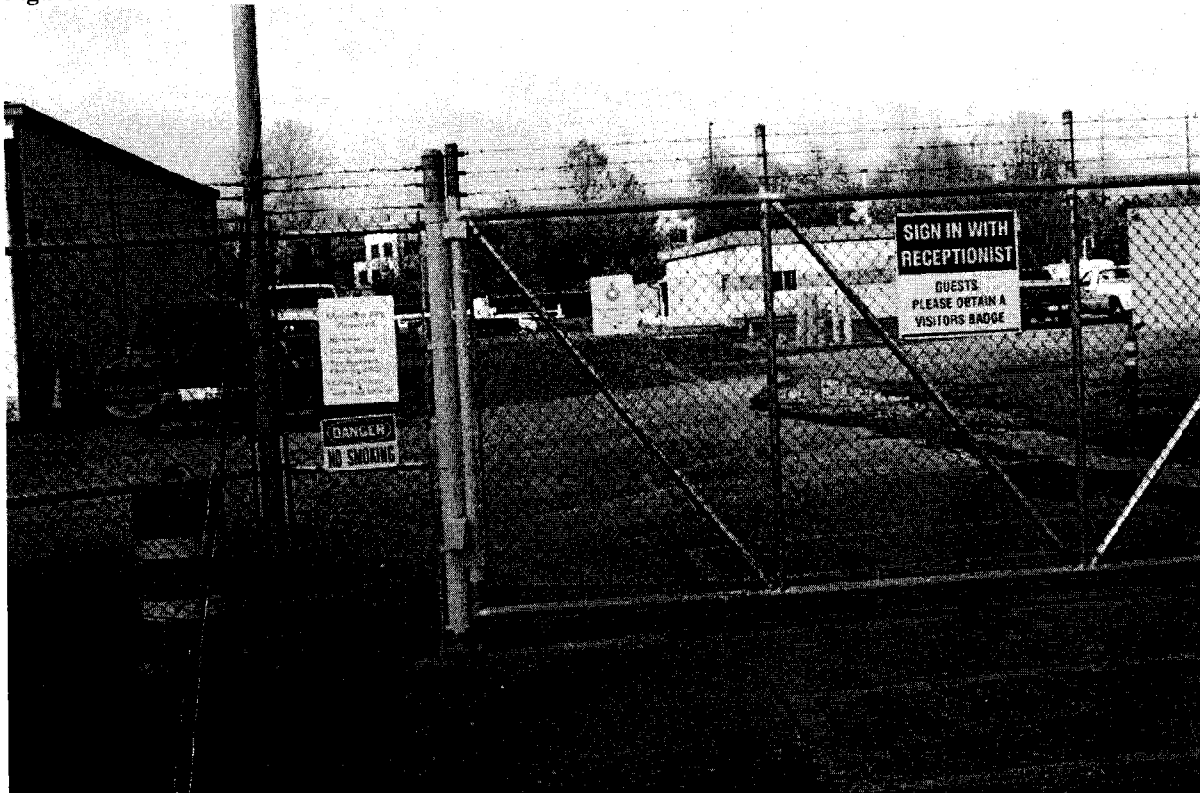
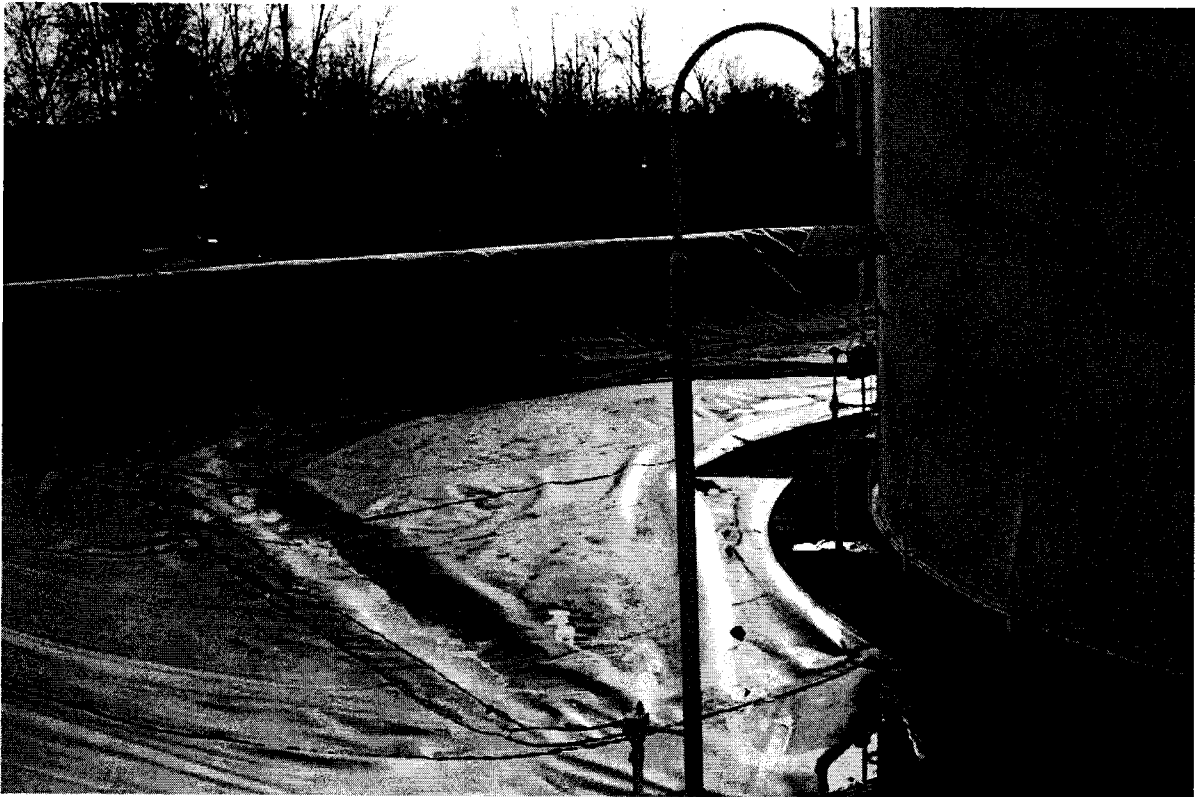
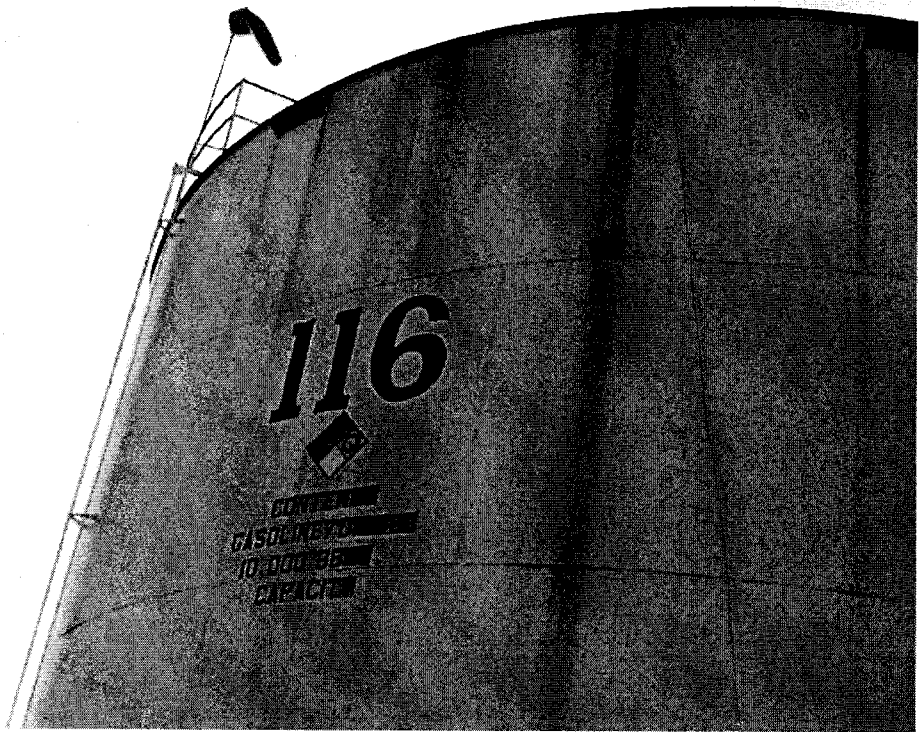
- 1) Visited Renton Pump Station (see pictures # 10, #11, and #12). Cathodic protection readings were taken on 20" incoming pipeline (-1.248v for on potential/-0.864v for off potential), 16" incoming line (-1.590v for on potential/-1.400v for off potential), 14" outgoing line (-1.884v for on potential/-1.428v for off potential). Rectifier readings were taken at the station (11/55v/10amp) and mainline (24.47v/14amp). A tag attached with a fire extinguisher #17 did not show an inspection for October 2010; however, a record was provided to indicate that all the fire extinguishers at the Renton Station were inspected for the month of October 2010. Tank # T-116 appears to have a bulge on one the shell (northeast side of a tank) (see picture #6). Tank # T-116 outlet flange appears to be seeping (see picture #13). Olympic personnel did mitigate the condition by tightening the

- During the field inspection of the Renton Station, it was noted that the tank shell of breakout tank # T-116 has a bulge on the northeast side of the tank. The latest API 653 out-of-service inspection was conducted in 2008 and the inspection report did include this item in their findings. However, no repairs or alterations to the distortion were recommended in the inspection report. It's recommended that the operator monitors the condition during their monthly tank inspections.

Figure 10: Signage at the Renton Station

Figure 11: Containment Area for Tank T-116 at the Renton Station

Figure 12: Tank T-116 at the Renton Station

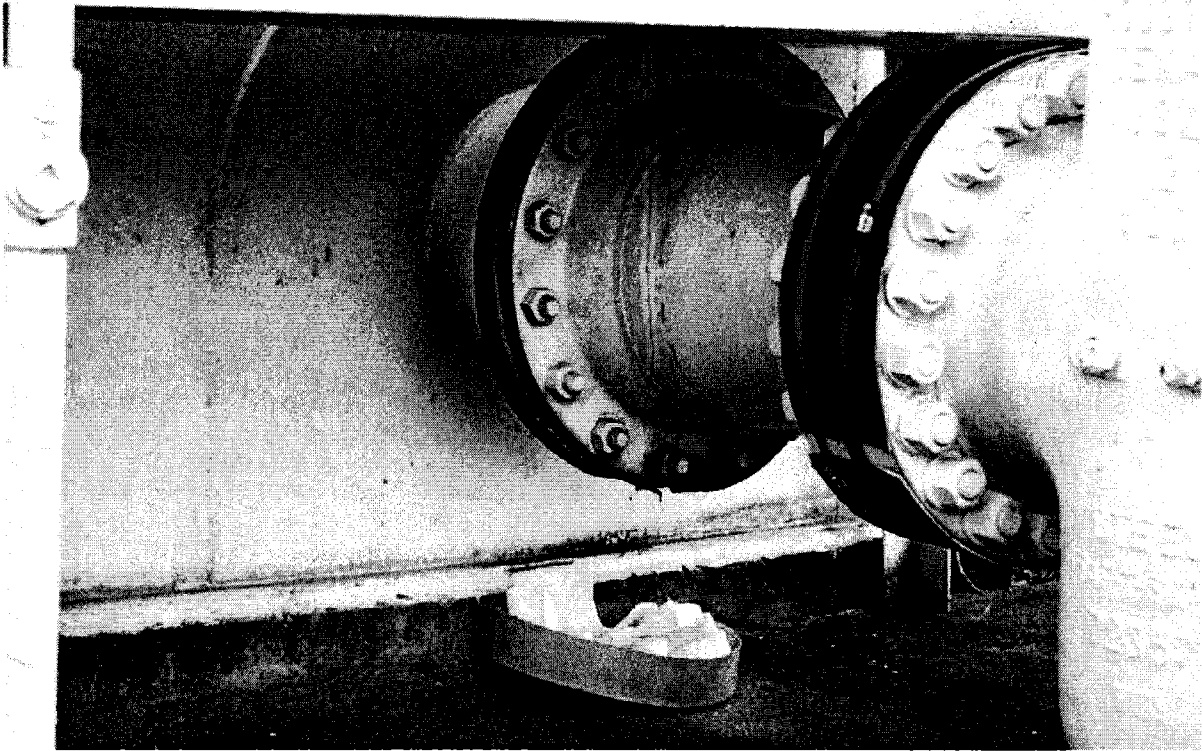
bolts for additional ½ to 1 turn. It appears the condition has been mitigated and the bucket is placed under the flange for precautionary measure. Observed two (2) covered task of Mr. Nick Kitzmiller for taking pipe-to-soil potentials and rectifier readings.

Figure 13: Flange of Tank T-116 at the Renton Station

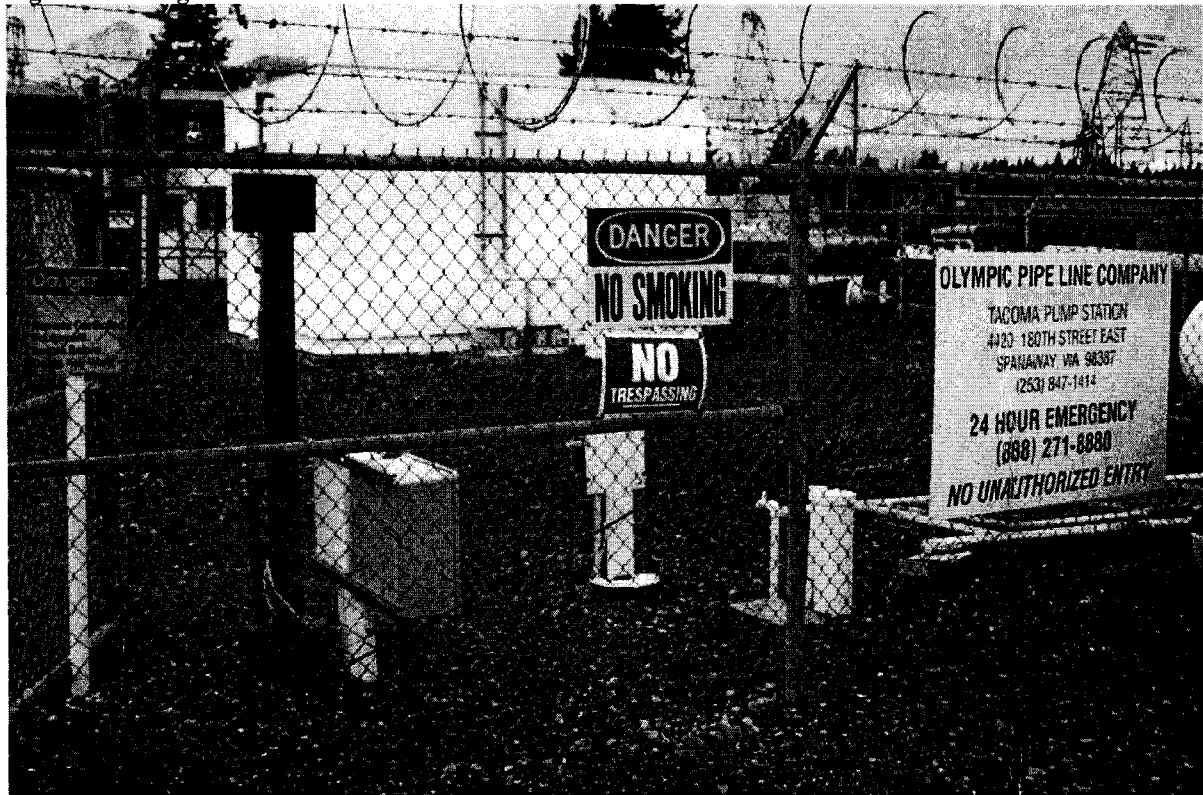
- 2) Visited Tacoma Pump Station (see picture #14). Cathodic protection readings were taken at an incoming mainline valve (-1.608v). Rectifier readings were taken at rectifier # 290 for pipeline (28.12v/7.8amp) and rectifier for station (60.23v/0.3amp).

Figure 14: Signage at the Tacoma Pump Station

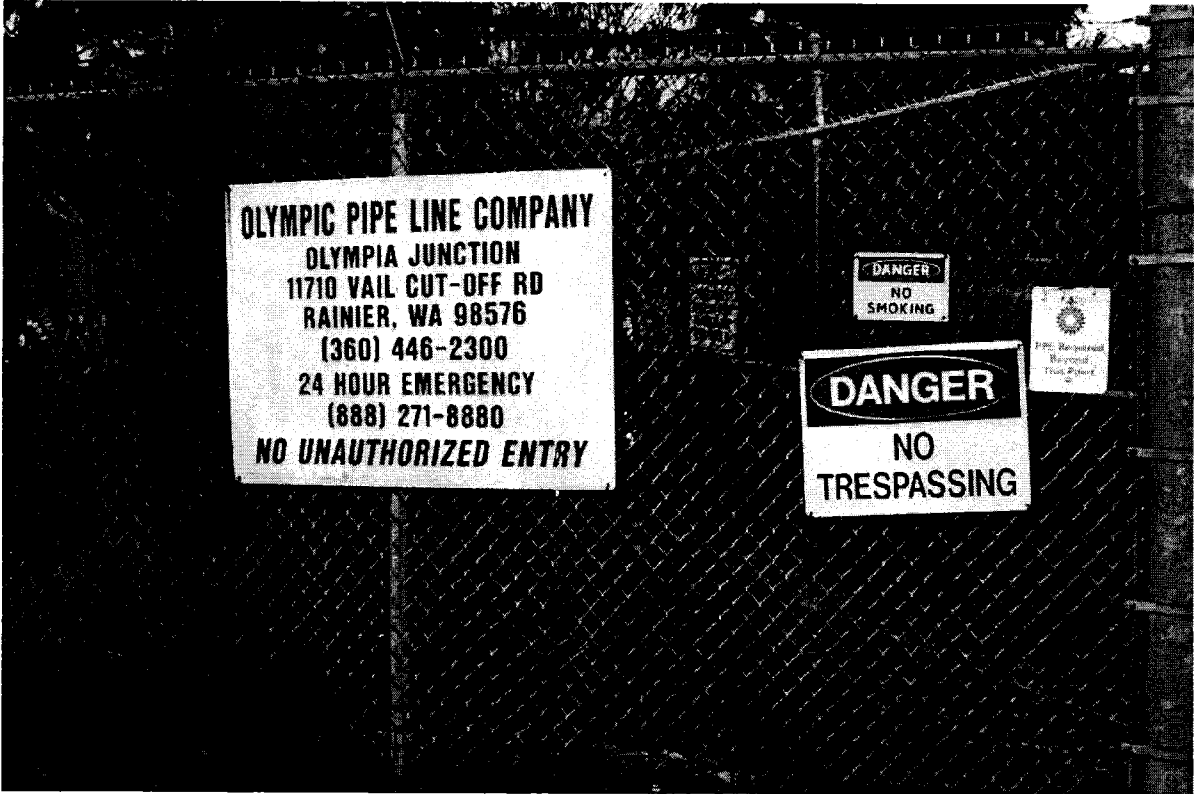
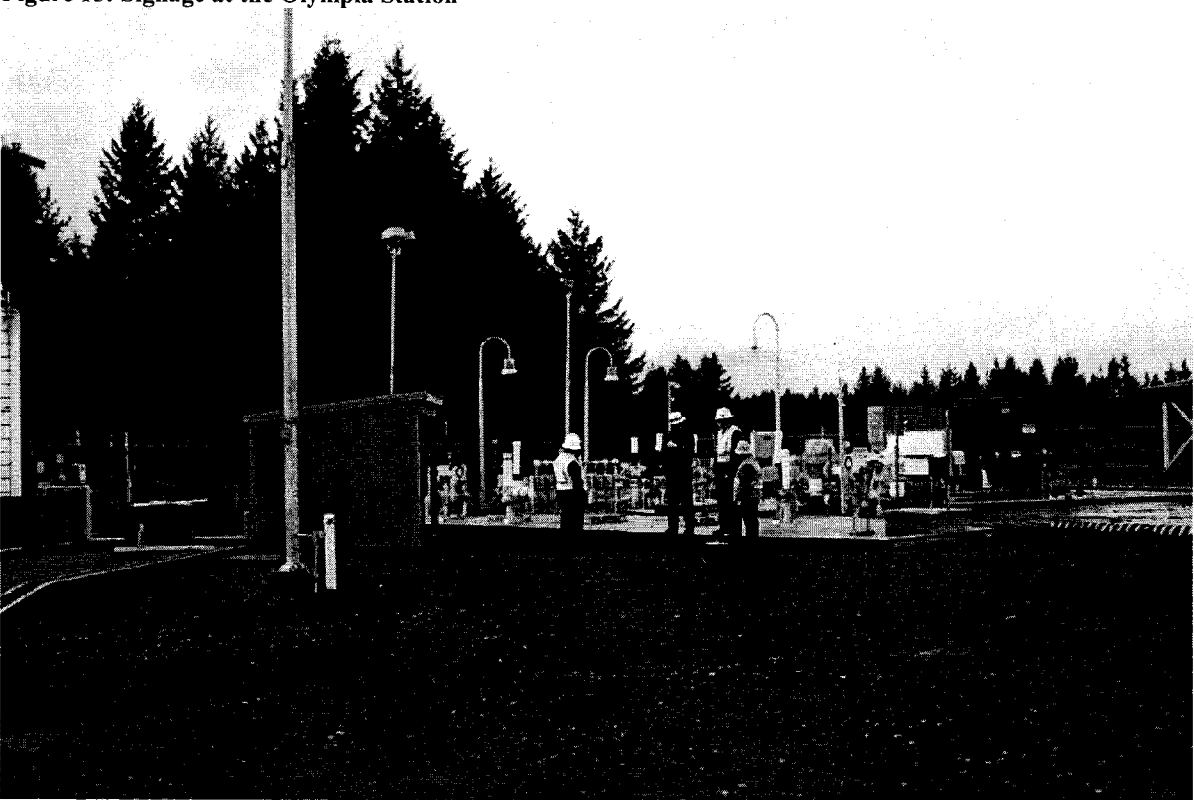
- 3) Visited Olympia Station (see picture #15 and #16). Rectifier readings were taken at rectifier #300 (55.3v/2.1amp).
- 4) Visited Castle Rock Pump Station (see pictures #17 and #18). Cathodic protection readings were taken at the incoming mainline block valve (-1.408v), MOV at MP196 (-1.800v). Rectifier readings were taken at rectifier #340 for the mainline (8.83v/3.12amp) and rectifier #342 for the station (46.8v/1.7amp). Observed one OQ covered task of Mr. Dave Wild to demonstrate the calibration of the pressure transmitter.

Figure 15: Signage at the Olympia Station

Figure 16: Olympia Station

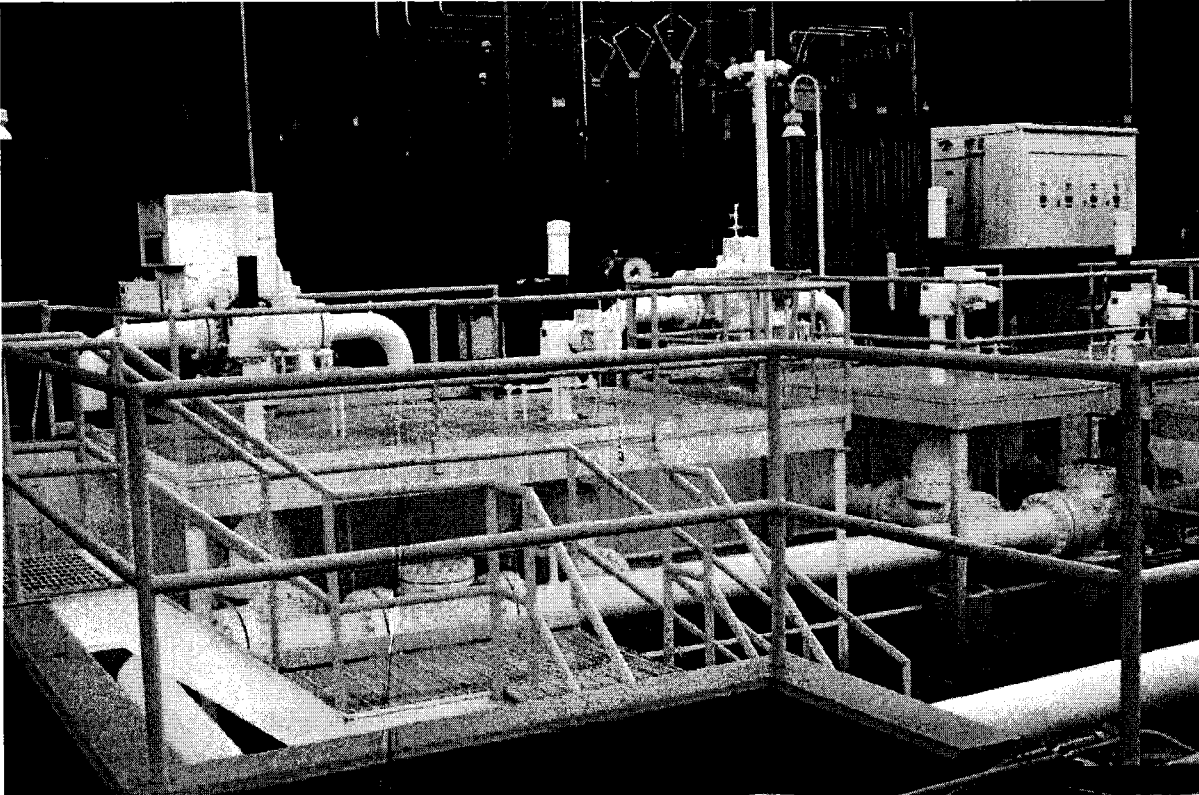
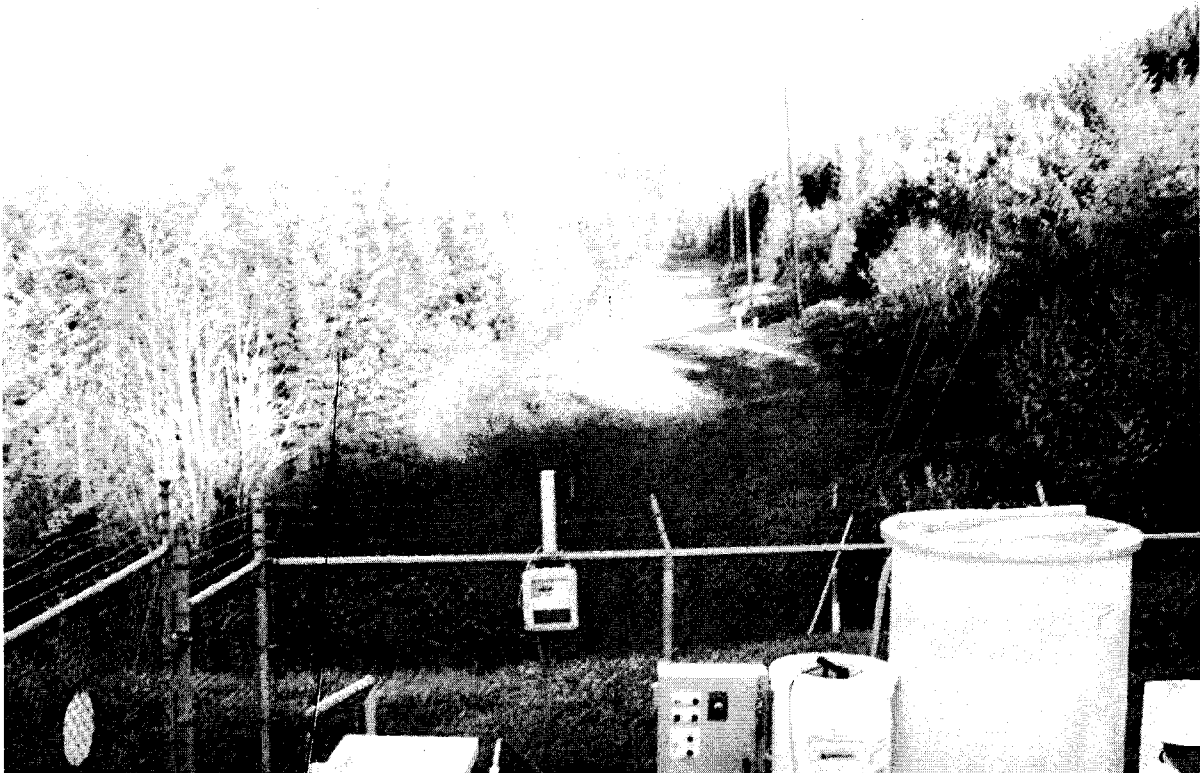
Figure 17: Castle Rock Pump Station

Figure 18: Pipeline right-of-way near the Castle Rock Station

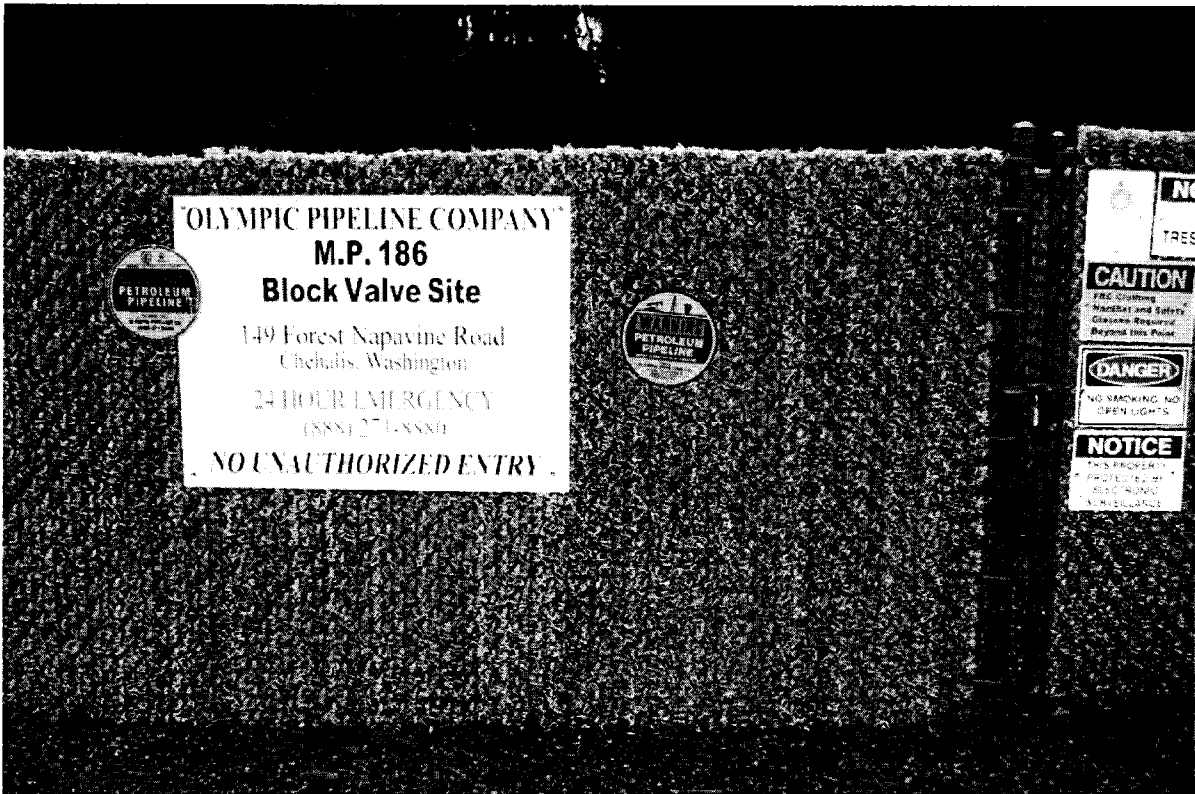
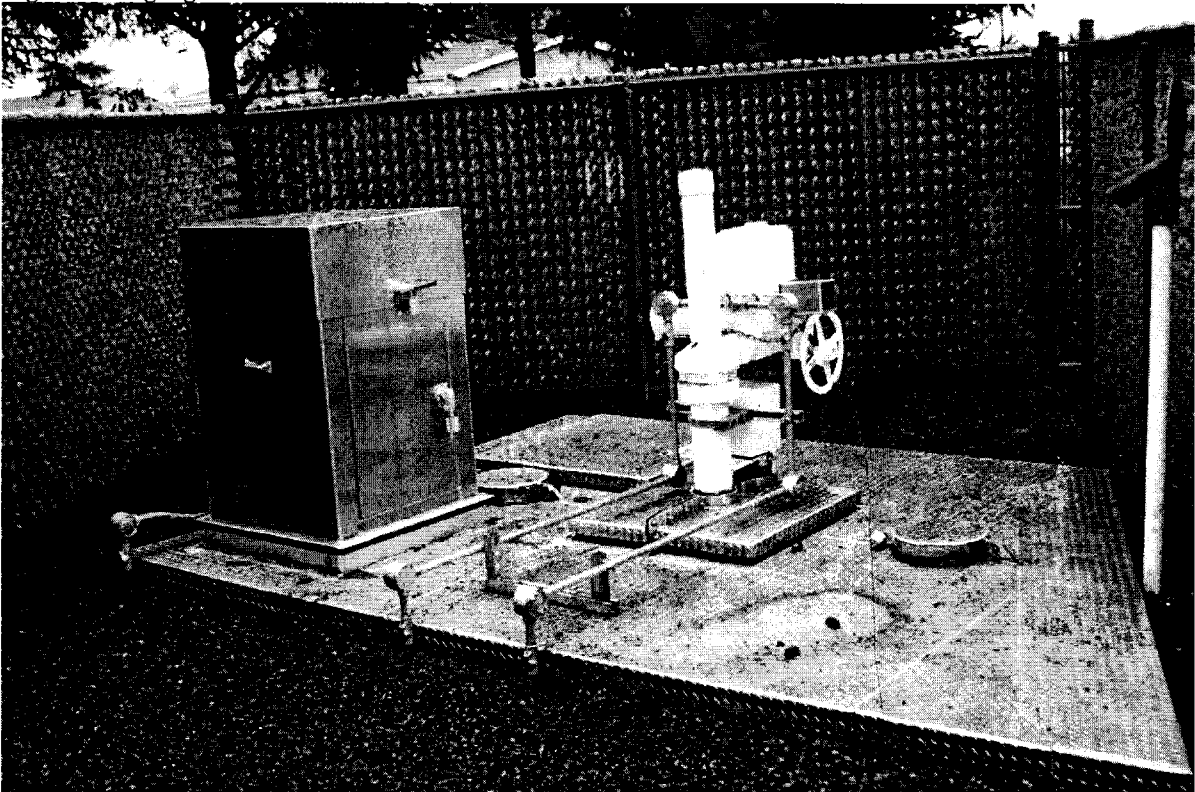
- 5) Verified a new actuator was installed in 2008 for mainline valve at MP186 (see pictures #19 and #20). Verified a new MOV was installed in September 2009 at MP 196 and it appears that drainage needs to be improved at the valve site (see pictures #21 and 22).

Figure 19: Signage for Mainline Valve at MP 186

Figure 20: Mainline Valve at MP 186

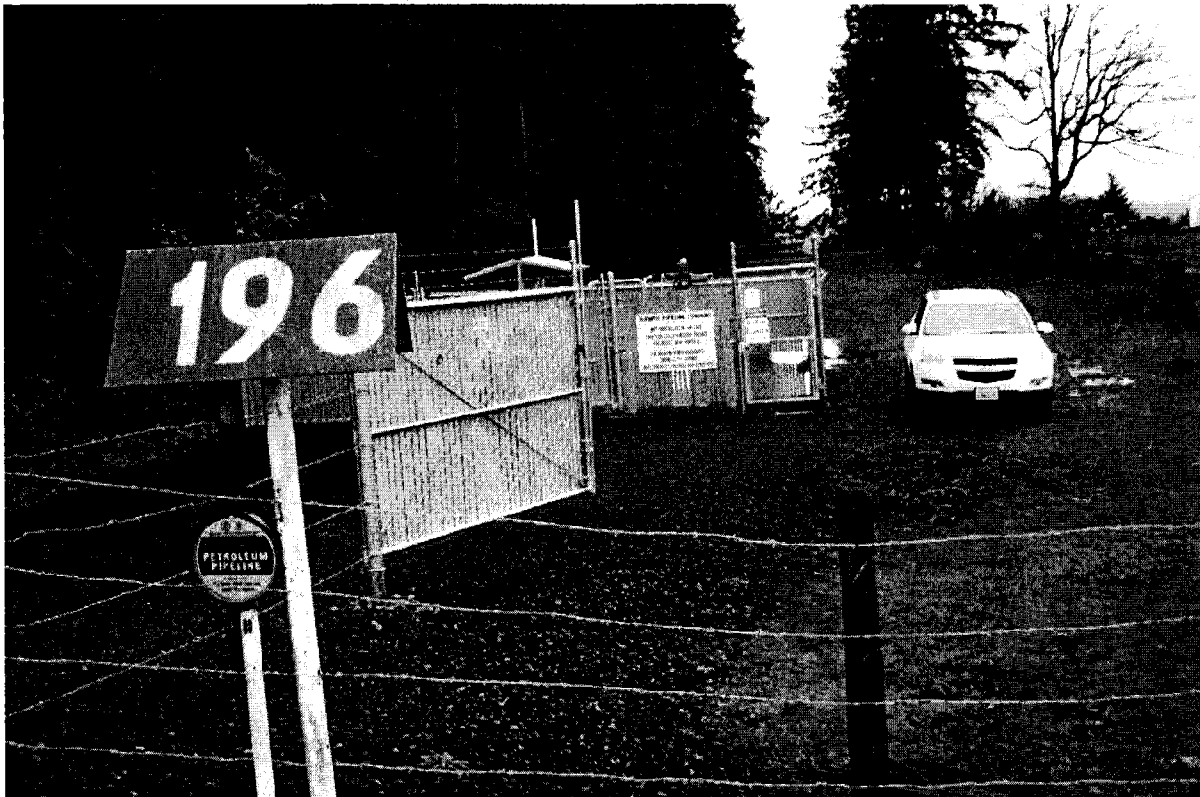
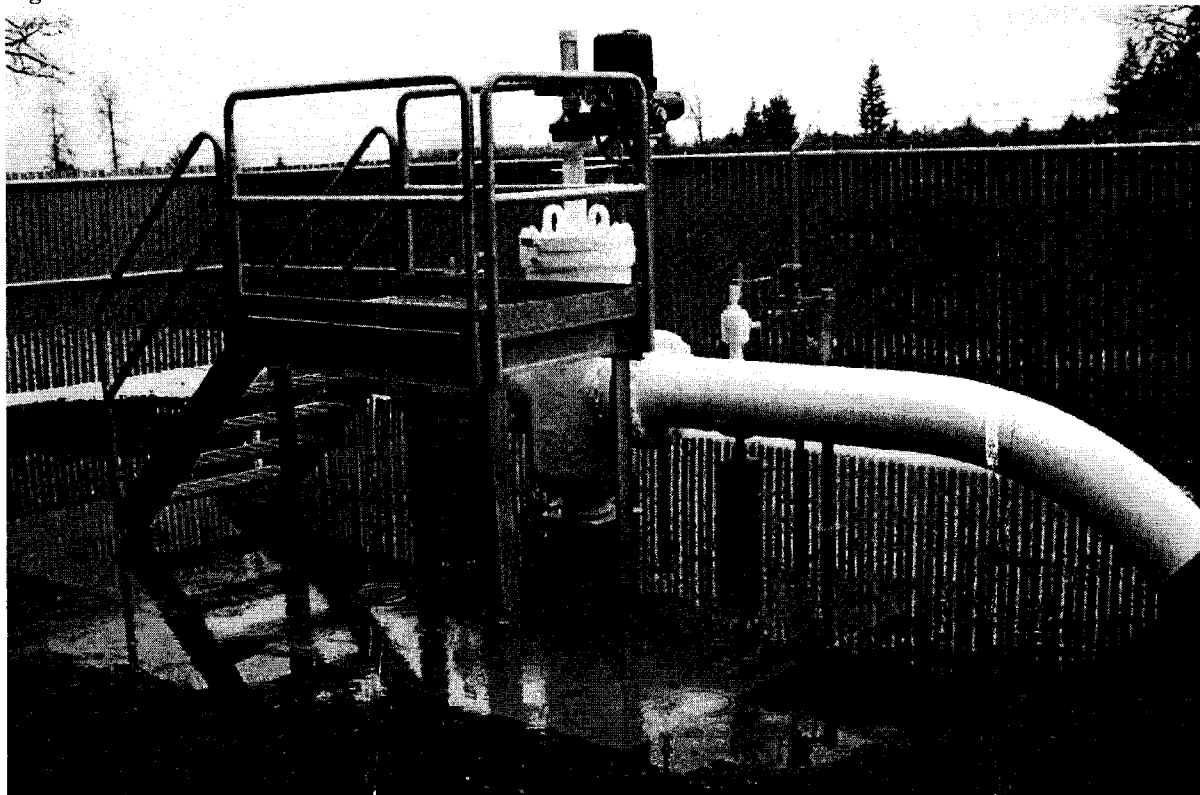
Figure 21: Mainline Valve at MP 196

Figure 22: Mainline Valve at MP 196
