POST INSPECTION MEMORANDUM

Operator Inspected:
Williams Gas Pipeline - West
2800 Post Oak Blvd
MC 1060/12314
Houston, TX 77056

Unit Inspected: Sumas District

Inspection Type: I01-Procedures Standard Inspection,
I07-IMP Field Verification & Follow up, and
I08-OQ Field Verification

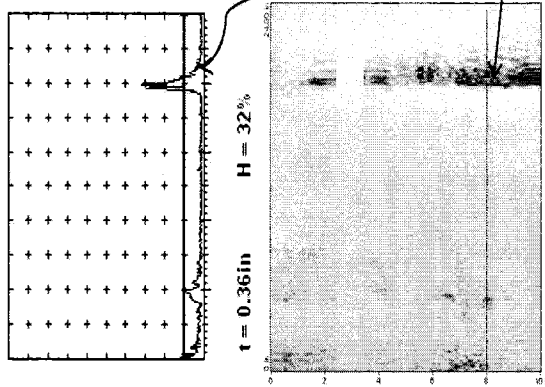
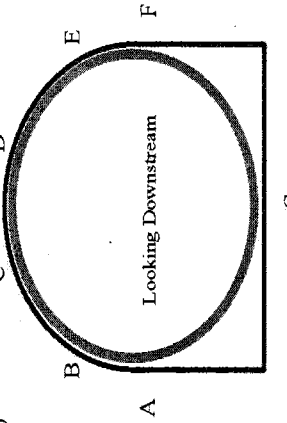
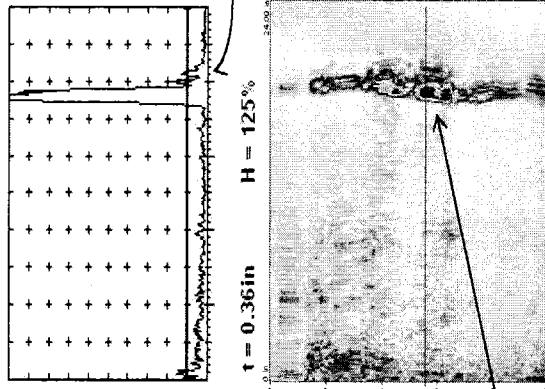
Layout and SETUP INFORMATION

total scan length; 60"/10" length per scan
 Probe loc. 6" from strap. Strap width 5 1/2" (note BOX in scan "A")

signals from girth weld at elbow averaged in order to set sensitivity

Avg of 32% and 125% = ~80% of sh

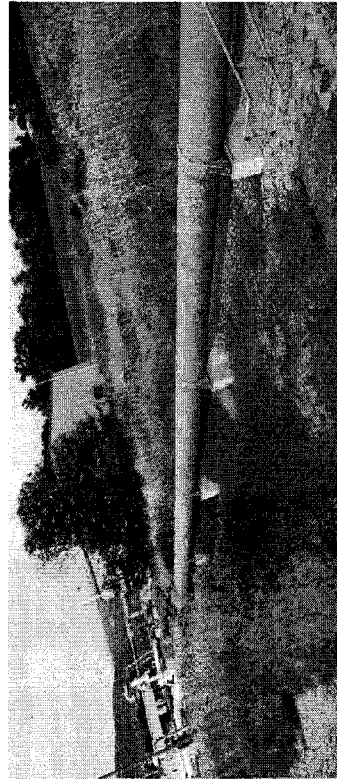
1 --- 7

Girth Weld signals

Coast Wave ISONIC Investigation, NDT was completed on the 30-inch incoming line supports and straps to the Sumas Compressor Station yard. The south support was of interest because it included a girth weld south of pipe strap #9 in the guided wave data. No additional evaluation or remediation is scheduled for this section of pipe. (wave date on right is zone "G" and left is zone "E")
