JCC-UTC-001

RE: Complaint Case 21-009: Johansen Construction Company vs. Puget Sound Energy  
(WA OCC Locate Ticket 21079531)

SUBJECT: PSE High Pressure Gas Main Miss-Locate on Weatherly Inn Project

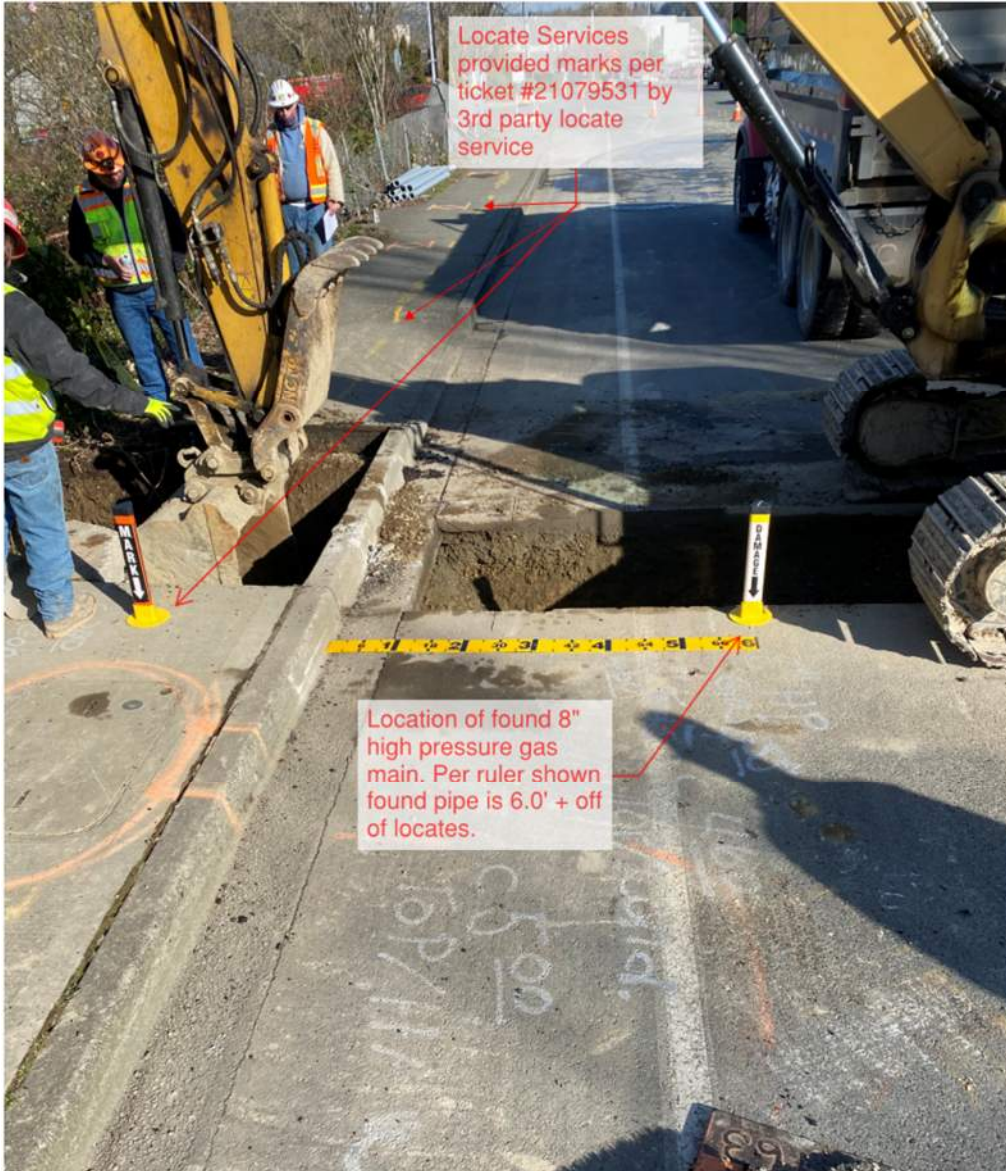
Photo Caption: Vicinity map with location of utility miss locate  
**JCC PHOTO #001**

*While inspector was off attempting to locate the line, JCC exposed a pipe that was 8", which was confirmed by Gas inspector to be the 8" HP line. The gas main was found 8 feet east of the locate marks provided by locate services.  
Ended additional potholing at 12:30PM.*

Upon start of work and potholing activities commencement – it became evident that the locates were substantially inaccurate – marks were 8 feet off of actual location.

*Photo Caption: Open trench where 8" high pressure gas main (PSE) was found vs where locate marks were provided*

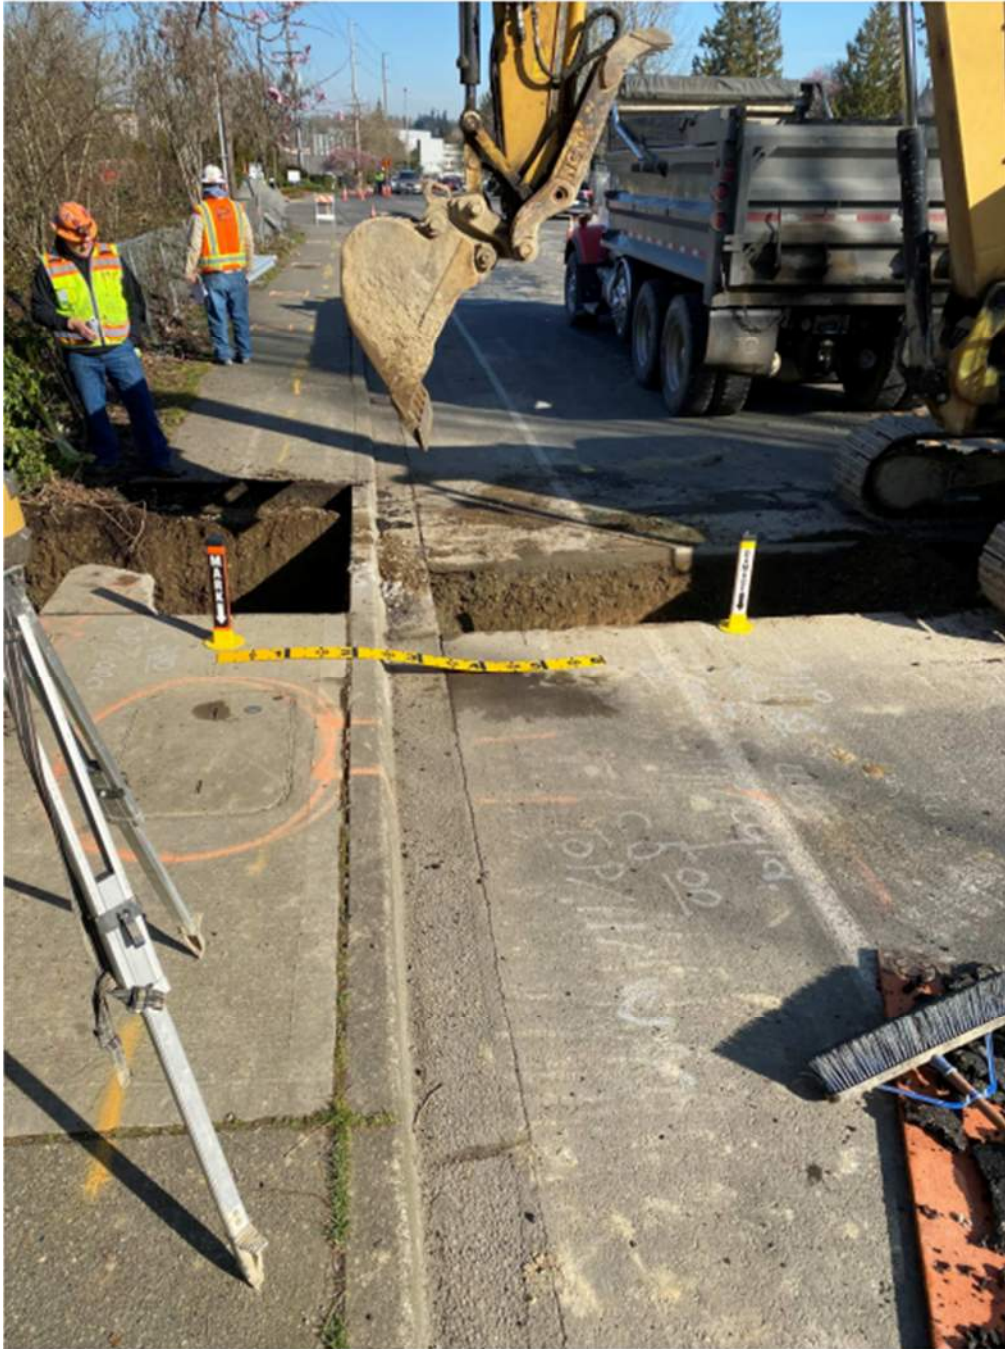
*Photo Caption: Larger view of locate marks and where pipe was found.*

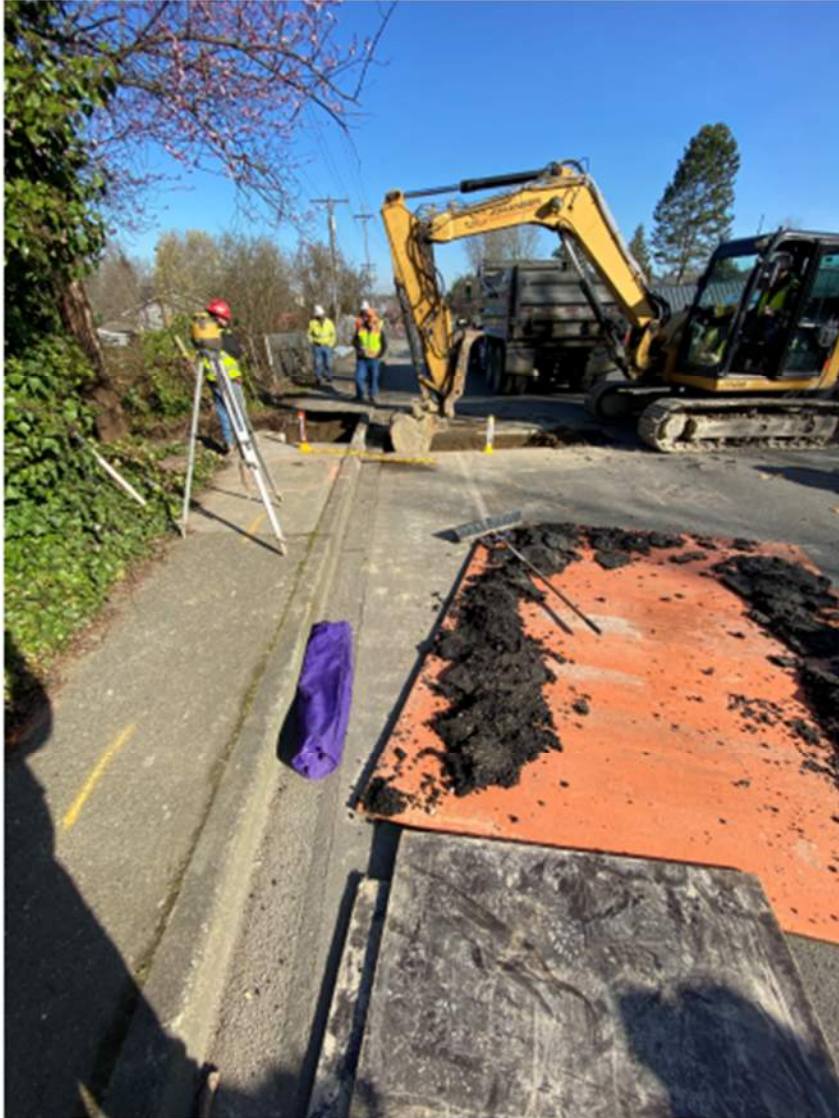
JCC PHOTO #003

*Photo Caption: Larger view of locate marks and where pipe was found.*

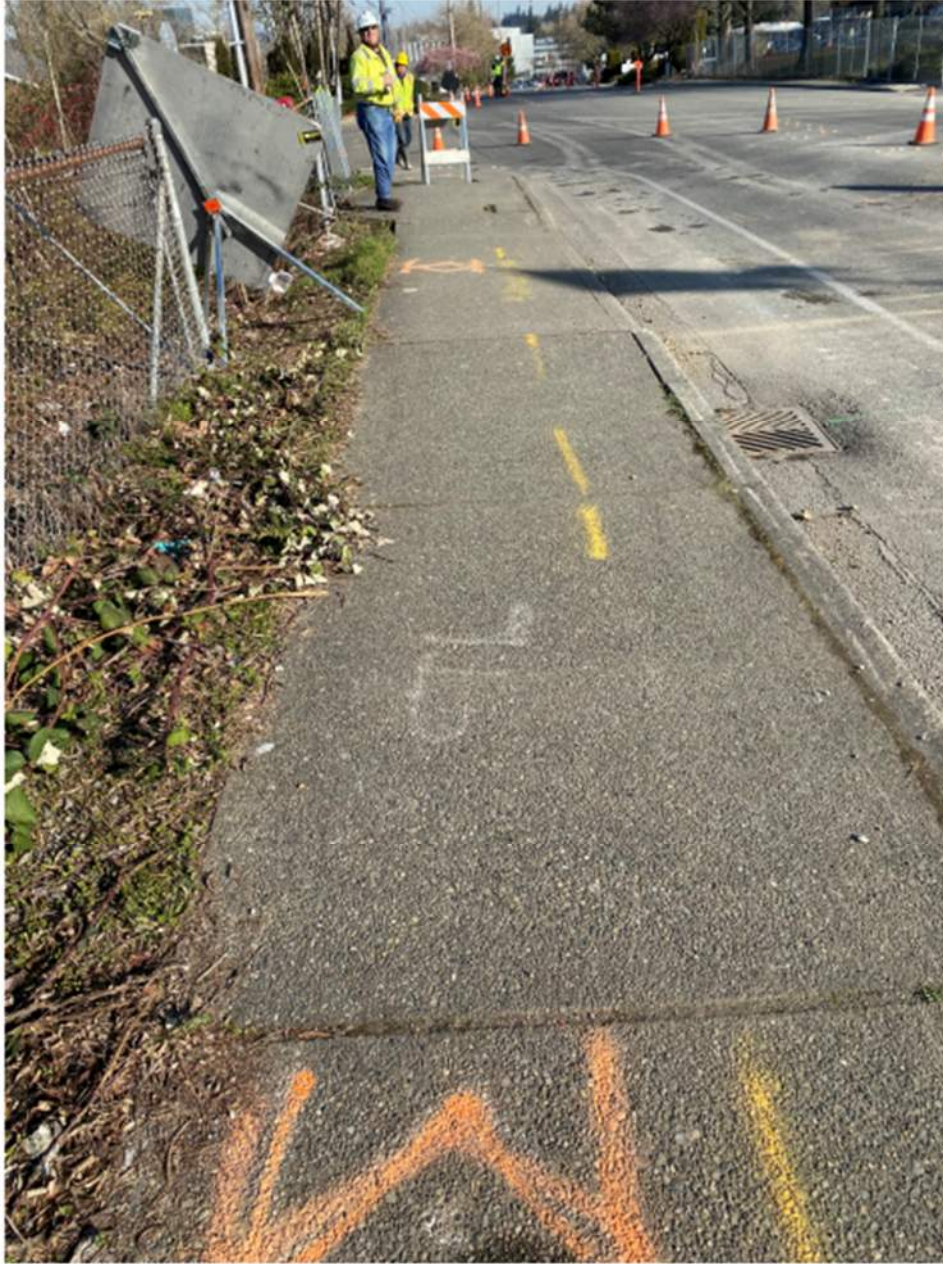
JCC PHOTO #004

*Photo Caption: photo of locate marks north of where potholing was completed on Talbot road  
– locate marks inaccurate by 6'+*
