Case 21-045
M&L Construction vs Avista

Ticket Number: 21440305

Location: Day Mt Spokane & Newport Hwy

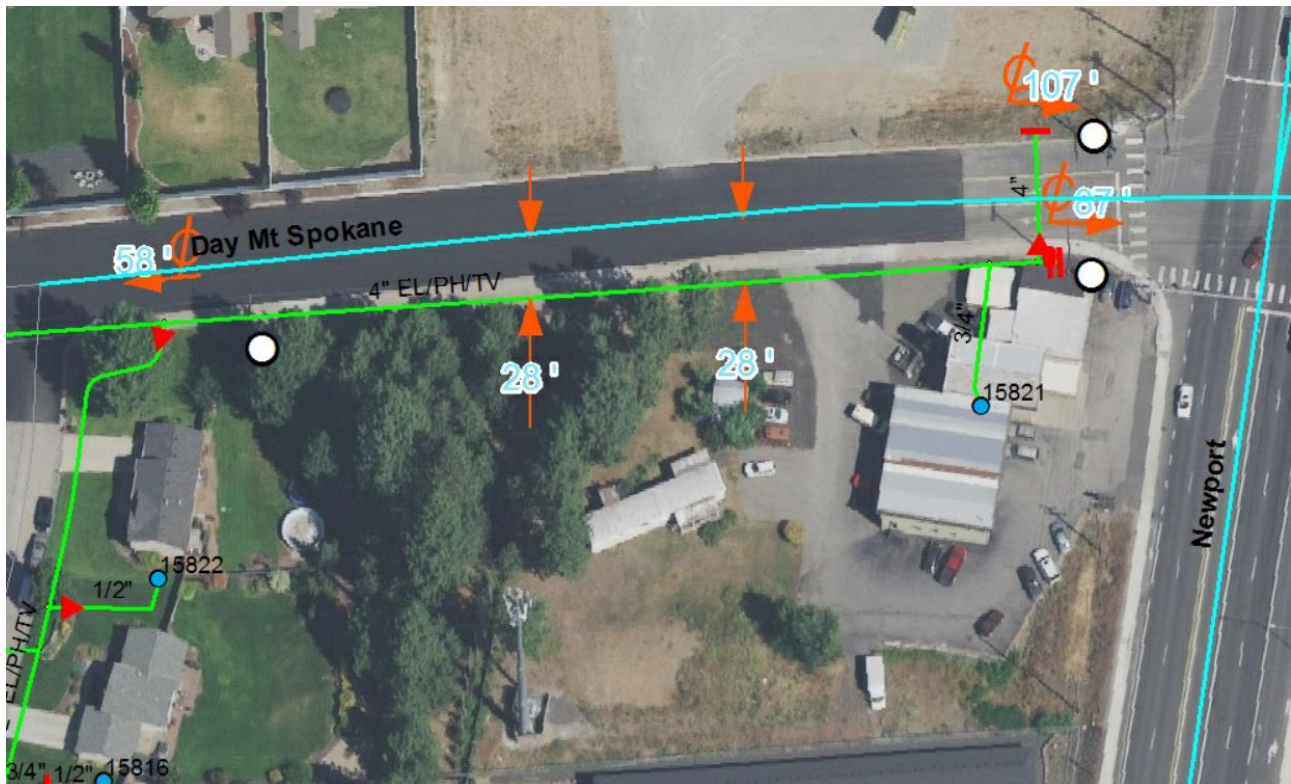
Exhibit A – Vicinity map of dig location, Day Mt Spokane and Newport Highway. Location of 4" pipe on south side of road where M&L Construction crossed.

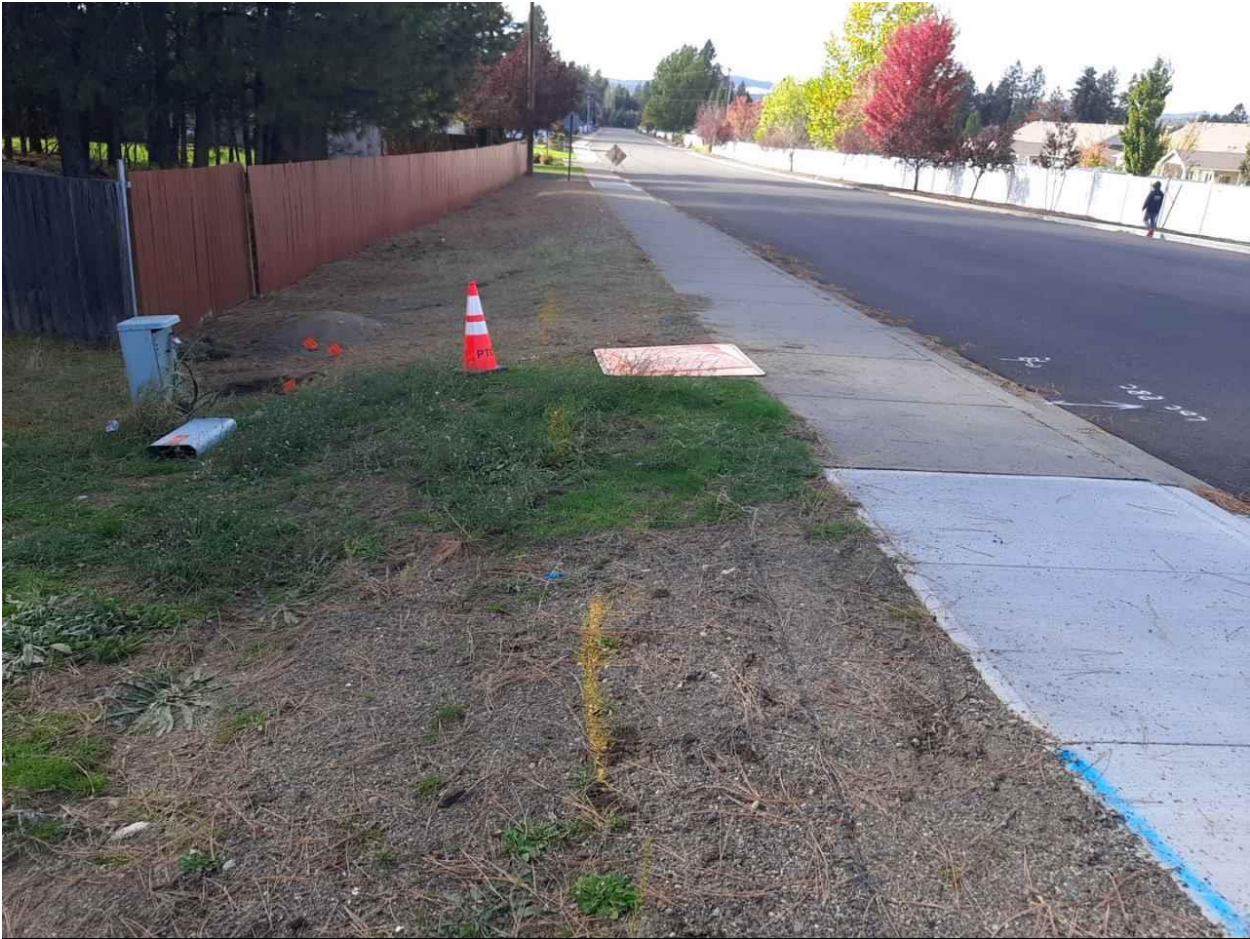
The original ELM Utility locator failed to locate a section of 4" plastic pipe in the dig zone on 9/27. The locator for Whitworth Water, an ex-ELM locator, contacted ELM on 10/6 to let them know that there was a 4" plastic main in the dig zone that he remembered being in this area. ELM immediately sent out a locator to locate the pipe in the south ROW. The original locator failed to see the white marks in the south ROW. If the locator would have slowed down and taken the time to read the location of work description on the ticket, he would have known to look for additional white marks on the south side of the road.

Exhibit B – Locating photo of 4” pipe that was located after Whitworth Water called ELM on 10/6.

Step #2 of ELM's locating procedures is to read the ticket to understand the scope of the work. The locator was only looking for white paint on the ground to expedite the process. Avista's Quality Assurance Department has been asked audit this locator to make sure that he understands and follows the procedures with emphasis on step #2. ELM has also been asked to discuss the importance of following procedures with their locators.
