Docket No. TP-220513

**Report of the Investigation into the EVER FORWARD Grounding, US Coast
Guard 2023**

REPORT OF THE INVESTIGATION INTO THE EVER FORWARD (O.N. 9850551) GROUNDING IN THE VICINITY OF CRAIGHILL CHANNEL ON MARCH 13, 2022

**THE GROUNDING OF THE FOREIGN CONTAINER VESSEL EVER FORWARD
(IMO 9850551) IN CRAIGHILL CHANNEL EAST OF BUOY 16 NEAR
BALTIMORE, MD ON MARCH 13, 2022**

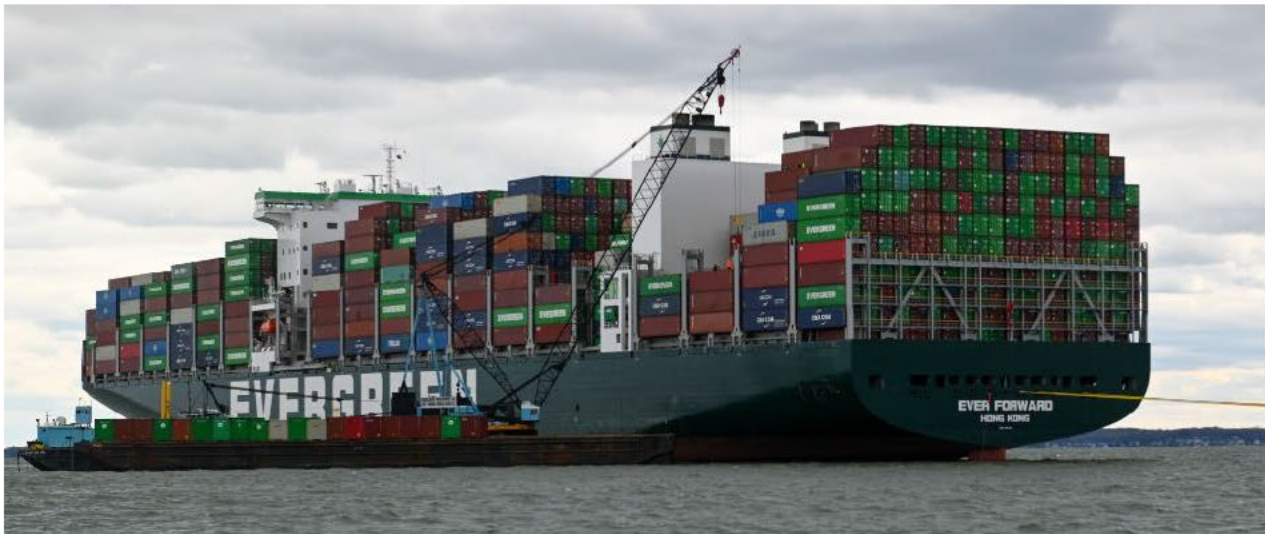
Figure 1. View from the port quarter of EVER FORWARD, aground east of the Craighill Channel.
Photograph taken April 14, 2022 by USCG.

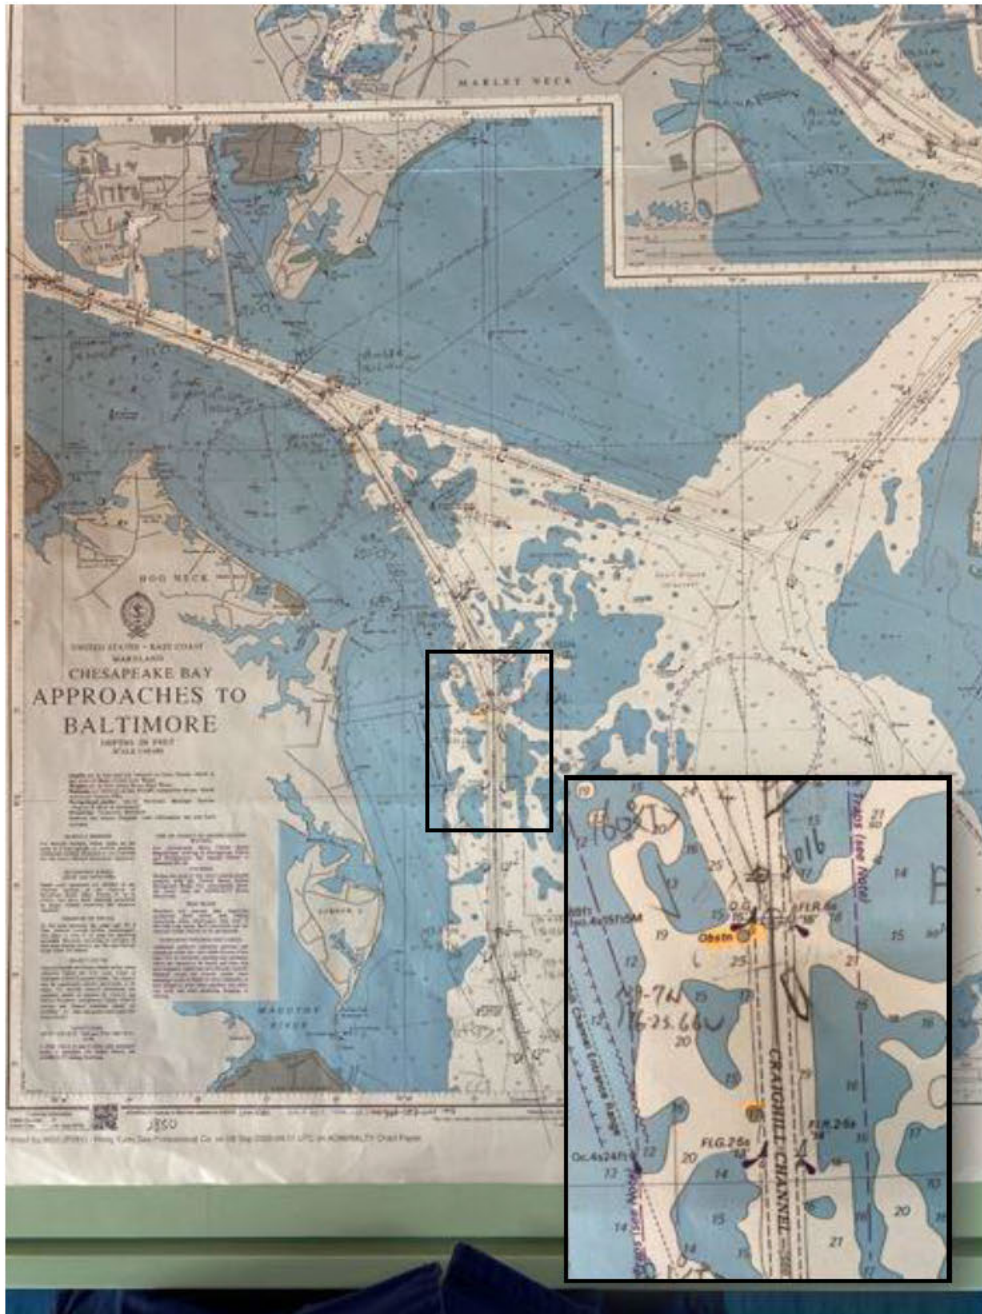
4.1.5. Pilot 1 was not aware that there were paper charts available and in use by the bridge team at the time of the transit.

Figure 3. Paper chart that was in use and on the bridge of the EVER FORWARD at the time of the grounding. The outlined inset shows a close-up of the plotted voyage plan track line and waypoints as well as the vessel location after grounding. Photograph by USCG Investigator.

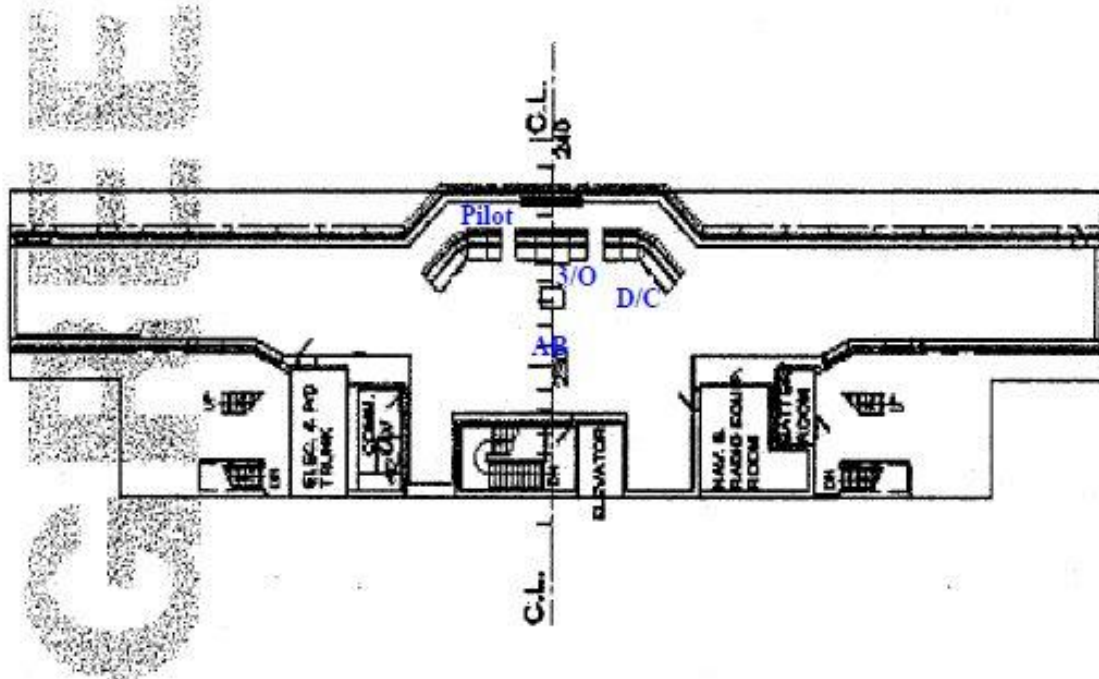
4.1.12. Pilot 1 was positioned forward of the navigation console, port (left) of ship's centerline (C.L. in Figure 4), by the vessel's pilot plug. The Third Officer (3/O in Figure 4) was positioned behind the navigation console, approximately at the centerline of the bridge. The Able Bodied Seaman (AB in Figure 4) was positioned at the helm, and the Deck Cadet (D/C in Figure 4) was behind the navigation console on the starboard (right) side. Bridge team members were generally in these locations but not restricted from movement for the duration of the voyage.

Figure 4. EVER FORWARD navigation bridge deck plan and approximate crew positions at time of grounding. Image obtained by USCG Investigator.

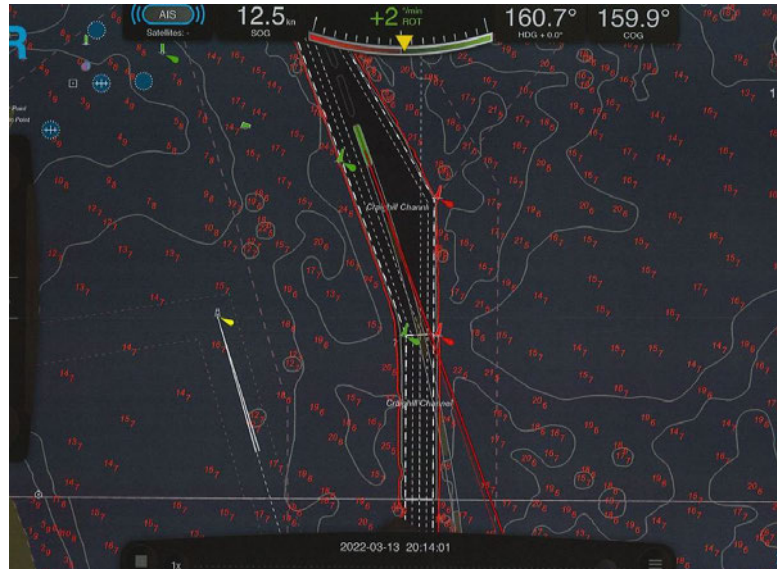
4.1.19. At 2014, Pilot 1 viewed another screen on the PPU with the intent to screenshot data from another voyage. This action stopped the recording of the active transit, and the PPU did not begin recording the active transit again until 2019, after the vessel grounded and the pilot returned to the active screen.

Figure 5. PPU screenshot just before the end of the first recording of EVER FORWARD's transit at 2014 on March 13, 2022, just prior to the grounding. Image provided by Pilot 1.

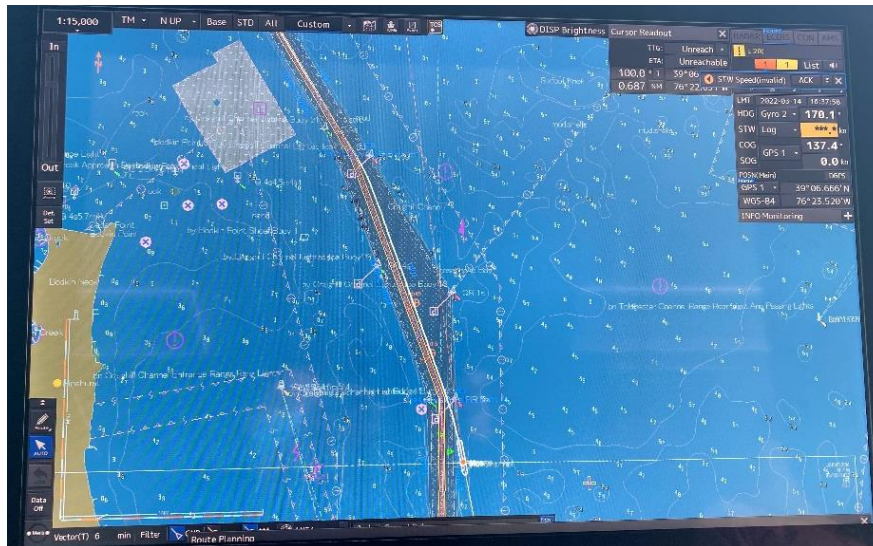
4.1.22. At 2017, the EVER FORWARD crossed the predetermined waypoint position to initiate a turn to approximately 180 degrees. No order to turn was given by Pilot 1, and the Voyage Data Recorder (VDR) showed the vessel maintained a heading of approximately 161 degrees.

Figure 6. ECDIS display of EVER FORWARD's intended voyage compared to actual track, showing the missed turn south to 180 degrees. Image obtained by USCG Investigator.

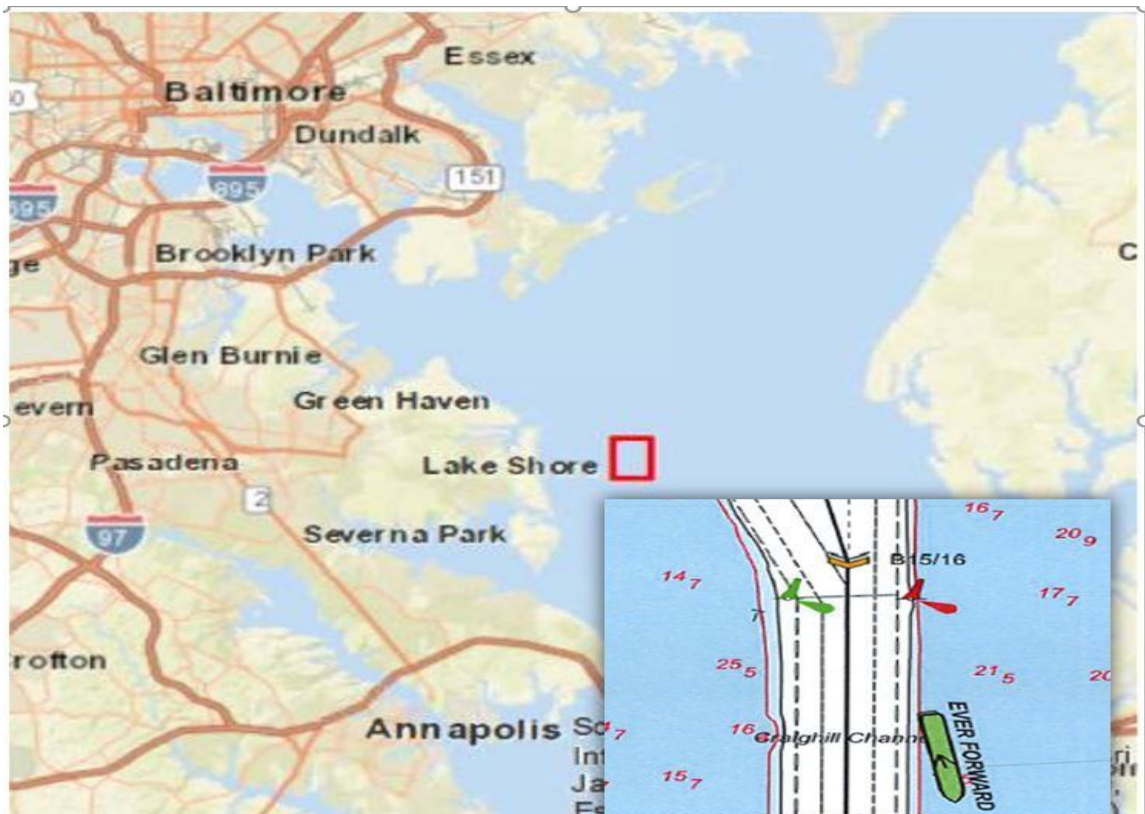
4.1.27. At 2018, the EVER FORWARD grounded outside of the Craighill Channel.

Figure 7. Red square indicates general location of grounding, south of buoy 16 outside the Craighill Channel. The inlayed image was obtained from USCG Navigation Center and obtained by USCG Investigator.

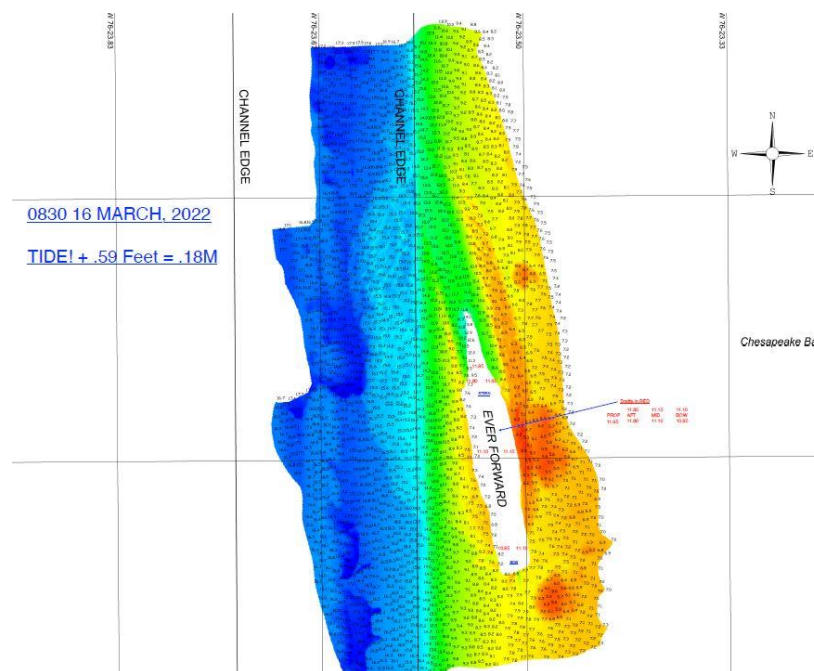
Figure 8. Multi-beam survey of EVER FORWARD grounded outside the Craighill Channel. Survey was conducted and image was produced by Donjon-SMIT LLC.

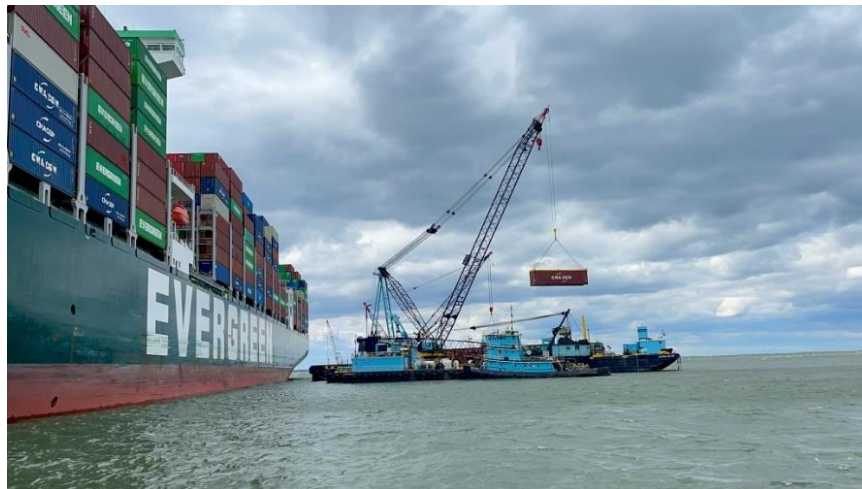
Figure 11. Crane operations on the port side of the EVER FORWARD during attempts to refloat the vessel. This photograph was provided by USCG District 5 Public Affairs.

4.2.22. On April 17, 2022 at approximately 0700, the EVER FORWARD was successfully pulled back into the channel and refloated, after dredging 206,280 cubic yards of material and the removal of 505 containers.

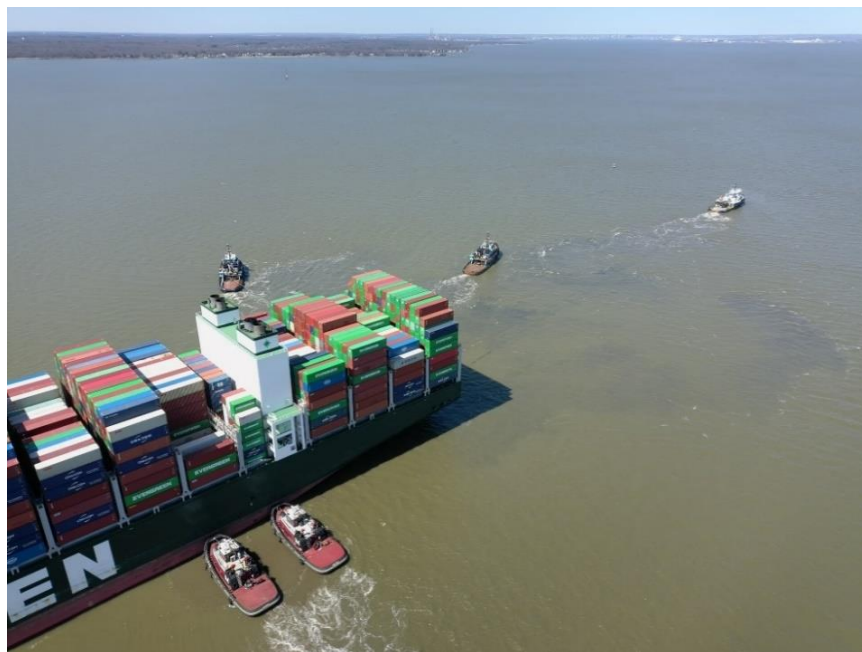
Figure 12. Aerial photo of the EVER FORWARD aft port quarter during refloat operations in an attempt to free the vessel. This photograph was provided by USCG District 5 Public Affairs.
