THE WASHINGTON UTILITIES AND TRANSPORTATION COMMISSION

Commission Staff Investigation Report on Explosion and Fire

12312 5th Avenue N.E., Seattle

DOCKET PG-111723

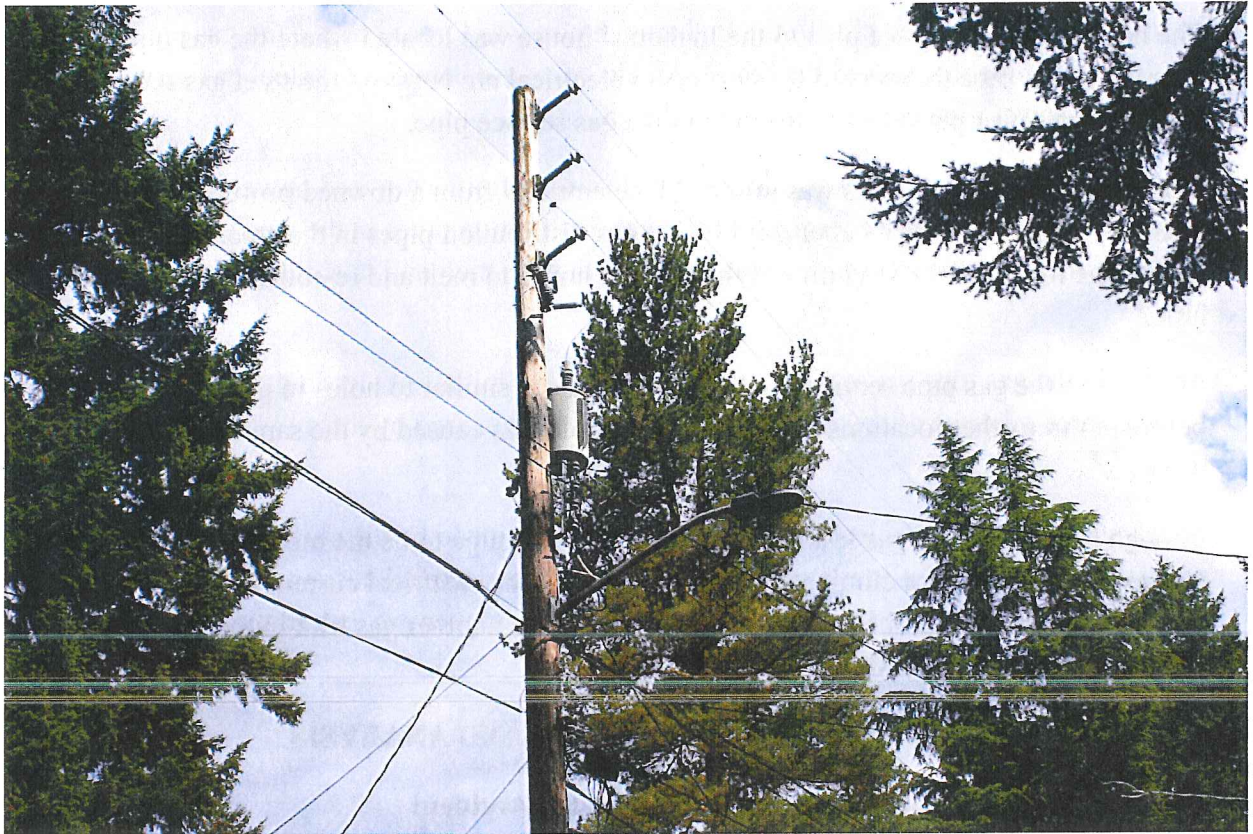
Photo 1: View of high voltage line (top of pole) near the intersection of N.E. 127th Street and 10th Avenue N.E. Photo taken September 30, 2011, by Kuang Chu, UTC engineer.

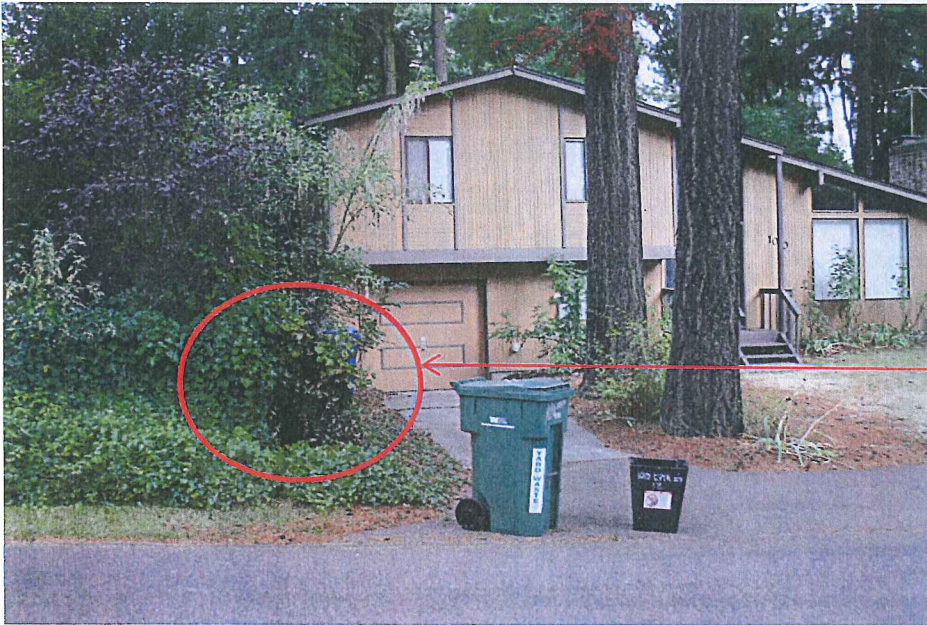
Location of fire at fence

Photo 2: View of where the high voltage line energized the fence post and caused a brush fire. Photo taken September 30, 2011, by Kuang Chu, UTC engineer

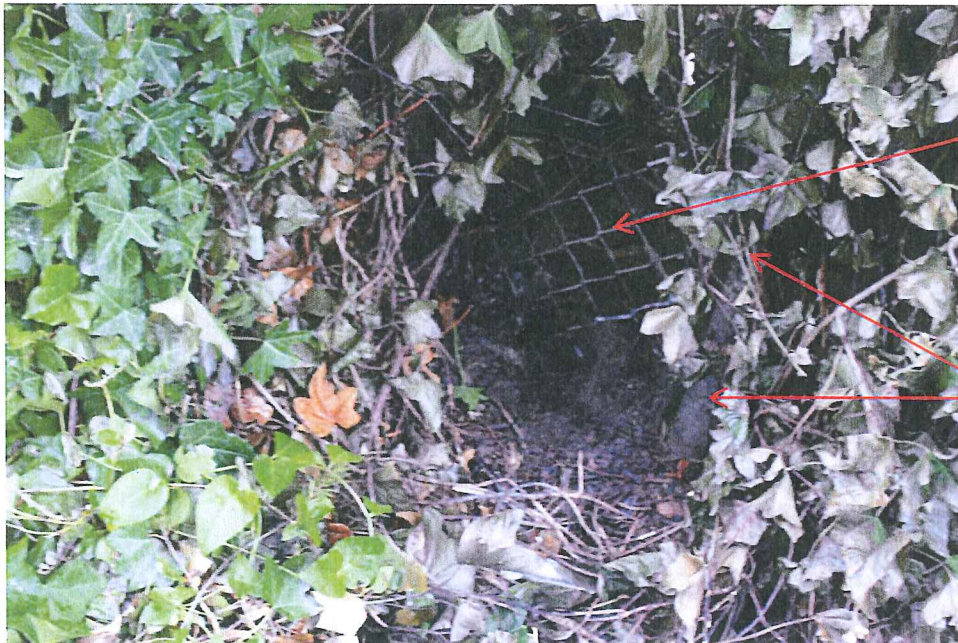
Photo 3: View of fence post, fencing, and fire debris. Photo taken September 30, 2011, by Kuang Chu, UTC engineer

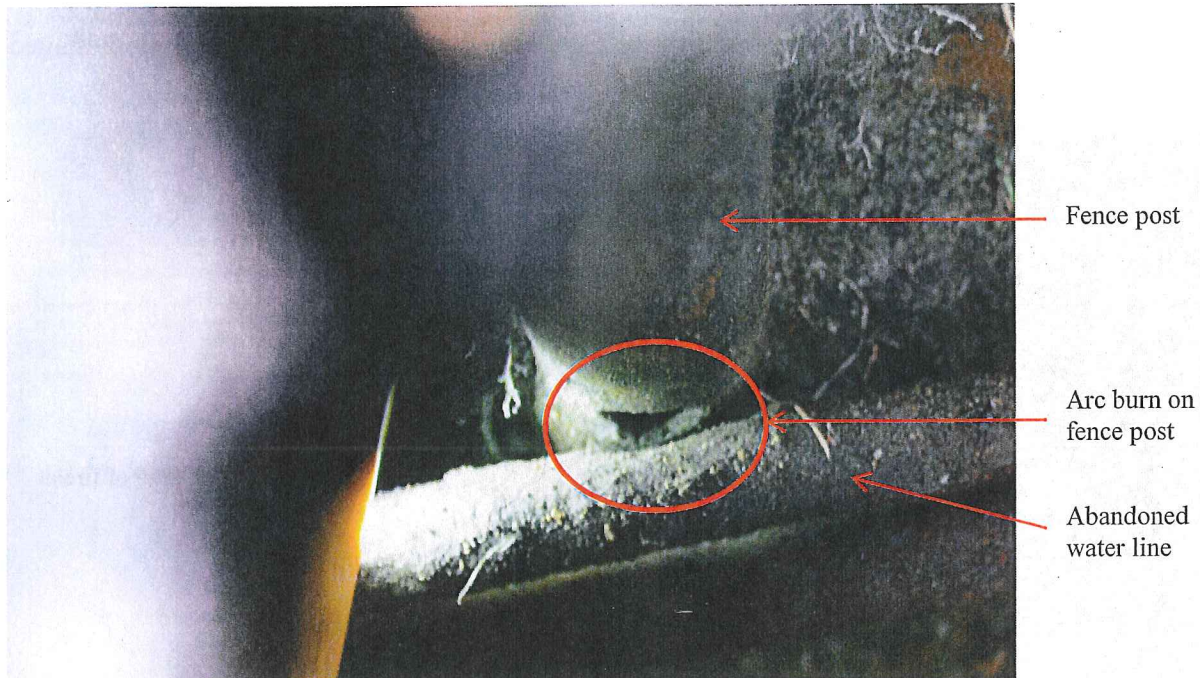
Photo 4: View of where the electrical arc damaged the metal fence post (hole in post) adjacent to the abandoned water pipe. Photo taken October 21, 2011, by Kuang Chu, UTC engineer

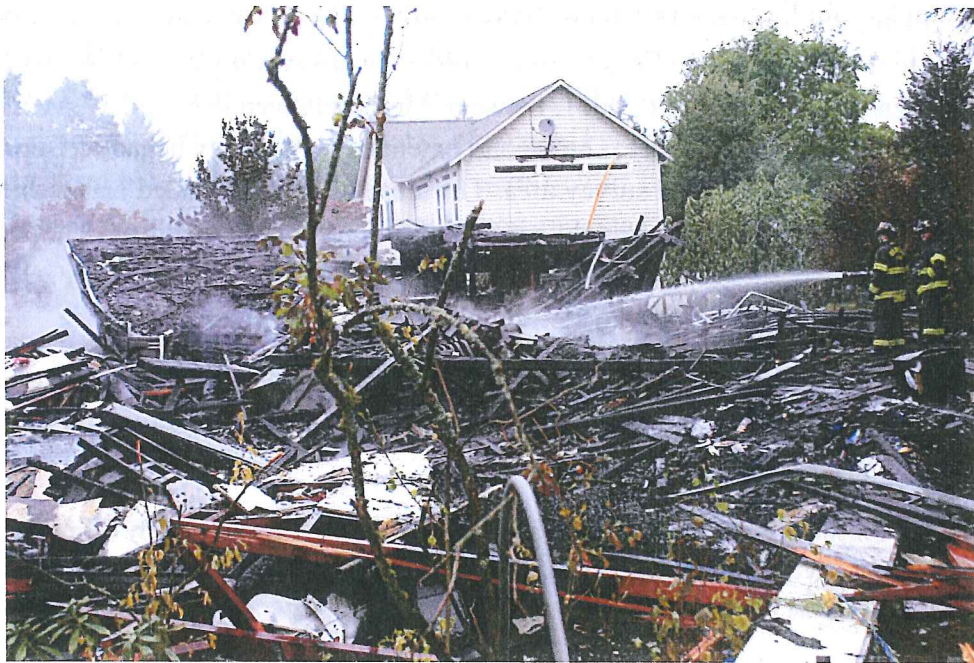
Photo 6: View of Inghams' home looking west. Photo taken September 26, 2011, by Kuang Chu, UTC engineer.

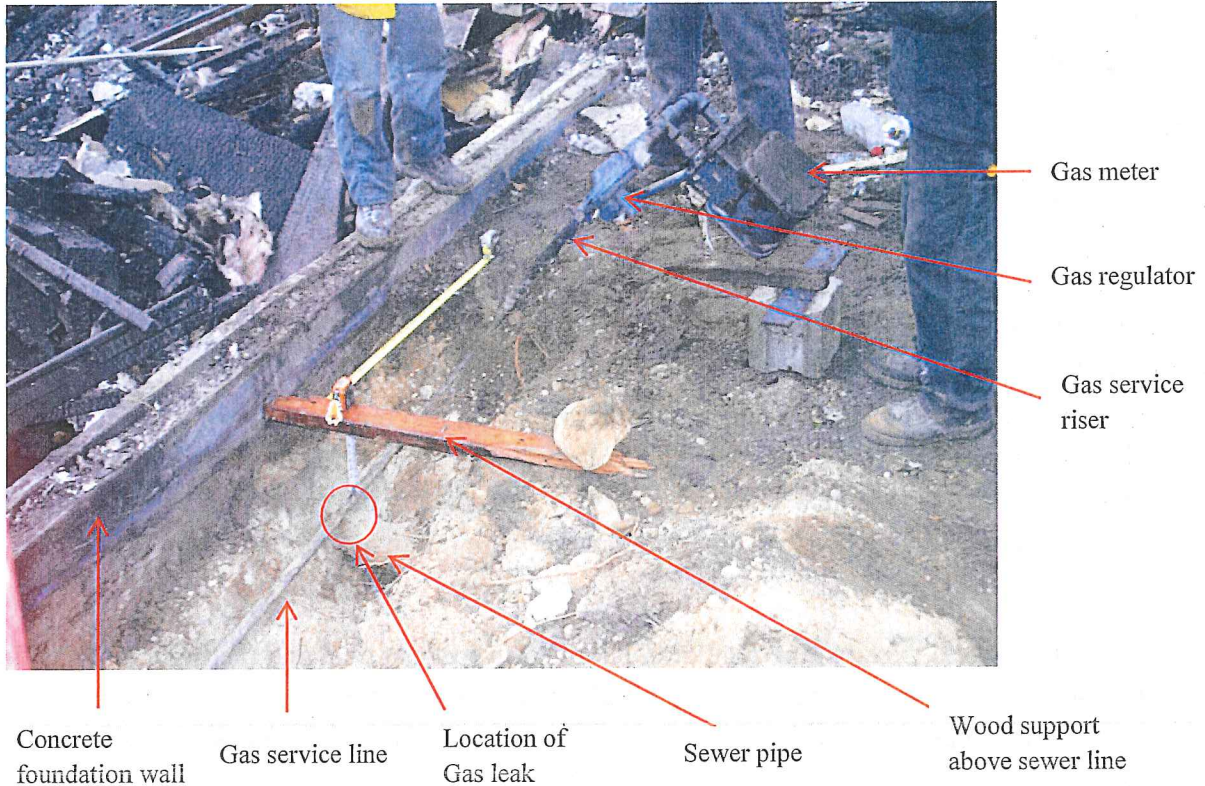
Photo 7: View of east foundation wall, location of service pipe, and meter set.-Photo taken September 26, 2011, by Al Jones, UTC engineer.

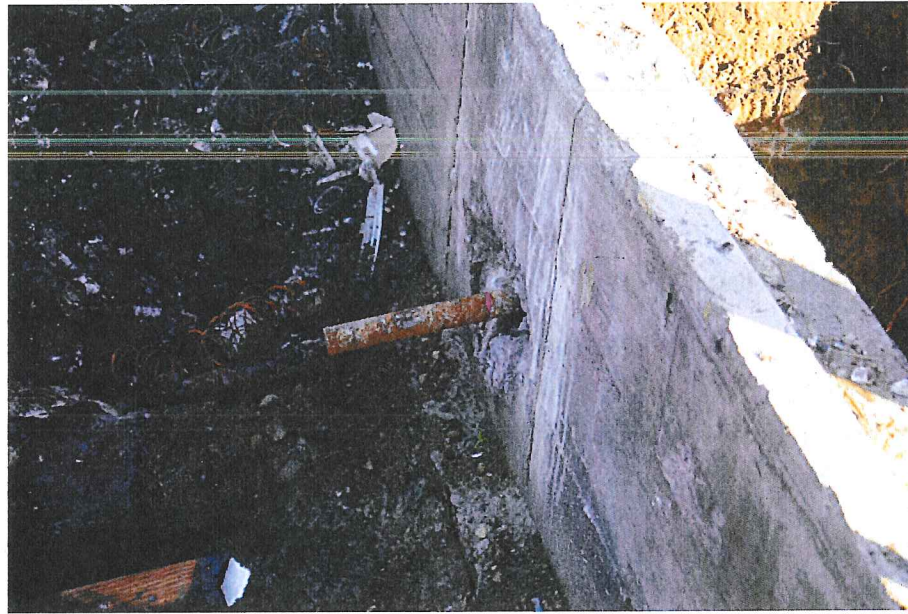
Photo 9: View of the gas fuel pipe entry into crawl space through east foundation wall. The vertical saw cuts in the concrete wall were made after the incident. Photo taken October 18, 2011, by Dennis Ritter, UTC engineer

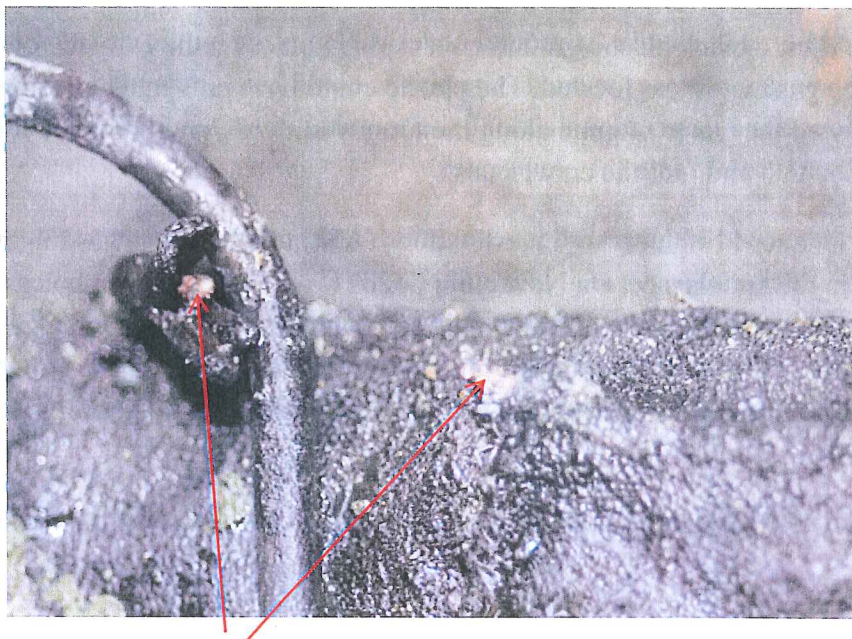
Damaged section of wire between the above end points

through the wire. Photo 10, below, is a photograph of the damaged bond wire PSE exposed.⁴² Approximately two inches of the wire was melted.

Photo 10: View of the damaged bond wire connection at gas main connection. About 2” of wire was melted. Photo taken October 25, 2011, by David Cullom, UTC engineer.

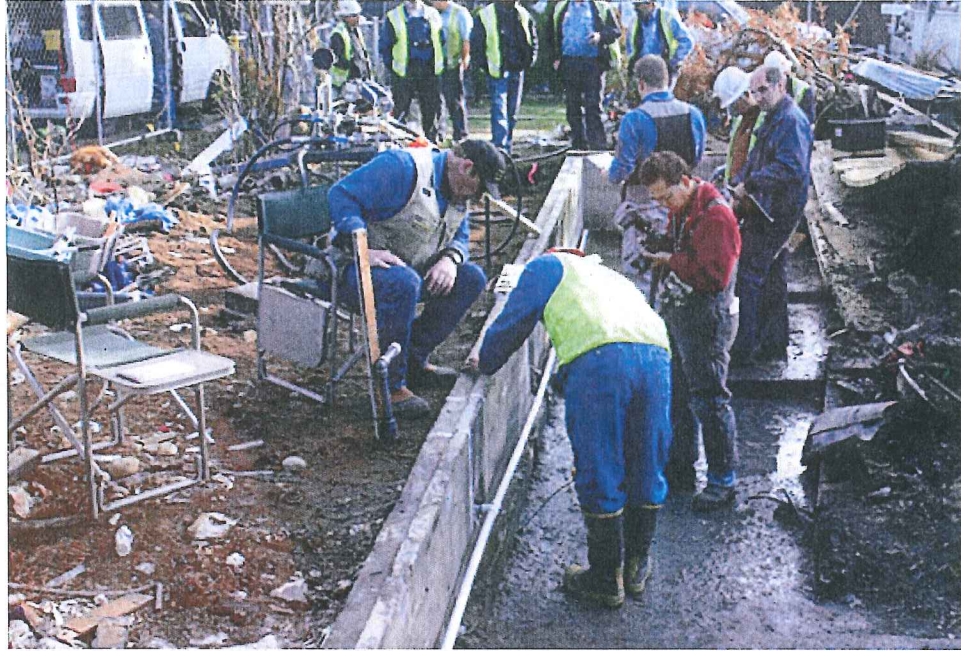
Photo 11: View of the east foundation wall (looking south) and the crawlspace concrete floor (right of the wall). The white plastic pipe at the base of the wall was supplied for use in the test. Photo taken November 8, 2011, by Scott Rukke, UTC engineer.
