THE WASHINGTON STATE UTILITIES AND TRANSPORTATION COMMISSION

DOCKET PG-082253

Commission Staff Investigation Report on Explosion and Fire

206 North Birch Street; Odessa, Lincoln County

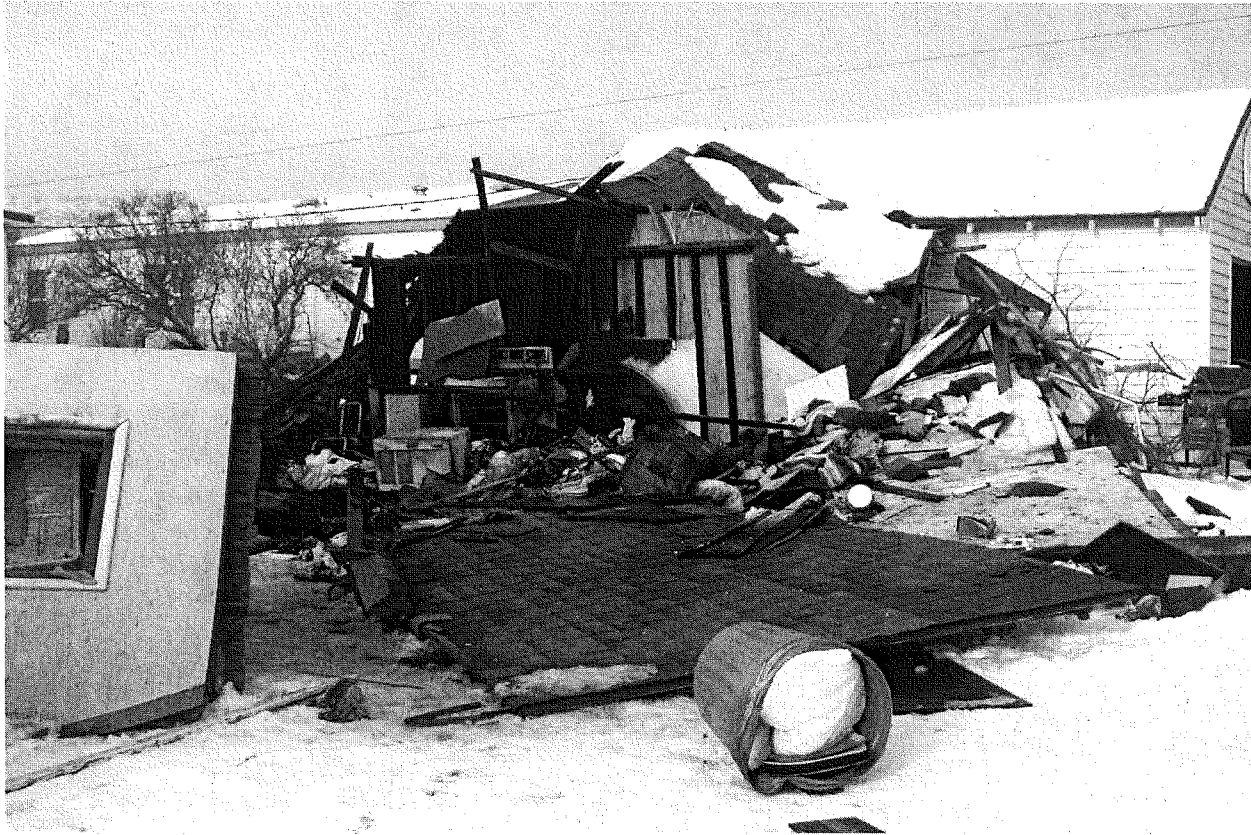
Exhibit B

10:30 A.M. Commission pipeline safety engineer Mr. Jones arrived at the incident site. Exhibit B²⁰ is a photograph he took showing the condition of the property at the incident site at that time. He observed that Avista had excavated the alley behind the incident site and exposed the 2-inch main (except for the failed section of pipe, which Avista had removed and taken to Spokane the previous day²¹).

View: Looking to the northwest at the destroyed secondary living quarters and damaged attached garage (white structure in background). The gas most likely entered through cracks in the concrete basement foundation walls and entered the garage through an internal door connecting the two structures. The fire was confined mostly to the secondary living quarters.

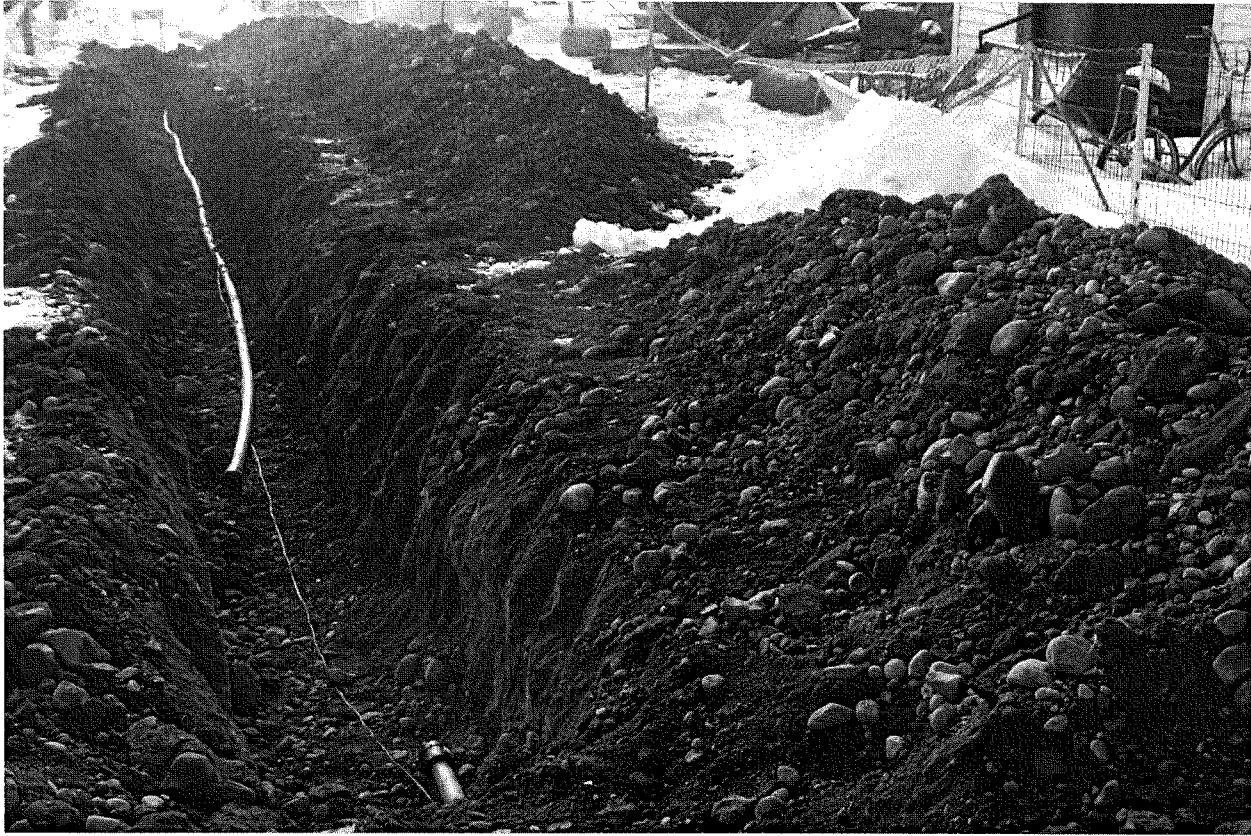
consistent with volcanic ash-like soil. At each end of the open trench, where the soil was not disturbed, there was no evidence that Avista placed any sand or other non-native material under or around the main when Avista installed it in August 1981. Exhibit C also shows the typical material found on-site.

View: Looking south down the alley. The two inch diameter PE gas main is in-situ. The section of failed pipe has been removed. Avista removed that section of main and transported it to Spokane. Typical bedding and backfill material in the trench is mostly round, smooth rock and some fractured rock less than 6-inch in diameter. Dirt consists mostly of fine volcanic ash-type soil.

Avista violated former WAC 480-93-010 because the material Avista placed next to the pipe at the time the pipe was installed did not provide a "firm support under the pipe," nor did the backfill "prevent damage to the pipe." Firm support should provide a uniform external load on the pipe and prevent damage from a point load or impingement. The gas main at issue failed due to impingement. Typically, impingement is from rocks that dent the pipe and eventually initiate a crack at the inside surface of the pipe. The photograph in Exhibit C shows several large rocks were present in the trench. Such rocks provide stress points or dents that cause slow crack growths to develop a through-wall fracture and eventually cause the pipe to leak.

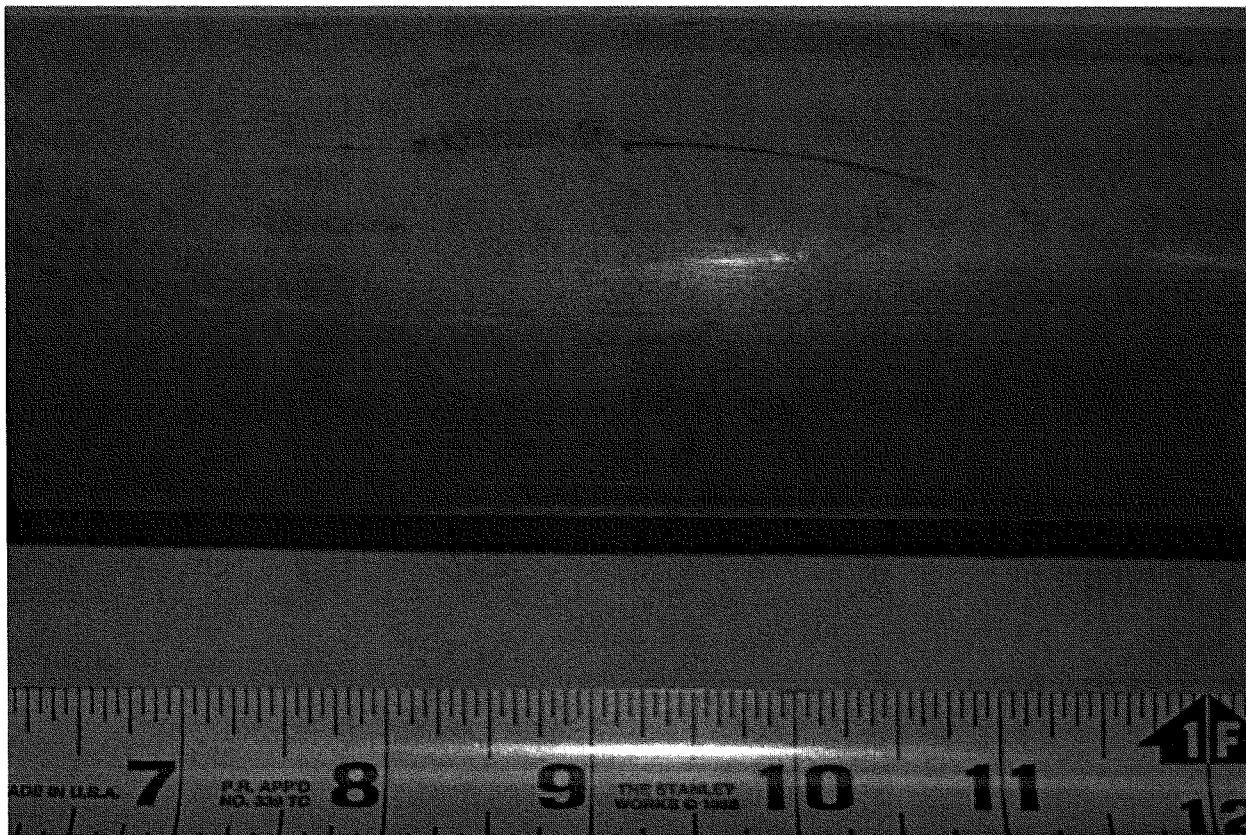
10:00 A.M. Mr. Jones arrived at Avista's facility in Spokane to visually inspect and photograph the failed section of pipe. He observed that the pipe was cracked longitudinally and was dented with abrasive marks, possibly from rock impingement against the pipe. Exhibit D is a photograph of the pipe section taken that day by Mr. Jones.

View of the 2-inch diameter PE main with longitudinal crack (dark line and scuff marks). This photo was taken at an Avista facility in Spokane.

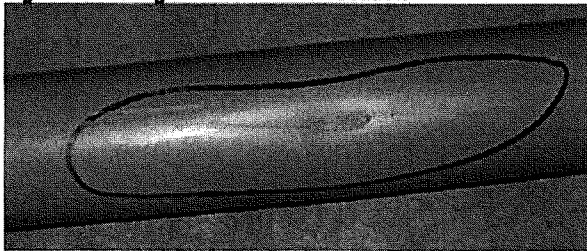
Figure 2: Through-Wall Fracture Location

The sample had one through-wall slit-type fracture apparent when examined from the outside of the pipe (marked on pipe with black oval). The sample also displayed evidence of external impingement in two locations, one of which was generally coincident with the fracture. A closer view of the through-wall fracture as viewed external to the pipe is provided in Figure 2.

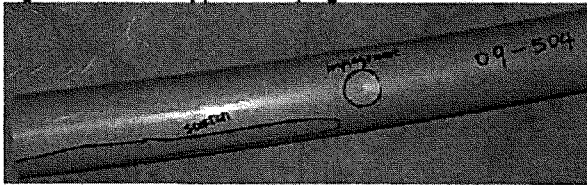
Figure 3: Second Apparent Impingement Location

A second area of apparent external impingement was visible as shown in Figure 3.

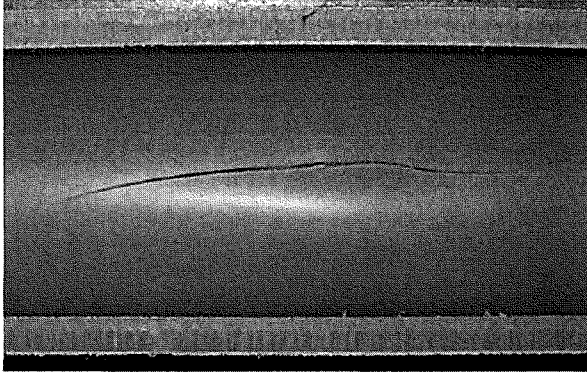
Figure 4: Through-Wall Fracture at First Impingement Location

According to the Jana Laboratories Report, the failed pipe showed evidence of external impingement in two locations, caused by rocks in the material around the pipe. The pipe had a through-wall fracture at one of these locations (Report at page 6, Figure 4), and a partial-wall fracture at the other location. Id. at page 7, Figure 5.

The sample was examined further by bisecting the pipe into half-round sections and inspecting the inside surfaces. The appearance of the full-wall fracture coincident with the first impingement location is shown in Figure 4.

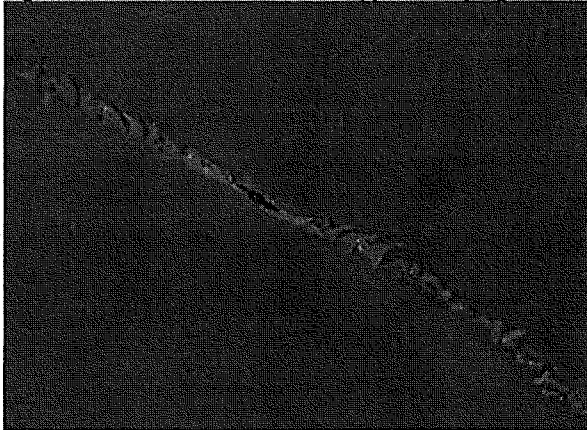
Figure 5: Inside Surface at Second Apparent Impingement Location 20X

A partial fracture (not extending entirely through the wall thickness) was visible coincident with the second apparent impingement location. This partial fracture at the inside surface is shown in a 20X close-up obtained using optical microscopy as Figure 5.

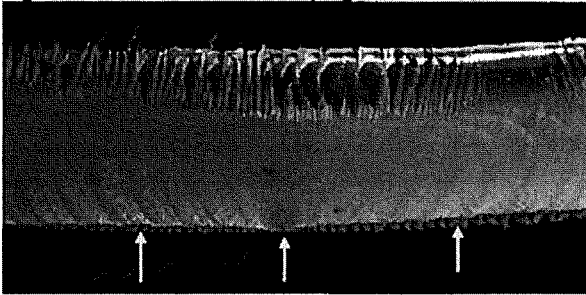
Figure 7: Fracture Surface at Impingement Location - 7X

One of the fracture surfaces is shown in detailed view in Figures 7 and 8. Figure 7 is a photograph of the full fracture surface taken by optical microscopy at 7X magnification. The inside surface is indicated by the arrows, with the center arrow indicating the area of fracture initiation.

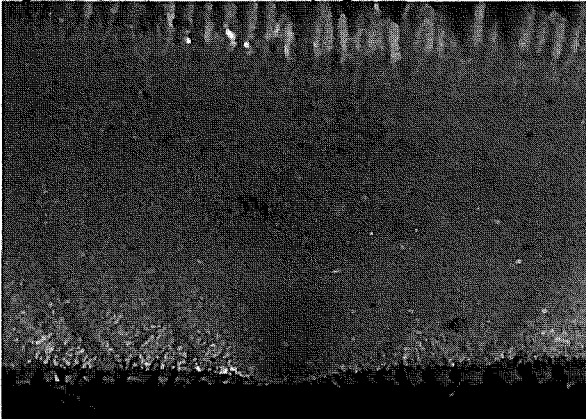
Figure 8: Fracture Surface at Impingement Location - 20X

Figure 8 shows the area of fracture initiation at 20X magnification. The characteristics of the fracture surface are typical of SCG initiated at the inside surface due to external rock impingement.

Therefore, the fracture of the sample was caused by impingement from bedding material such as rocks. The elevated local stress in this area from the impingement caused a crack to initiate at the inside surface. This crack then propagated by Slow Crack Growth (SCG) from the inside surface outward. When this crack reached the outside surface leaking occurred.
