**Test Report No. 607531-02-1-11**

**STANDARD DELINEATOR TESTING SPECIFIC TO  
MANAGED LANE USE FOR OPTIMIZATION OF  
SERVICE LIFE – PHASE 2**

**State of Florida Department of Transportation**

**TEXAS A&M TRANSPORTATION INSTITUTE PROVING GROUND**

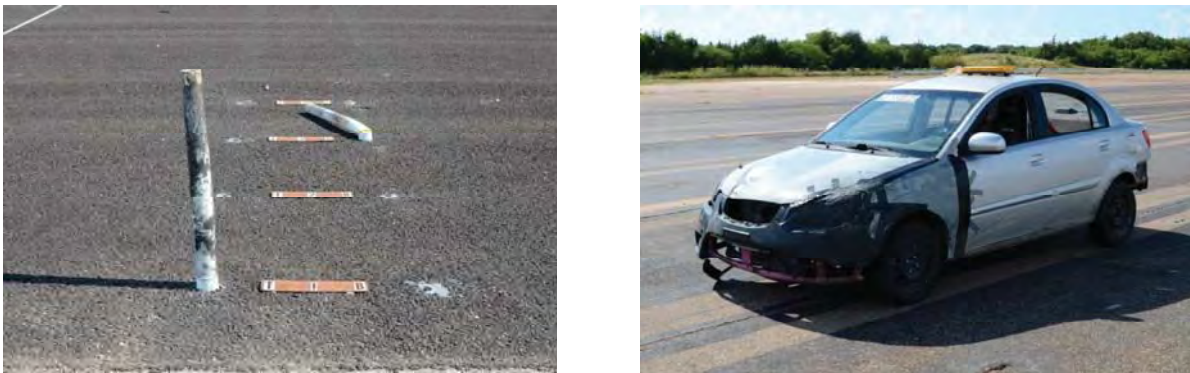
Figure 3.13. 607531-02-3 Delineators and Test Vehicle after Testing.

Table 3.4 documents the list/lean and failure modes witnessed under Test No. 607531-02-3. Seven of the samples failed to resist 200 impacts. A failure to restore to within 15 degrees of vertical was observed for delineator #1B on run 1, delineator #3T on run 3, delineator #2B on run 14, delineator #3B on run 19, delineator #4B on run 20, and delineator #4T on run 91. Delineator #2T completely tore from the base on run 3, and delineator #1T completed all 200 runs. Ambient temperature was greater than or equal to 82°F throughout the conducted test.

The primary mode of failure was exceeding the maximum allowable degree of list/lean and post fracture near the base.

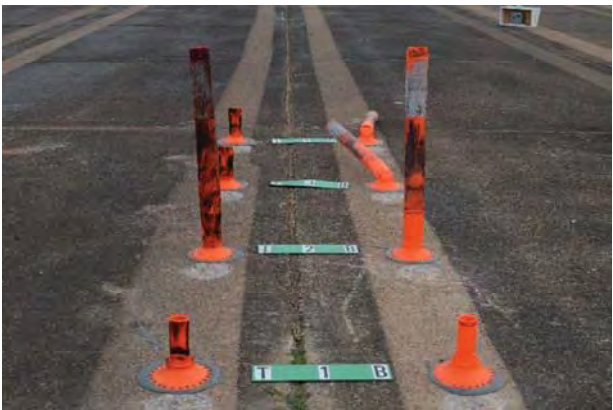
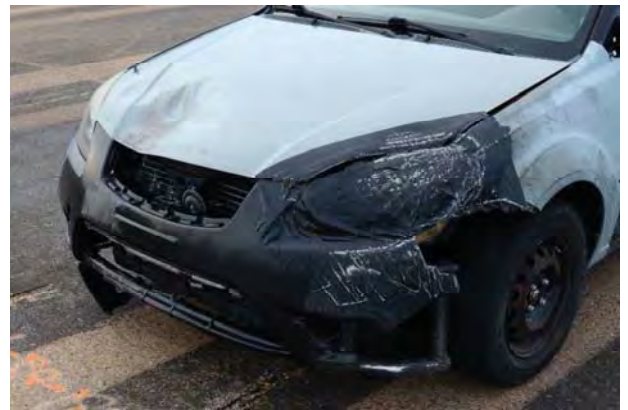
**Figure 3.18. 607531-02-4 Delineators and Test Vehicle after Testing (Concrete Surface).**

The primary mode of failure was tearing of the post approximately one foot above the base and fracture of the post at the base.

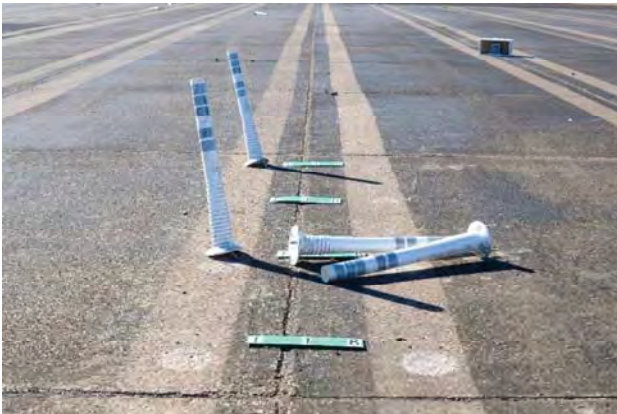
**Figure 3.47. 607531-02-11 Delineators and Test Vehicle after Testing (Concrete Surface).**

Table 3.10 documents the list/lean and failure modes witnessed under Test No. 607531-02-11. Fourteen of the samples failed to resist 50 impacts. The attachment failed on all the delineators on the concrete surface, # 1T, #1B, #2T, #2B, #3T, #3B, #4T, and #4B, on run 1. A failure to restore to within 15 degrees of vertical was observed for delineator #5B on run 1, delineator #6B on run 2, delineator #7B on run 28, and delineator #5T on run 47. A complete post tear was observed for delineator #8B on run 6, and a tear of more than 50% of the cross section was observed for delineator #7T on run 25. Delineators #6T and #8T completed 50 runs without failure. Testing was discontinued after run 50, per Sponsor's request. Ambient temperature was greater than or equal to 60°F throughout the conducted test. This is below the required temperature.

The primary mode of failure was pull out of the mechanical anchors for the delineators on the concrete surface and exceeding the maximum allowable degree of list/lean for the delineators on the asphalt surface.
