Example of Leak Work Order
Leak Work Order 10
(Leak L9604014)

Madrone Park Leak Work Order

SECTION 1:	Project	L9604014 10	Complete on or Before	04/01/2002	AREA:	211
House 1/2 Street					PLAT MAP:	189074
3339 E FORD PL						
Originally Reported Date: 09/19/1996			Source: Outside Consultant

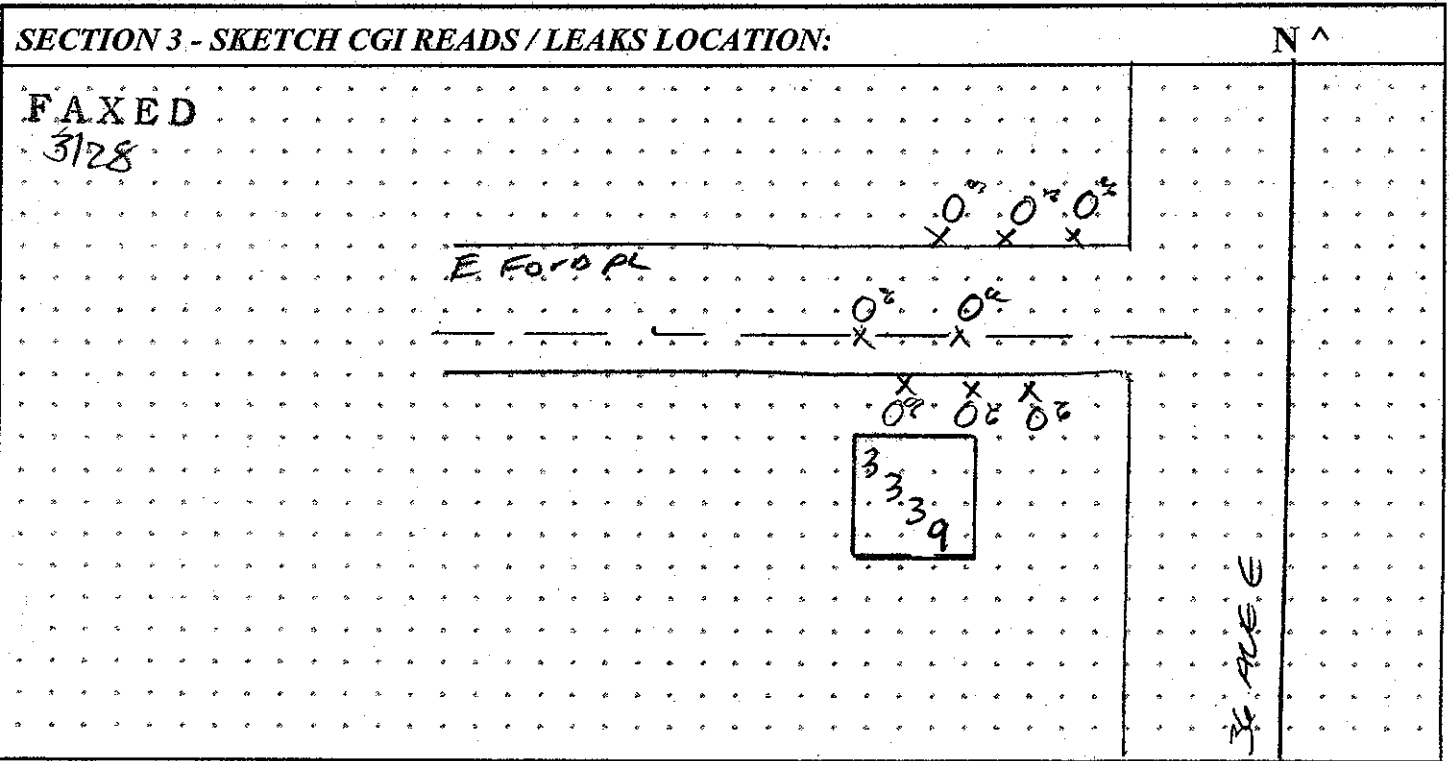
! Loc Cgi Reads Remaining / Comments: 0% GAS or LEL READS FOUND AT NW CURB OPP EBL
