Capsizing of Roll-on/Roll-off
Vehicle Carrier *Golden Ray*
St. Simons Sound, Brunswick River,
near Brunswick, Georgia
September 8, 2019

Marine Accident Report

NTSB/MAR-21/03
PB2021-100930

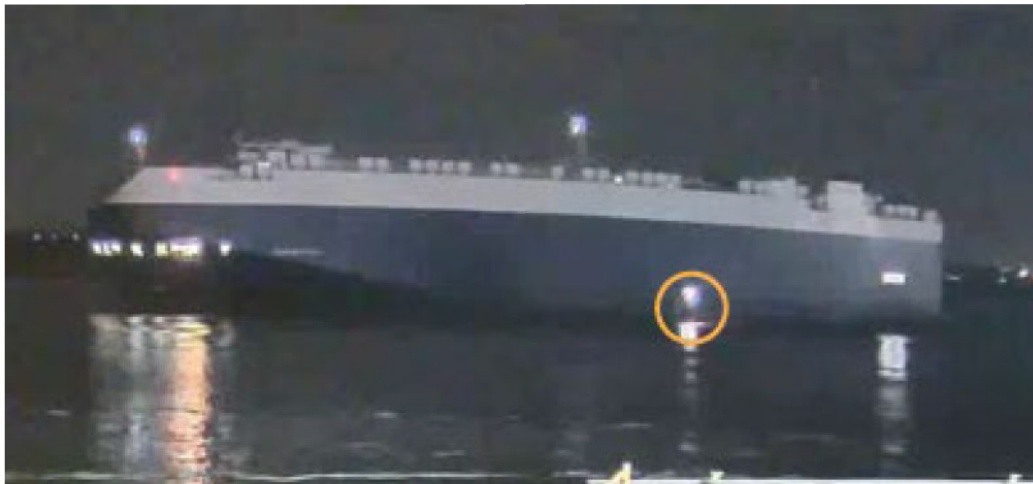
About the same time, the master ordered the crew to open the portside pilot door (side port), located on deck 5, in preparation for the pilot's planned departure just outside of the Port of Brunswick at the sea buoy (see figure 3). The pilot door was a watertight hatch in the side shell that opened and closed locally by an electronic/hydraulic system; the door was 7 feet (2.1 meters) high and 7 feet (2.1 meters) wide. After supervising the opening of the portside pilot door, the chief officer went to his stateroom. The crewmembers left to conduct other duties, and no one remained at the open door as the vessel proceeded outbound.

Figure 3. The *Golden Ray* departing Jacksonville, Florida, about 0130 on September 7. The light amidship is the open portside pilot door. (The lights on the blue hull at the bow and stern are mooring line stations.)

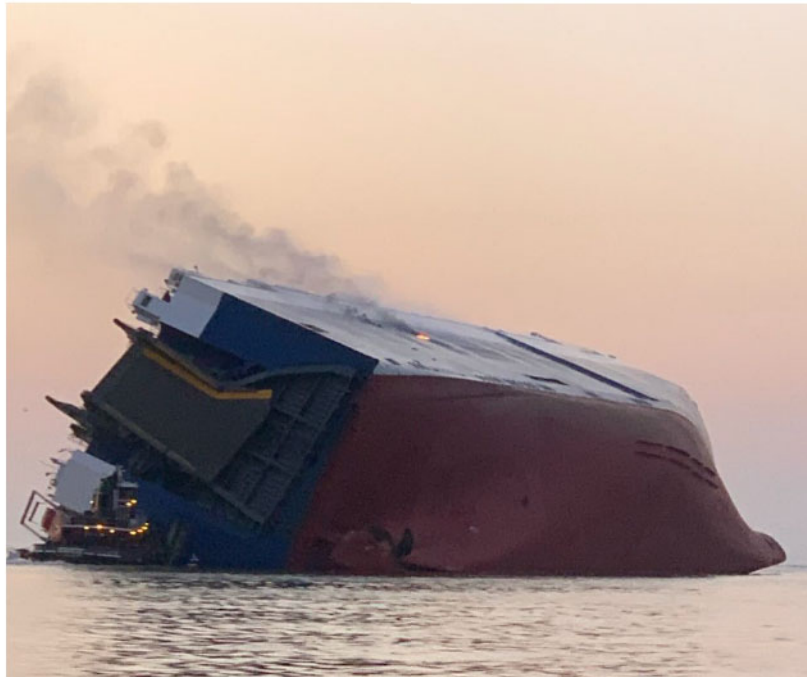
About 0430, first responders noticed smoke and flames on the starboard side of the *Golden Ray* in the area of the vehicle decks (see figure 5). The cargo hold contained combustible materials, including tires and plastic components in the vehicles. Because of the reported thick, black smoke

Figure 5. Stern view of the grounded *Golden Ray* after the heeling event. Flame and smoke emanate from the starboard side in the area of the cargo decks. Photo taken 6 hours after the heeling event.

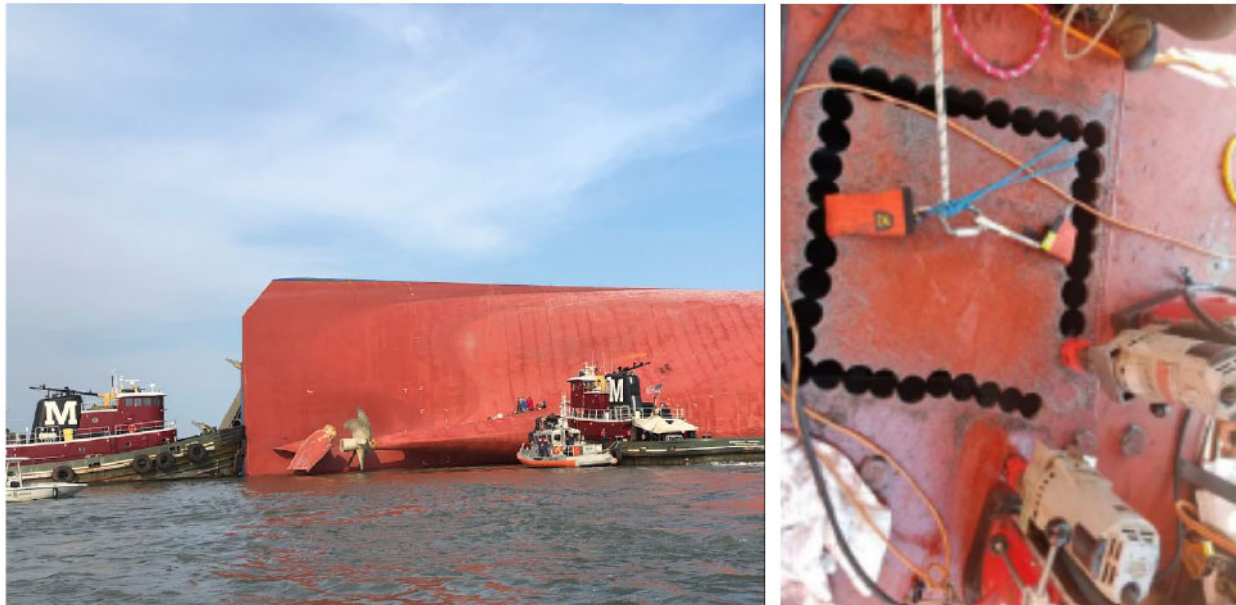
contact with the engineers (see figure 7). An atmosphere reading of the engine room showed its temperature was as high as 155°F. Realizing that the internal atmosphere was extremely hazardous to the engineers, the rescuers continued drilling holes to create a square access opening into the hull rather than wait for the requested cold cutting equipment to arrive.

Figure 7. Emergency responders attempt to rescue the trapped engineers and cadet (left). Responders drilled holes into the hull to access the engineers (right).

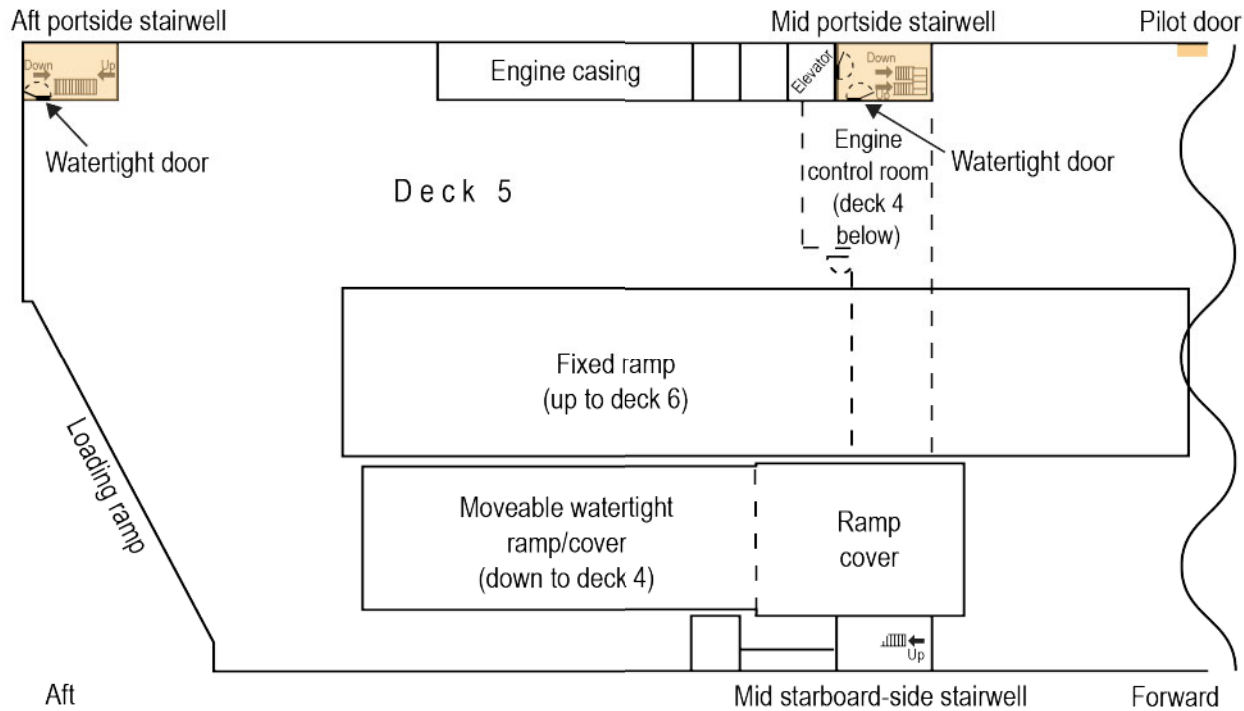
The IMACS data showed that in addition to the portside pilot door, the watertight doors to both the aft and mid portside deck 5 stairwells were open at the time of the accident and had been open since 2341 on September 7 before the vessel departed the Colonel’s Island Terminal. The mid portside stairwell, about 75 feet (22.9 feet) aft of the pilot door, served as the primary access to the engine room and the engine control room on deck 4; the escape trunk stairwell serving the lower engine room exited to this stairwell at deck 4 (see figure 11).

Figure 11. Simplified overhead plan of the aft portion of deck 5. The stairwells with open watertight doors and the pilot door are highlighted. Dashed lines indicate spaces on deck 4 below.

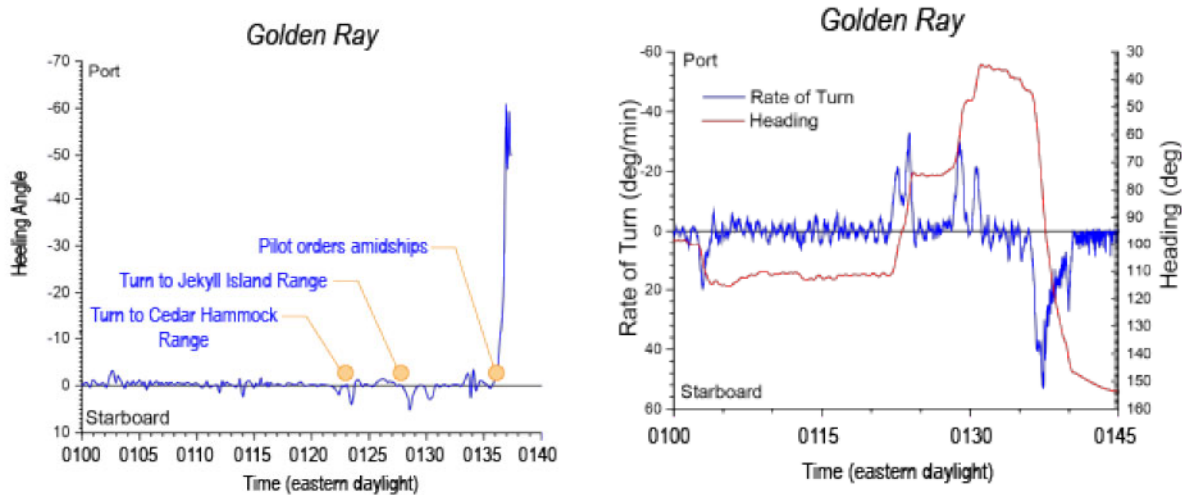
Figure 14. Graphs from the *Golden Ray* performance study by the NTSB. Left: heeling angle through the transit, including previous two left turns. Right: heading and rate of turn through the transit.

According to the study, the heeling of the vessel was driven by a moment created by hydrodynamic side force on the hull at a distance below the center of gravity during a starboard turn at 12–13 knots. The hydrostatic stability (buoyancy) resisting the heel was much less than would be expected for the reported GM of 2.45 meters (8 feet) and instead was consistent with a GM of approximately 0.45 meters (1.5 feet). The study also found that although the effect of wind could not be calculated precisely, the low magnitude of the heeling moment from wind relative to other sources of heeling moment was not significant. The study found that the vessel’s center of gravity was significantly higher than reported, leading to the lack of roll resistance.

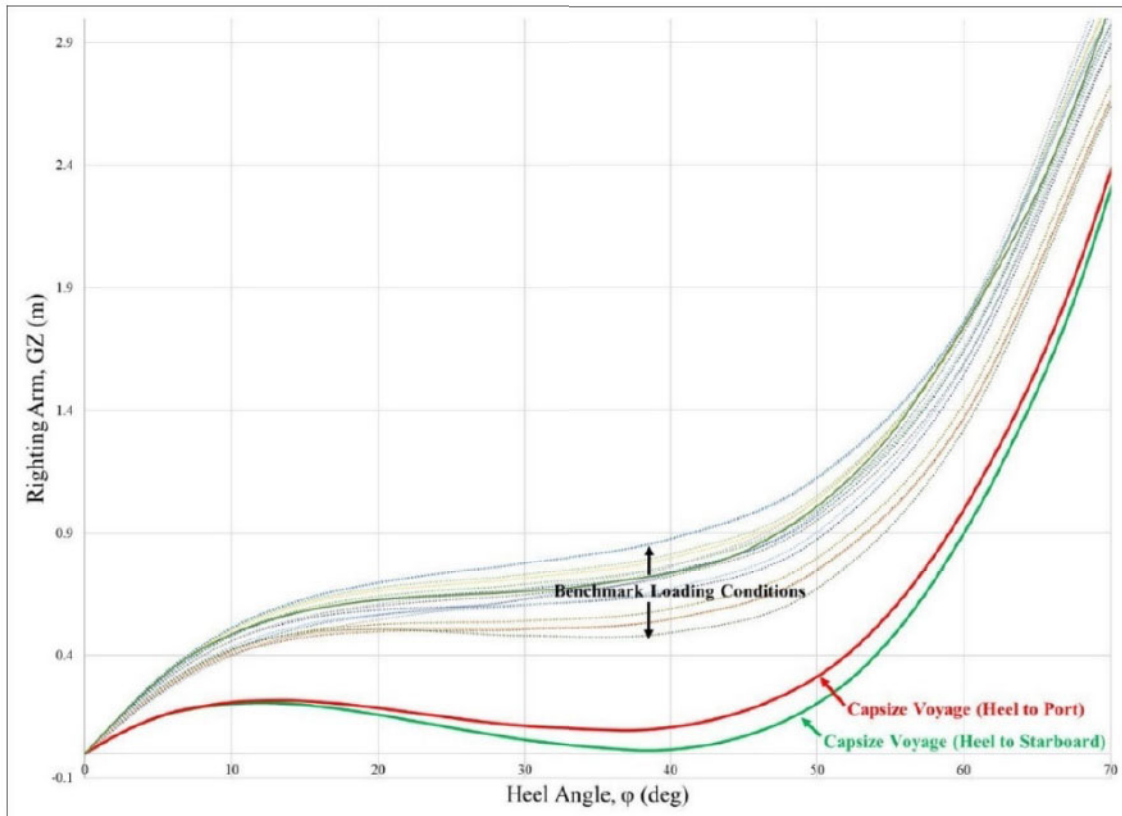
IS Code criteria were applied to these righting arm curves, the MSC found that with the vessel's loading condition, the area under the vessel's righting arm curve between 30° and 40° was particularly limited, and it failed to meet the 2008 IS Code (see figure 16). Because there was limited area under the righting arm curve, the MSC determined that the vessel did not meet the area ratio criteria of the 2008 IS Code's severe wind and rolling criteria. The MSC concluded that the vessel, as loaded, had an extremely low righting energy, which prevented it from withstanding further adverse static or dynamic heeling effects and enabled the vessel to capsize due to the centrifugal force experienced by the vessel throughout the starboard turn.

Figure 16. Righting arm curves generated from the MSC analysis of the *Golden Ray* during the accident voyage compared with benchmark righting arm curves chosen from the vessel's T&S Booklet loading conditions.

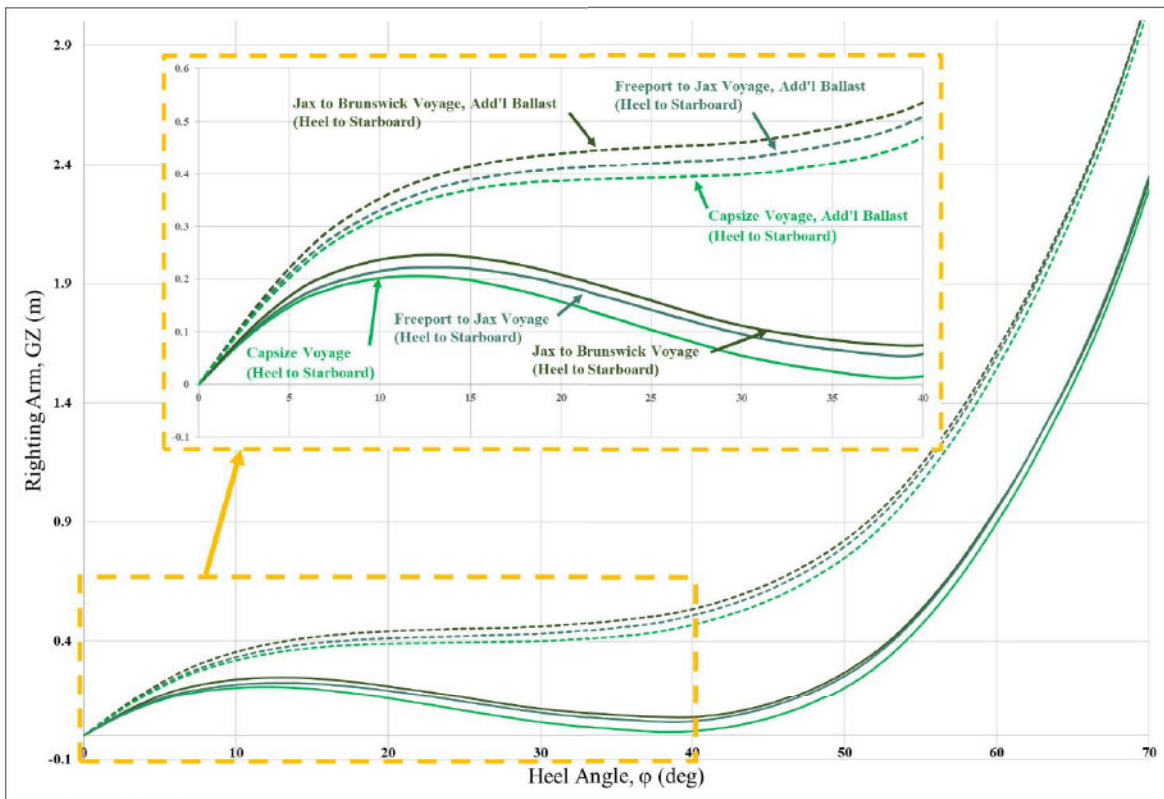
The MSC report also stated that if the *Golden Ray* had maintained an additional 1,492 MT of ballast (1,500 MT was loaded after departure from Freeport and then discharged before the vessel arrived in Jacksonville in order to meet the port’s draft requirements), the vessel would have been in compliance with the 2008 IS Code during both previous voyages and the accident voyage (see figure 17). The MSC also noted that, with the additional ballast, the vessel’s theoretical initial GM for those voyages would have been 2.25 meters (7.4 feet) for the accident voyage, 2.4 meters (7.9 feet) for the voyage from Freeport, and 2.47 meters (8.1 feet) for the voyage from Jacksonville. (For comparison, the MSC calculated the initial GM for the representative loading condition to be 1.76 meters (5.8 feet) for the accident voyage, 1.84 meters (6 feet) for the voyage from Freeport, and 1.91 meters (6.3 feet) for the voyage from Jacksonville.)

Figure 17. Theoretical righting arm curves (dashed green lines) generated from the MSC analysis of the *Golden Ray* during the accident voyage and previous two voyages with an additional 1,492 MT of ballast. The righting arm curves (solid green lines) generated from the MSC analysis for the vessel in the representative loading condition for each voyage are shown for comparison.

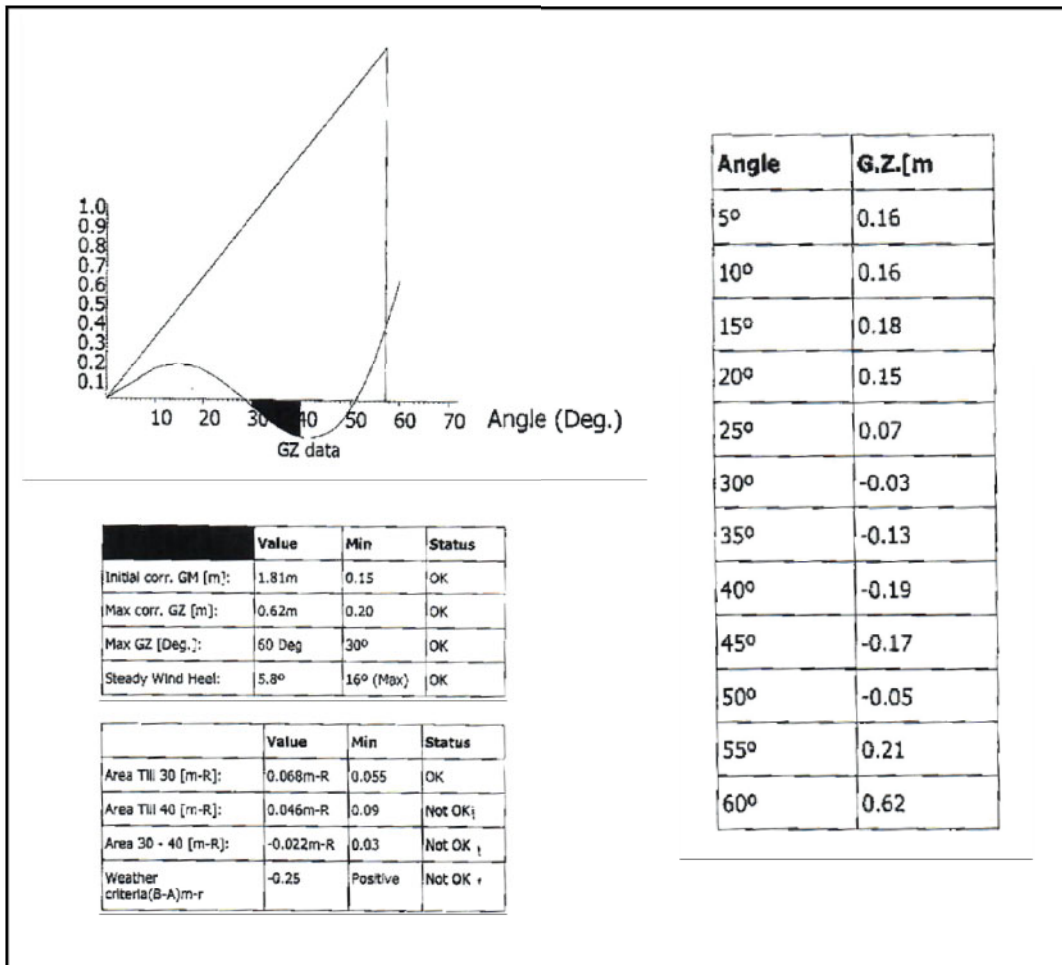
Hyundai Glovis. The charterer conducted a simulated stability analysis of the *Golden Ray* using the LOADCOM computer on board the *Silver Ray*, a vessel of the same class as the *Golden Ray* (Hyundai Glovis Co. Ltd. 2020). This simulation used vessel data and conditions collected by the charterer and was not observed by the Coast Guard or the NTSB. The simulation calculated that the GM of the *Golden Ray* was 1.8 meters (5.9 feet), indicated that the righting arm curve for the *Golden Ray* at the time of the accident was extremely low, and showed a LOADCOM status of “Not OK” for three stability requirements (see figure 18). Additionally, the righting arm curve showed negative stability after a heel of about 25°.

Figure 18. Righting arm curve calculated on the *Silver Ray*'s LOADCOM stability computer based on the *Golden Ray*'s vessel data from the accident. Note that three of the stability requirements have a status of "Not OK" and the righting arm (GZ) is negative beyond 25°.
