APPENDIX 5

Example of a Date Alteration
Incident 55
(Two versions of Leak Work Order 2)
(Leak N0010784)

Leak Work Order

Incident 55

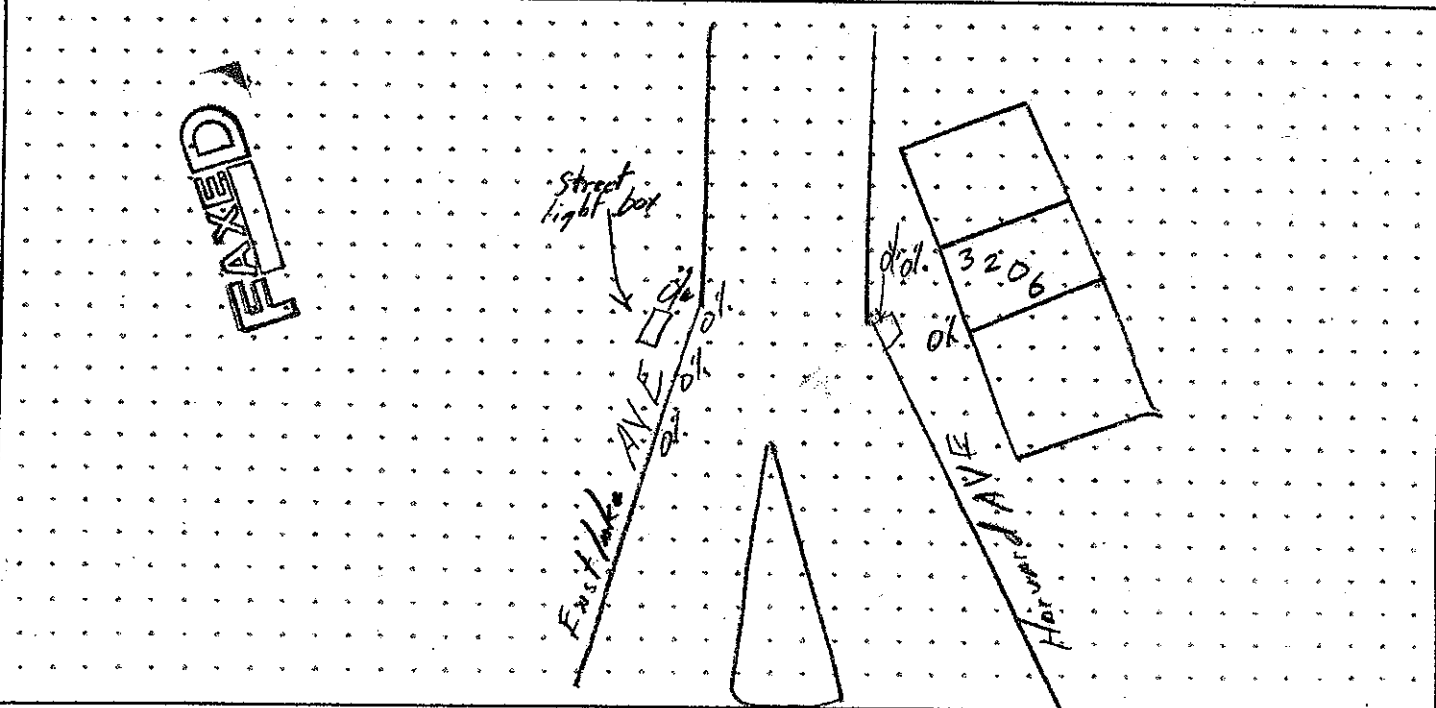
SECTION 3 - SKETCH CGI READS / LEAKS LOCATION N ^

! Loc Cgi Reads Remaining / Comments: 0 reads Found I took
read each side of the street street light box 0%

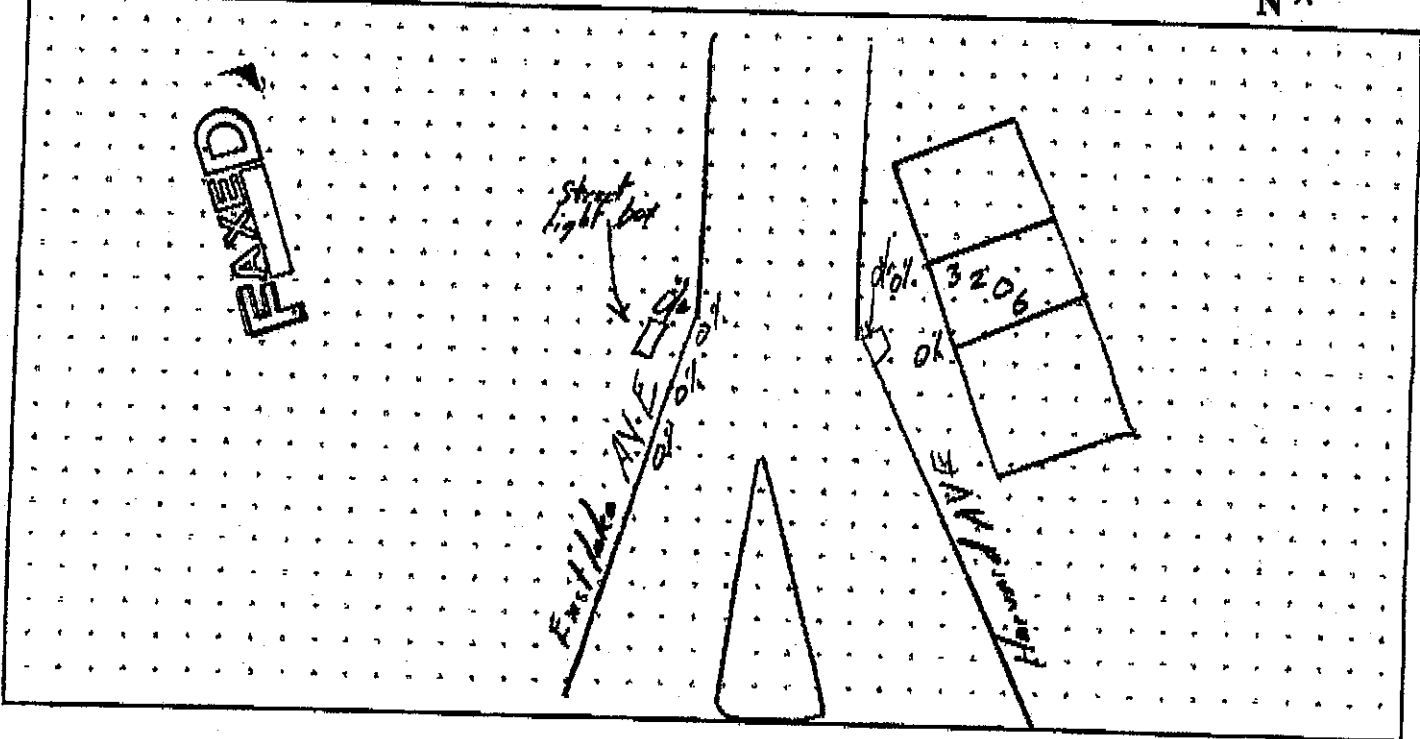
SECTION 3 - SKETCH CGI READS / LEAKS LOCATION

Field Response Data: ! Grade Found 0 ! Grade Left: 0 Excavation Only: JUN 23
! Response Type: J ! Response Co: Pilchuck >Pipe: >Material >Size >Yr Inst
! Responder Name: Chamberlain >Facility: >Type >Below Grade? Yes No CP Reads psp
! Arrived Date: 6/20/03 ! Time 10:40* >Leak: >Component >Cause
! Finished Date: 6/20/03 ! Time 10:55* Recheck? Yes No Date / / /
Repair Types: #Qty Followup? Yes No Date / / /
+ Pressure Test By: +Date / / / +Hrs Min at psi +Type
+ - Required for Response Type R(Repair) & Repair Type D(Replace)
! Loc CGI Reads Remaining / Comments: 0 reads Found. I took
read each side of the street Street light box 0%
