Avista Utilities Asset Management

Proposed Protocol for Managing Select Aldyl A Pipe in Avista Utilities' Natural Gas System

February 23, 2012

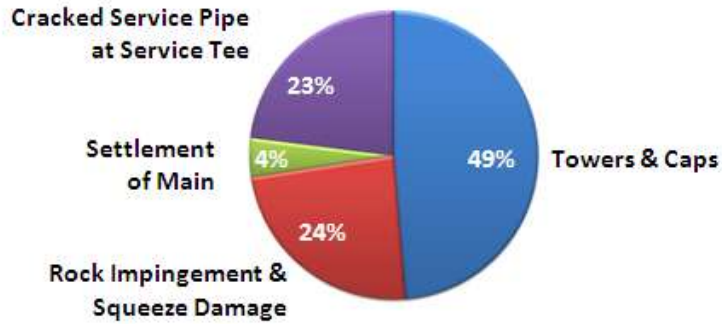
In tackling the first objective of the assessment of its Aldyl A piping, Avista aggregated the gas leaks resulting from Aldyl A material failures found in its gas system in Washington State from late 2005 through March 2011. The sample included 113 material failures that were evaluated and summarized by component to offer an understanding of the specific failure modes for Aldyl A pipe. The 'modes' or types of material failures categorized are shown below in Figure 1.

Figure 1. Modes or types of material failures documented in a sample of 113 leaks in Avista's Aldyl A piping in Washington State, December 2005 through March 2011.

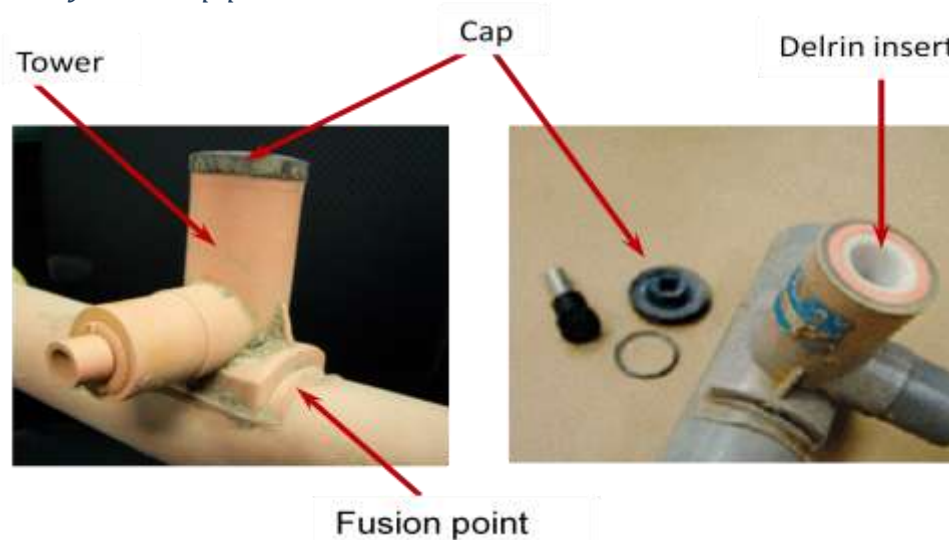
The largest percentage of material failures in the sample occurred in Towers and Caps, referring to failure of the service tapping tee itself, shown below in Figure 2. In these cases, the pressure applied to the tee as the cap was tightened onto the body during initial installation has resulted in slow crack growth and failure of the tower body, the cap, or the Delrin® insert many years later. Additionally, the saddle fusion point of the tower to the main pipe is another frequent point of failure in this assembly. The unavoidable stresses created during standard installation (using factory recommended procedures) have led to brittle cracking in these components many years later. This phenomenon clearly demonstrates the susceptibility of certain resins of Aldyl A piping to tend to fail by brittle cracking due to the slow crack growth initiated during installation.

Figure 2. External features and internal components of a typical Aldyl A service tee, as fused to Aldyl A main pipe.

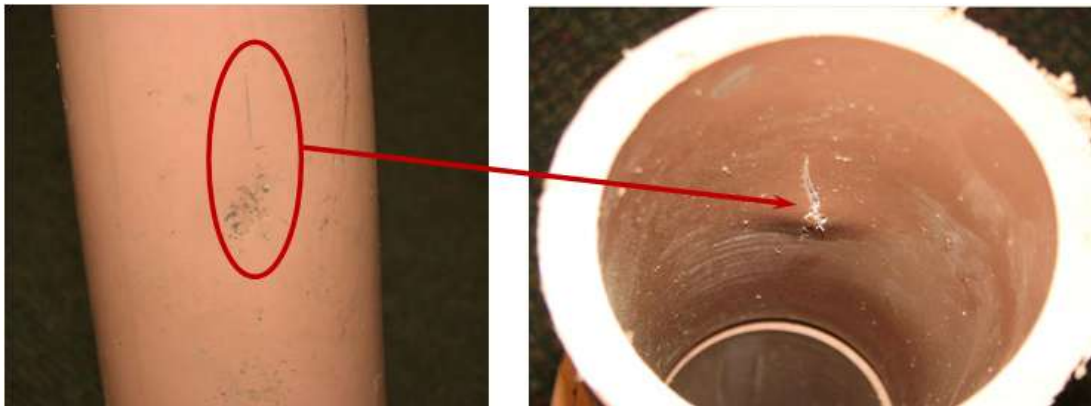
The second-most common material failure observed in Avista's Aldyl A pipe was due to localized, brittle cracking in Aldyl A mains that resulted from rock impingement – rock pressure directly on the pipe, or places where 'squeeze-off' was applied over the pipe's service life. These failures are very typical for certain resins of Aldyl A main pipe, having been consistently reported by other utilities since before the time of DuPont's 1986 letter. As described earlier, when these external stresses (rock impingement or squeeze-off) cause the pipe to fail, it always begins with crack initiation on the inside surface of the pipe wall, eventually resulting in slow crack growth that propagates toward the outer wall of the pipe, and finally, through-wall failure. These failures generally appear as short, tight cracks in the outer wall of the pipe that run either parallel, or slightly off-parallel with the length of the pipe. A typical failure in Aldyl A main pipe, showing a crack through the pipe wall as it appears on both the inner and outer surfaces, is shown below in Figure 3.

Figure 3. Typical brittle-like crack through the wall of Aldyl A pipe, resulting from rock contact directly on the pipe.

Although the duration of the stress caused by rock contact with the pipe is very different from that associated with squeeze-off, they both result in the same pattern of crack initiation and slow crack growth leading to failure of the pipe. Other sources of external stress that can result in brittle failure of Aldyl A pipe, as mentioned earlier in the report, include bending of the pipe, soil settlement, dents or gouges to the pipe, and improper installation of fittings.

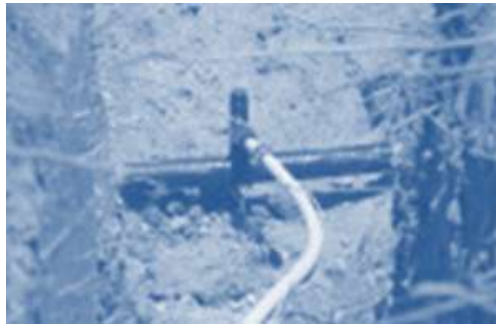
The third most-common failure in Avista's sample occurred where small diameter Aldyl A service pipe is tapped from steel main pipe. In this application, a steel service tee is welded to the steel main pipe and the small-diameter Aldyl A service pipe is then connected to a mechanical transition fitting on the tee, as pictured below in Figure 4.

Figure 4. Typical polyethylene service tapped from a steel main.

It is at this transition point, between the rigid steel fitting and the more-flexible Aldyl A service pipe, that brittle-like cracking has been observed. This failure mode in older plastic pipe is well understood, and was one of the three study objectives reported by the National Transportation Safety Board in its 1998 bulletin, summarized earlier in this report.

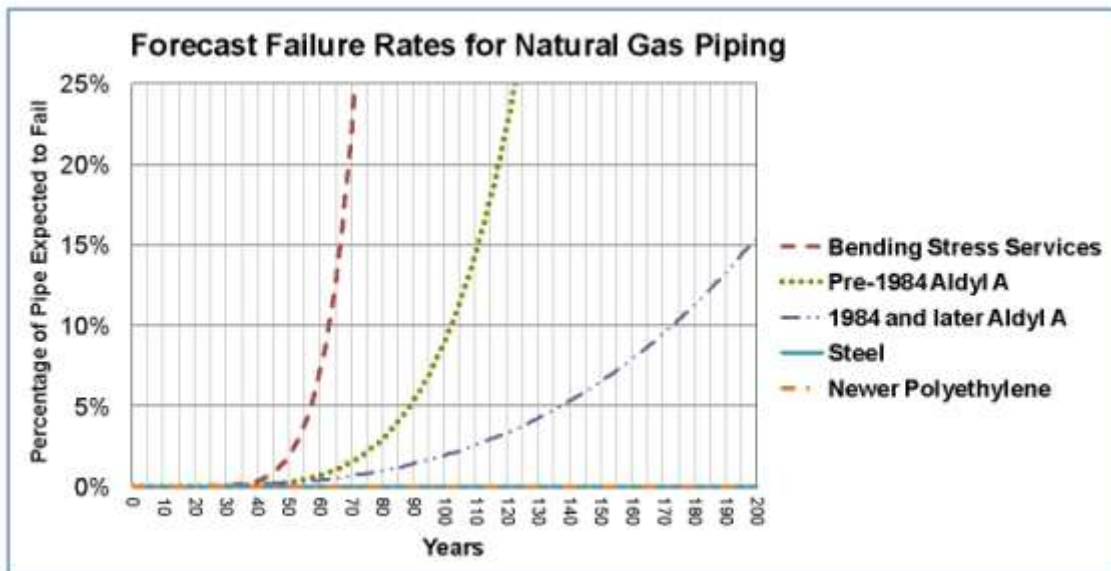
Results of the forecast modeling, for the pipe classes evaluated, are represented as ‘curves’ showing the percentage of the amount of each pipe class that is projected to fail in each year of the forecast time period. The resulting reliability curves are shown in the graph below in Figure 5.

Figure 5. The expected failure rates for several classes of pipe in Avista’s system, as forecast by Availability Workbench Modeling. The “Steel” curve is obscured by the “Newer Polyethylene” curve, both of which are essentially flat lines.

The failure curves show dramatic differences in the expected life for the pipe classes evaluated. The difference in expected life between the Aldyl A products as a group, compared with that of steel and newer-generation plastic pipe, is particularly evident. Striking also, are the expected performance differences among the classes of Aldyl A pipe evaluated, providing some clear trends useful in designing remediation strategies.

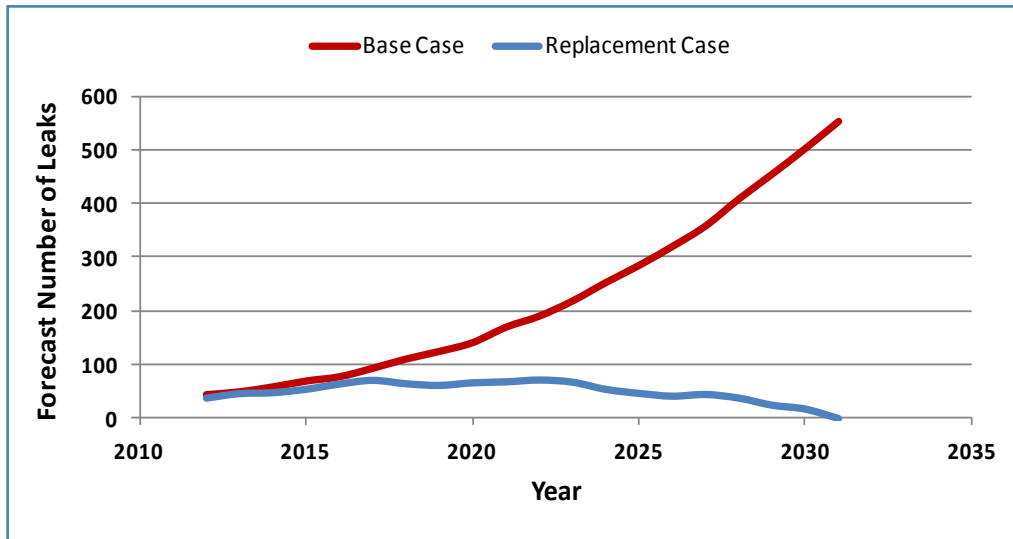
failures each year is expected to increase slightly until 2017, at which time the cumulative effect of priority piping replaced since 2012 begins to check the failure count and then drive it toward zero over the remaining course of the program (Figure 8).

Figure 8. Expected numbers of material failures in Avista’s priority Aldyl A piping in two cases: Replacement Case - piping replaced over a twenty year horizon in the manner proposed by Avista in this report, and Base Case – assumed that priority piping was not remediated under any program.
