# 2009 Jackson Prairie Atmospheric Corrosion Survey

**2009 Jackson Prairie Atmospheric Corrosion Survey  
Remedial Action Report**

## Atmospheric Corrosion Repair Report

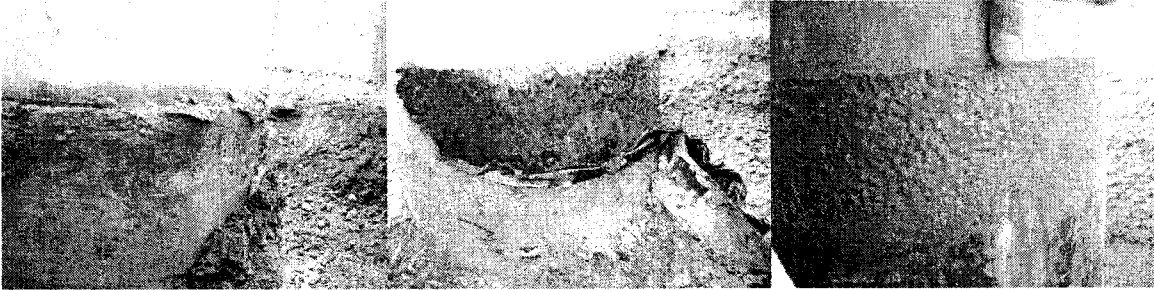
On the June 2009 Atmospheric Corrosion Survey John Santee reported found what he believed to be a class 4 corrosion cell in Section 6 of the compressor station. The north end of the 14"-H-15-801 line about 12" above ground level at the pipe wrap to air interface. The pipe was hand dug down 2 feet and the polyken wrap removed. The following information was emailed to Alan Mulkey, Steven Schueneman and Michelle Gallardo of PSE's corrosion department along with the following pictures.

The root cause of the corrosion appears to be a failed coating which trapped moisture and debris. Rick stated the wrap is Polyken and was applied from top down. Polyken 930 is not UV resistant and may become brittle over time when exposed to the sunlight. When the tape deteriorates, it may lose adhesion. Since it was applied from top down, it could easily trap water.

I recommend the Polyken tape be removed from the above ground portion of the pipe, the pipe be cleaned and then rewrapped with an UV resistant coating such as Tapecoat H35. Tapecoat H35 tape (MID 9997000 (2") or MID 9997004 (4")) is stocked in the PSE warehouse.

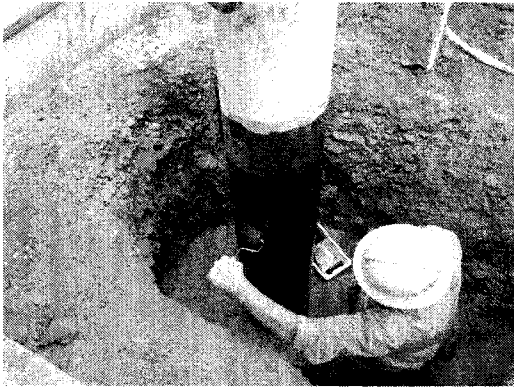
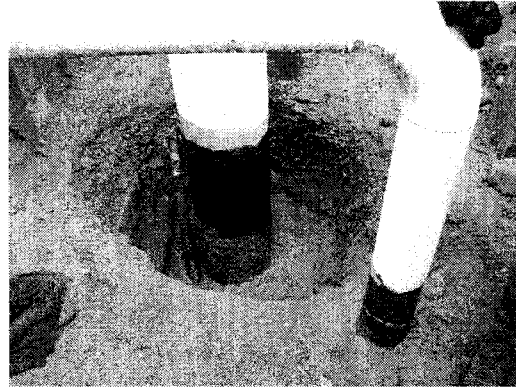
The pipe was excavated with a vacuum trailer to a depth of 3 foot 11 inches which was the extent of the dis-bonding. At the same time two adjacent pipes (14"-H-12-801 & 6"-G062-D) were found to have dis-bonding of the wrap and was also excavated to a depth of 2 feet. The dis-bonded wrap was removed and found surface rust only. The exposed pipe was walnut shell blasted to remove all rust and loose material. The pipe was then painted with Tapecoat's TC Omniprime primer.
