POST INSPECTION MEMORANDUM

Operator Inspected:
Kelso-Beaver Pipeline Company
Portland General Electric
121 SW Salmon Street
Portland, Oregon 97204

Unit Inspected: Washington portion of pipeline

Inspection Type: 107-UTC IMP Verification Inspection

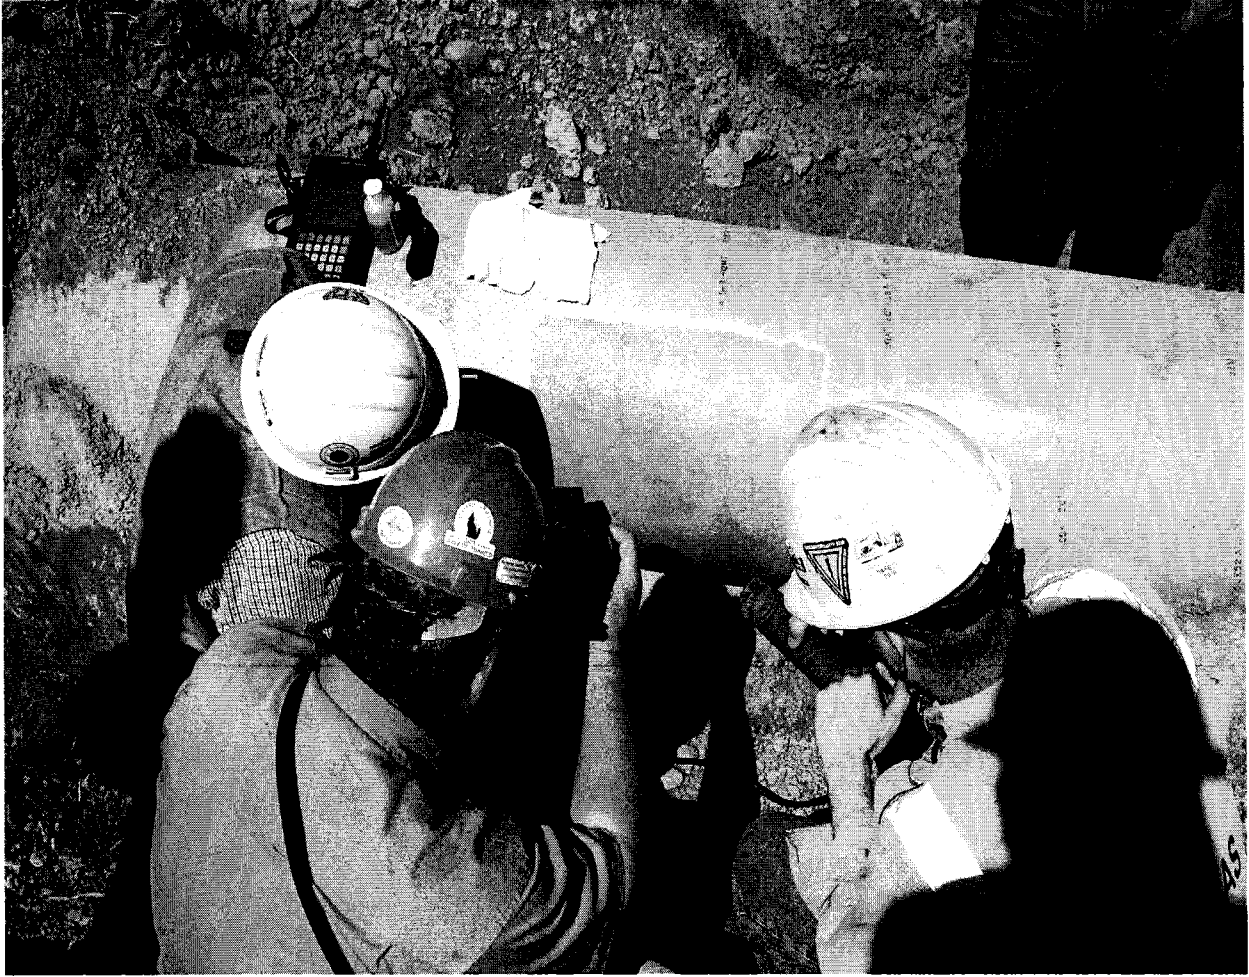
Photo "A"

- Anomaly S9 is located downstream about 300 feet from S8 and near the longitudinal seam at the 9:30 clock position. See photo A and B. NDE identified surface crack using a long shear wave unit. The cracks were less than 10/1,000th of an inch in depth and were removed by sanding the pipe surface. Corrosion was eliminated because the FBE coating was in good condition.

Anomaly S9 located near longitudinal seam, 9:30 clock position.

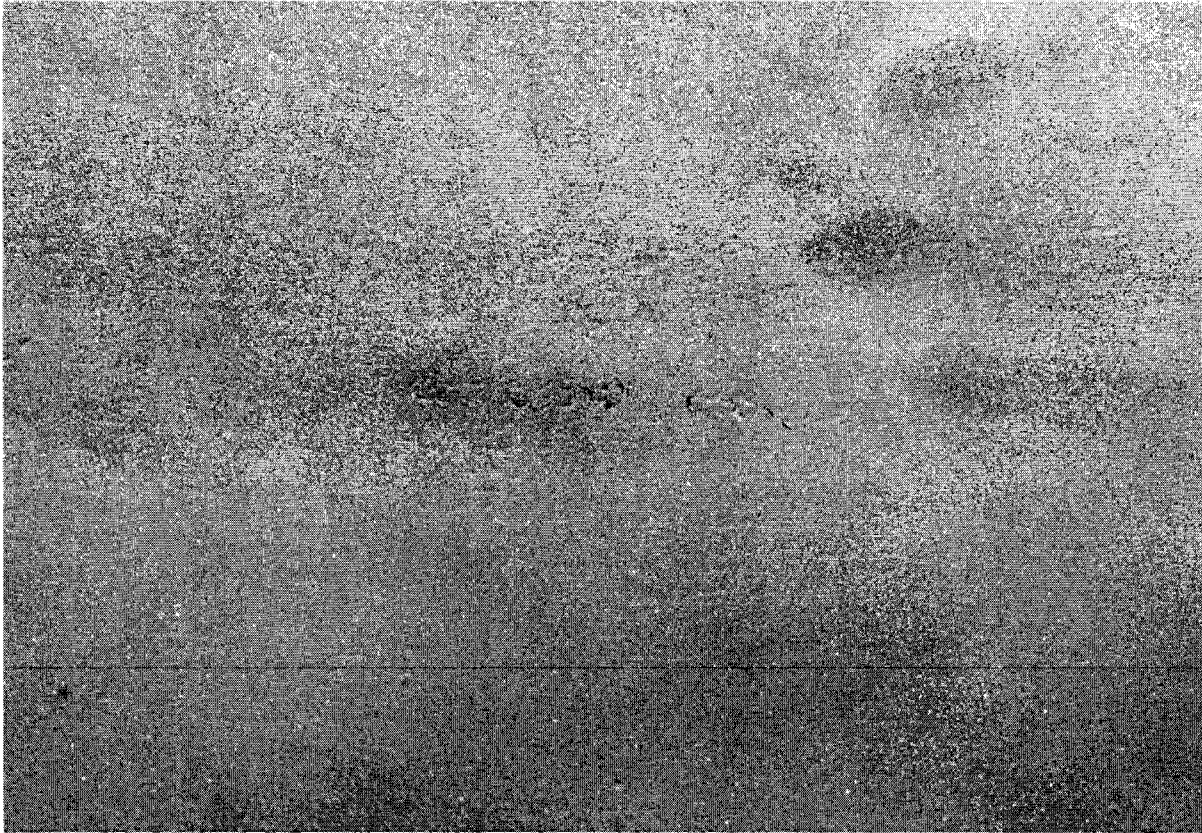
Photo "B"

Anomaly S9 located below longitudinal seam at 9:30 clock position.

NDE identified surface crack using a long shear wave unit. The cracks were less than $10/1,000^{\text{th}}$ of an inch in depth and were removed by sanding the pipe surface.
