Incident Investigation

M/T Overseas Boston

9/8/14

Incident Type: Pilot Ladder Accident/Injury at Port Angeles Pilot Boarding Area, WA

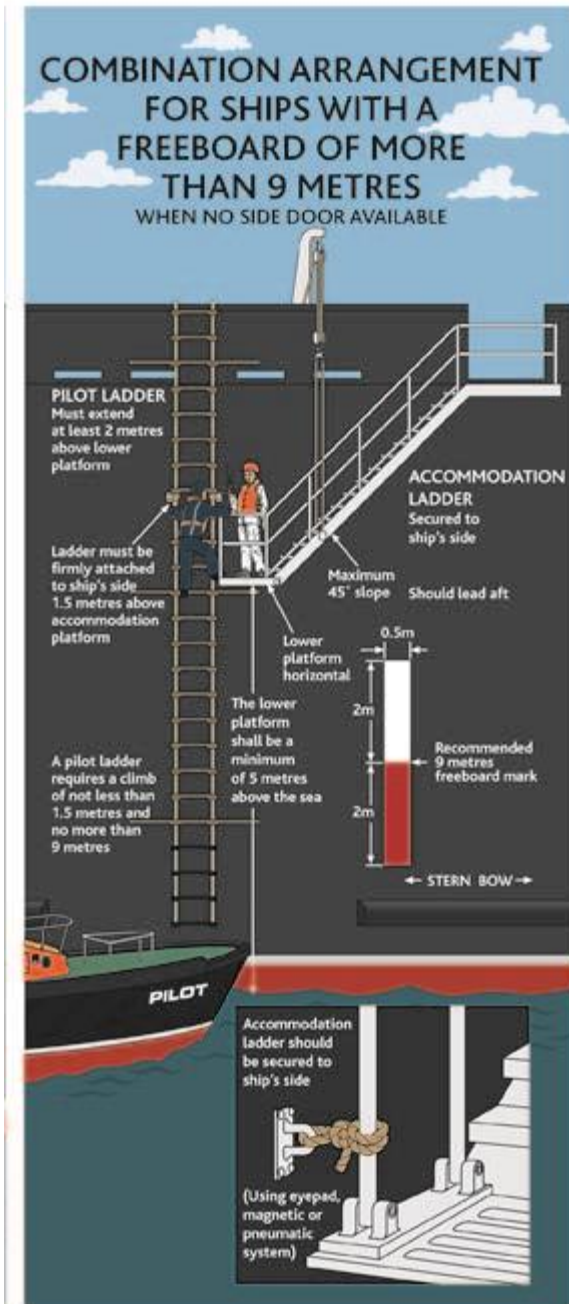
Overseas Boston was rigged with a combination set-up with an accommodation ladder and pilot ladder as required when vessel freeboard exceeds 9 meters similar to the sketch below:

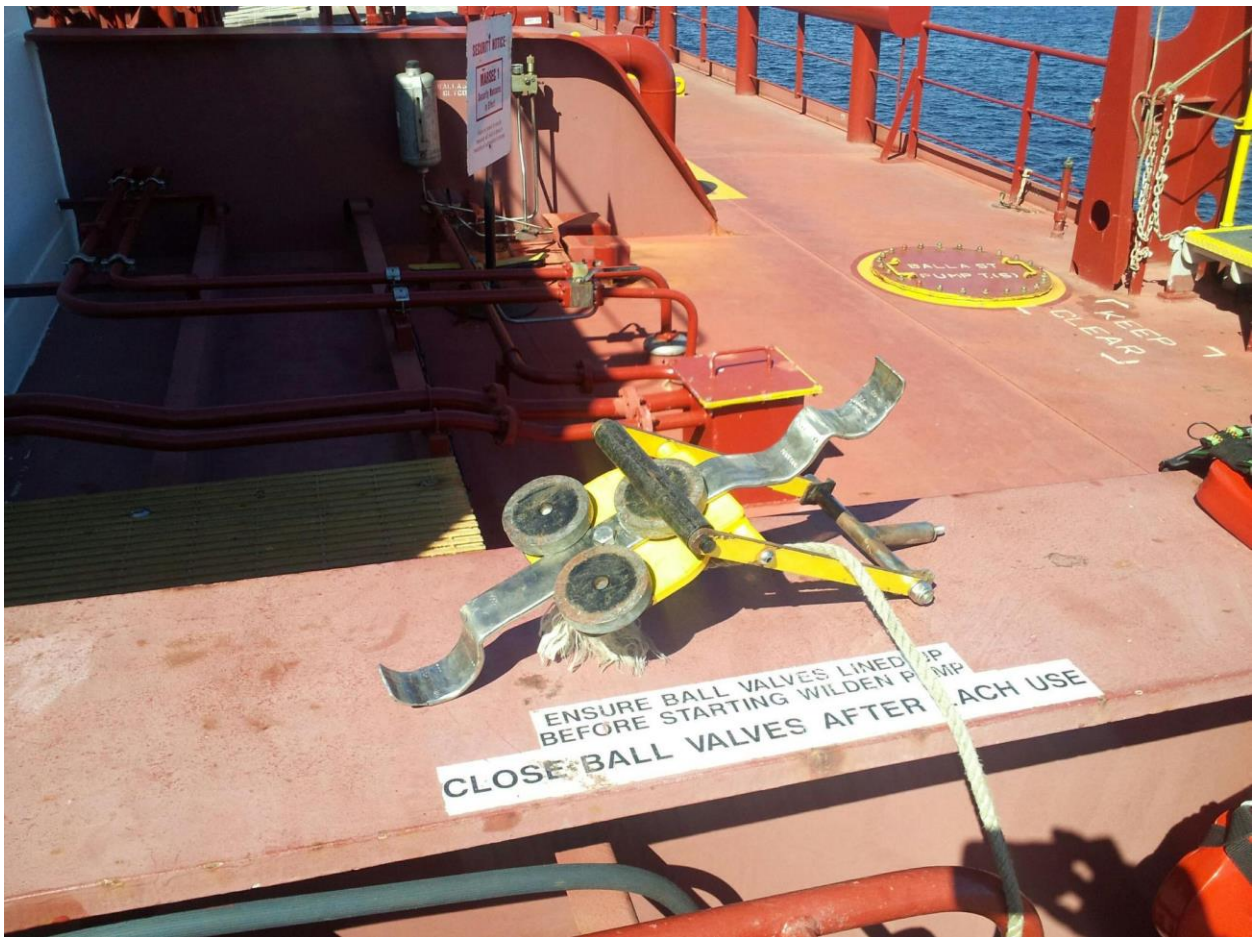
The object that struck Capt. Ward was a pilot ladder anchor magnet assembly manufactured by PTR Holland. The device that struck Capt. Ward landed on the pilot boat and was hauled up to ship's main deck by a quick release/retrieval line that was already attached to the device. The device is photographed below:

I examined the device aboard Overseas Boston with the vessel's Chief Mate. We had no accurate scale available on deck, but we both hefted the device and estimated the device as modified to weigh approximately 10-12 pounds. Eyewitness accounts from the pilot boat crew estimated the device fell 5 to 8 feet before striking Capt. Ward on

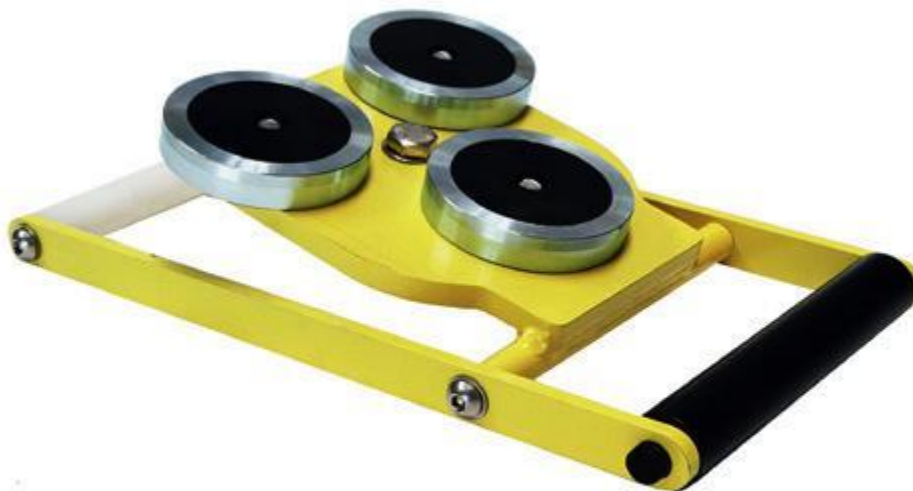
Here is a photograph of the device as it is delivered from the manufacturer:

It is designed and intended to be used as a paired set mounted one device on each side of the pilot ladder. The attachment point is to be 1.5 meters above the bottom platform of the accommodation ladder in accordance with SOLAS Regulation V/23 and IMO Resolution A.1045 (27) as described in the sketch above. The link below leads to the manufacturer's video demonstrating intended usage:

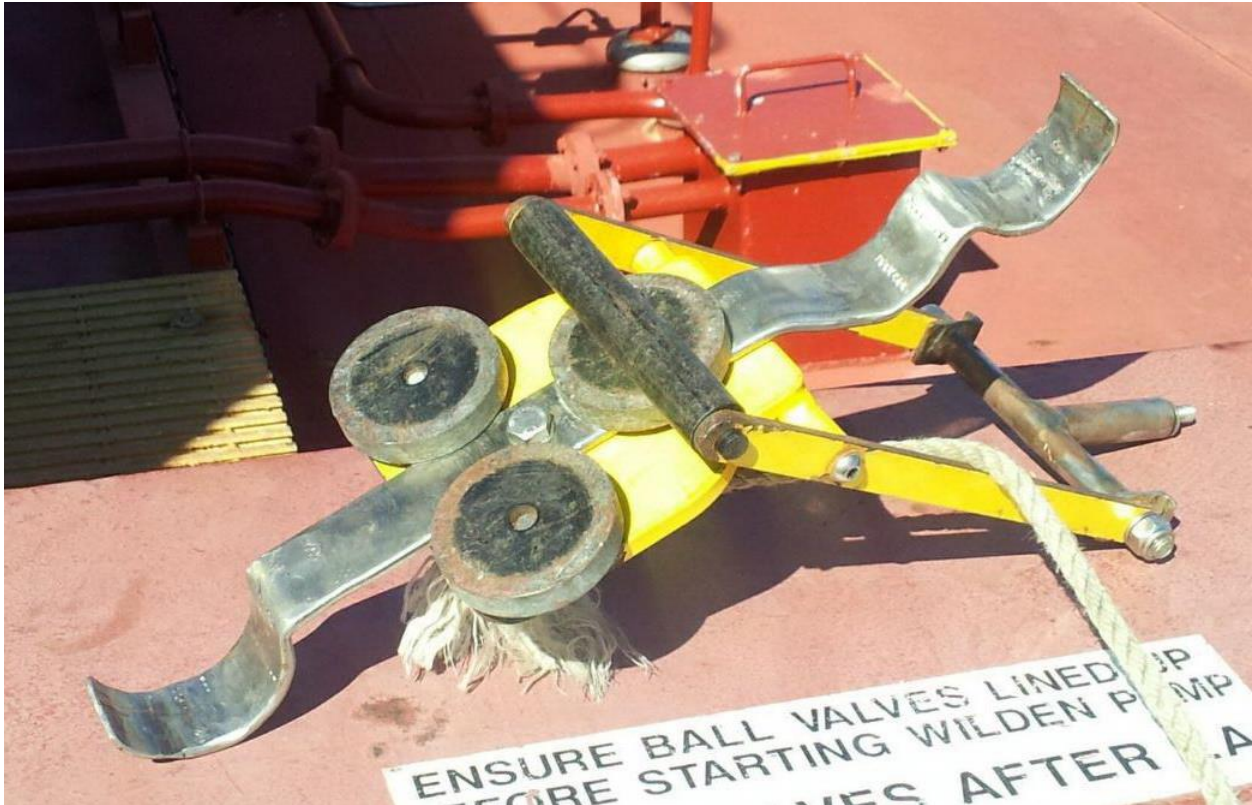
Aboard Overseas Boston, practice was to use a single device to anchor the pilot ladder, so that instead of 6 magnets locking the ladder in place only 3 magnets on a single device were used. That single device was modified aboard ship with the installation of a stainless steel crossmember to straddle two rungs of the pilot ladder. A quick release line was attached that led from the device up to the main deck of the vessel. Another metal piece appears to have been welded on as can be seen in the photo below of the modifications made aboard Overseas Boston.

The other half of the pair had been rigged to act as an anchor for the base of the accommodation ladder. So instead of 6 magnets (3 on each side of the pilot ladder locking the ladder in place, the crew of Overseas Boston used only 3 magnets in one device, thereby reducing holding capacity to 50% of the manufacturer's intended usage. Then, the one device used on the pilot ladder was further modified with a stainless steel crossmember adding both weight and a point of leverage to break the magnetic hold of the device, further reducing holding capacity to some unknown point, but certainly less than 50% of the manufacturer's design.

being used to attach the pilot ladder to the side of the ship. Coast Guard Investigating Officer, LT Paul Schachtner confirmed that the OSG Ship Superintendent, Mr. Pat Callahan, issued an order to stop using the modified devices and to return them to their original configuration.

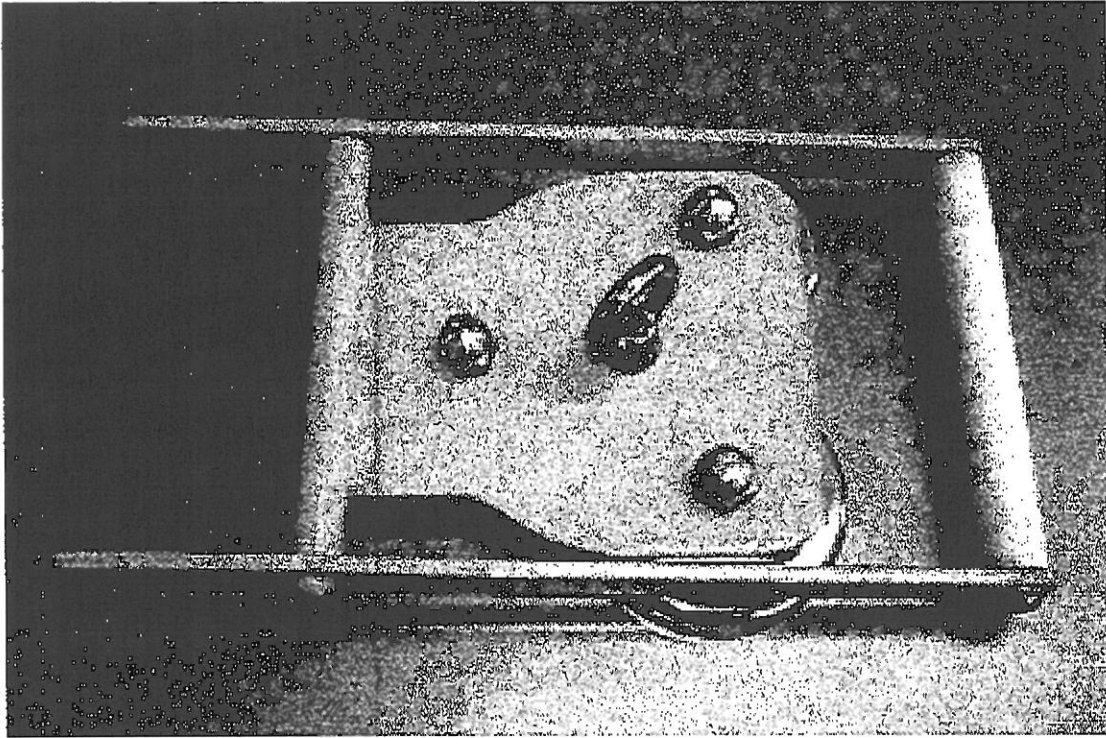
PILOT LADDER
MAGNET

DESCRIPTION OF CIRCUMSTANCES: CAPT WAJ BOARDED THE "O/S BOSTON" APPX
10:05. CAPT WAJ WAS BETWEEN THE 1ST AND 2ND RUNGS ON PILOT LADDER
WHEN THE LADDER RESTRAINT MAGNET — HOLDS PILOT LADDER TO GANGWAY
TO PREVENT MOVEMENT — CAME LOOSE AND FELL 5' TO 8' DOWN STRIKING
CAPT WAJ ON THE TOP OF HIS HEAD. CAPT WAJ WAS ABLE TO STEP BACK
ONTO THE PILOT BOAT EVEN THOUGH I BELEIVE HE WAS DISORIENTED.
JEFF RUSHTON AIDED CAPT WAJ INTO PILOT HOUSE AND ISSUED FIRST AID.
