Ref. No. Docket PG-070175

**Subject: 2007 Standard Inspection of Kittitas County Distribution System**

**WASHINGTON UTILITIES AND TRANSPORTATION COMMISSION**  
**2007 Natural Gas Pipeline Standard Inspection Report**  
**Puget Sound Energy – Kittitas County District**  
**Docket No. PG-070175**

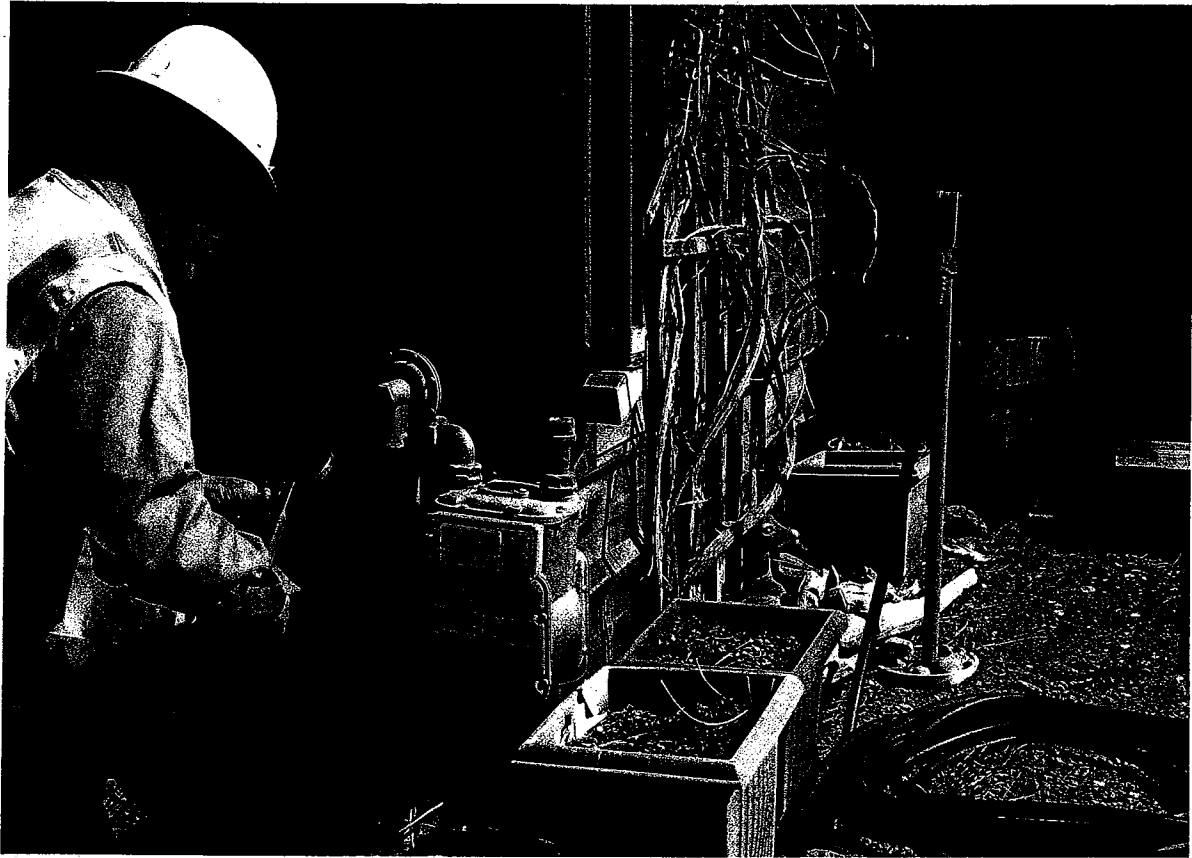
During the 2001 inspection (Docket No. 010854), meter sets were found at residences in Kittitas County that were not gas customers. PSE removed those meter sets after the inspection. During this inspection, six year later, additional meters were found that are not used or useful without the customer's fuel lines. Again, the meter sets are not adequately supported (Refer to photo on next page).

**Data Request:**

Please provide a complete list of locations where the service lines are in-place and not providing service. How many of these service lines have meter sets which are not connected to a fuel line?
