**RE: Letter from Mike Hale, Boise, Inc., dated October 10, 2012
Docket UE-121680**

As part of MEHC transaction commitment Wa25 (Transaction Commitment), PacifiCorp committed to take specific actions described in the Cascade Kraft Substation Outage and Power Quality Study dated January 10, 2005 (2005 Study).² PacifiCorp committed to certain action items to increase power quality and improve reliability to Boise's facility in Wallula, Washington.

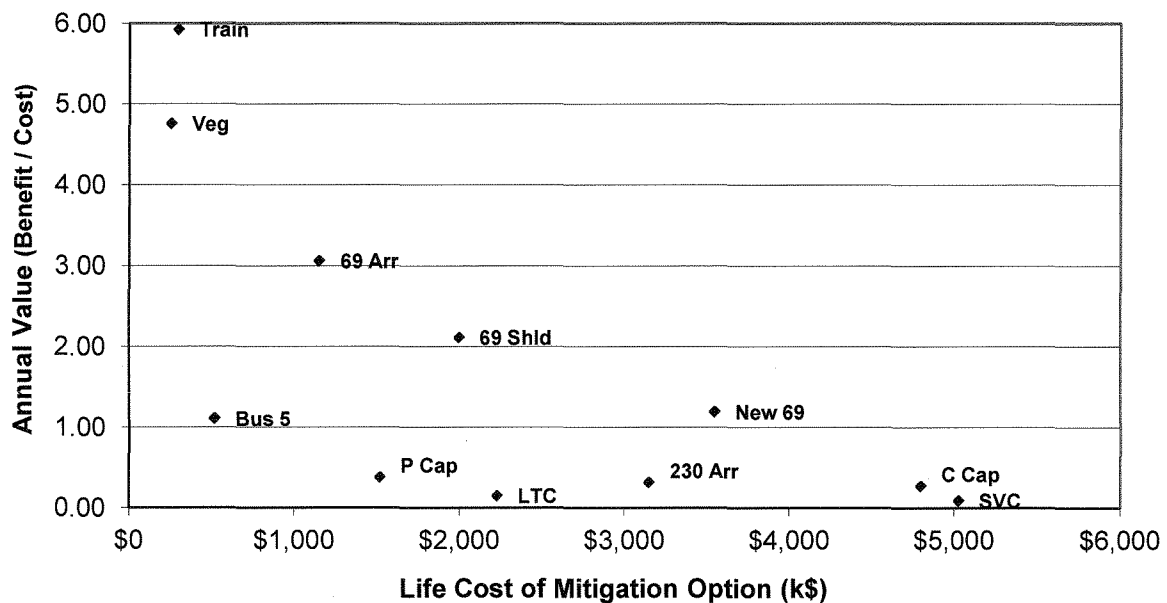
Figure 3.1

Bang / Buck vs. Total Cost
Boise-Cascade Wallula Plant Mitigation
Without 2 Highest-cost Options*
 *DVR & New 230 kV Line

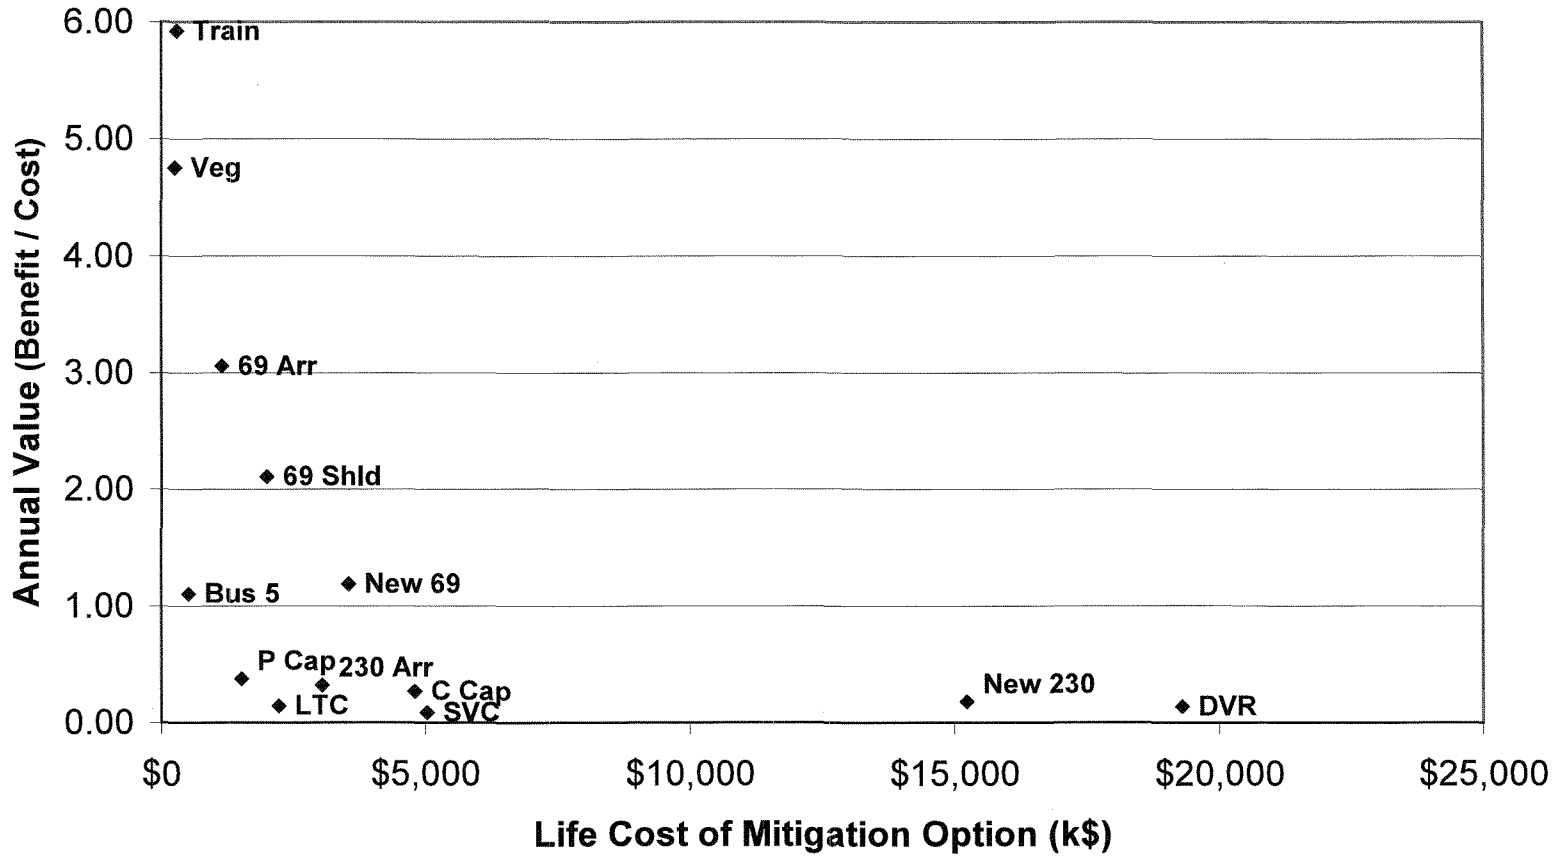
Bang / Buck vs. Total Cost Boise-Cascade Wallula Plant Mitigation Options

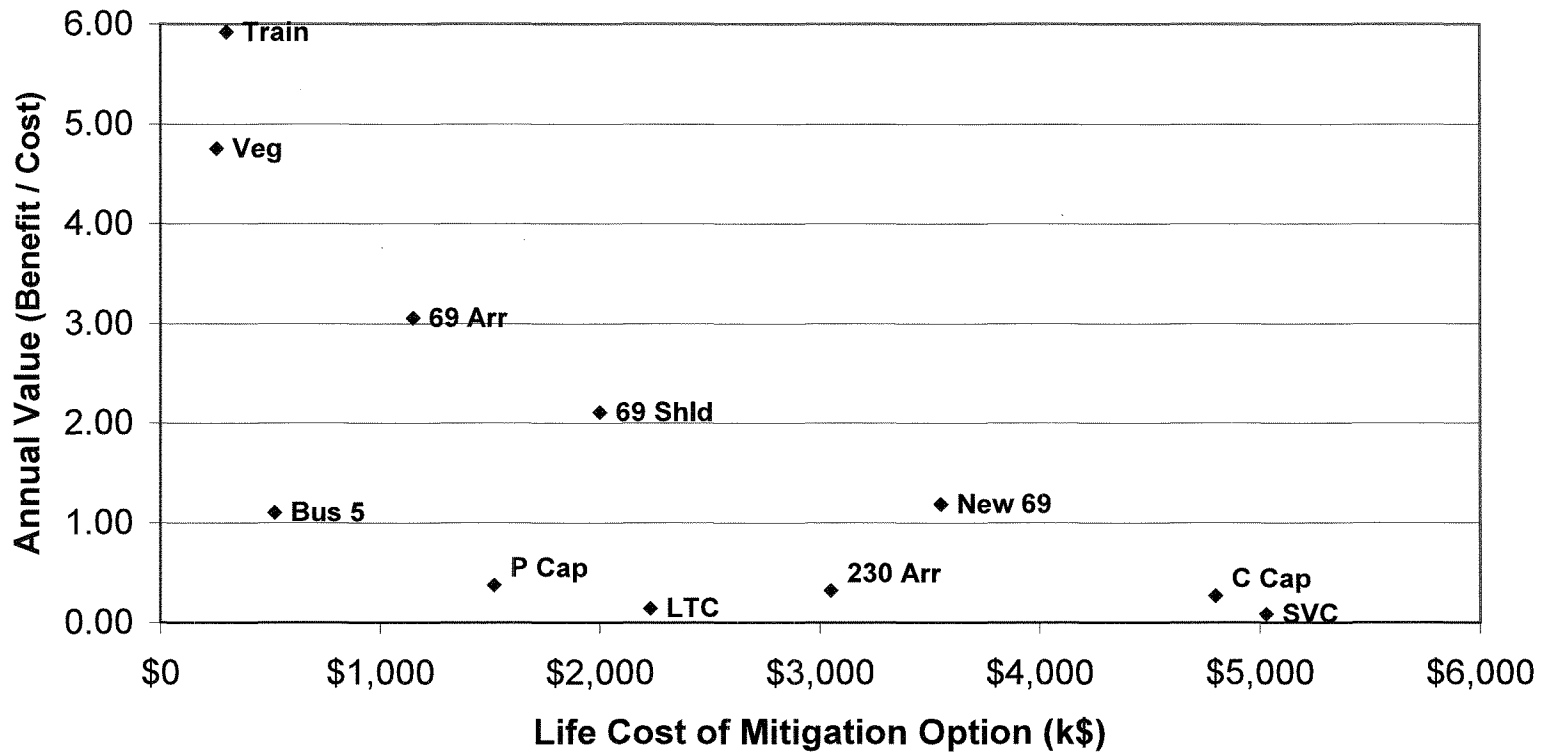
Bang / Buck vs. Total Cost Boise-Cascade Wallula Plant Mitigation Without 2 Highest-cost Options*

*DVR & New 230 kV Line
