**Subject: Annual Flow Meter and Outfall Inspections, NW Natural Source Control Groundwater Treatment Facility, 7900 NW St. Helens Road, Portland, NPDES Permit Number 103061 (permit renewal application pending)**

## DIVE INSPECTION REPORT

NW Natural - Gasco Willamette River Outfall Diffuser  
Inspection

NW Natural Gasco Willamette River Outfall Diffuser Inspection

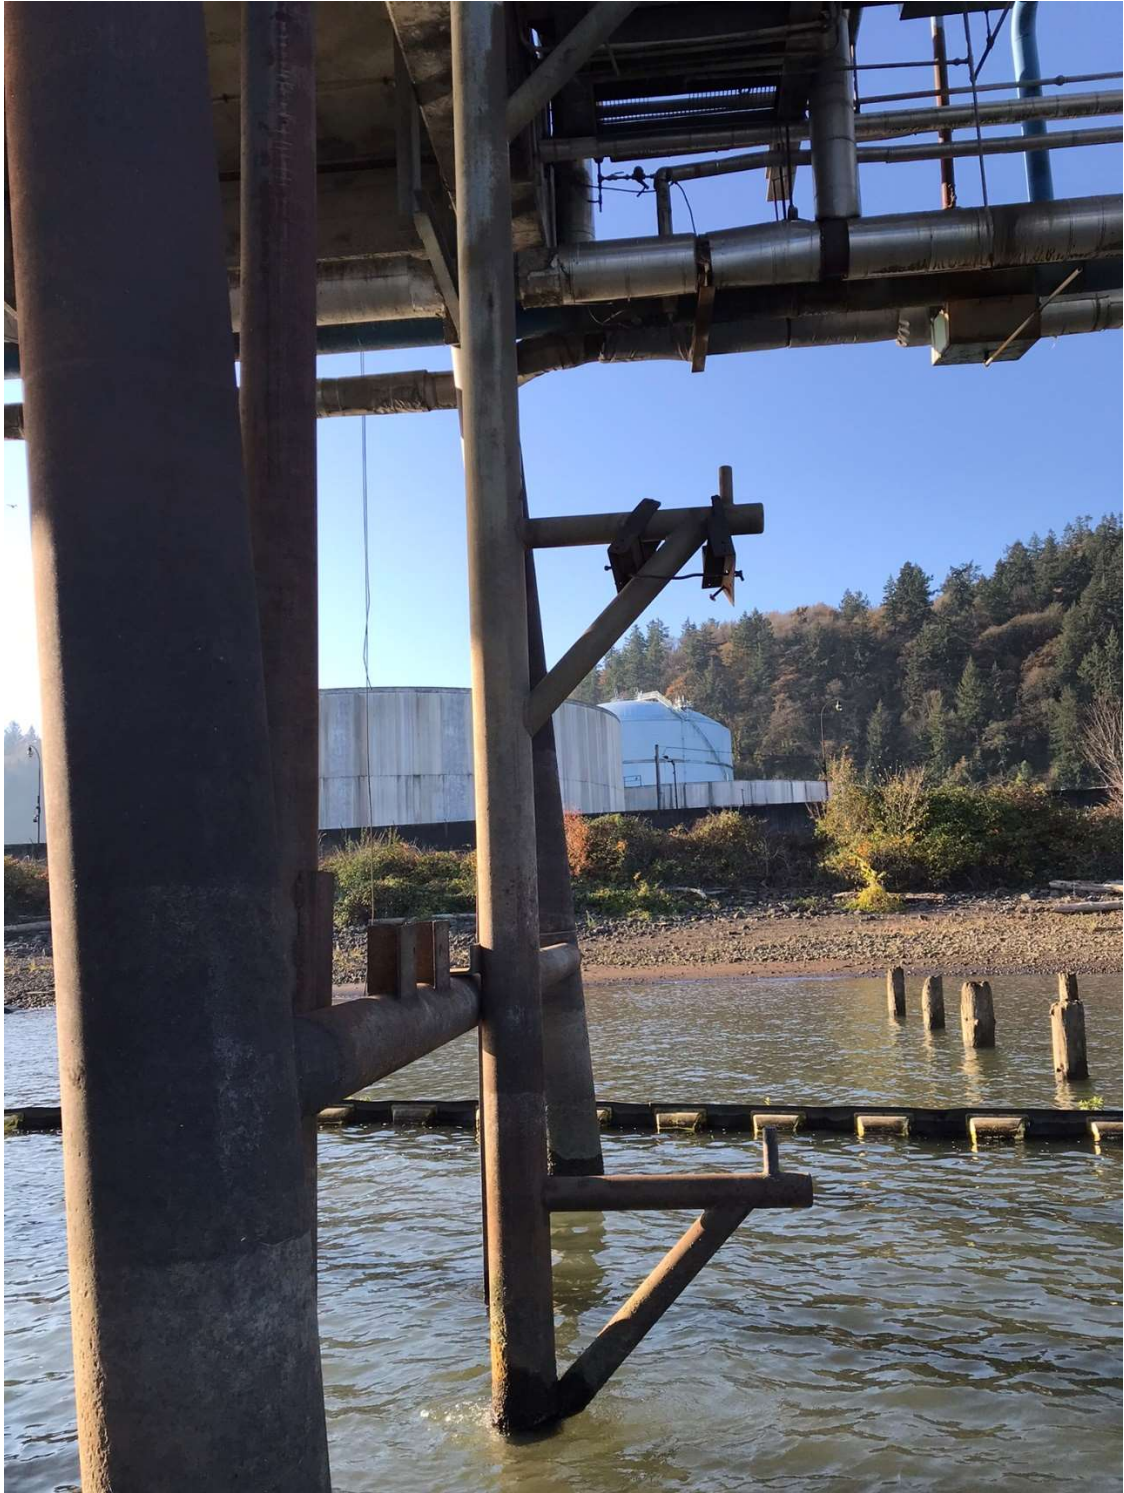
- Pipe had both minor corrosion and marine growth build up present.
- The overall integrity of the pipe was determined to be good with no discrepancies noted.
- Pipe was securely hanging in the water column with very little movement when checked by the diver.

**Figure 2 - Gasco outfall as it enters the water.**

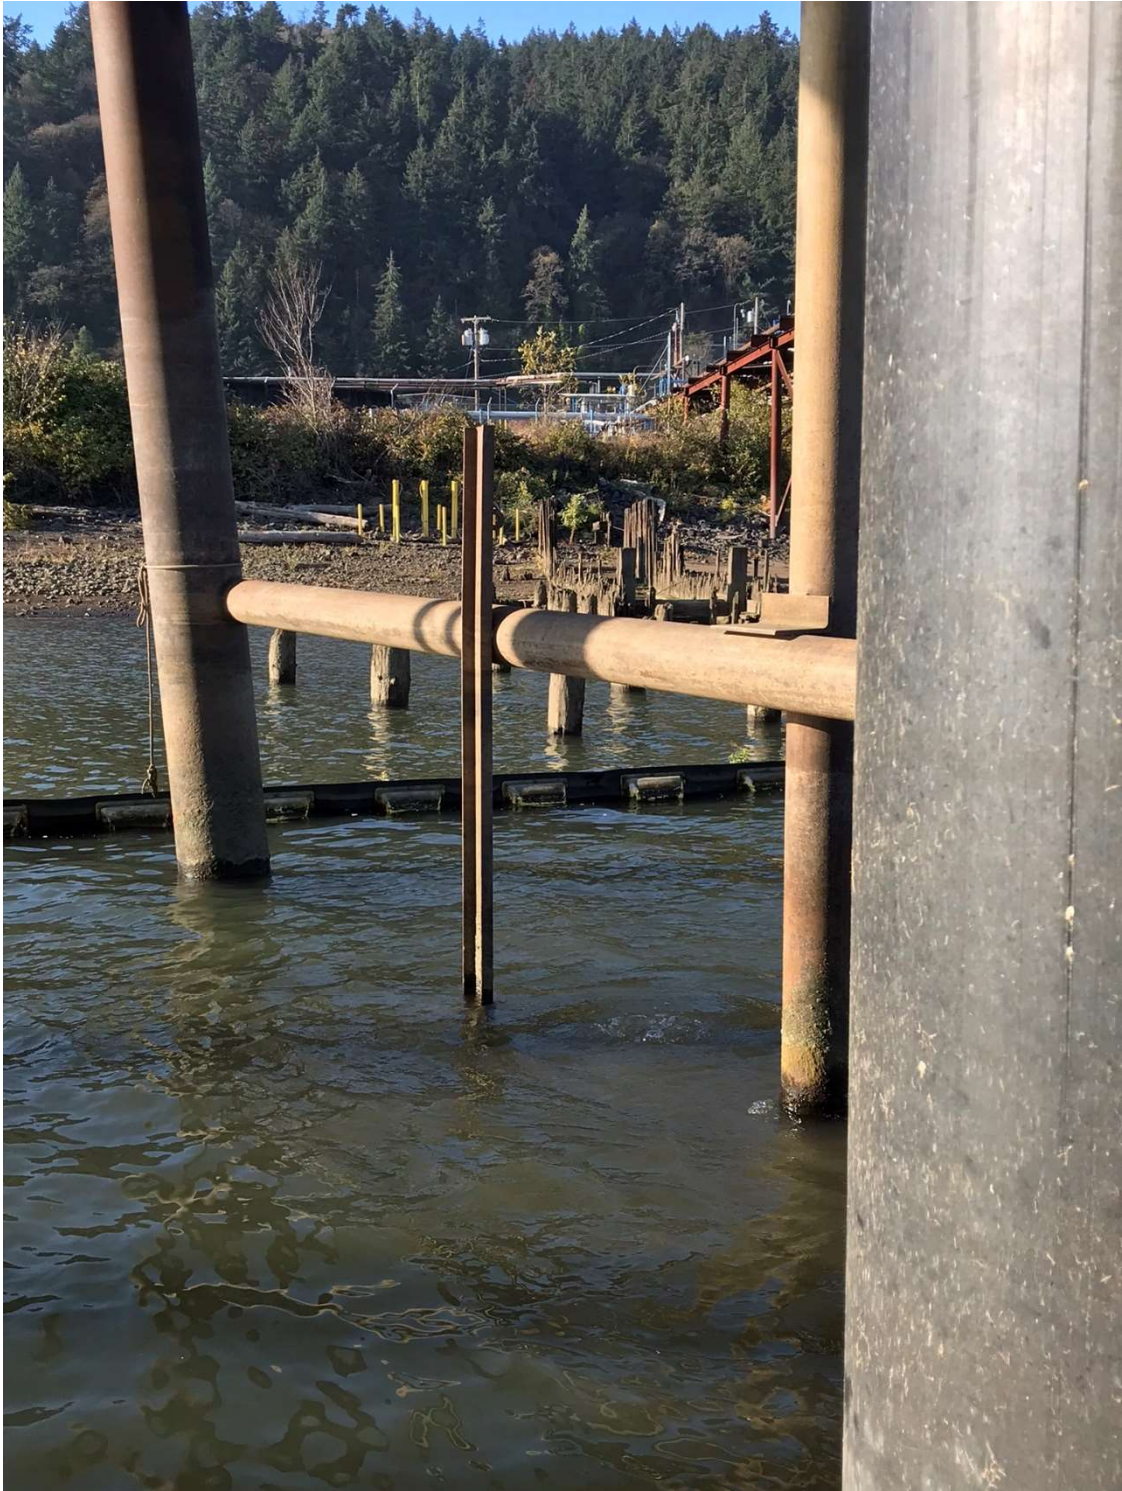
- Above surface horizontal support welded to 8" outfall pipe was in good working order with no broken welds present.
- Below water vertical channel that is welded to 8" outfall pipe was in good working order with no broken welds present. The Below water section was covered with marine growth and minor pitting is present.

**Figure 3 - Outfall channel iron support.**

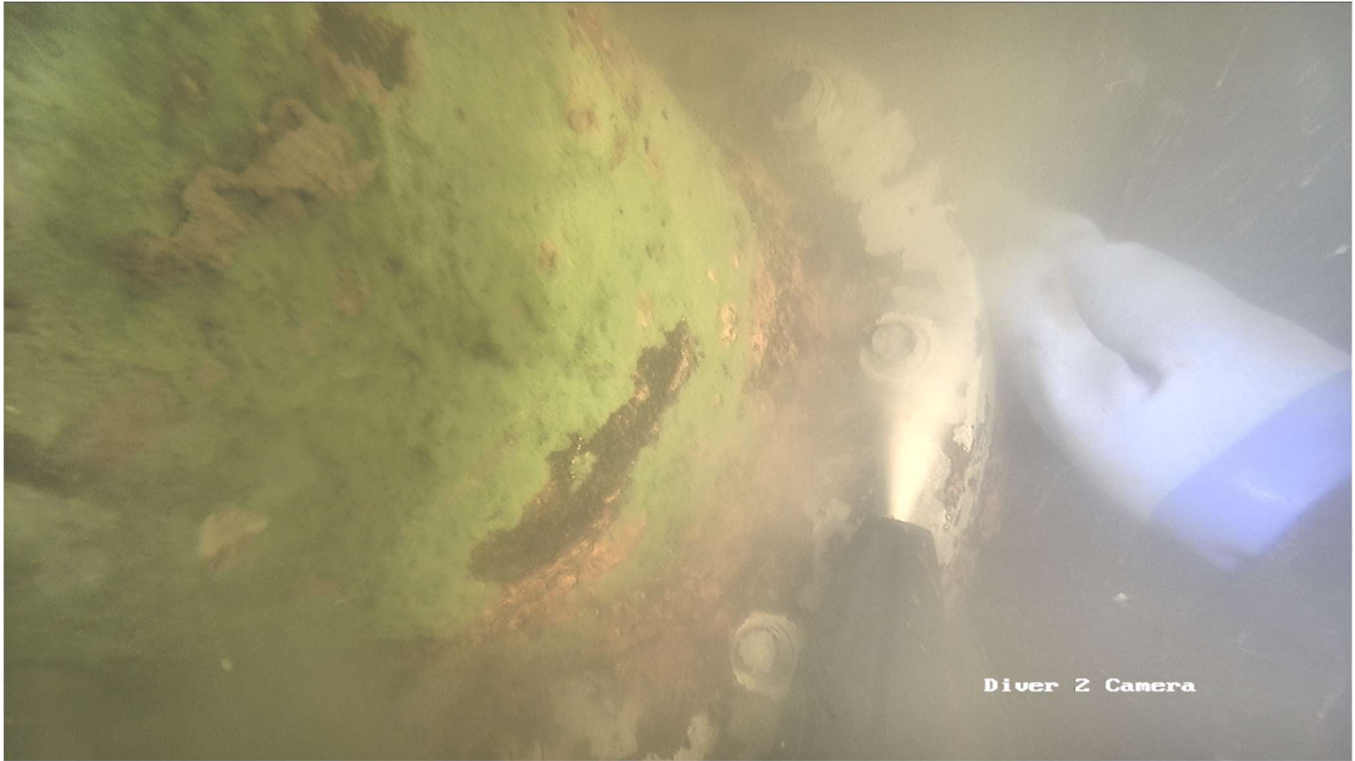
- Both the vertical flange that was installed prior to the 8" main pipe turns horizontal in water and the blind flange had all hardware present and tight. Hardware and flange corroded and marine growth build-up present.

**Figure 4 - AAC Diver cleaned the hardware and connections.**

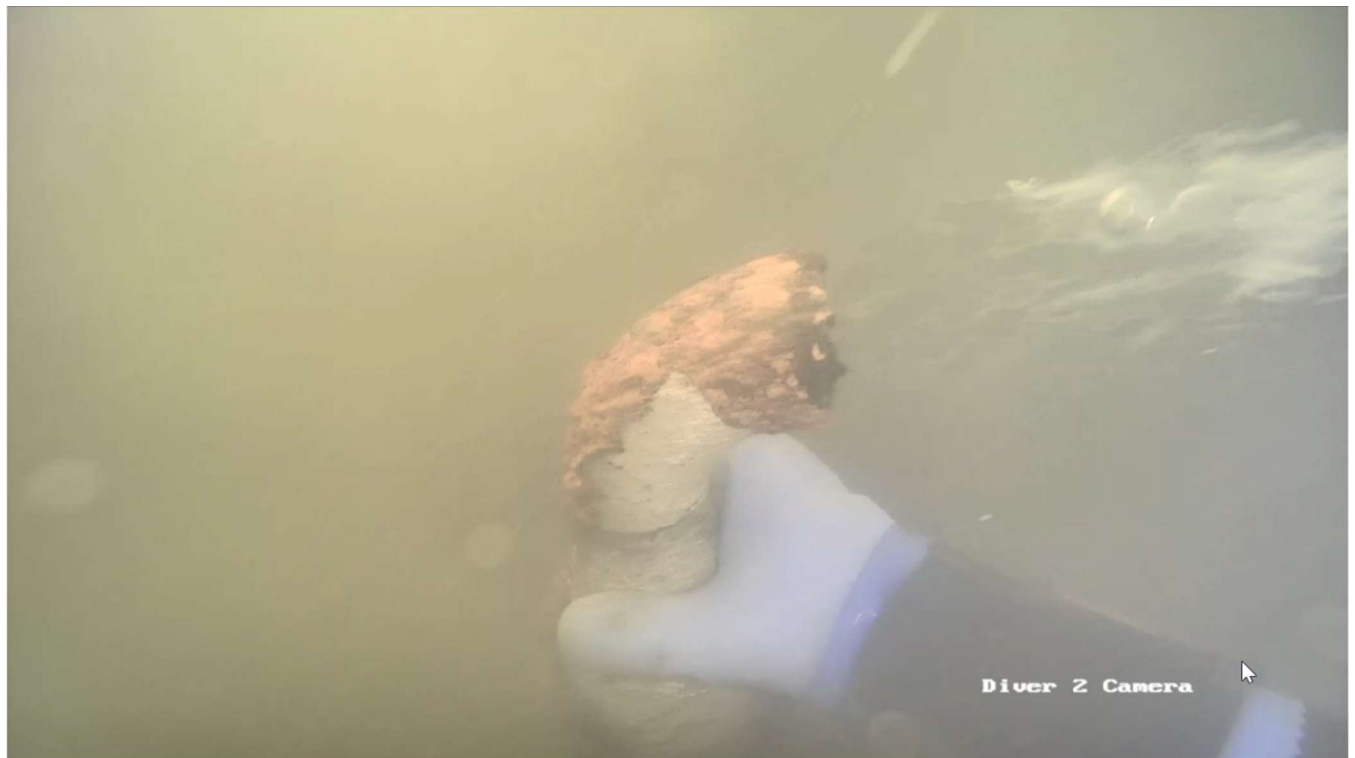
- Diffuser #1 – Welded connection to crown of main 8" pipe was in good condition with no cracks. Pipe had both rust corrosion and marine growth build up present. The diffuser was not obstructed, and no cover or screen was present. A light amount of air bubbles exited the diffuser with the effluent.

- The diver noted that diffuser #1 had the strongest flow and it began tapering down as he moved down to each diffuser with #4 being the weakest.

**Figure 5 - Flow from diffuser #1**

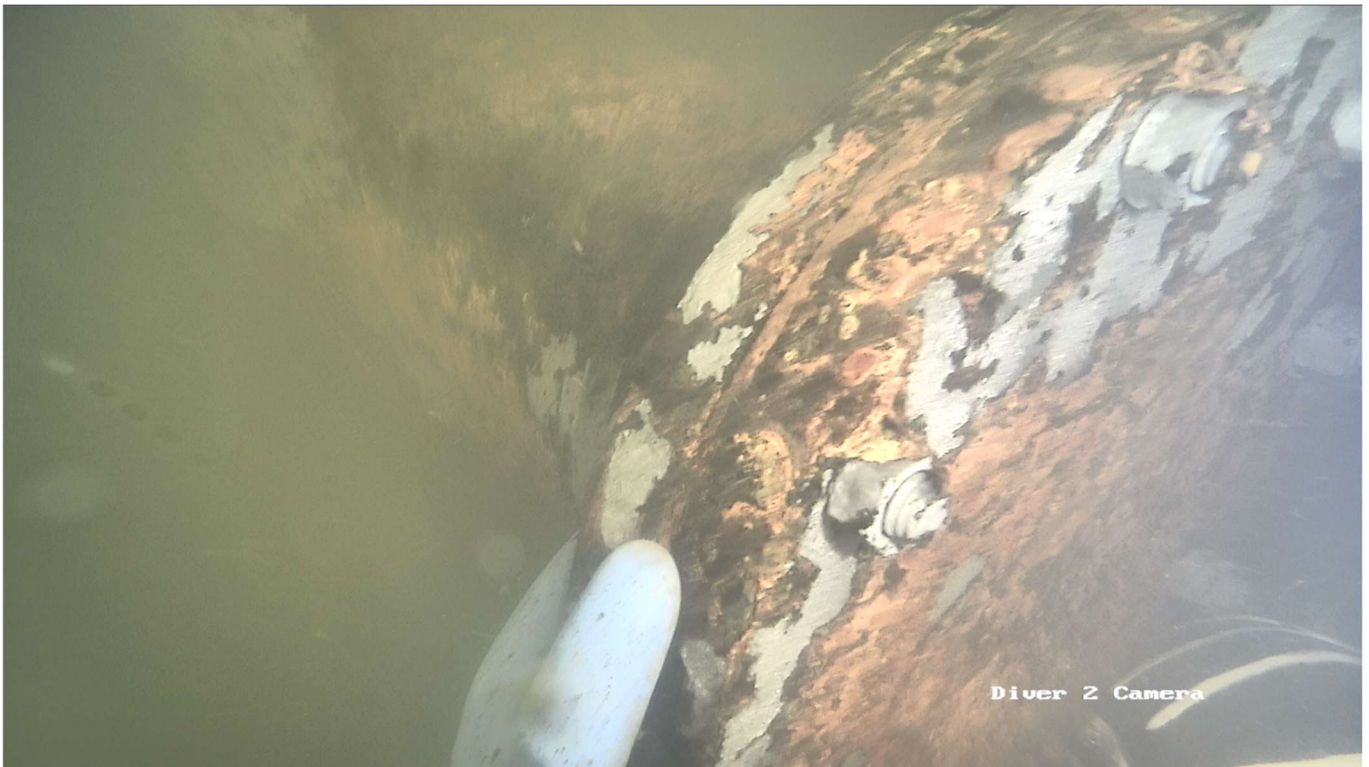
**Figure 6 - Blind flange hardware in good condition.**

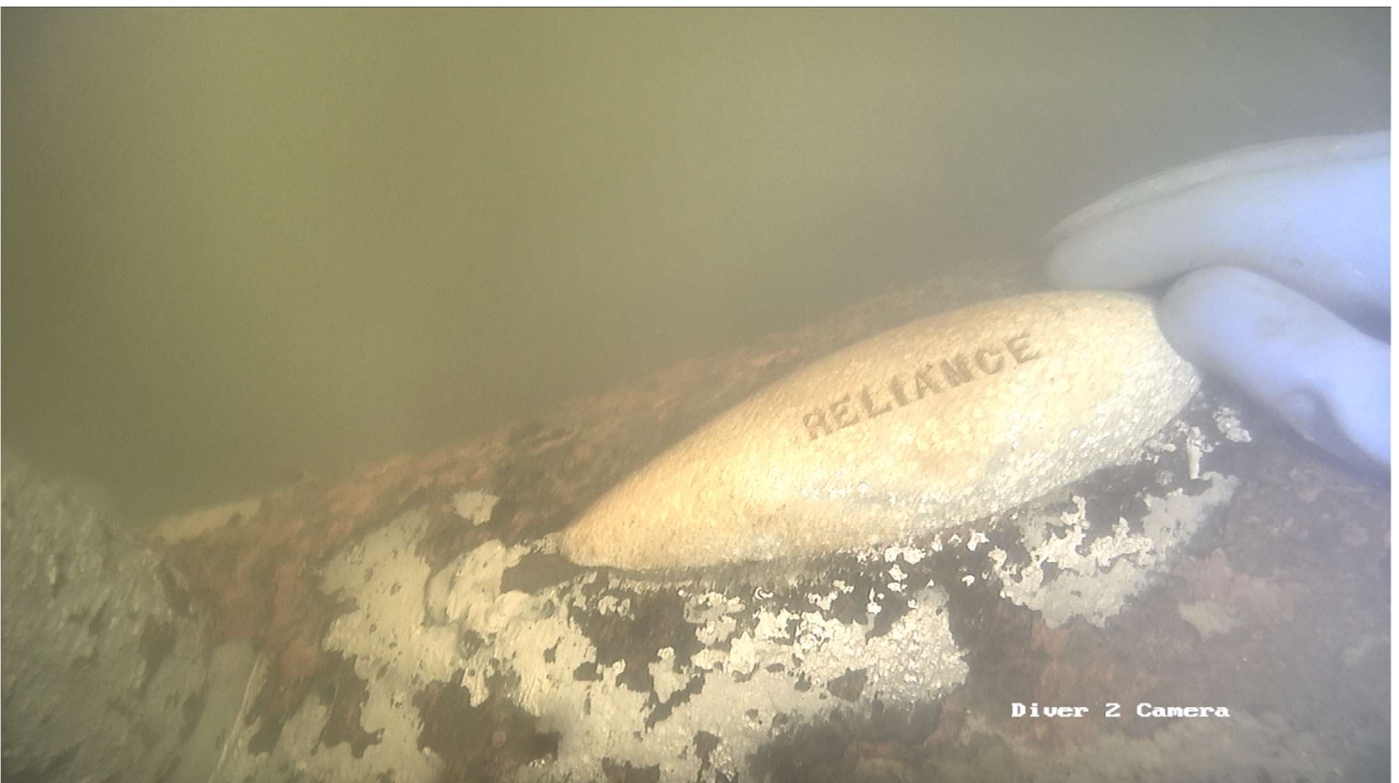
- An 8-pound sacrificial zinc anode was welded to the 8" mainline between diffusers #2 and #3 in 2020. The anode is in good condition with approximately 95% life remaining.
- The Diver reported minor pitting of the steel throughout the outfall estimating approx. 1/16" deep, virtually the same as observed in previous years. The sacrificial anode seems to be functioning as intended.

**Figure 7 - Sacrificial anode in good condition.**

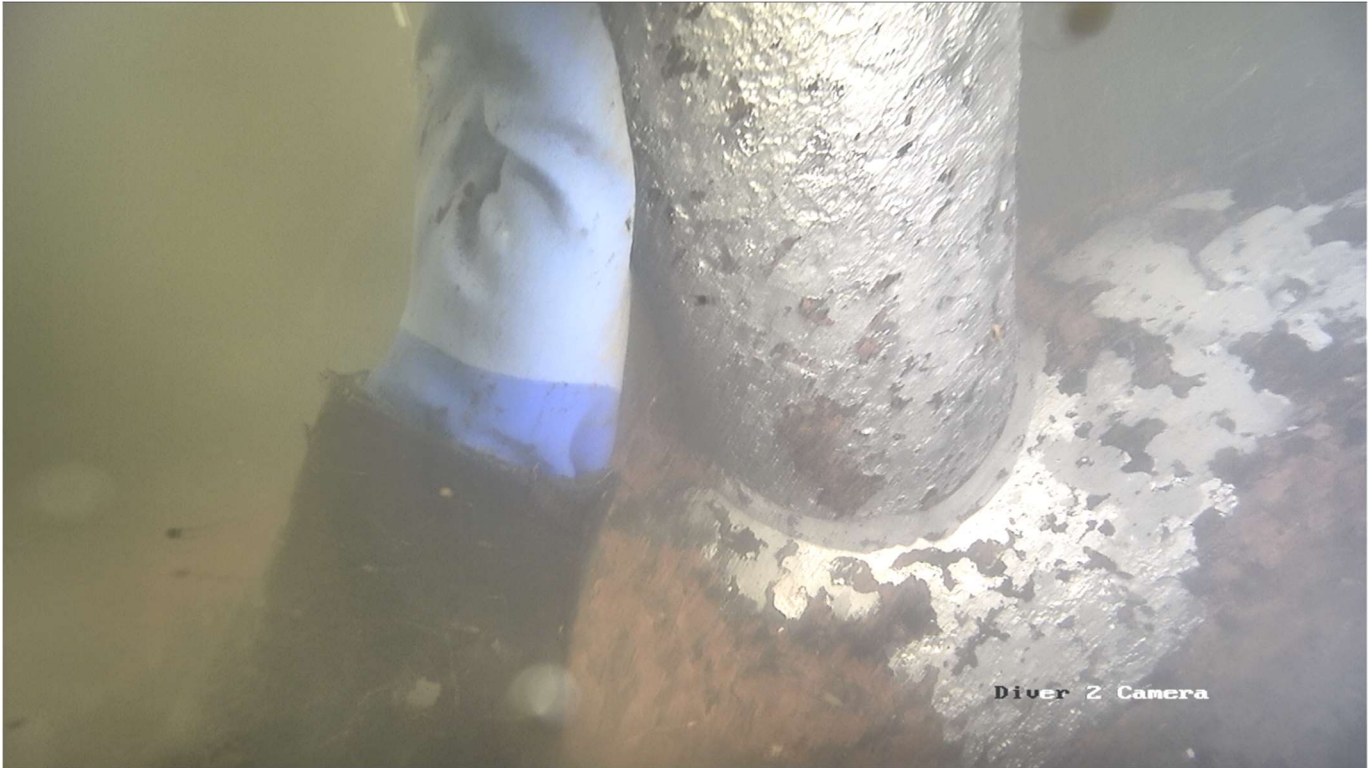
Figure 8 - Weld connection diffuser #1

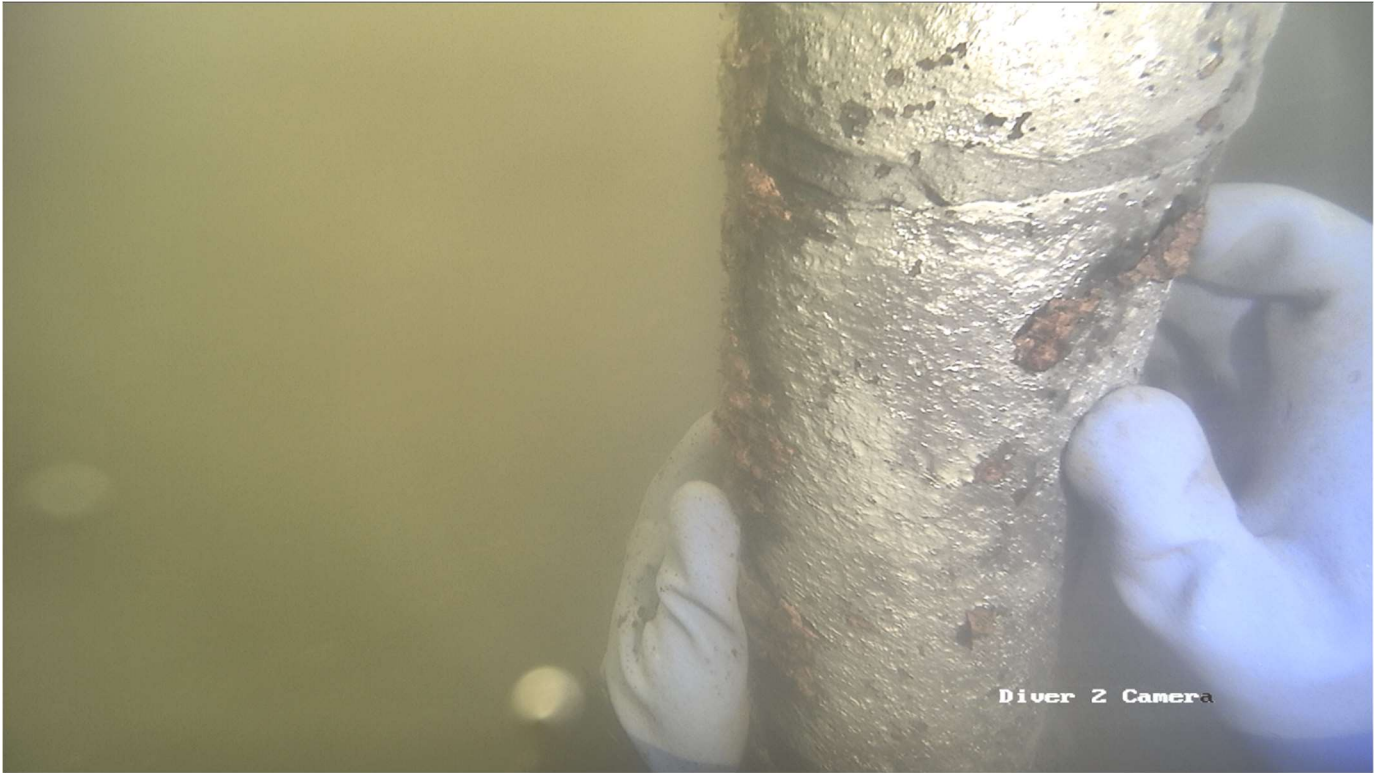
**Figure 9 - Minor pitting present (typical).**
