Exh. JDW-4 Docket UT-181051 Witness: James D. Webber

FCC Report Narrative, August 2019

December 27, 2018 CenturyLink Network Outage Report

A Report of the Public Safety and Homeland Security Bureau Federal Communications Commission August 19, 2019

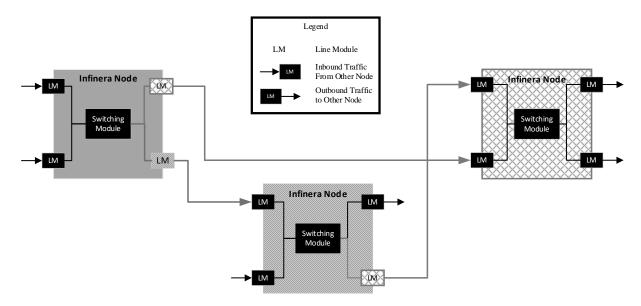
Figure 1: Conceptual Infinera Node Interconnection Diagram

inbound line module to the correct port on the correct outbound line module. This report refers to this successful traffic direction as "synchronization." Correct synchronization ensures the line modules internal to the node are mapped correctly. Lack of synchronization would cause network data to drop or be corrupted as either an inbound line module would send traffic to the wrong outbound line module, or an outbound line module would attempt to receive traffic from the wrong inbound line module. Figure 1 conceptually shows how the Infinera nodes, line modules, and switching modules act together to send and receive network traffic from other nodes across the country.

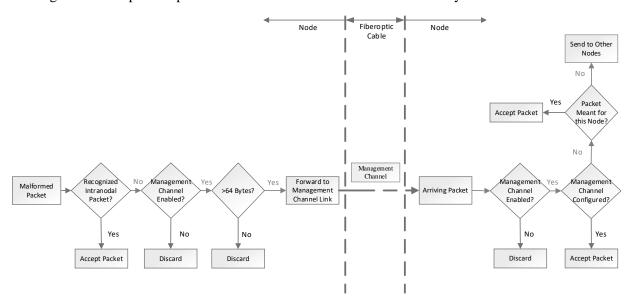
Figure 2: Malformed Packet Distribution Flow Chart

11. The switching module that generated the malformed packets sent them as network management instructions to a line module. Figure 2 illustrates how the malformed packets then flowed through the network.²² The packets were examined through a sequential series of conditions that produced either a "yes" or a "no" response. As shown in Figure 2, the malformed packets were able to pass each condition without being discarded. Because the packets were larger than 64 bytes, they were not stopped by the filter. Finally, while not shown, each malformed packet also passed the checksum condition, which is a test to determine if any errors occurred during the transmission of the packet, such as the changing of one or more bits in the message or if the message was randomly formed. As a result, the packets were transmitted along the enabled and unconfigured proprietary management channel.²³ The arriving malformed packets passed each condition at the nodes at which they arrived.

- 12. Due to the packets' broadcast destination address, the malformed network management packets were delivered to all connected nodes. Consequently, each subsequent node receiving the packet retransmitted the packet to all its connected nodes, including the node where the malformed packets originated. Each connected node continued to retransmit the malformed packets across the proprietary management channel to each node with which it connected because the packets appeared valid and did not have an expiration time. This process repeated indefinitely.
- 13. The exponentially increasing transmittal of malformed packets resulted in a never-ending feedback loop that consumed processing power in the affected nodes, which in turn disrupted the ability of the nodes to maintain internal synchronization. Specifically, instructions to output line modules would

lose synchronization when instructions were sent to a pair of line modules, but only one line module actually received the message. Without this internal synchronization, the nodes' capacity to route and transmit data failed. As these nodes failed, the result was multiple outages across CenturyLink's network.

- For unidentified failure modes, implementing filters can alleviate the impact of the failure. In this case, filters were designed to only mitigate specific risks. Thus, catch-all filters should be designed to only allow for expected traffic. In this event, the filter prevented transmission of packets 64 bytes or fewer over the proprietary management channel, regardless of packet content. Because other characteristics of the packet were not considered, the malformed packets were able to propagate.
