**Avista Corp.**

Re: Avista's Supplemental Response to Docket D-240262 - Notice of Opportunity to Respond

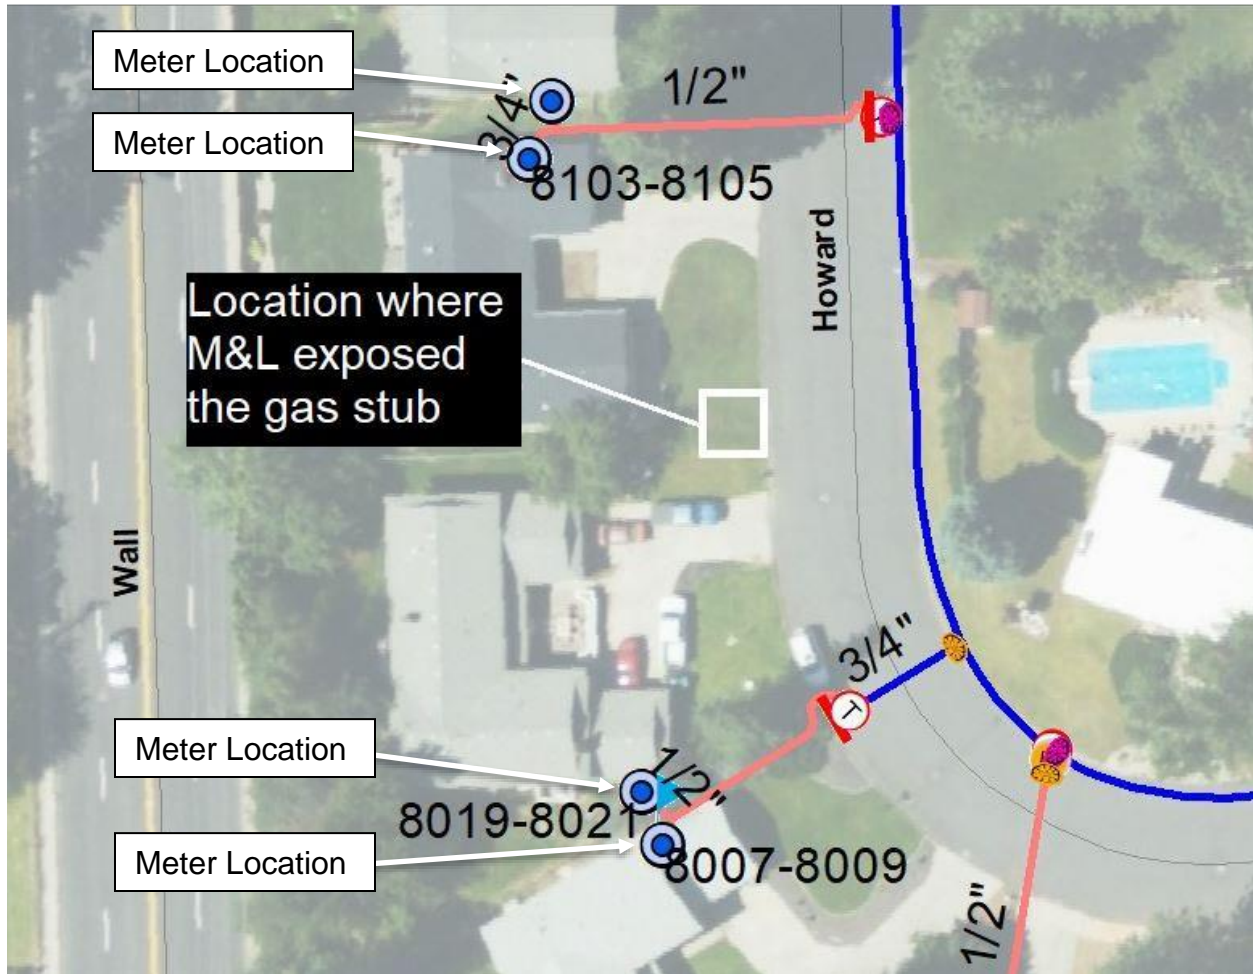
- While excavating, M&L Construction found an unmapped underground gas stub on the west side of N Howard St, at the joint property line north of 8021 and south of 8103 N Howard St.

- There was no digital or hard copy evidence of an underground facility in the area where the unmapped stub was uncovered at the time of the locate or the requestor’s excavation.

- There were no physical indications of a buried underground facility where the excavator found the unmapped gas stub. No valve cans, stub markers, gas meters, gas risers, pipeline markers, or previous locate markings were present.

Avista mapping showing the field location where the excavator found the unmapped stub.

As you can see, the two houses to the north and the two houses to the south of the location where the unmapped gas stub was uncovered are supplied with gas through split services on opposite property lines of the unmapped stub's location.

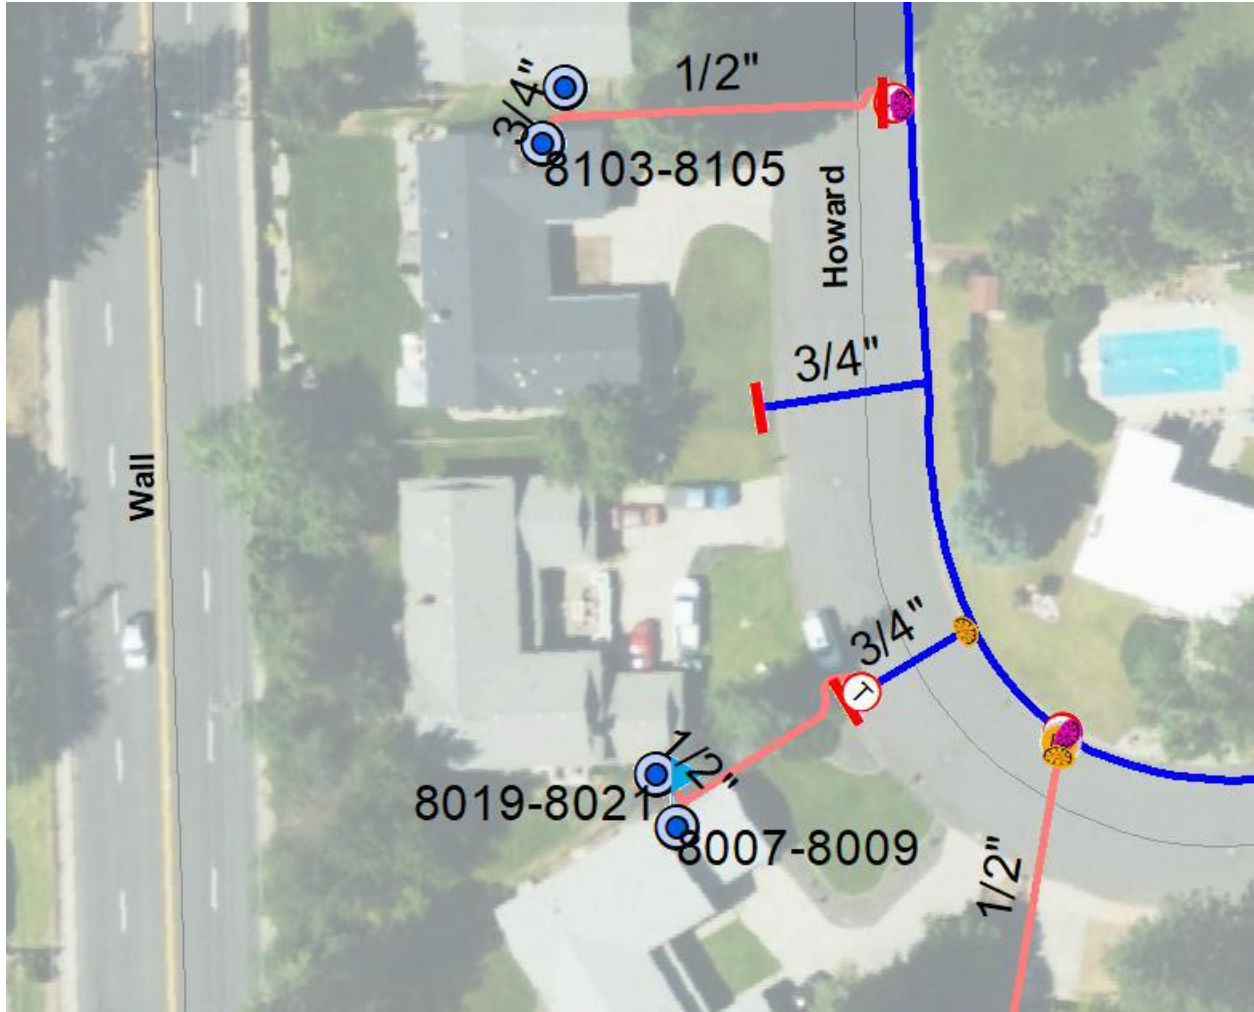
Mapping correction to include the previously unmapped stub.

- After Avista was made aware of the mapping error and the precise location of the gas stub from main to end point was determined, it was incorporated and mapped properly into Avista’s digital mapping system.
